ITB11-039a

## VOLUNTARY SAFETY RECALL CAMPAIGN 1997- 2003 QX4 IN SALT STATES LEFT FRONT STRUT HOUSING CORROSION

CAMPAIGN ID #: R1109  
NHTSA #: 11V-244  
APPLIED VEHICLES: 1997- 2003 QX4 (JR50)

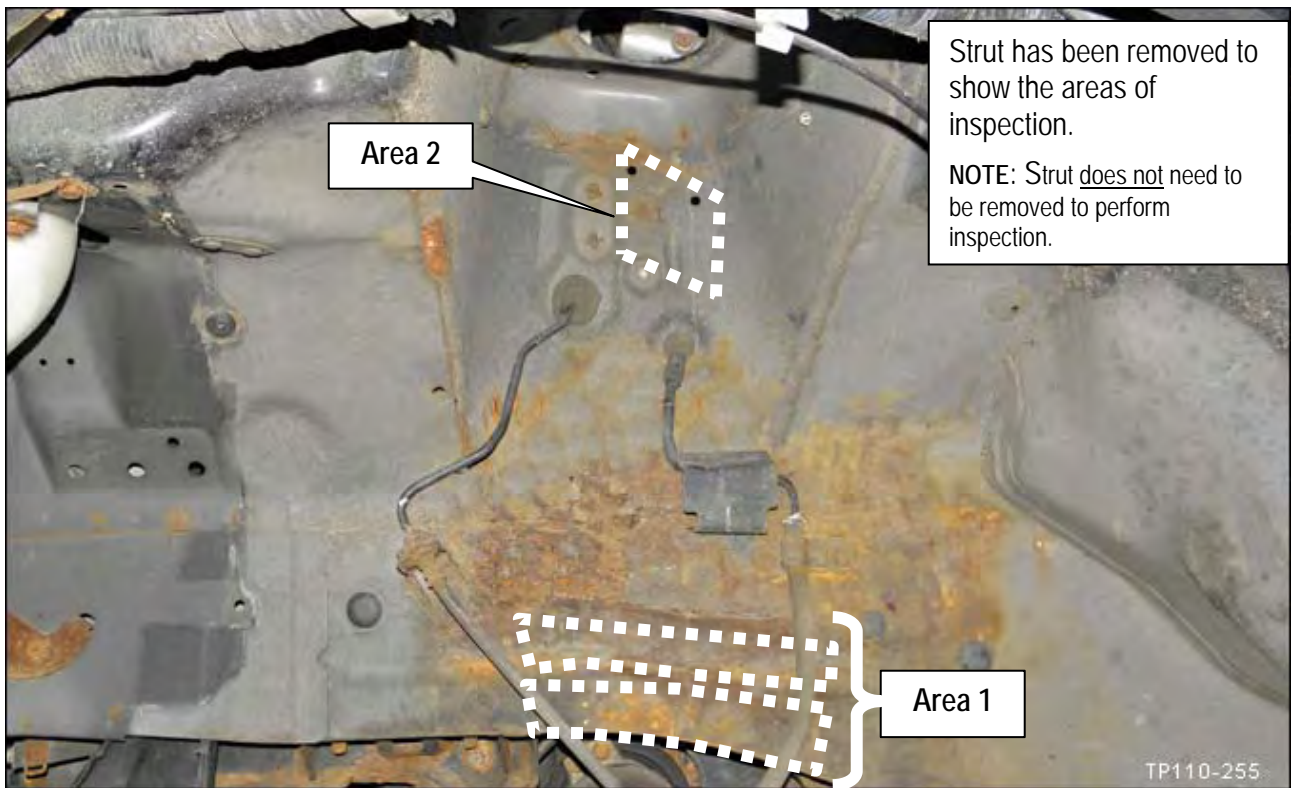
Figure 2

This photo shows the inspection areas in relation to the repair bracket installation.

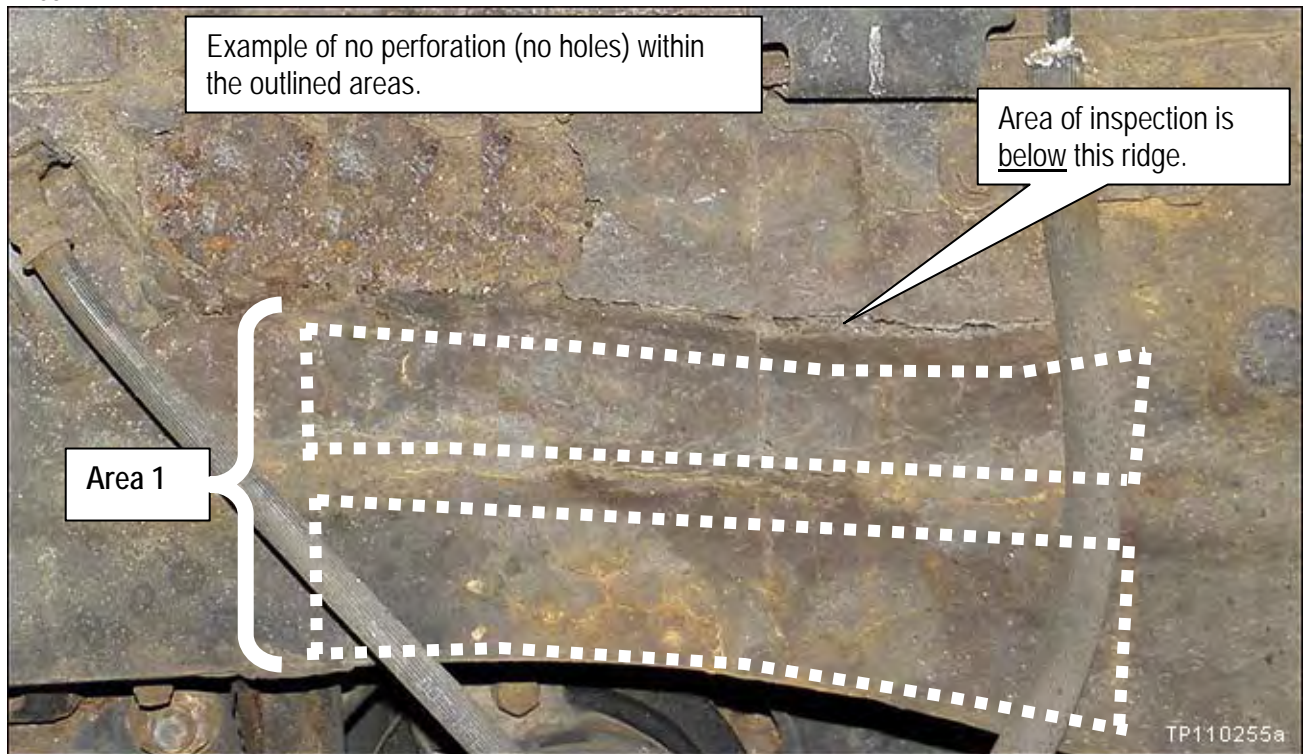
Figure 3

**Area 1:** Look for perforation (holes) in the metal only in the areas outlined above.

- Retain the vehicle at the dealer. (The vehicle is not repairable.)
- Supply the customer with a rental car.
- Fax a completed Non-Repairable Report to Morley (see page 53).

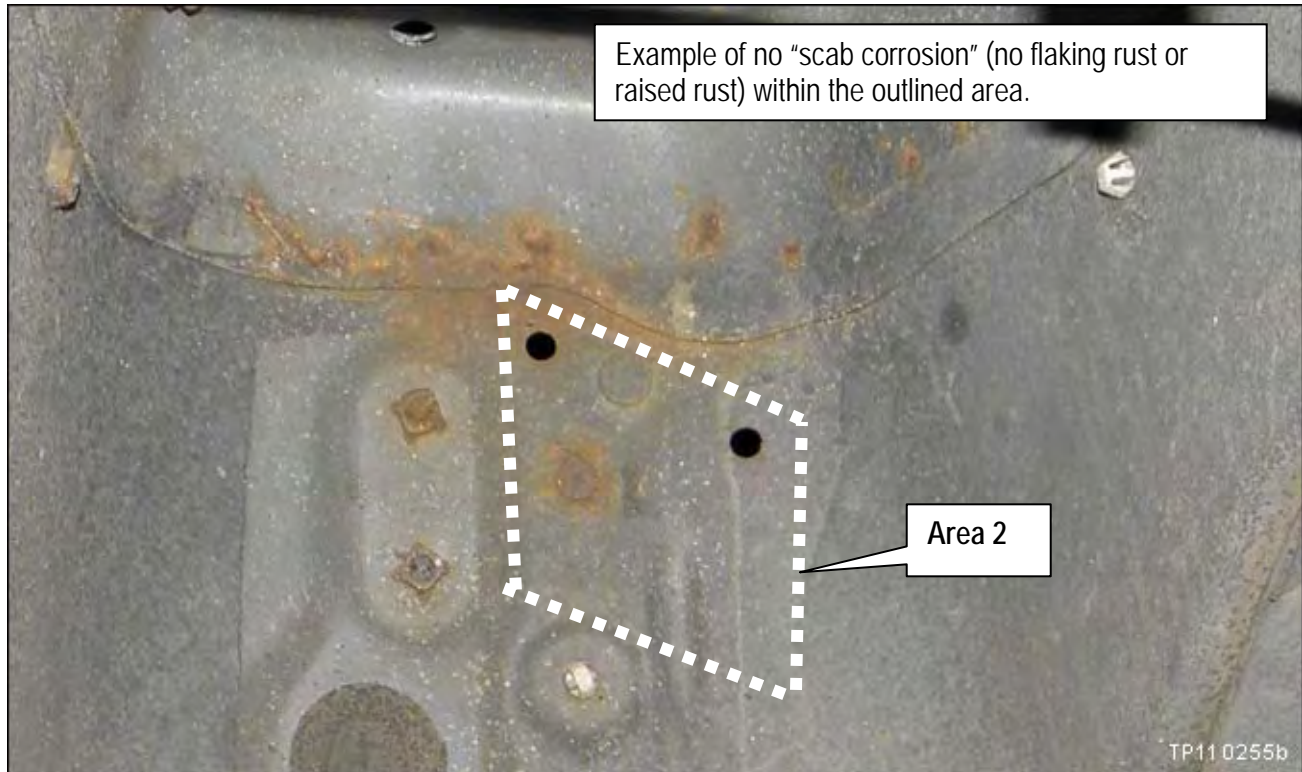
Figure 4

**Area 2:** Look for "scab corrosion" (flaking rust or raised rust) only in the area outlined above.

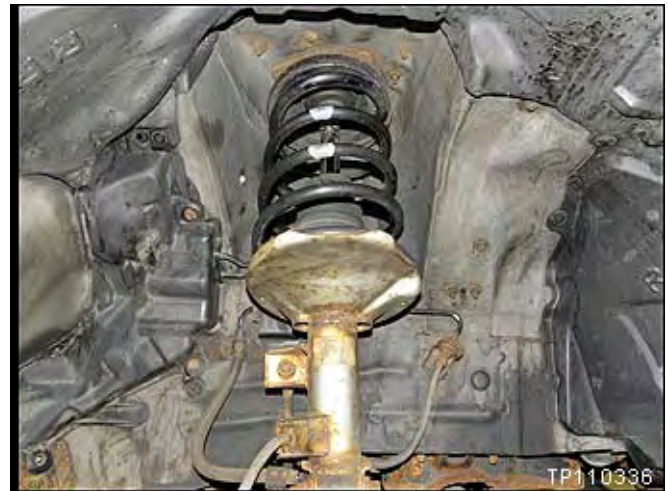
Figure 6

**NOTE:** Passenger side is shown, driver side is similar.

2. Visually inspect for corrosion and rust on the wheel housing panel and the strut housing panel (driver and passenger side).

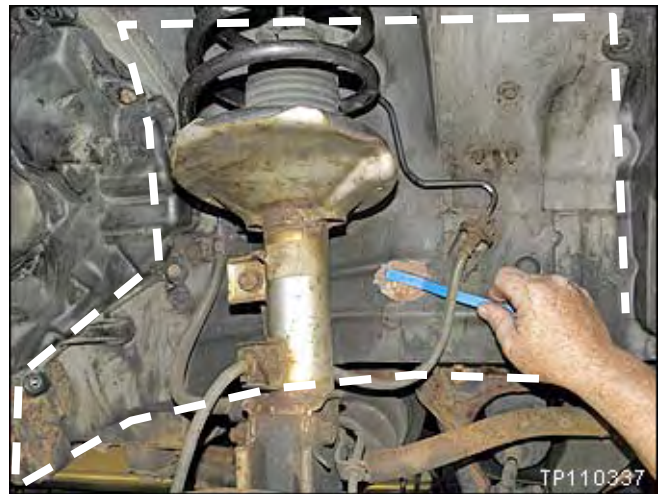
Figure 7

1. Use a wire brush to remove loose rust in the area shown with dashed line.
2. Clean dust, dirt, or other debris from the wheel housing and strut housing area.

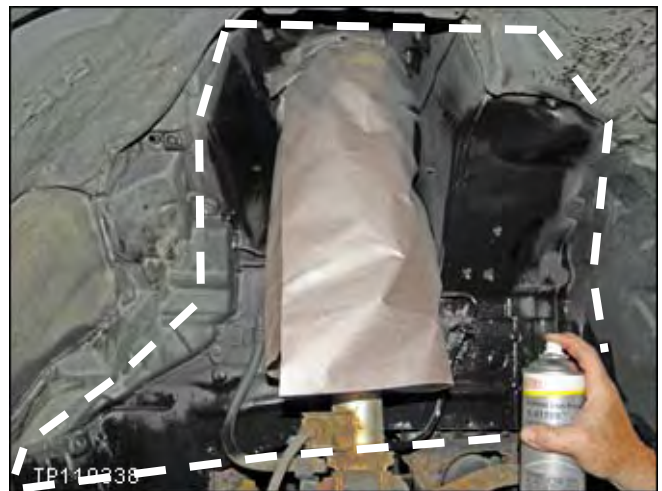
Figure 8

3. Cover the strut so it is protected from overspray.
4. Completely and liberally coat the strut housing and wheel house area with self etching primer.
  - Use Dupont Etch Primer (P/N A-4119S™) or equivalent.
  - Follow all product instructions.
  - Coat all of the exposed metal areas of the strut housing and wheel house panels.
  - A second coat may be needed for heavy rust spots.
  - Let each coat dry for 5 minutes.

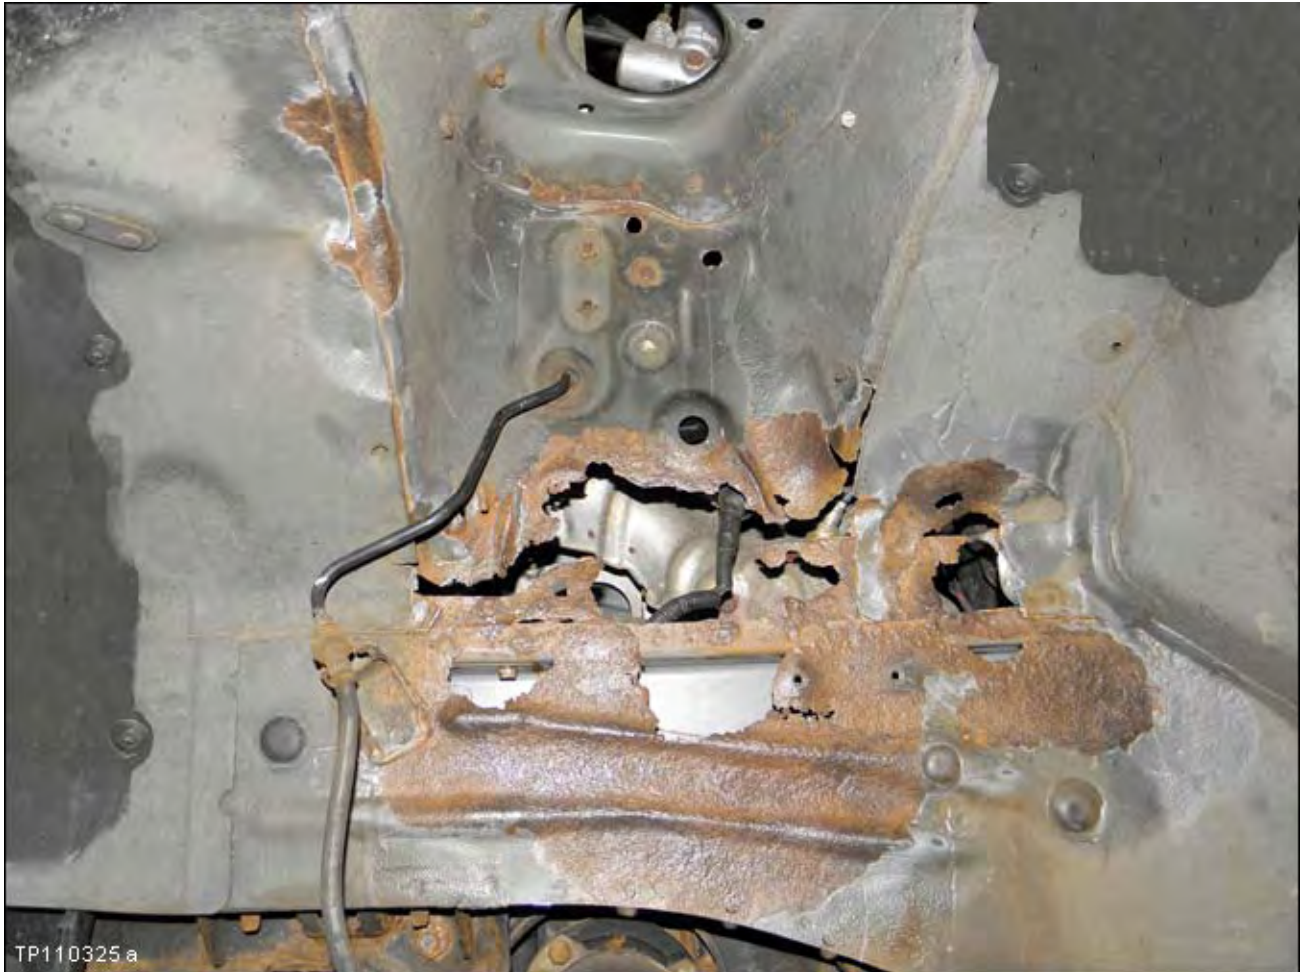
Figure RB3

4. Clean all the loose rust from the strut housing and wheel house areas (see Figure RB3).
  - Use an abrasive pad or other suitable tool.

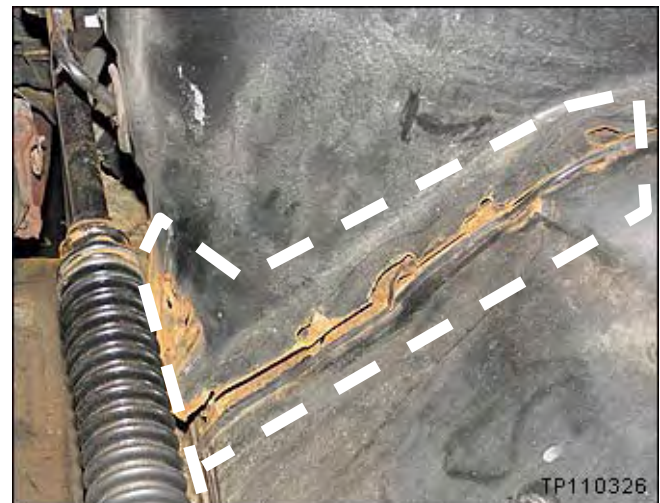
Figure RB5

7. Only if the strut housing panel is separated as show in Figure RB5:

Use a wire brush to clean any loose rust, paint, or other debris from the area shown with dashed line.

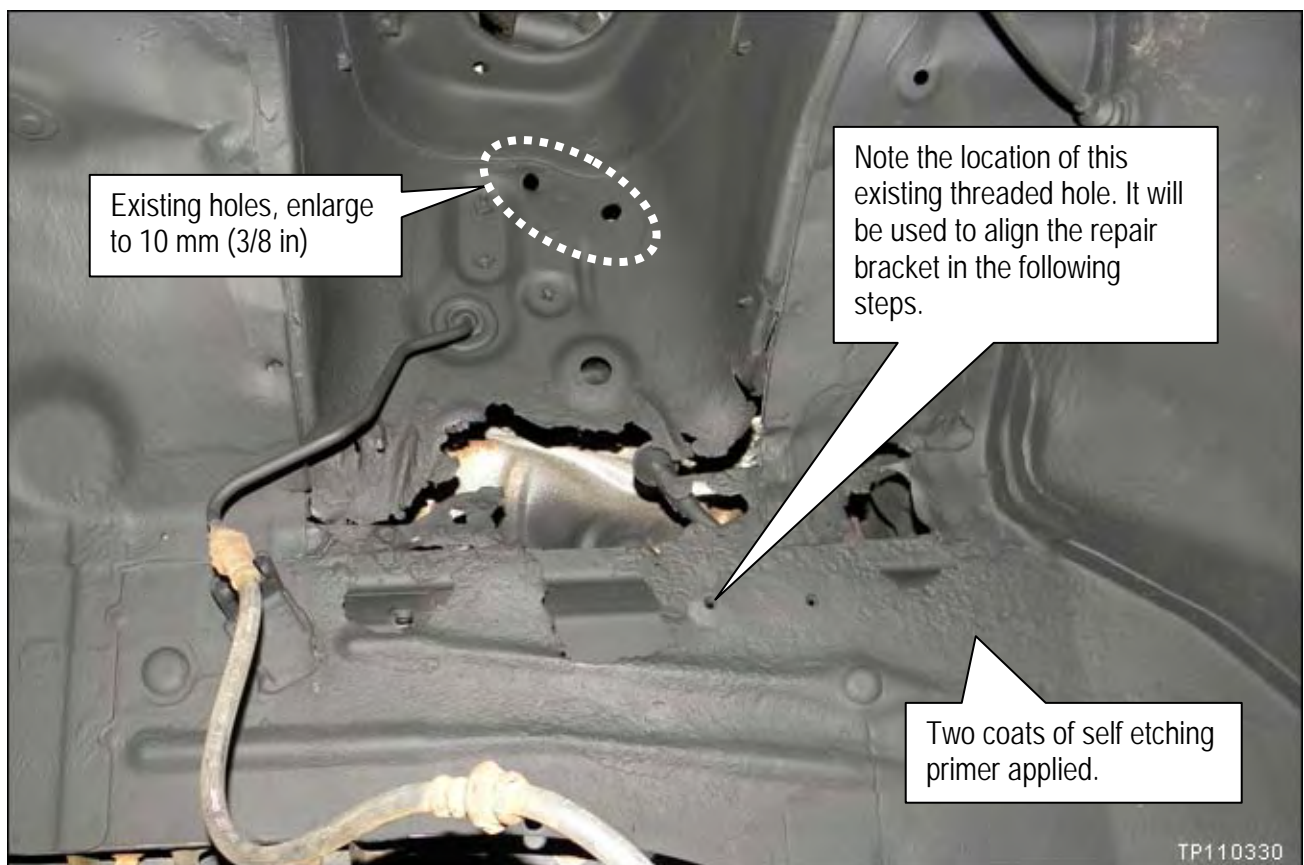
Figure RB7

13. With a drill bit, enlarge these two existing holes to 10 mm (3/8 in).

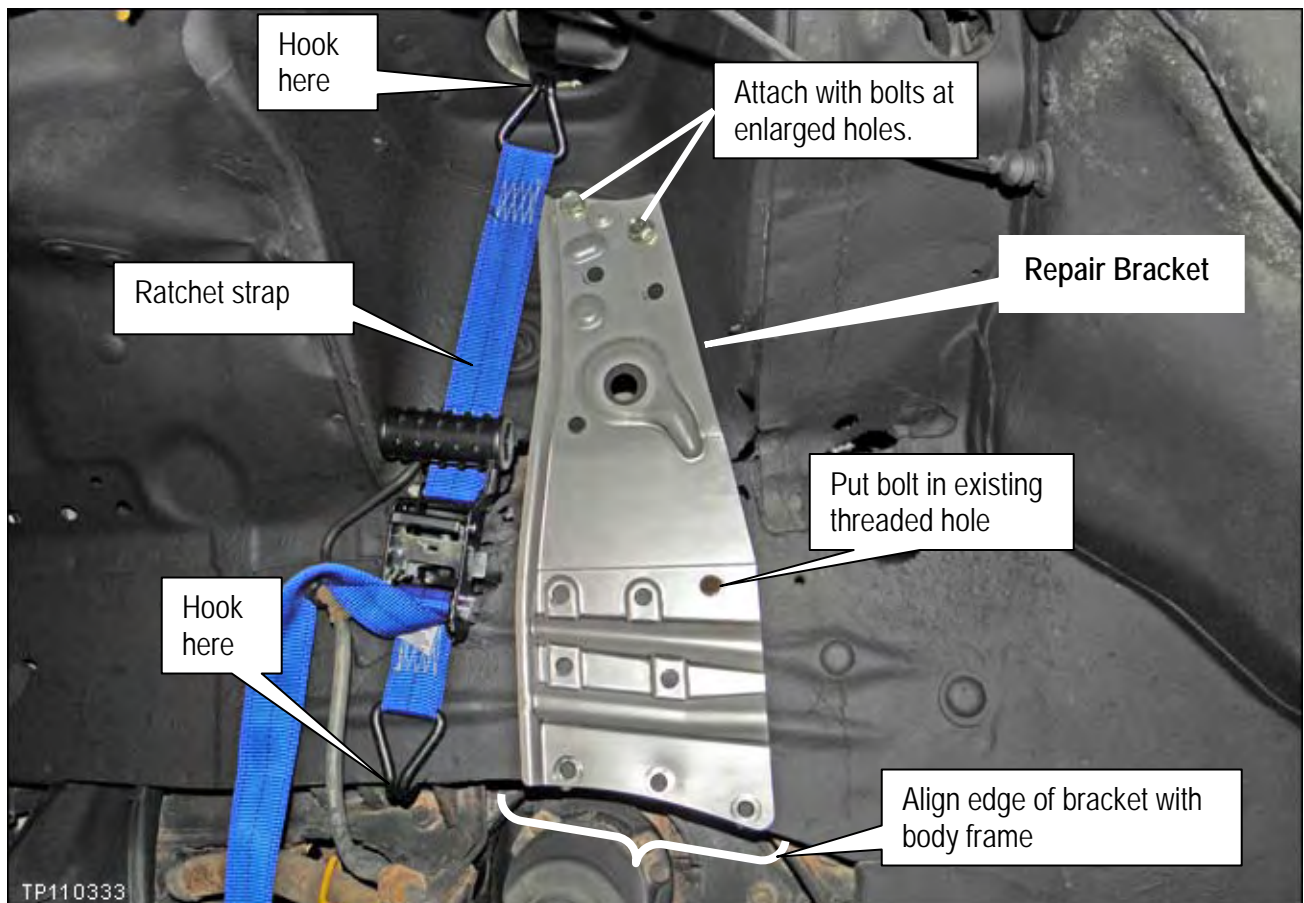
Figure RB8

14. Attach the repair bracket to the existing holes that you enlarged (see Figure RB8).
  - Repair bracket is part of the Repair Kit listed in the Parts Information.

- Use bolts and hex nuts from the Repair Kit.
  - Tighten the bolts/nuts finger tight.
15. Only if the strut housing panel is separated:
  - a. Attach the ratchet strap as shown in Figure RB8.

- b. Use the ratchet strap to pull the strut housing panel down until the existing threaded hole is aligned with the matching hole in the repair bracket (see Figure RB8).

**NOTE:** Photos for installation of the repair bracket show the ratchet strap being used. In most cases the strut housing panel will not be separated and the ratchet strap will not be needed.

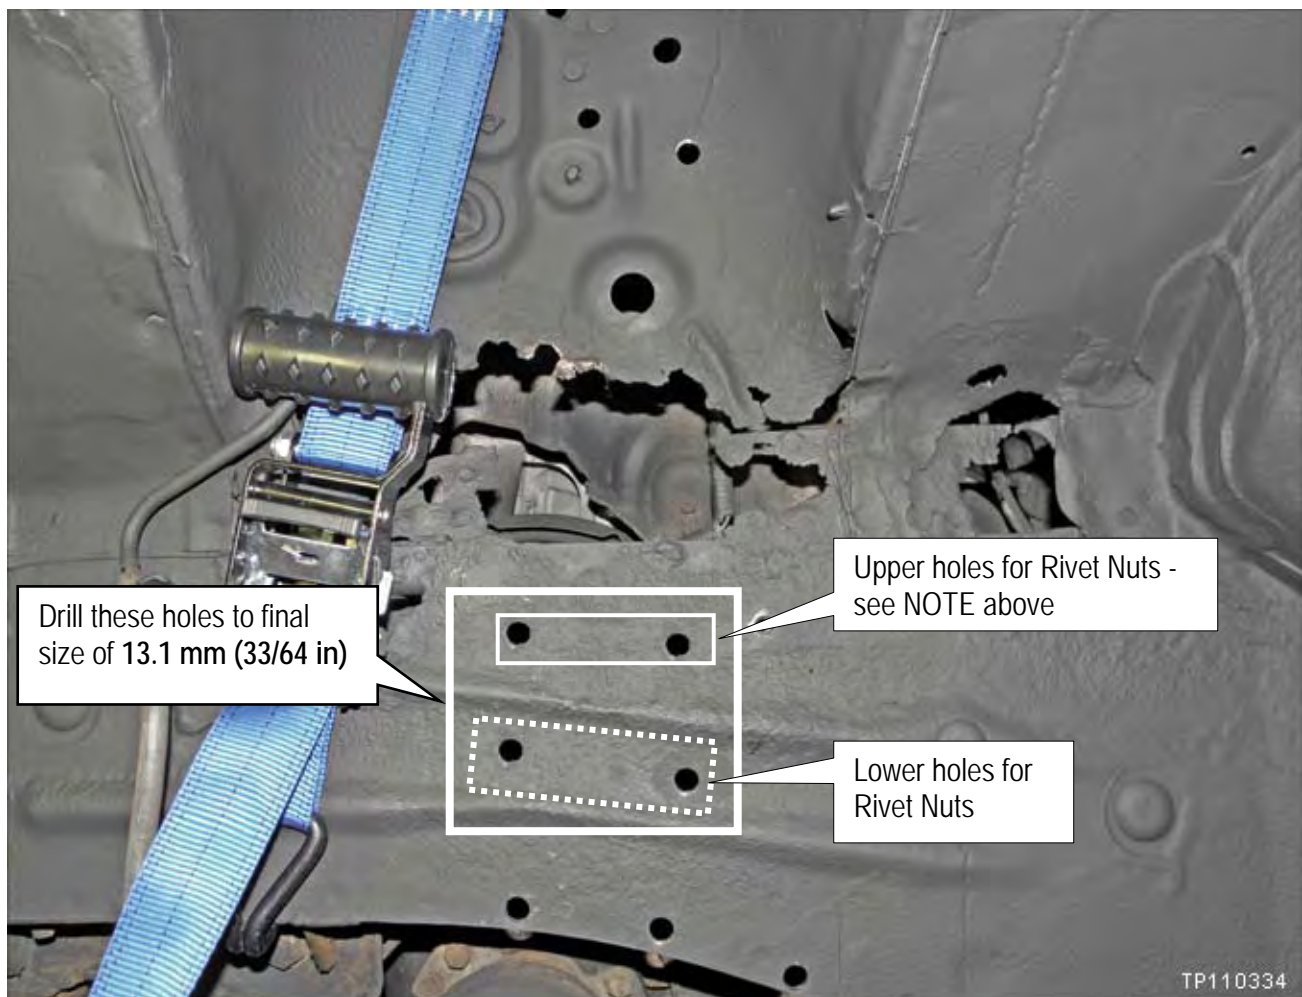
Figure RB10

If the metal in the area of the lower holes will not support the Rivet Nuts, then the vehicle is “not repairable”: Retain the vehicle at the dealer, supply the customer with a rental car, and Fax a completed Non-Repairable Report to Morley (see page 53).

**NOTE:** Upper holes – not required: If the metal in the area of the upper holes will not support Rivet Nuts, continue with the repair. Rivet Nuts are preferred but not required in the upper holes.

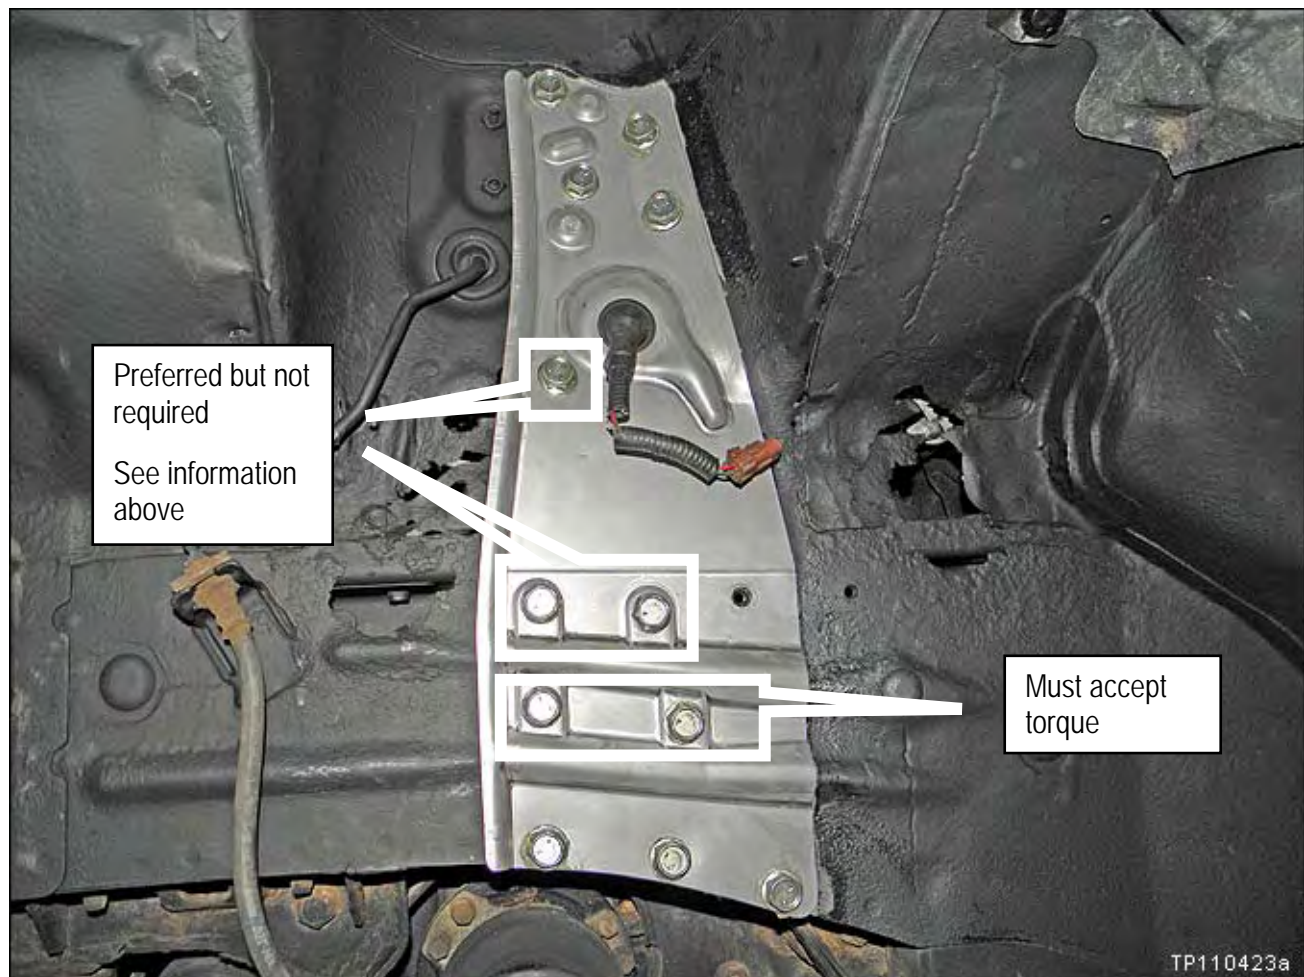
Figure RB25

- These bolts are required and must accept the torque value of 50 N•m (5.1 kg-m, 37 ft-lb).
- If these bolts will not accept the specified torque value, the vehicle is not repairable:
  - a. Retain the vehicle at the dealer.
  - b. Supply the customer with a rental car.
  - c. Fax a completed Non-Repairable Report to Morley (see page 53).

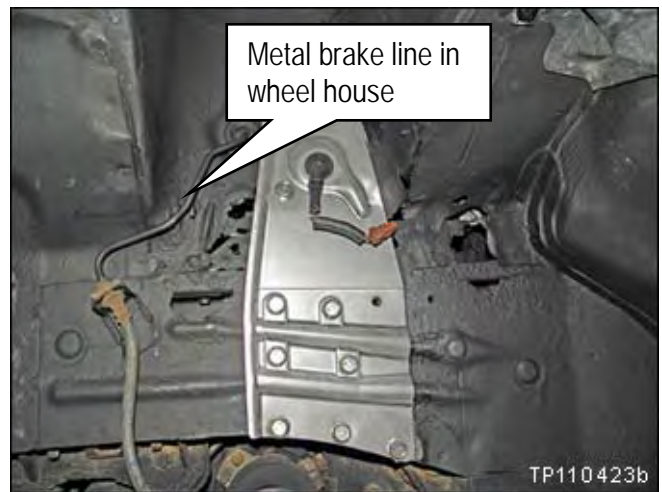
Figure RB26

30. Inspect the metal brake line for damage. If there is damage, replace the line.

- Inspect the line in the wheel house area (see Figure RB26).

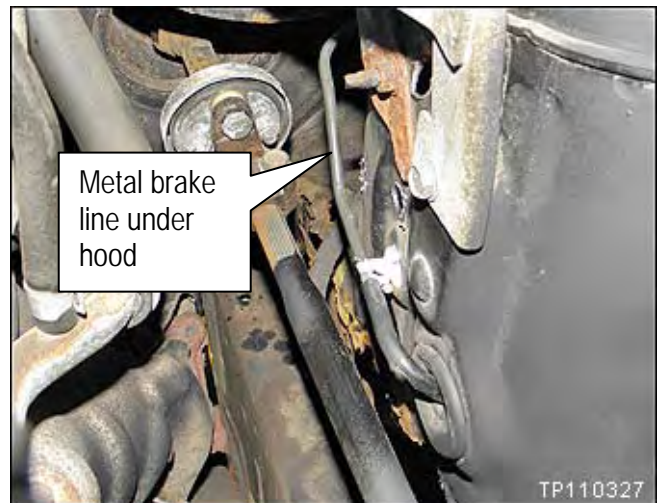
Figure RB27

- Inspect the line under the hood (see Figure RB27).
- Scratches or nicks of the E-coat are not considered damage that requires brake line replacement.
- Refer to the appropriate Service Manual for brake line replacement information.

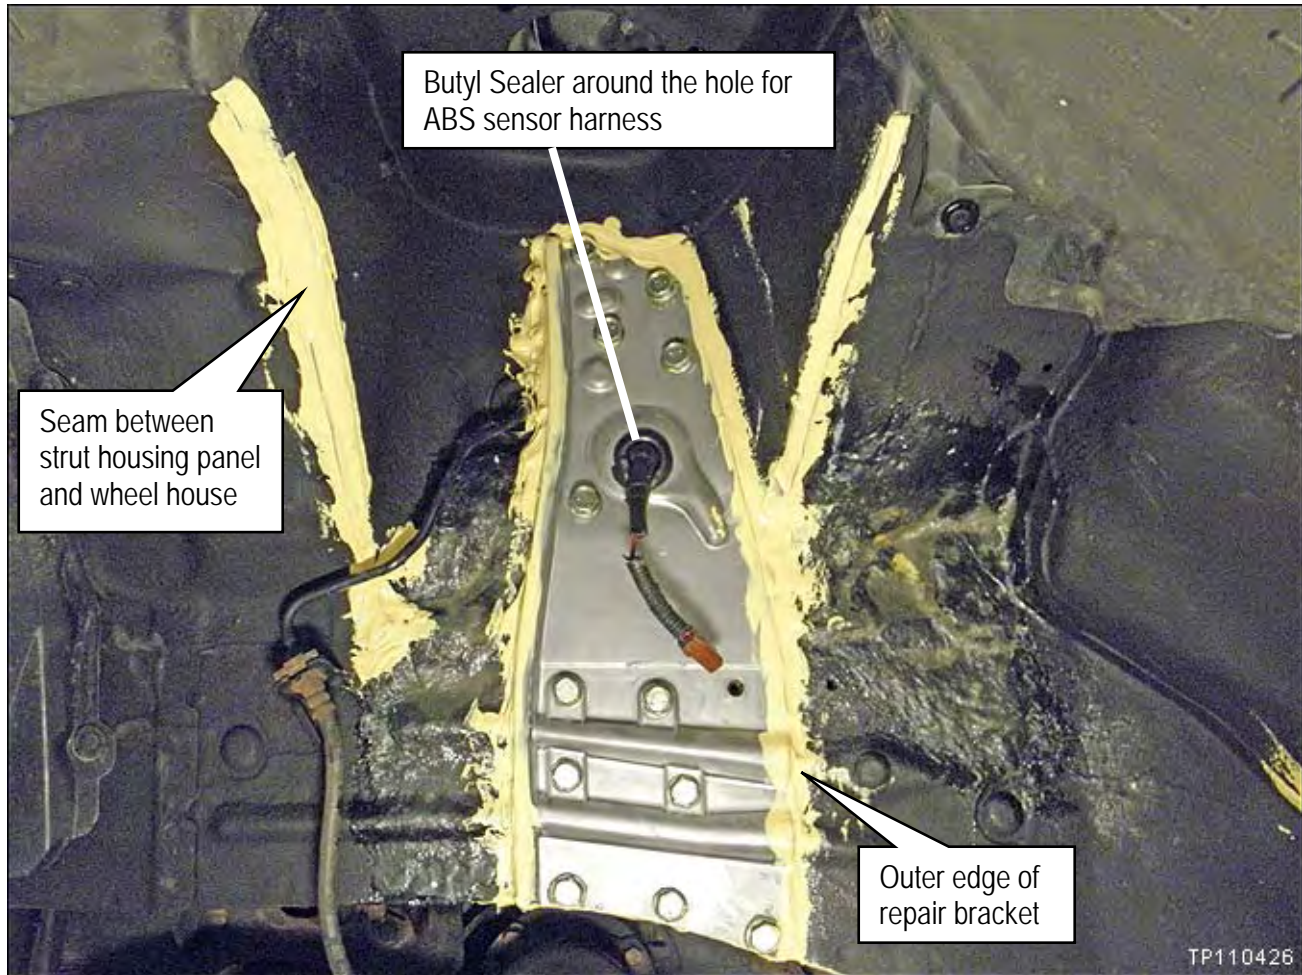
Figure RB31

37. Apply Butyl Sealer (P/N B6553 – 89915) around the opening for the ABS sensor harness (see Figure RB31).

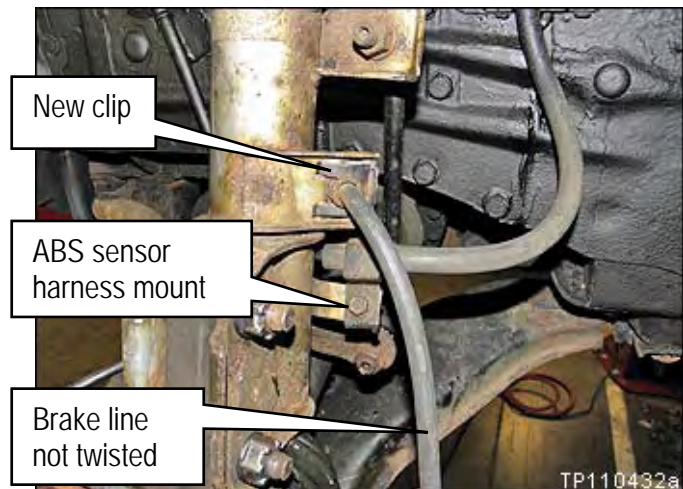
Figure RB37

- Use a new clip for the brake line mount (P/N 46206 – 2J00A).
- Confirm the ABS sensor harness is mounted correctly as shown in Figure RB37.
- Make sure the brake line is not twisted.

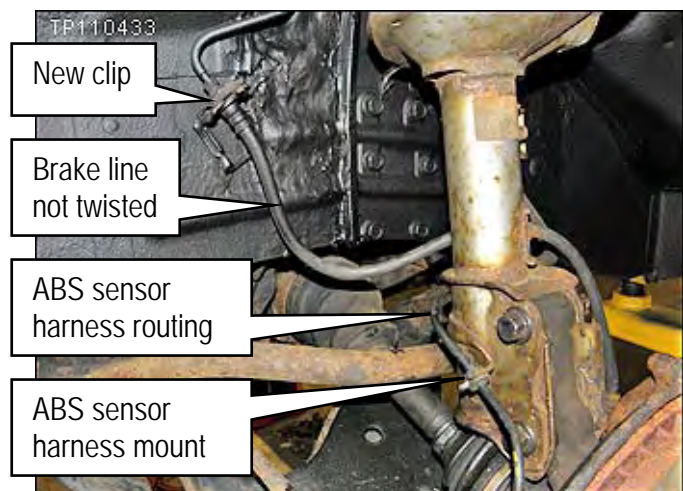
Figure RB38

- Use a new clip for the brake line mount (P/N 46206 – 2J00A).
- Make sure the brake line is not twisted.
- Confirm the ABS sensor harness is routed correctly behind the strut.
- Make sure the ABS sensor harness is mounted correctly as shown in Figure RB38.

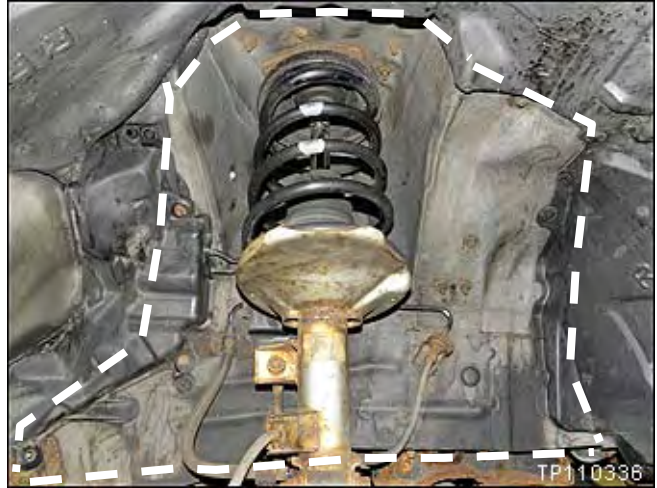
Figure PS1

- This repair is **only** used if there is metal perforation on the passenger side in the area show in Figure PS1.
- If there is no perforation, go to Level 1 repair on page 11.
- For 4WD vehicles: If the drive shaft boot is ripped, it should be covered to prevent debris from entering the drive shaft joint.

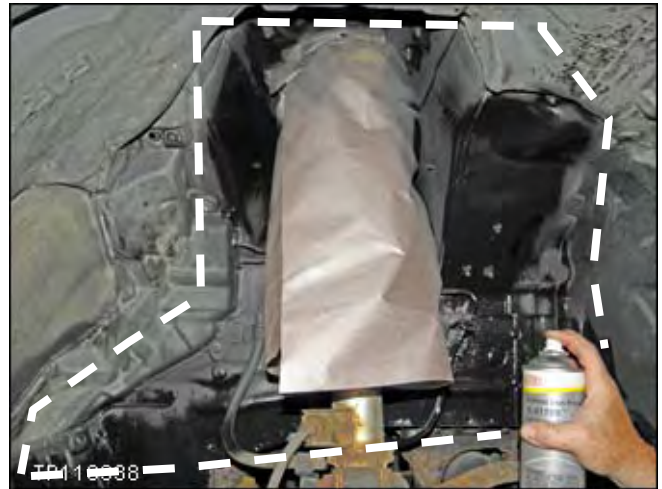
Figure PS2

4. Completely and liberally coat the strut housing and wheel house area with self etching primer (see Figure PS2).
  - Use Dupont Etch Primer (P/N A-4119S™) or equivalent.
  - Follow all product instructions.
  - Coat all of the exposed metal areas of the strut housing and wheel house panels.
  - A second coat may be needed for heavy rust spots.
  - Let each coat dry for 5 minutes.
