ITB11-039

July 14, 2011

## VOLUNTARY SAFETY RECALL CAMPAIGN 1997- 2003 QX4 IN SALT STATES LEFT FRONT STRUT HOUSING CORROSION

CAMPAIGN ID #: R1109  
NHTSA #: 11V-244  
APPLIED VEHICLES: 1997- 2003 QX4 (JR50)

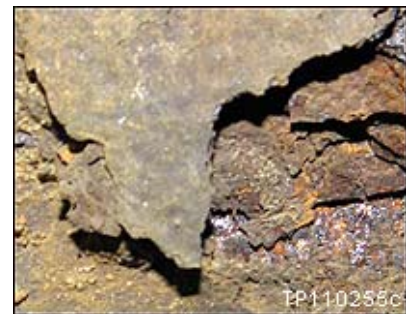
Figure 5 is an example of “scab corrosion” (flaking and raised rust).

- Retain the vehicle at the dealer. (The vehicle is not repairable.)
- Supply the customer with a rental car.
- Fax a completed Non-Repairable Report to Morley (see page 53).

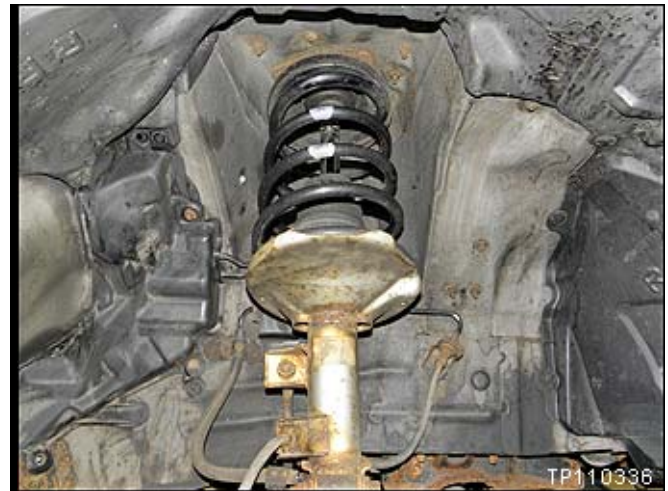
Figure 6

**NOTE:** Passenger side is shown, driver side is similar.

2. Visually inspect for corrosion and rust on the wheel housing panel and the strut housing panel (driver and passenger side).

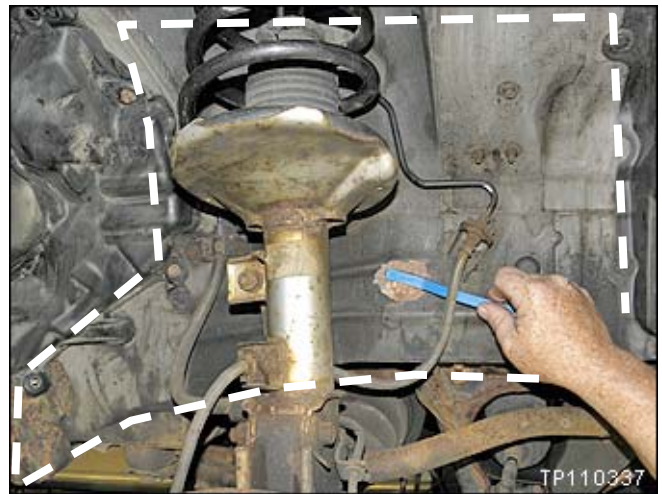
Figure 7

1. Use a wire brush to remove loose rust in the area shown with dashed line.
2. Clean dust, dirt, or other debris from the wheel housing and strut housing area.

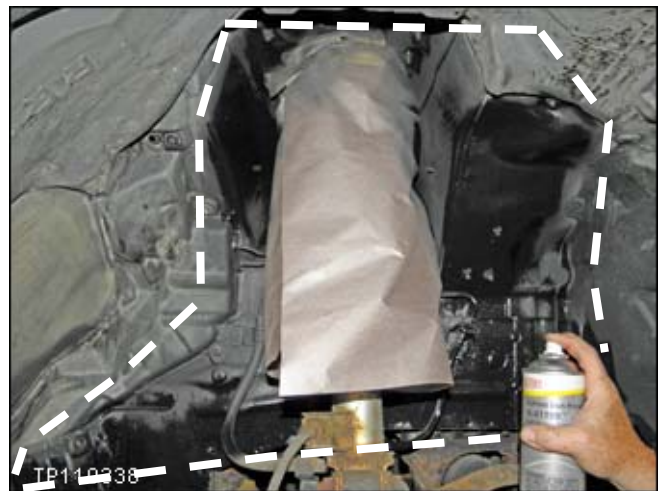
Figure 8

3. Cover the strut so it is protected from overspray.
4. Completely and liberally coat the strut housing and wheel house area with self etching primer.
  - Use Dupont Etch Primer (P/N A-4119S™).
  - Follow all product instructions.
  - Coat all of the exposed metal areas of the strut housing and wheel house panels.
  - A second coat may be needed for heavy rust spots.
  - Let each coat dry for 5 minutes.

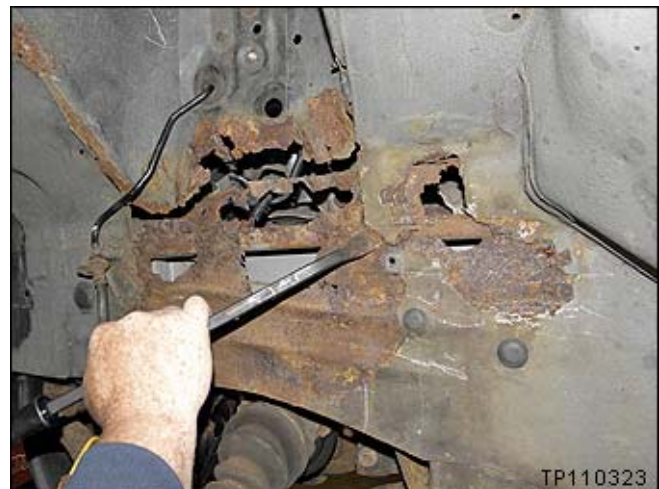
Figure RB2

3. Use a scraper bar to scrape off loose flaking rust and corrosion.

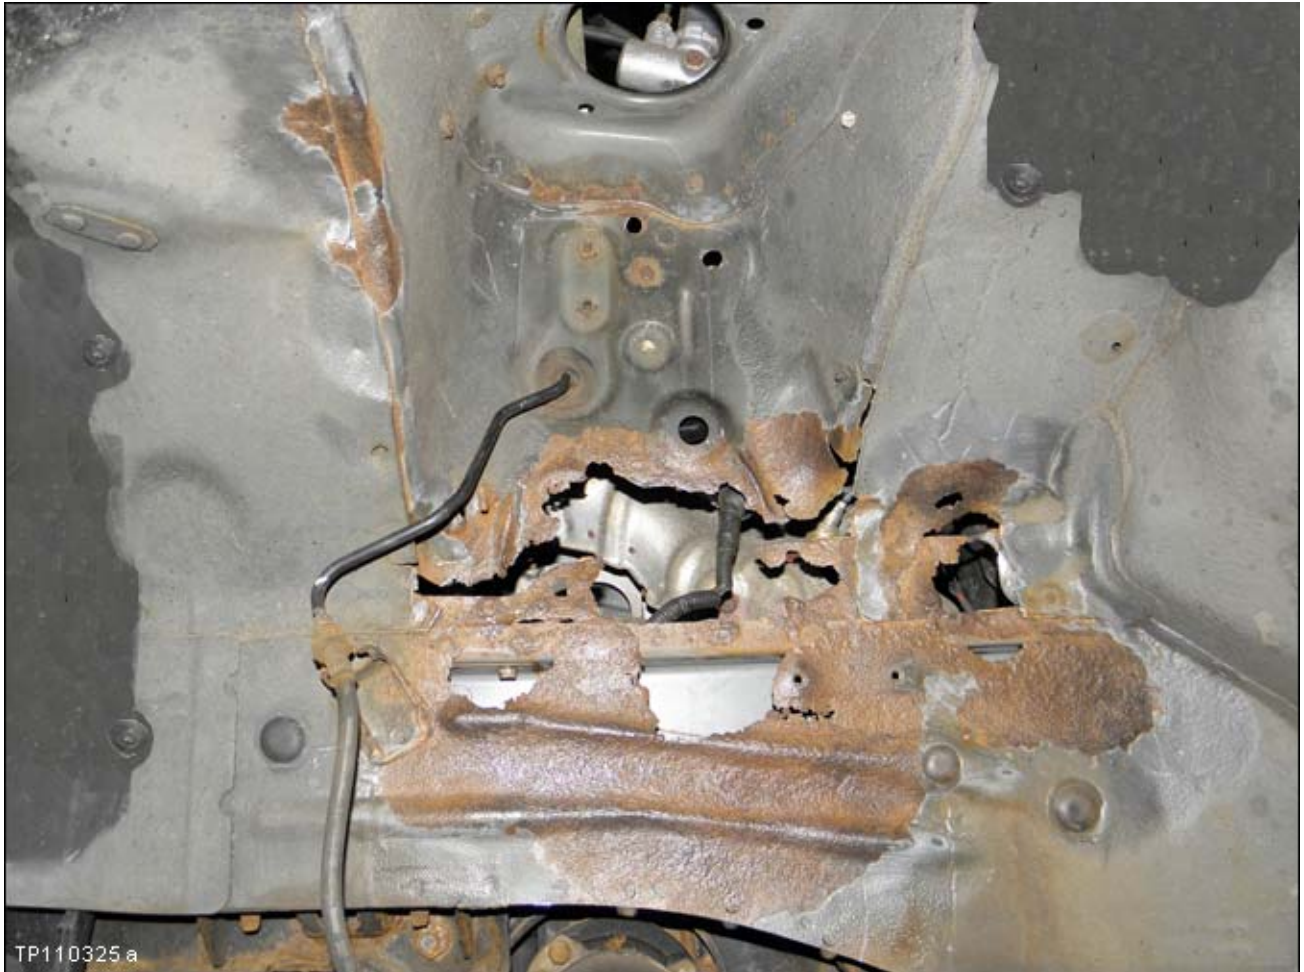
Figure RB3

4. Clean all the loose rust from the strut housing and wheel house areas (see Figure RB3).

**NOTE:** If the brake line is in the way of the area that needs to be cleaned, remove it from the mount and move it out of the way.

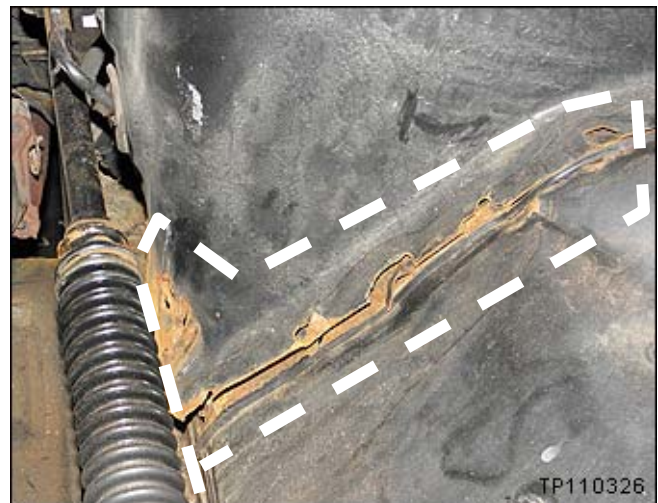
Figure RB5

7. Only if the strut housing panel is separated as show in Figure RB5:

Use a wire brush to clean any loose rust, paint, or other debris from the area shown with dashed line.

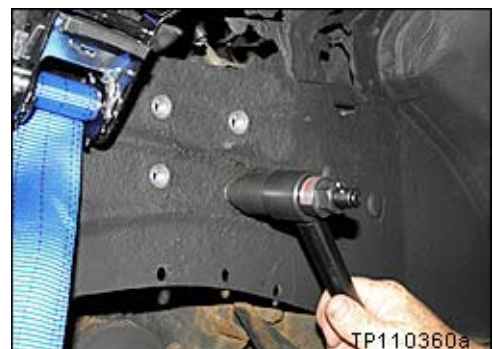
Figure RB16

- E. Place the Rivet Nut into the 13.1 mm (33/64 in) hole.

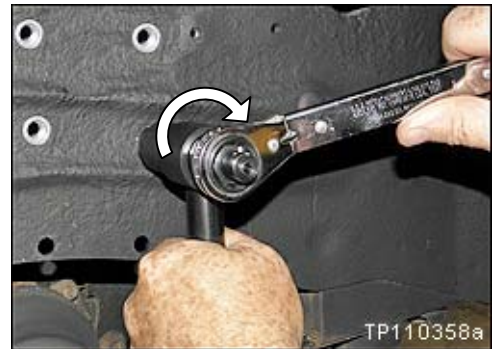
Figure RB17

- F. Hold the tool at a right angle to the hole.
- G. Use a 19 mm wrench to turn the hex nut clockwise 2 ½ to 2 ¾ turns.
- Use the mark (white dot) on top of the hex nut to keep track of the number of turns.

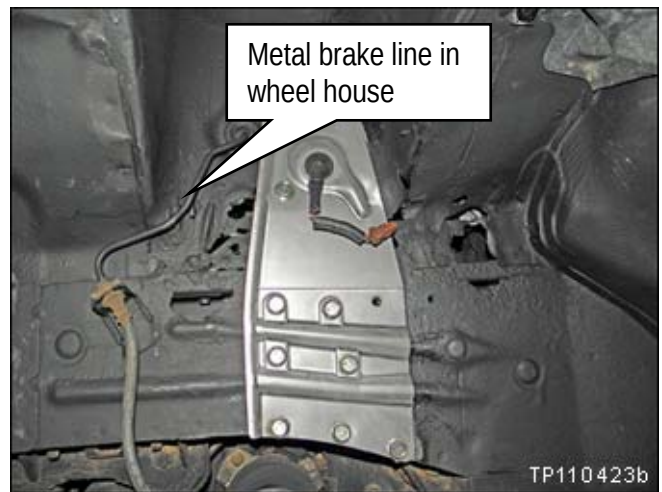
Figure RB26

30. Inspect the metal brake line for damage. If there is damage, replace the line.

- Inspect the line in the wheel house area (see Figure RB26).

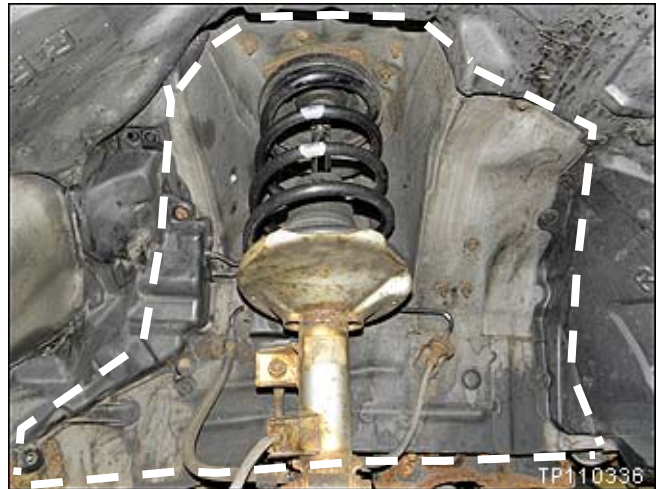
Figure PS1

- This repair is **only** used if there is metal perforation on the passenger side in the area show in Figure PS1.
- If there is no perforation, go to Level 1 repair on page 11.
- For 4WD vehicles: If the drive shaft boot is ripped, it should be covered to prevent debris from entering the drive shaft joint.

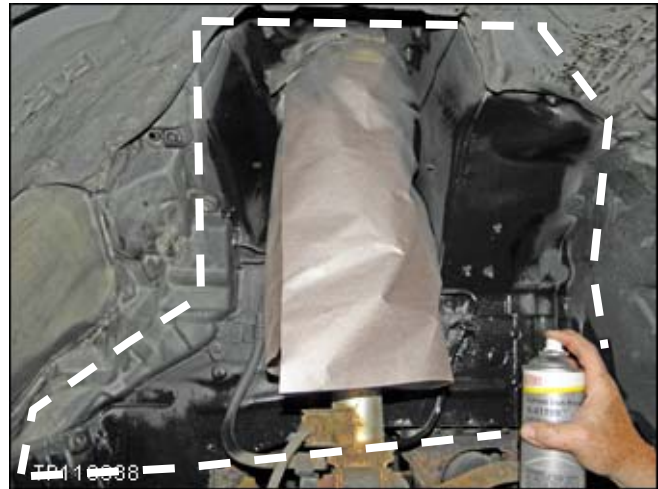
Figure PS2

4. Completely and liberally coat the strut housing and wheel house area with self etching primer (see Figure PS2).
  - Use Dupont Etch Primer (P/N A-4119S™).
  - Follow all product instructions.
  - Coat all of the exposed metal areas of the strut housing and wheel house panels.
  - A second coat may be needed for heavy rust spots.
  - Let each coat dry for 5 minutes.

- If the strut has not been removed, cover the strut so it is protected from overspray.
