RECALL CAMPAIGN BULLETIN

NTB11-064d

VOLUNTARY SAFETY RECALL CAMPAIGN 1996-2004 PATHFINDER IN SALT STATES LEFT FRONT STRUT HOUSING CORROSION

CAMPAIGN ID #: R1107
NHTSA #: 11V-244
APPLIED VEHICLES: 1996 – 2004 Pathfinder (R50)

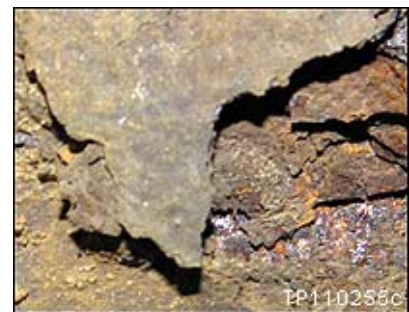
Figure 5 is an example of “scab corrosion” (flaking and raised rust).

- Retain the vehicle at the dealer. (The vehicle is not repairable.)
- Supply the customer with a rental car.
- Fax a completed Non-Repairable Report to Morley (see page 53).

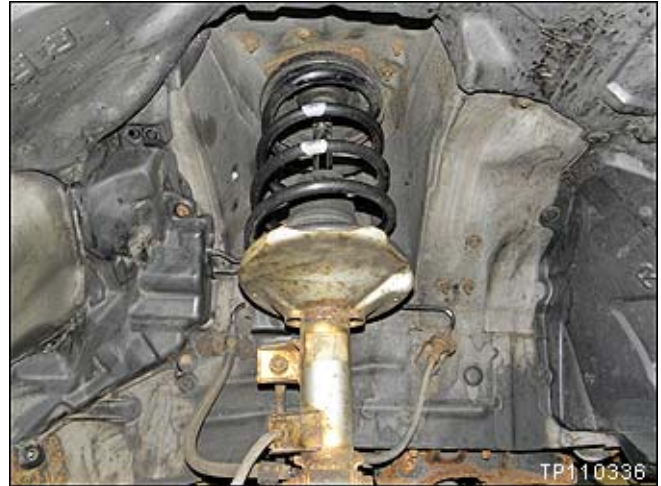
Figure 6

NOTE: Passenger side is shown, driver side is similar.

2. Visually inspect for corrosion and rust on the wheel housing panel and the strut housing panel (driver and passenger side).
 - Inspect for corrosion and rust on the panels only.

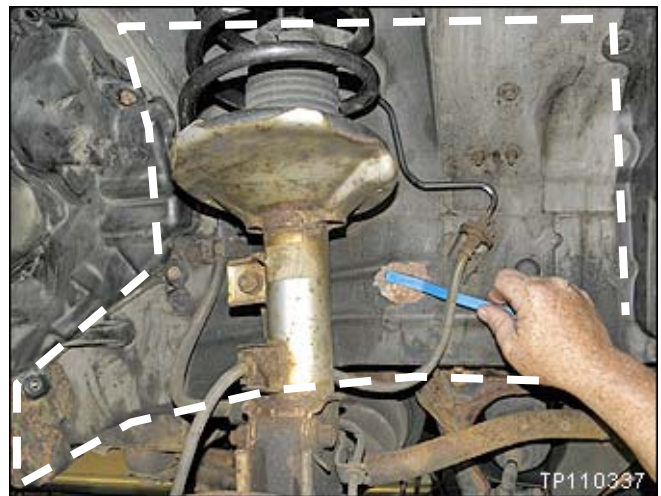
Figure 7

1. Use a wire brush to remove loose rust in the area shown with dashed line.

2. Clean dust, dirt, or other debris from the wheel housing and strut housing area.

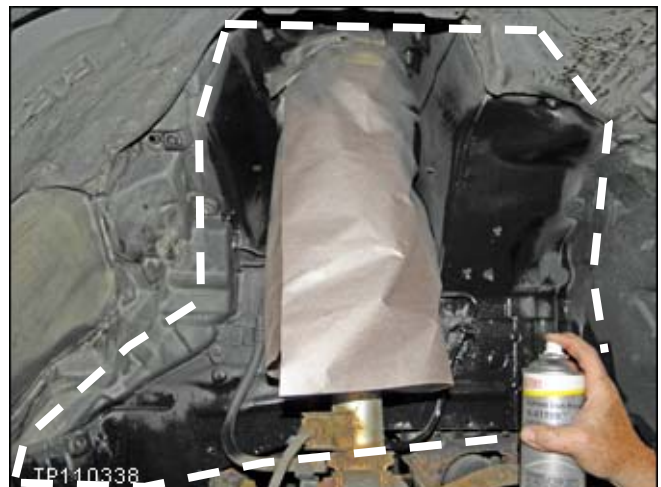
Figure 8

- Use Dupont Etch Primer (P/N A-4119S™) or equivalent.
- Follow all product instructions.
- Coat all of the exposed metal areas on the strut housing and wheel house panels.

- A second coat may be needed for heavy rust spots.
- Let each coat dry for 5 minutes.

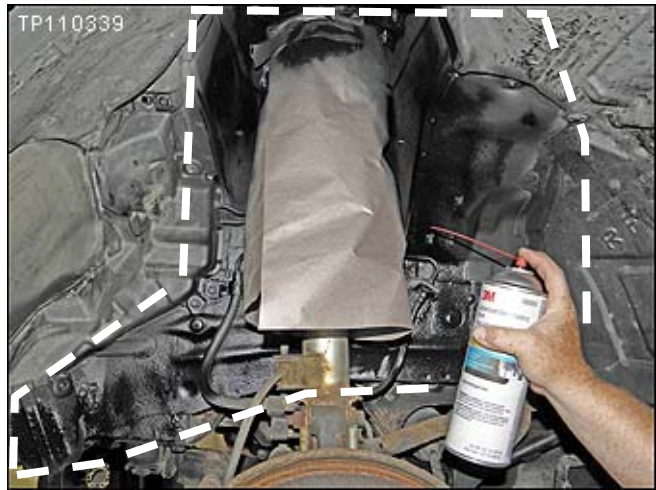
Figure 9

- Use 3M Rubberized Undercoating (P/N 051135 – 08883) or equivalent.
- Follow all product instructions.
- Coat all of the exposed metal areas on the strut housing and wheel house panels.
- Use a spray nozzle to spray the areas behind the strut and other hard to reach areas.

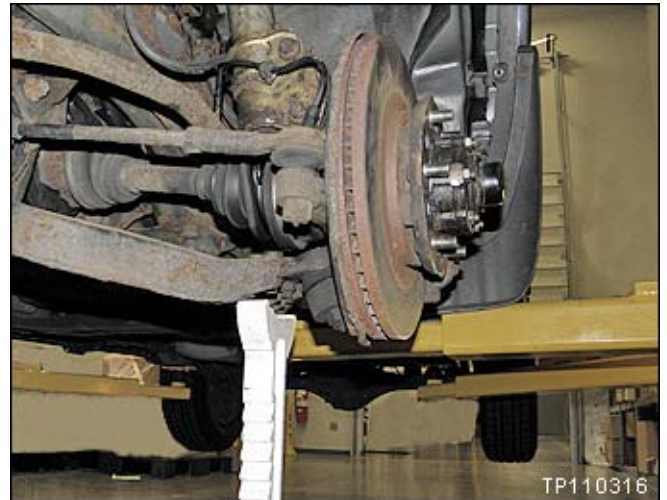
Figure SR1

NOTE: Do not lower the vehicle beyond just touching the jack stand. Do not put tension on the coil spring.

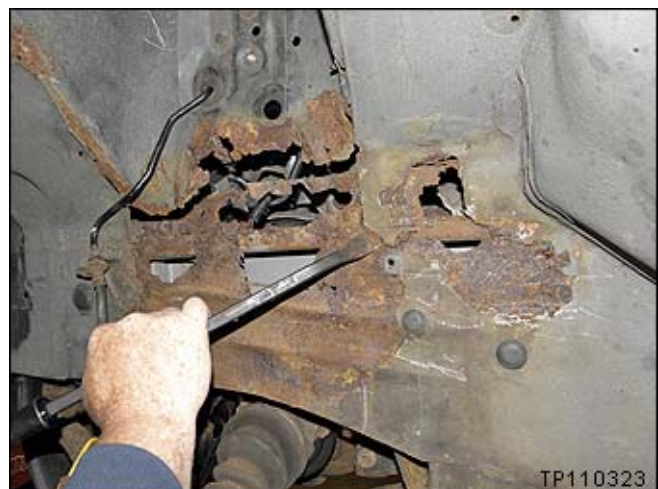
Figure RB2

3. Use a scraper bar to scrape off loose flaking rust and corrosion.

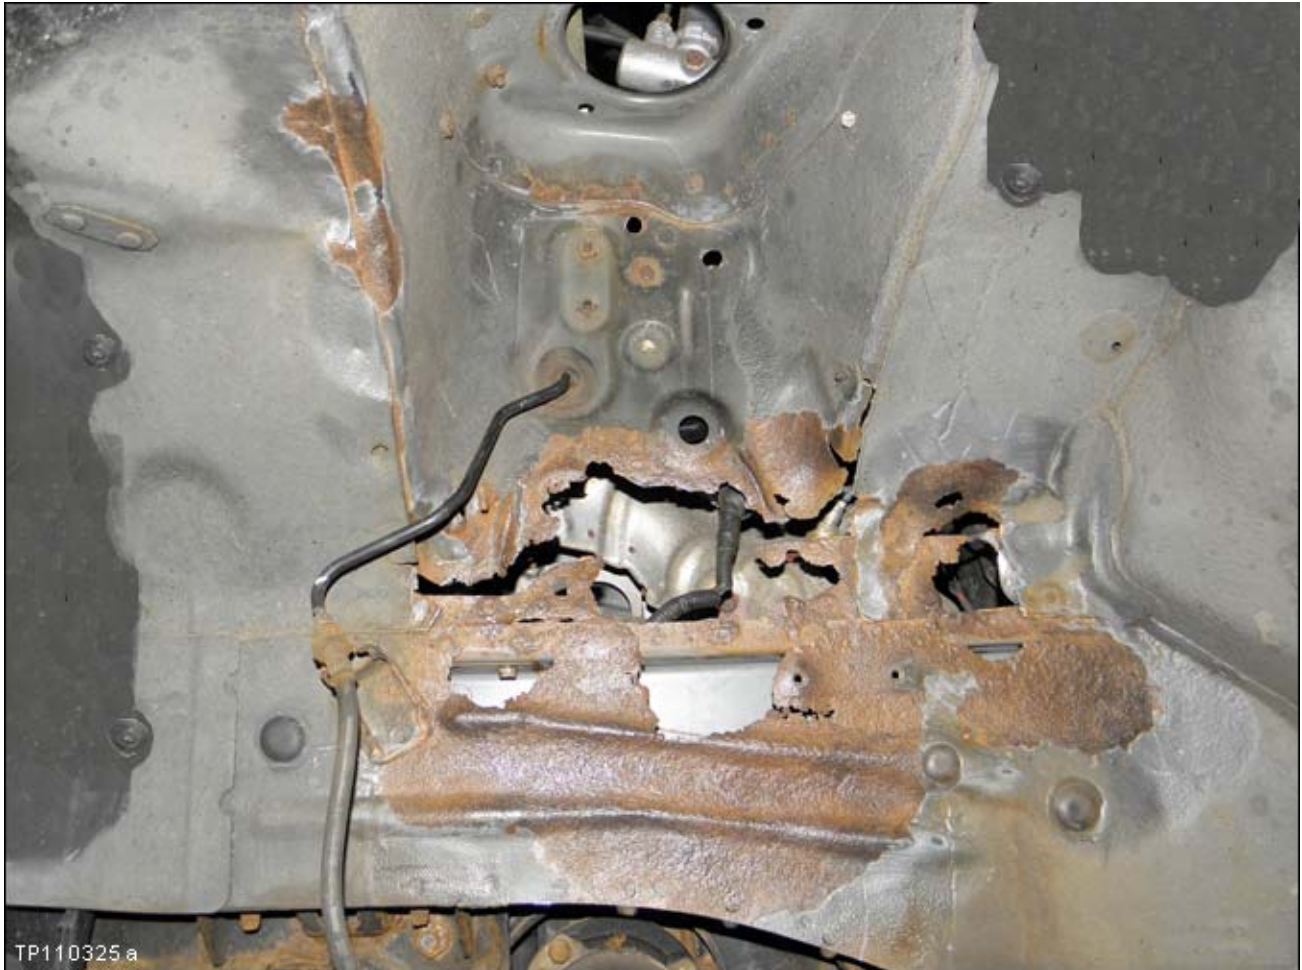
Figure RB3

4. Clean all the loose rust from the strut housing and wheel house areas (see Figure RB3).
 - Use an abrasive pad or other suitable tool.

NOTE: If the brake line is in the way of the area that needs to be cleaned, remove it from the mount and move it out of the way.

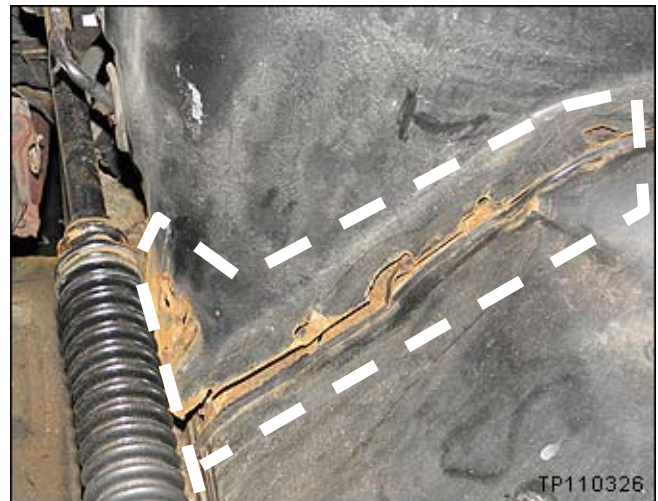
Figure RB5

7. Only if the strut housing panel is separated as show in Figure RB5:

Use a wire brush to clean any loose rust, paint, or other debris from the area shown with dashed line.

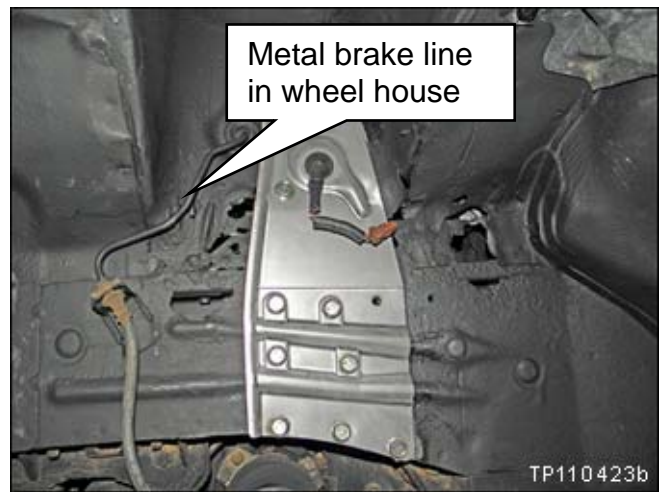
Figure RB26

30. Inspect the metal brake line for damage. If there is damage, replace the line.

- Inspect the line in the wheel house area (see Figure RB26).

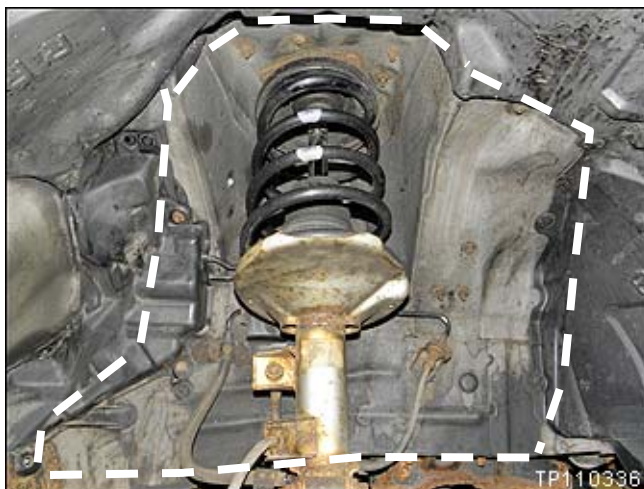
Figure PS1

- This repair is **only** used if there is metal perforation on the passenger side in the area show in Figure PS1.
- If there is no perforation, go to Level 1 repair on page 11.
- For 4WD vehicles: If the drive shaft boot is ripped, it should be covered to prevent debris from entering the drive shaft joint.

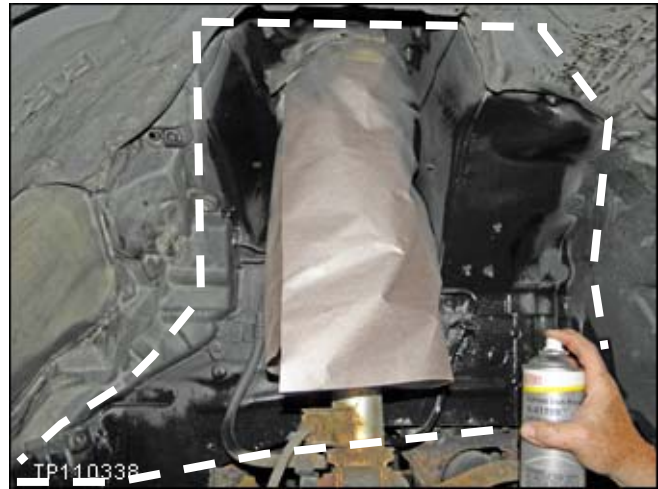
Figure PS2

4. Completely and liberally coat the strut housing and wheel house area with self etching primer (see Figure PS2).
 - Use Dupont Etch Primer (P/N A-4119S™) or equivalent.
 - Follow all product instructions.
 - Coat all of the exposed metal areas on the strut housing and wheel house panels.
 - A second coat may be needed for heavy rust spots.
 - Let each coat dry for 5 minutes.

- If the strut has not been removed, cover the strut so it is protected from overspray.
