ITB11-039d

VOLUNTARY SAFETY RECALL CAMPAIGN 1997-2003 QX4 IN SALT STATES LEFT FRONT STRUT HOUSING CORROSION

CAMPAIGN ID #: R1109
NHTSA #: 11V-244
APPLIED VEHICLES: 1997- 2003 QX4 (JR50)

Infiniti is conducting a voluntary safety recall campaign on certain model year 1997 – 2003 QX4 vehicles that are currently registered in States where heavy concentrations of road salt are used in the winter to inspect for corrosion, and if necessary repair the front strut housing panels.

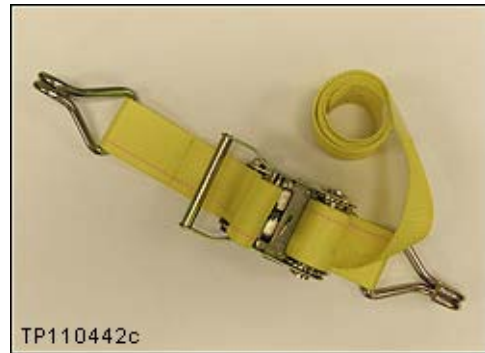
Ratchet Strap (J-50836)

- Each dealer will be shipped, at no charge, one Ratchet Strap.
- Additional tools can be ordered from TechMate at 1-800-662-2001.

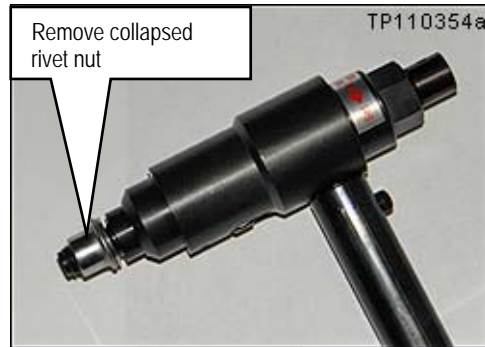
Rivet Gun (J-50827)

- Each dealer will be shipped, at no charge, one Rivet Gun.
- First time use; tool is shipped with collapsed rivet nut, remove and discard.
- Additional tools can be ordered from TechMate at 1-800-662-2001.

CAUTION: DO NOT use power tools or impact tools with the Rivet Gun – use hand tools only.

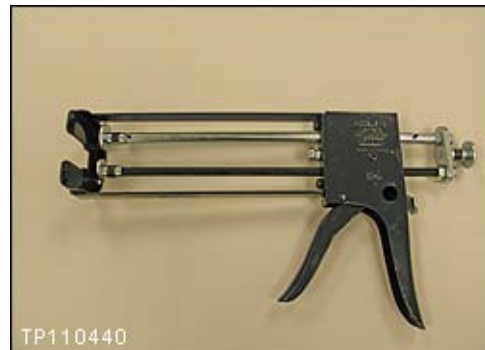
2:1 Dispensing Gun (J-50816)

- This tool is used to dispense LORD Fusor® 108B (structural adhesive).
- Each dealer will be shipped, at no charge, one 2:1 Dispensing Gun.
- Additional tools can be ordered from TechMate at 1-800-662-2001.

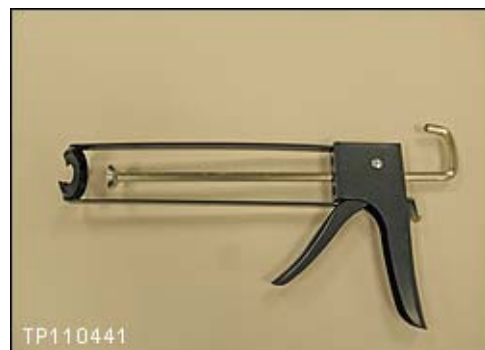
1:1 Dispensing Gun (Caulking Gun)

- This tool is used to dispense LORD Fusor® 800EZ (seam sealer).
- Caulking guns are commonly used for application of other automotive products. Each dealer should already have a caulking gun as a shop tool.

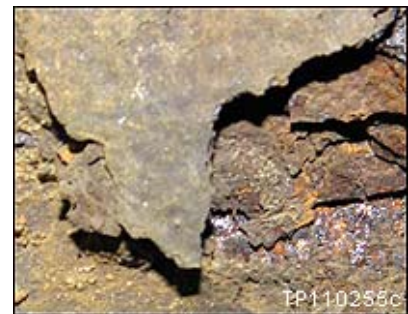
Figure 5 is an example of "scab corrosion" (flaking and raised rust).

- Retain the vehicle at the dealer. (The vehicle is not repairable.)
- Supply the customer with a rental car.
- Fax a completed Non-Repairable Report to Morley (see page 53).

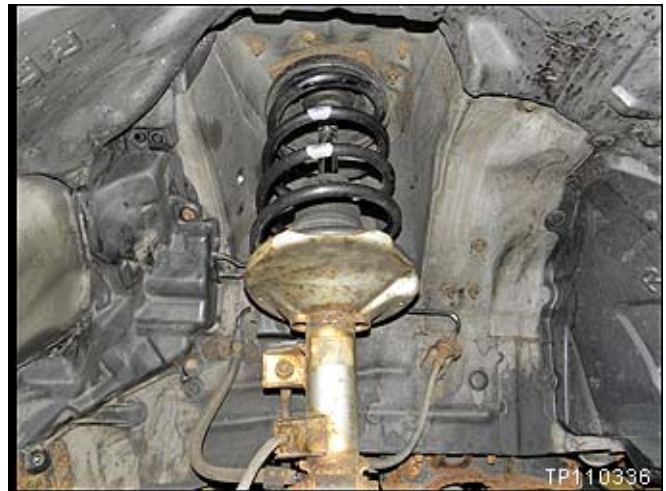
Figure 6

NOTE: Passenger side is shown, driver side is similar.

2. Visually inspect for corrosion and rust on the wheel housing panel and the strut housing panel (driver and passenger side).
 - Inspect for corrosion and rust on the panels only.

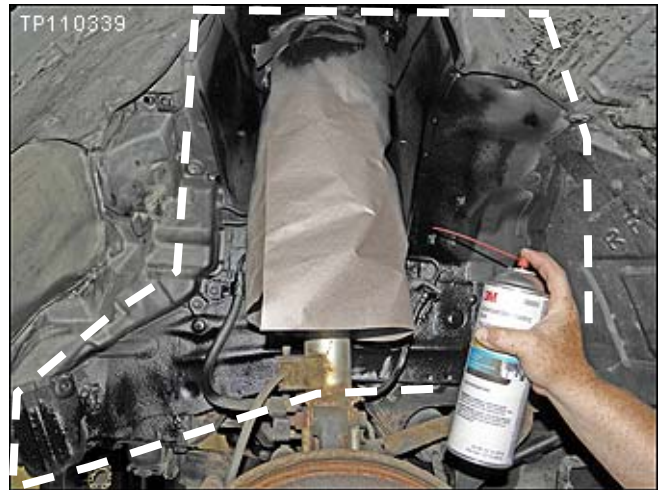
Figure 9

- Use 3M Rubberized Undercoating (P/N 051135 – 08883) or equivalent.
- Follow all product instructions.
- Coat all of the exposed metal areas of the strut housing and wheel house panels.
- Use a spray nozzle to spray the areas behind the strut and other hard to reach areas.

6. Let the undercoat dry for about 1 hour before removing the strut cover.

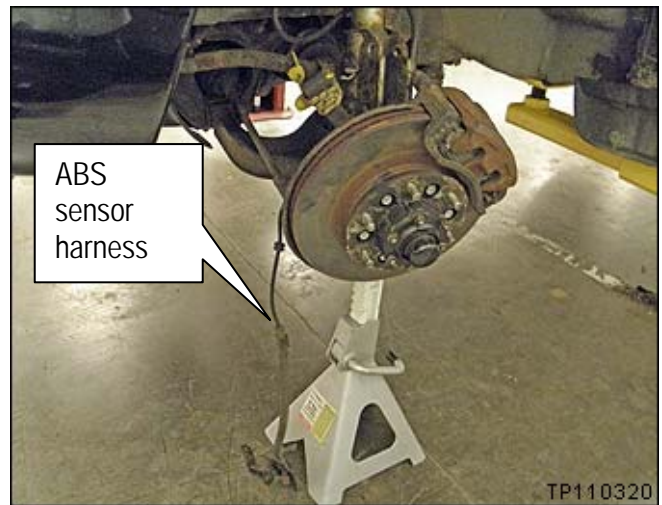
Figure SR6

7. Pull the ABS sensor harness from behind the strut.
8. Let the ABS sensor harness hang out of the way as shown.

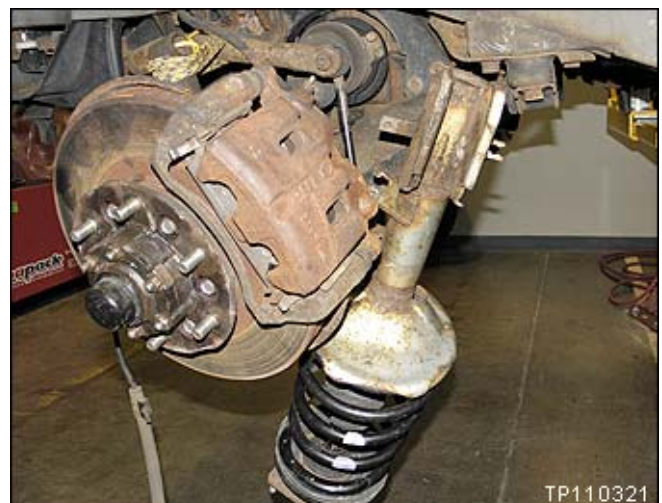
Figure SR8

11. Maneuver the strut so it is hanging upside down as shown.

NOTE: The weight of strut is supported by the stabilizer connecting rod.

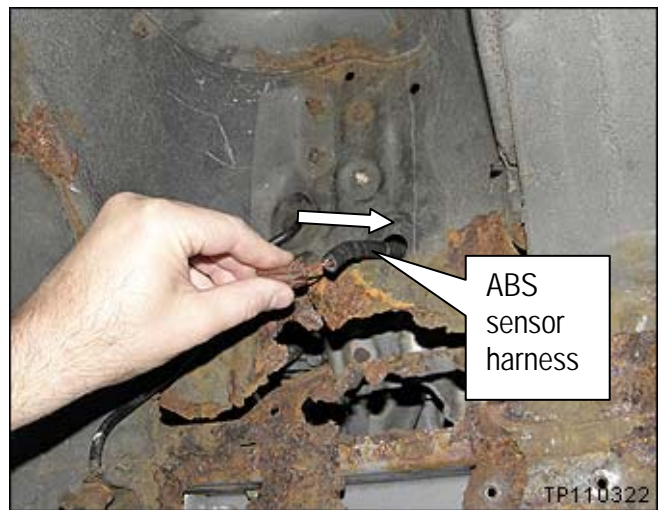
Figure RB1

1. Inspect the ABS sensor harness for damage. If damaged, repair as necessary.
2. Push the ABS harness and connector through the panel.
 - The harness/connector will now be out of the working area.

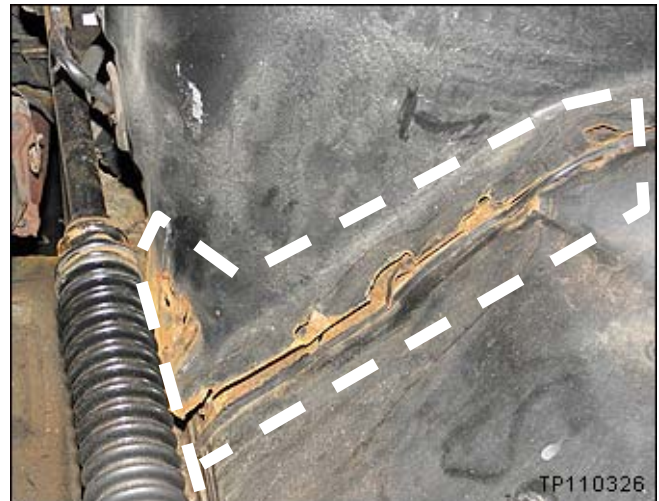
Figure RB5

7. Only if the strut housing panel is separated as show in Figure RB5:

Use a wire brush to clean any loose rust, paint, or other debris from the area shown with dashed line.

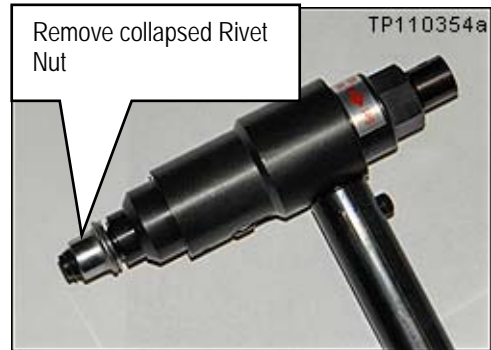
Figure RB11

NOTE: First time use:

- The rivet gun may be shipped with a collapsed Rivet Nut installed on the mandrel.
- Remove the collapsed Rivet Nut and discard.

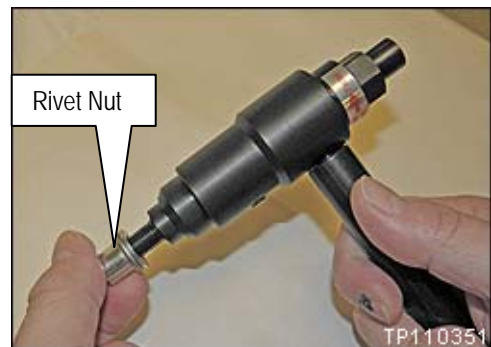
Figure RB13

- B. Screw a new Rivet Nut onto the mandrel.

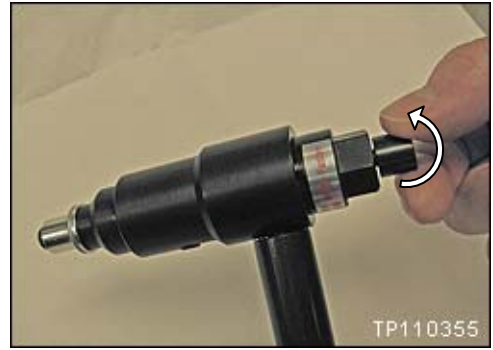
Figure RB14

- C. Turn the rear knob clockwise until it stops.

NOTE: Turning the rear knob sets (screws) the Rivet Nut all the way onto the mandrel.

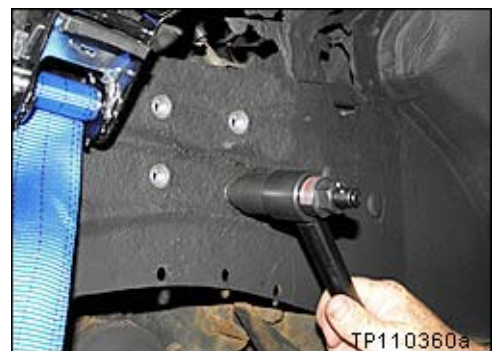
Figure RB16

- E. Place the Rivet Nut into the 13.1 mm (33/64 in) hole.

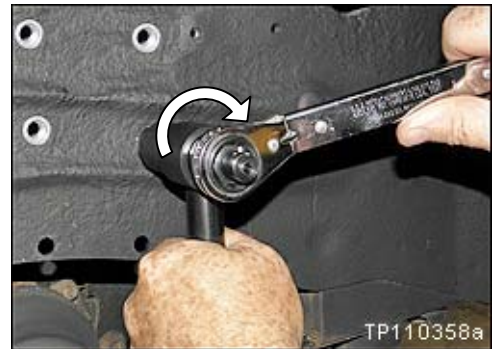
Figure RB17

CAUTION: DO NOT use power tools or impact tools with the Rivet Gun – use hand tools only.

- F. Hold the tool at a right angle to the hole.
- G. Use a 19 mm wrench to turn the hex nut clockwise a **maximum** of 2 ½ to 2 ¾ turns.
- Use the mark (white dot) on top of the hex nut to keep track of the number of turns.

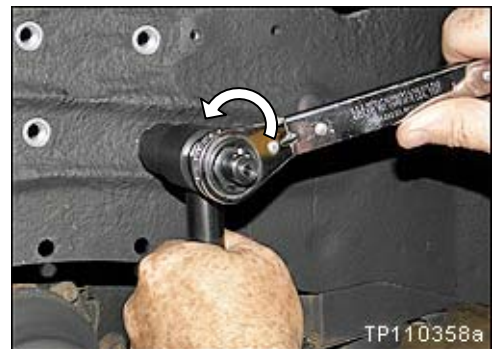
Figure RB18

- H. Turn the hex nut about ½ turn counterclockwise to release the mandrel tension.

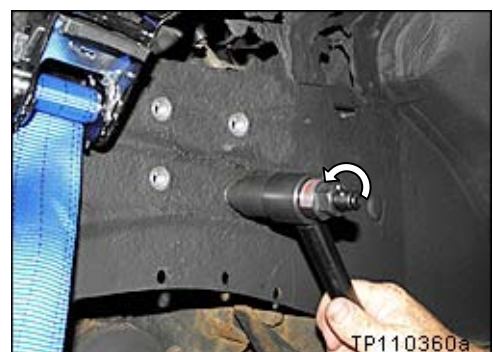
Figure RB19

- I. Turn the rear knob counterclockwise to remove (unscrew) the mandrel from the Rivet Nut.

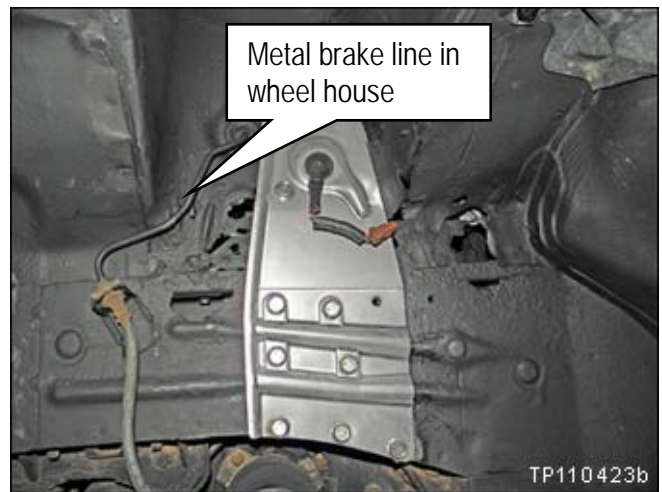
Figure RB26

- Inspect the line in the wheel house area (see Figure RB26).

30. Inspect the metal brake line for damage. If there is damage, replace the line.

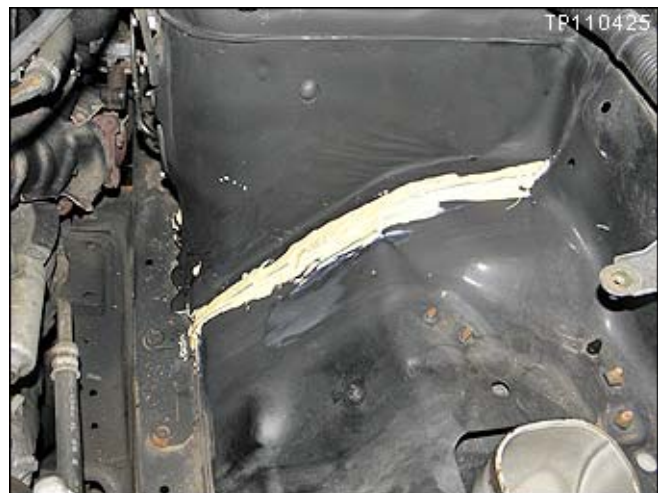
Figure RB32

Apply Fusor® 800EZ (seam sealer) as shown in Figure RB32.

- Apply along the front seam between the strut housing panel and the wheel house.
- Use a brush or other suitable tool to smooth the sealer for good seam coverage.
- Allow seam sealer to dry for 10-15 minutes.

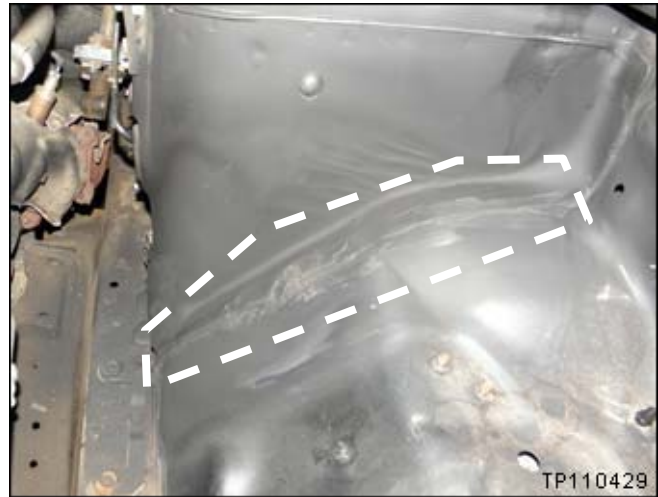
Figure RB34

- This is the under hood front of strut housing panel.
- Use Dupont Etch Primer (P/N A-4119S™) or equivalent.
- Follow all product instructions.

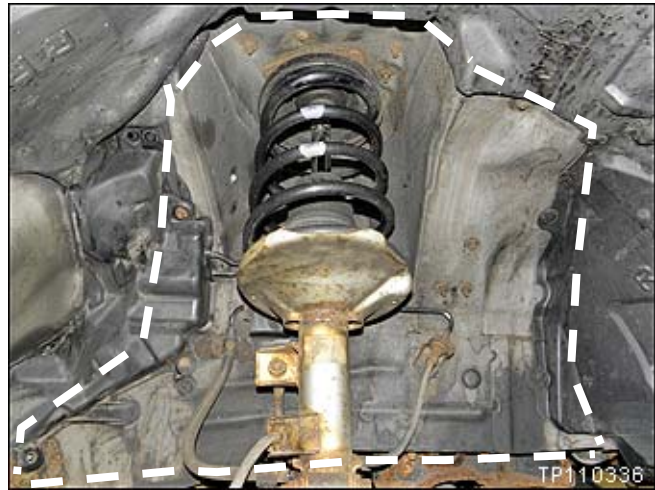
Figure PS1

- This repair is **only** used if there is metal perforation on the passenger side in the area show in Figure PS1.
- If there is no perforation, go to Level 1 repair on page 11.
- For 4WD vehicles: If the drive shaft boot is ripped, it should be covered to prevent debris from entering the drive shaft joint.

1. Clean all loose rust from the perforated area and other areas in the wheel house, and strut housing.
 - Use an abrasive pad or other suitable tool.
 - **Only if necessary** to access the perforated area, remove the right front strut. Refer to Strut Removal on page 13.
2. Use low pressure compressed air to blow off dust and debris from the cleaned area.
3. Use isopropyl alcohol to clean/wipe down the area.

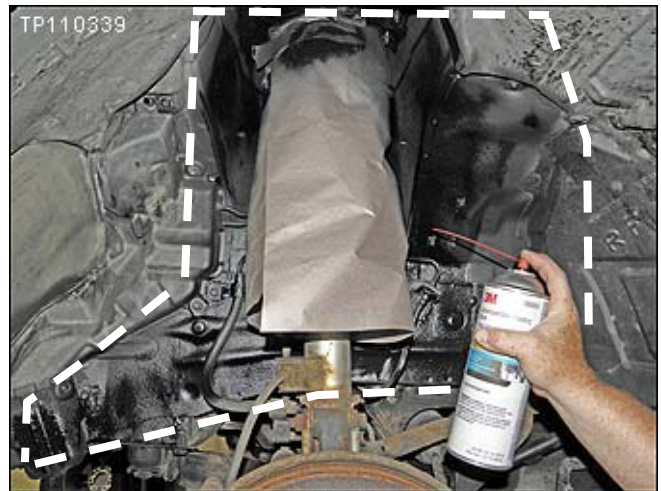
Figure PS3

- If the strut has not been removed, cover the strut so it is protected from overspray.
- Use a spray nozzle to spray the areas behind the strut and other hard to reach areas.

9. Let the undercoat dry for about 1 hour before removing the strut cover (if used).
10. If the strut was removed, reinstall it in reverse order.
 - Use new nuts for the upper strut mounting (P/N 01225 – 00231).
 - Use new nuts for the lower strut mounting (54588 – ED00A).
 - Use new clips (lock springs) for the brake line mounting points (P/N 46206 – 2J00A).
 - Make sure the brake lines are not twisted.
 - Confirm the ABS sensor harness is mounted and routed correctly.
 - Make sure the ABS sensor connector cover is in place.
11. Reinstall the wheel.
 - Torque for wheel nuts is 118 – 147 N•m (12 – 15 kg-m, **87 – 108 ft-lb**).

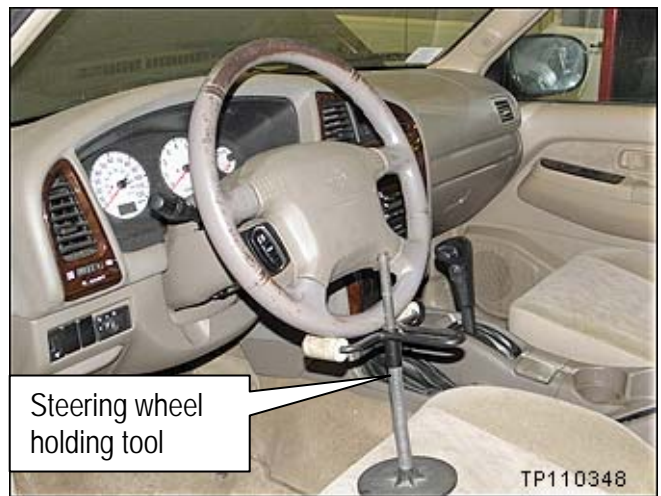
Figure SS4

5. Set the steering wheel in the straight ahead position.
6. Position a steering wheel holding tool as shown.
 - This will keep the steering wheel stationary while replacing the steering shaft.

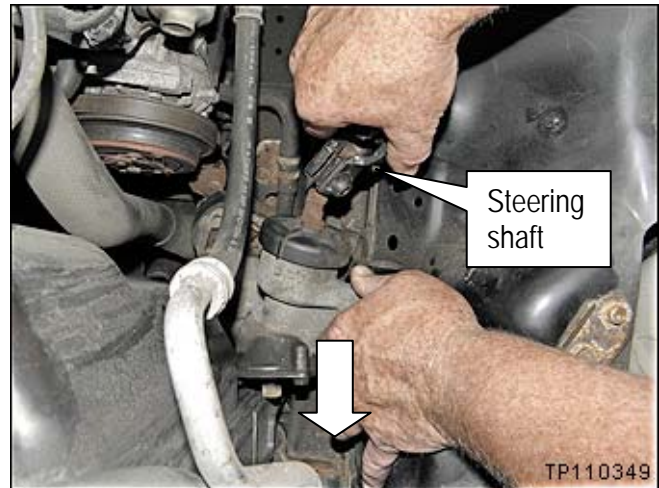
Figure SS7

8. Push the transfer gear assembly forward and remove the steering shaft.

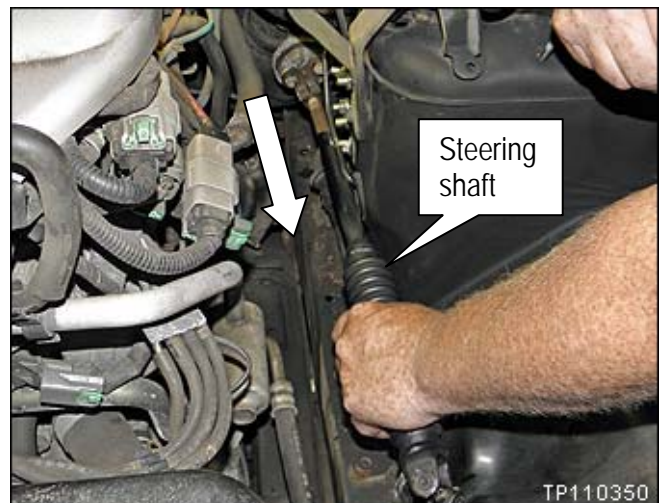
Figure SS8

9. Pull the steering shaft to remove it from the other end.

10. Install the new steering shaft in reverse order.
