<b>HYUNDAI</b> NEW THINKING. NEW POSSIBILITIES.	GROUP <b>CAMPAIGN</b>	NUMBER <b>11-01-015</b>
	DATE <b>MAY, 2011</b>	MODEL(S) <b>2010 TUCSON (LM)</b>
<b>Technical Service Bulletin</b>		
<b>SUBJECT TUCSON (LM) REAR REFLECTOR REPLACEMENT (CAMPAIGN 101)</b>

**Description:** This bulletin provides information related to a recall on some 2010 MY TUCSON (LM) vehicles to replace the rear reflectors. The reflecting performance of rear reflectors may decrease by improper rear reflector lens.

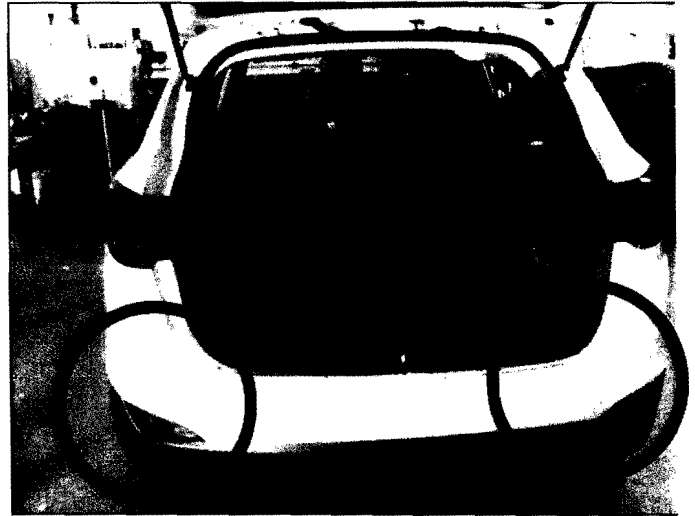
Locate the rear reflectors.

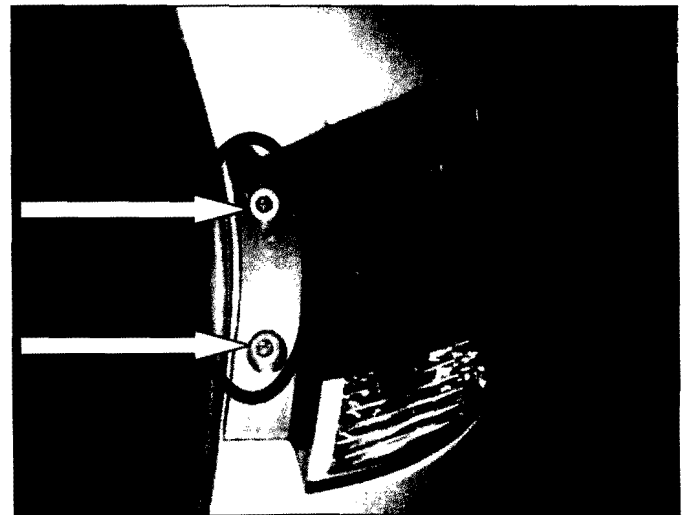
2. Remove the rear combination lamp mounting screws (LH/RH).

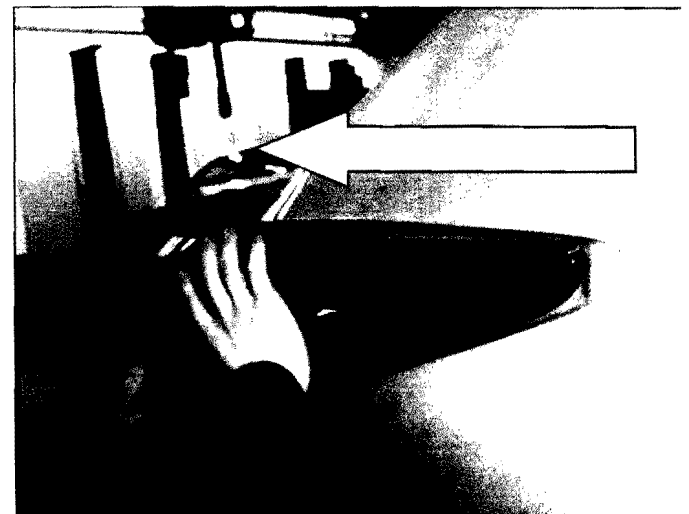
3. Push/pull the rear combination lamp rearward and remove it (LH/RH).

**Be careful not to damage the rear combination lamp and paint.**

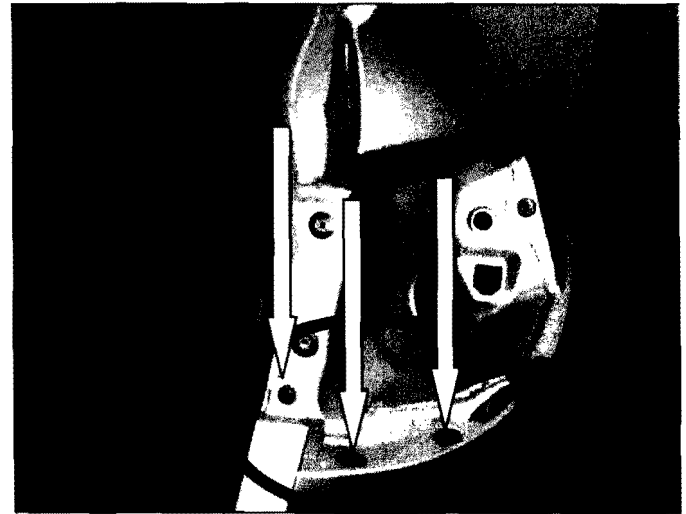
- 5. Remove the rear bumper upper screw and clips (LH/RH).

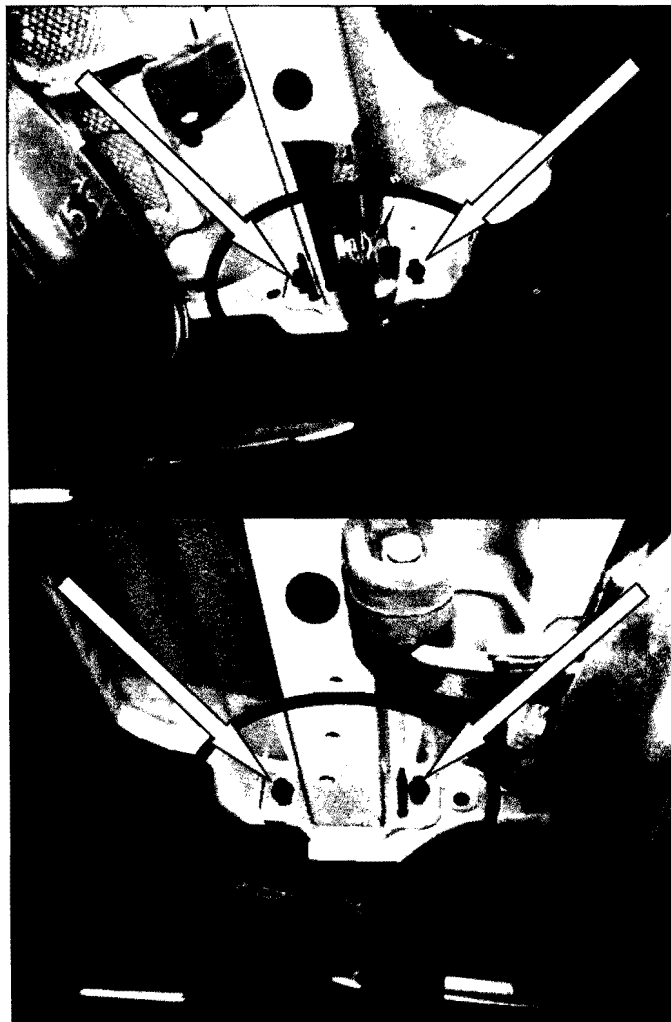
7. Remove the bumper mounting bolts (LH/RH).

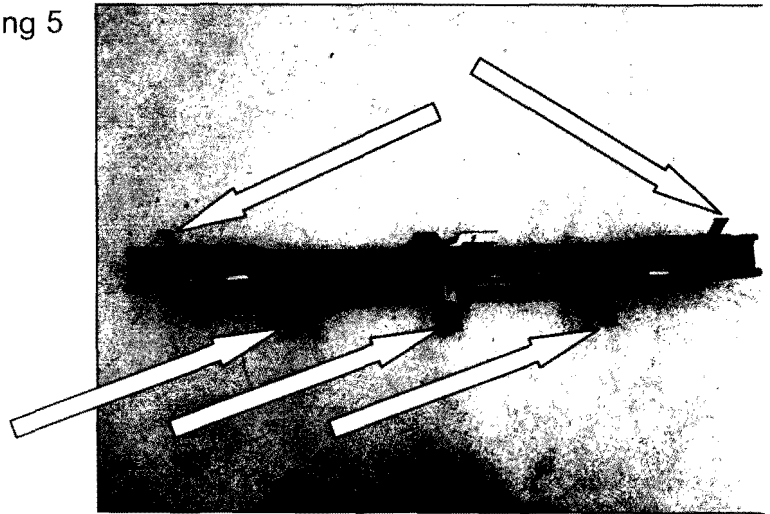
10. Remove the rear bumper rail by removing 5 fasteners.

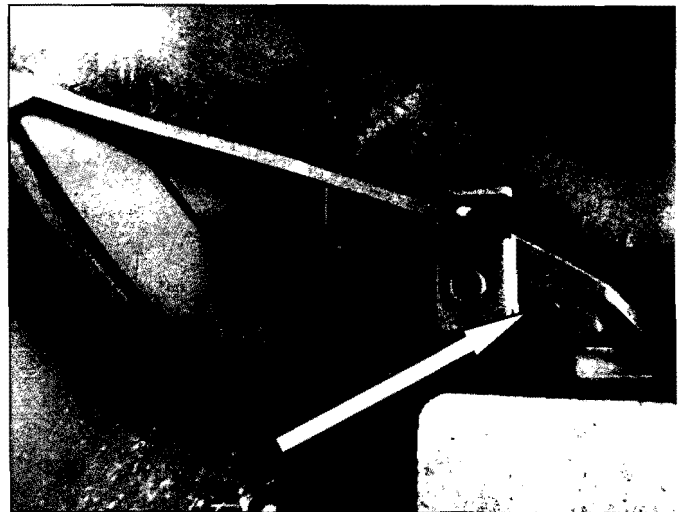
11. Remove the screw from the reflector on each side (LH/RH).
