# Safety Recall Trucks

| Date | Group. | No. | Page |
|---|---|---|---|
| 06.11 | <b>SC0354</b> | | 1(11) |

## Battery Cable Routing and Clipping

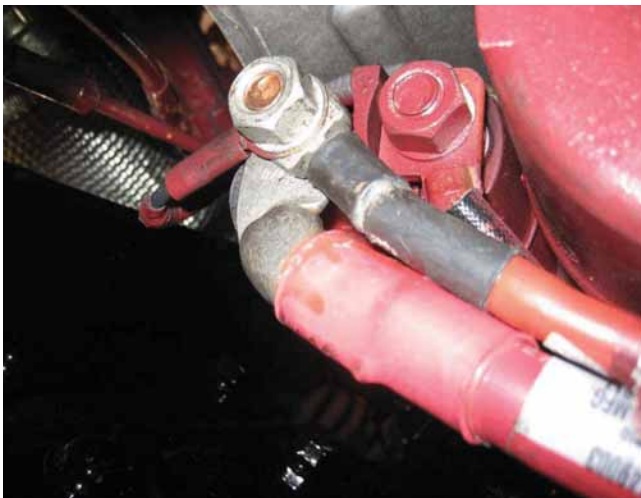
9. Locate and install bracket part number 965580 onto engine as shown. Install plastic cable clamps and secure both positive and both negative cables. Secure smaller cables with cable ties as shown  
Note: Use third slot in bracket.

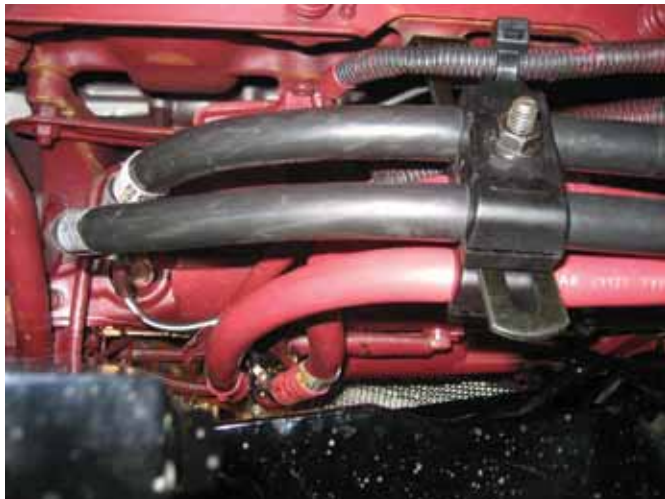
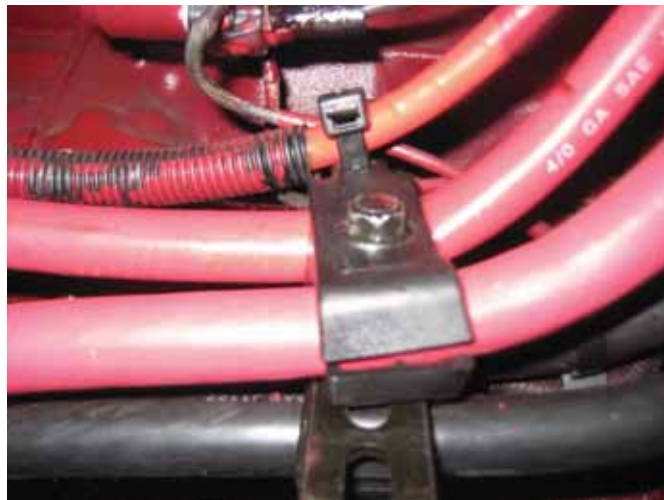
10. Tighten the nuts on the starter to the proper specification.
11. Locate and secure battery cables at the next clip point between the transmission and frame. Use the existing L-bracket mounted to clutch housing and secure cables with the plastic cable clamps and cable ties as shown.

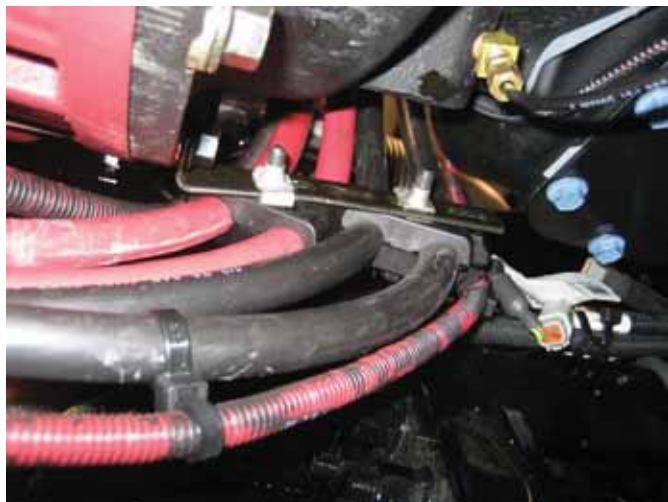
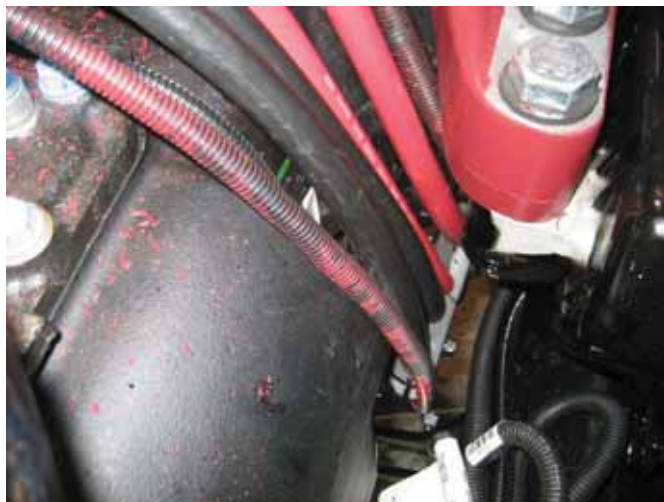
12. Locate and replace the existing bracket on the upper center of clutch housing with bracket part number 965536. Install plastic clamps and cable ties as shown.

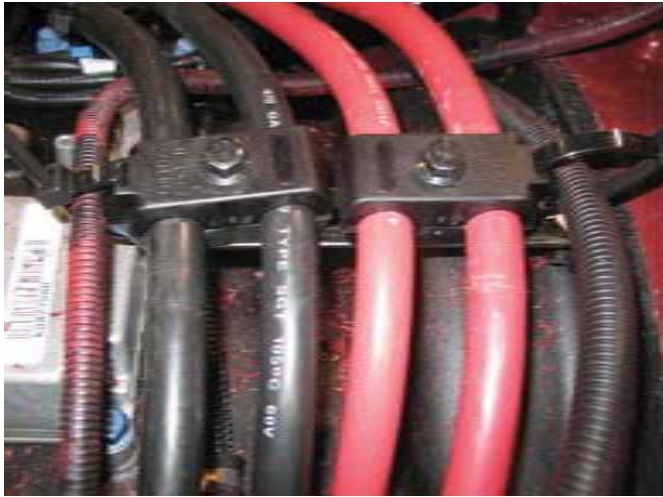
13. Install plastic cable clamps and cable ties as shown on the top side of the transmission.

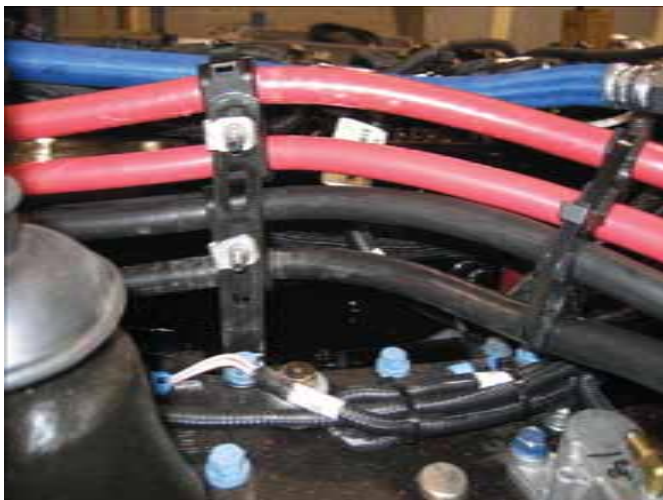
14. Install spacers as needed in between fixed bracket locations as shown above.  
Note: This will allow for proper spacing and reinforce the battery cable clipping.

15. Remove the existing bracket on rear of transmission and install new bracket part number 965565 and plastic cable clamps as shown.

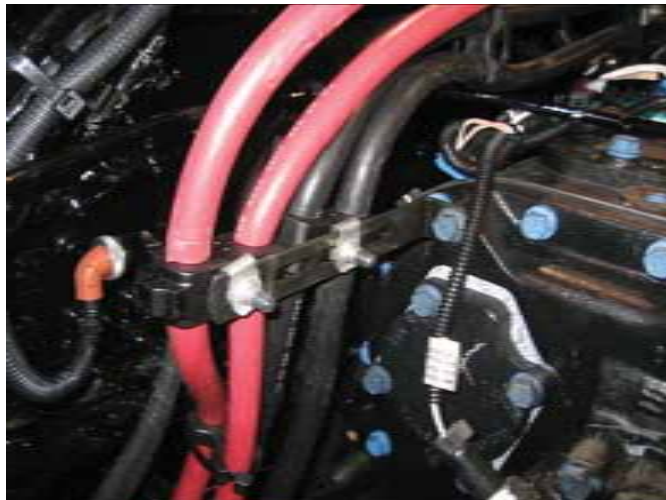
16. Install spacers as needed in between fixed bracket locations.  
Note: This will allow for proper spacing and reinforce the battery cable clipping.

17. Install bracket part number 965567 and 965558 onto fuel tank J-bracket in the location shown.  
Install plastic cable clamps, cable tie retainer, and cable ties as shown.

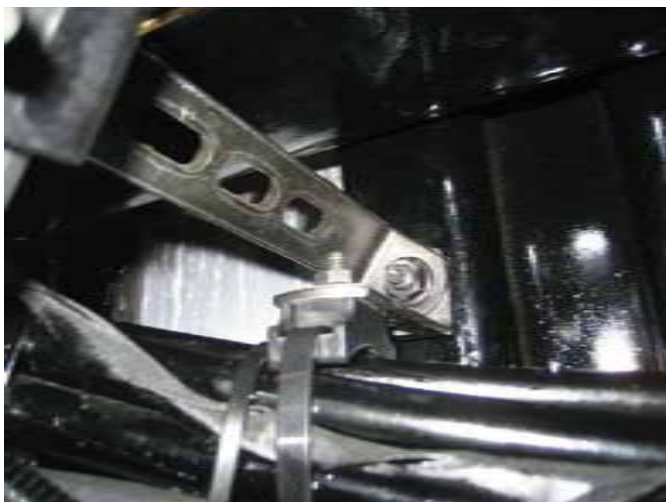
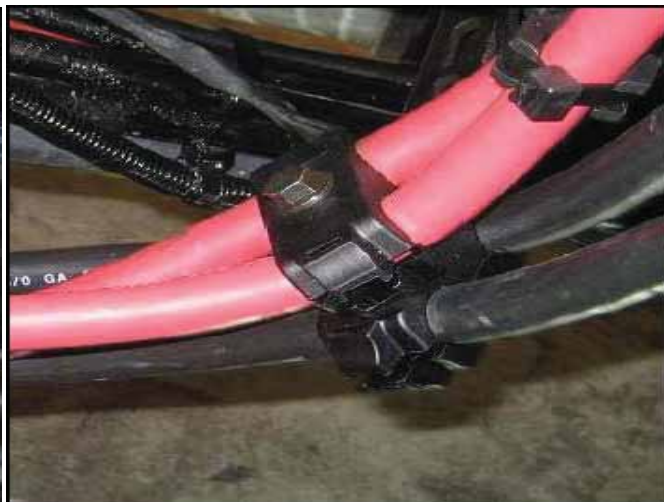
18. Locate the back of cab cross member and install the bracket part number 21530755 and 965564 in the hole location and orientated as shown.

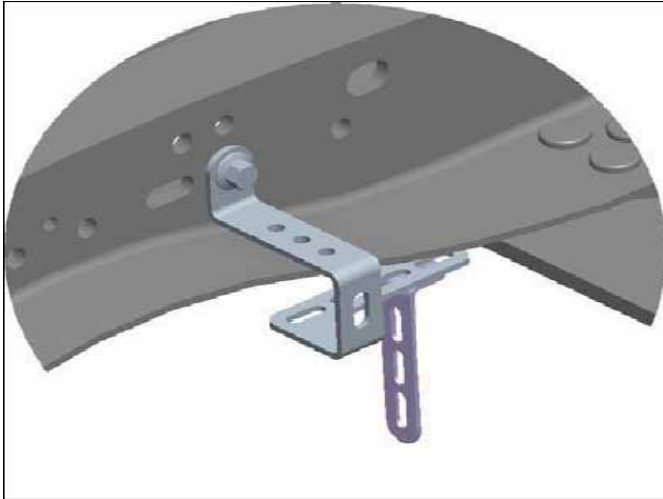
19. Install plastic cable clamps and cable ties as shown.

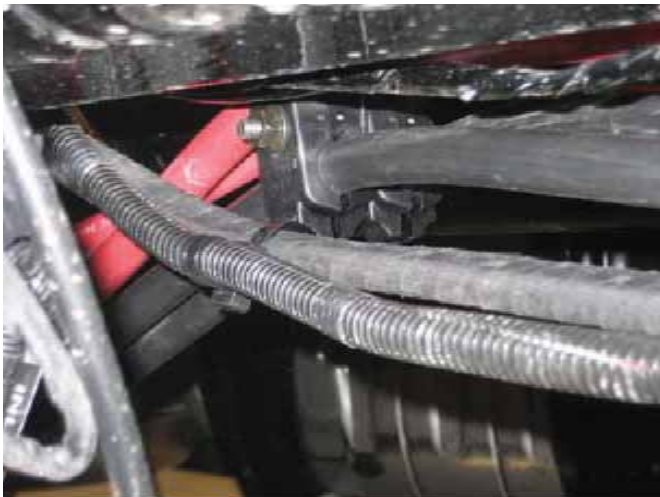
20. Locate the next bracket location on the frame rail and install the plastic cable clamps and cable tie as shown.

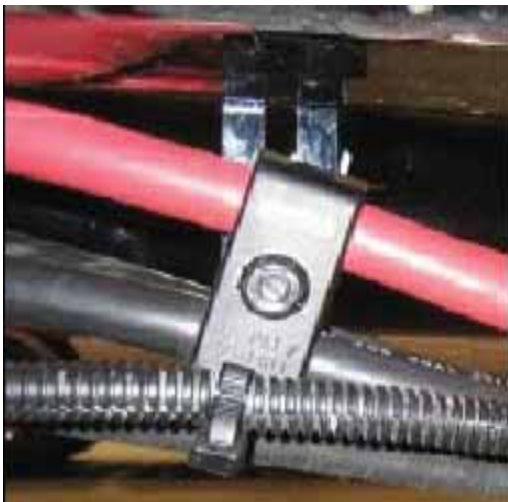
21. Install spacers as needed in between fixed bracket locations.

Note: This will allow for proper spacing and reinforce the battery cable clipping.

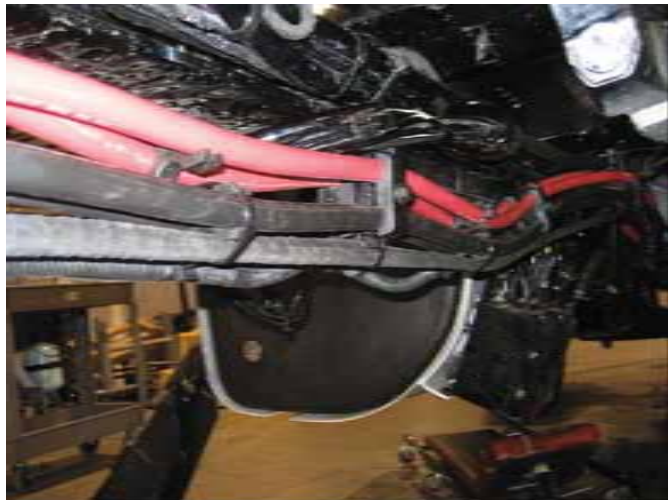
22. Locate the next bracket location on the frame rail and install the plastic cable clamps and cable tie as shown.

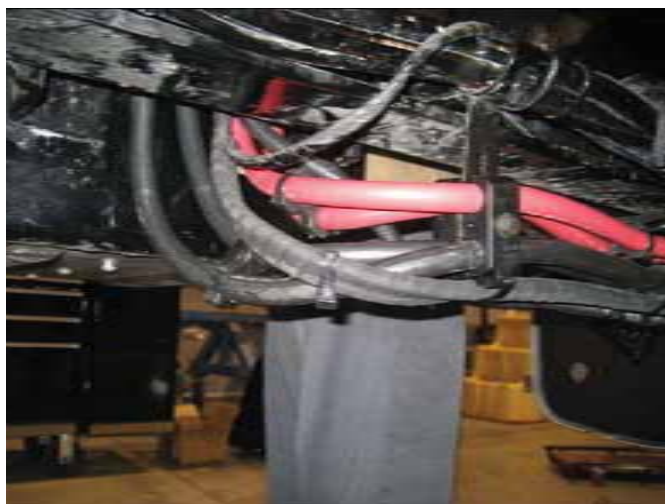
23. Locate the bracket on the frame rail behind the battery box and install the plastic cable clamps and cable tie as shown.

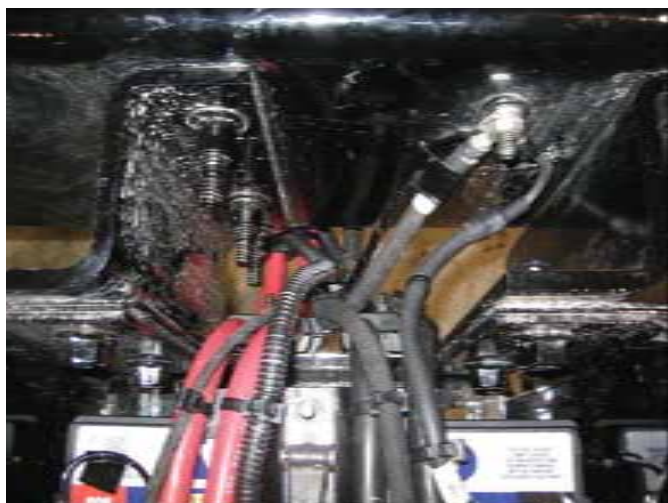
24. Install spacers as shown in between the fixed bracket and the back side of the battery box.  
Note: This will allow for proper spacing and reinforce the battery cable clipping.
25. Locate the three fasteners protruding into the battery box rear mounting flange and reverse the direction the bolts face so the flange head is on the battery box side of the frame rail. Torque the fasteners to 175 Nm (129 ft-lb).

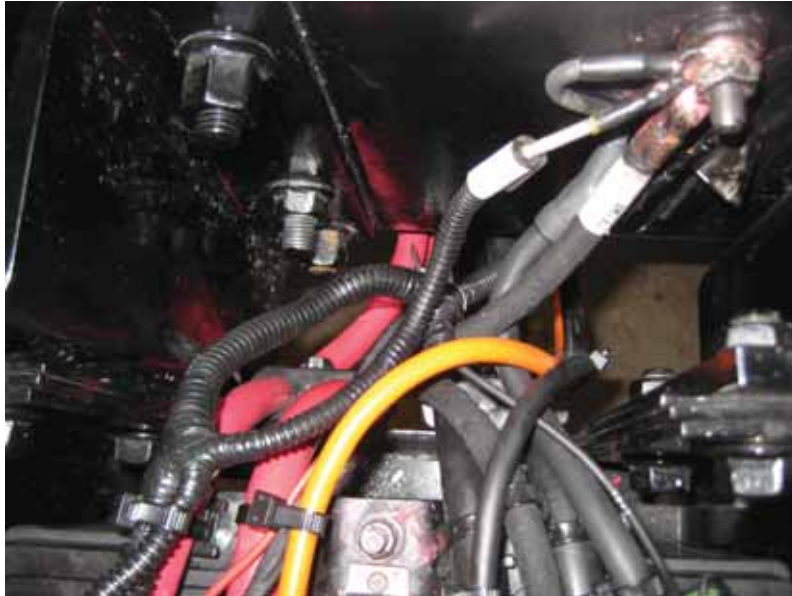
26. Cut 2 pieces of flat rubber stock material 2" x 3". Cut holes where the battery hold-down and cable tie fasteners will install.
27. Lay both rubber flaps onto the end of the battery hold-down metal plate and insert the push through cable tie fasteners.

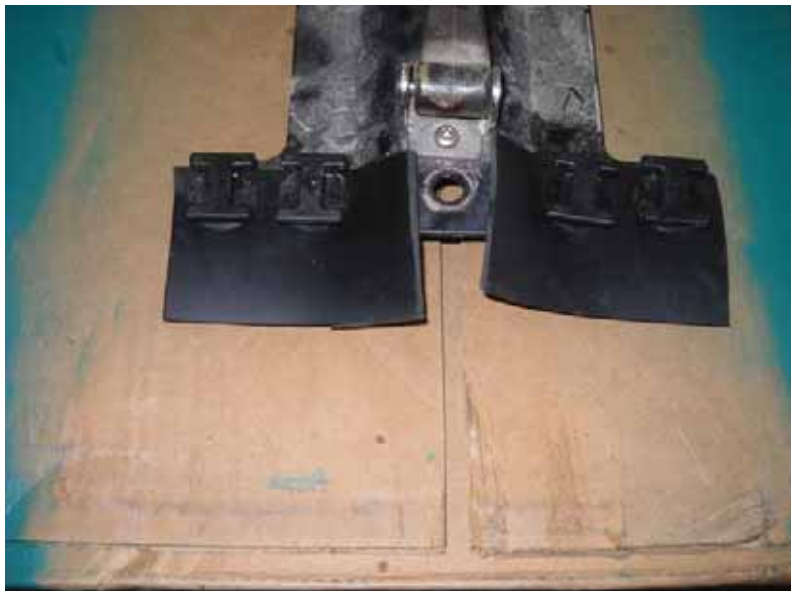
28. Locate the area between the battery box and frame rail.  
Route the battery cables as shown.

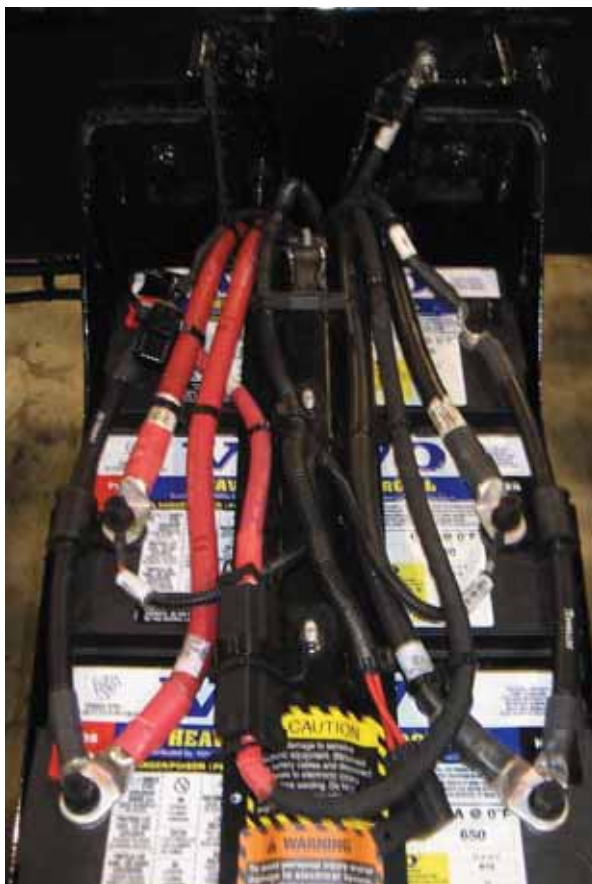
29. Connect the battery cables and secure  
Make certain the routing agrees with illustration and then secure each cable as shown with the proper cable tie.  
Torque the battery stud nuts to  $20 \pm 2$  Nm ( $14.8 \pm 1.5$  ft-lb).
