**Micro Bird Inc**

**SAFETY  
RECALL**

**TITLE:** Flat floor (torn wire insulation)

**Reference:** Recall 11-044-EHU /NHTSA #11V-319

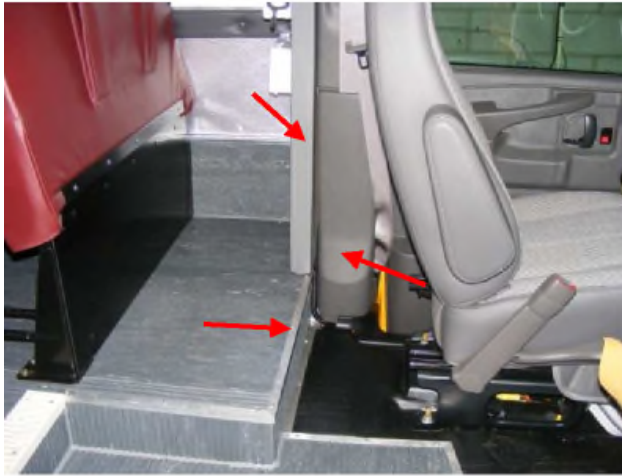
- 1- Push the driver's seat to the farthest position near the dash.
- 2- Remove the corner trim and the B Pillar trim.

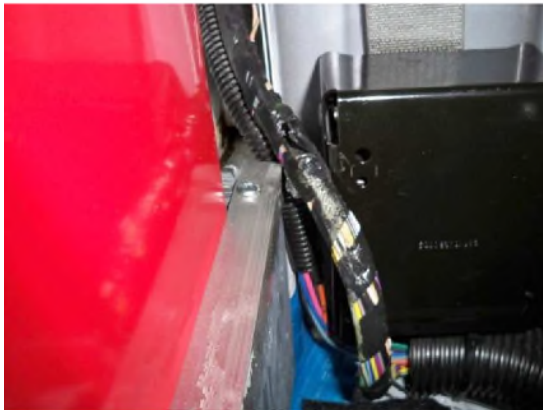
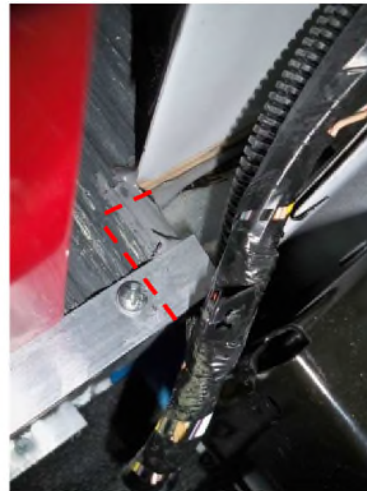
- 3- Remove the aluminum trim and cut approximately one inch at the end.
- 4- Remove the same area on the corner of the floor using a wood chisel to allow clearance of the electrical harness. (The use of any saw is not recommended since there is a metal sheet under the plywood.)

- 5- Install a loom or any other protection against abrasion over the OEM harness. An electrical tape is not sufficient.
- 6- **Fix the harness in place using sealant (very important).**
- 7- Reinstall the aluminum trim.
