**Regarding: 11V-338**

# Technical BULLETIN

## SAFETY RECALL

### 2006~2009 FJR1300 MODELS FACTORY MODIFICATION CAMPAIGN – Ground Wire Junction

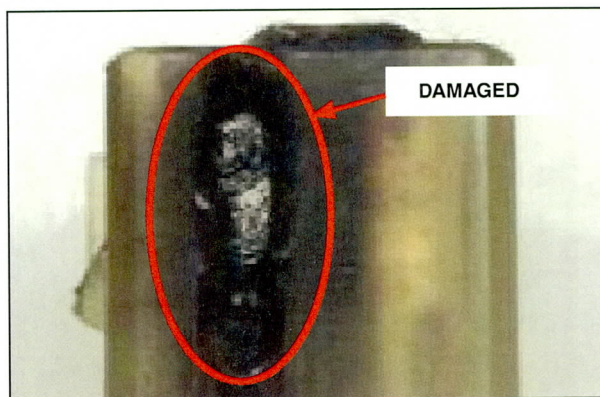
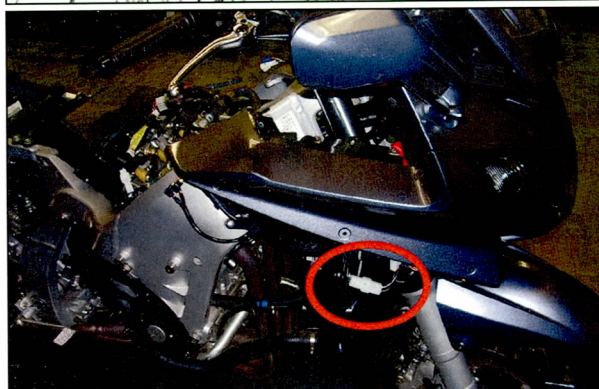
2. Disconnect the negative lead coupler.
