# ***SERVICE PROCEDURE***

**G-11510  
JANUARY 2012**

**SUBJECT: SAFETY RECALL  
BATTERY CABLES on certain RE model  
commercial buses built 8/24/10 thru 6/8/11 with a  
2010 exhaust emissions engine feature code  
510974.**

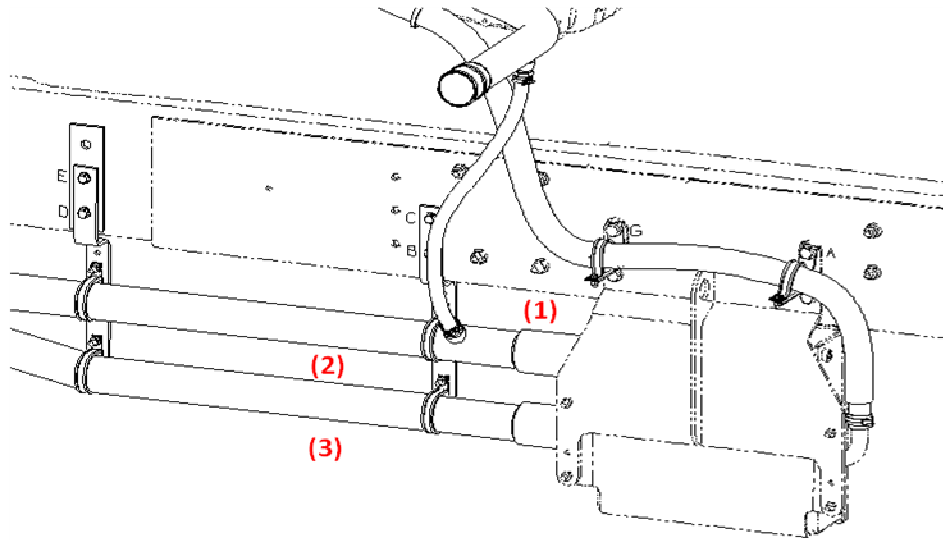
**Figure 1**

2. Inspect negative and positive battery cable routing path from the rear of the battery box to the starter. Cables that are routed over or between the coolant pipes will require removal from the starter to allow routing per the following steps. Cables that are routed under (3) the coolant pipes will not require removal from the starter attachment points. (Figure 1)

Possible battery cable routing, over (1), between (2) or under (3) coolant pipes.

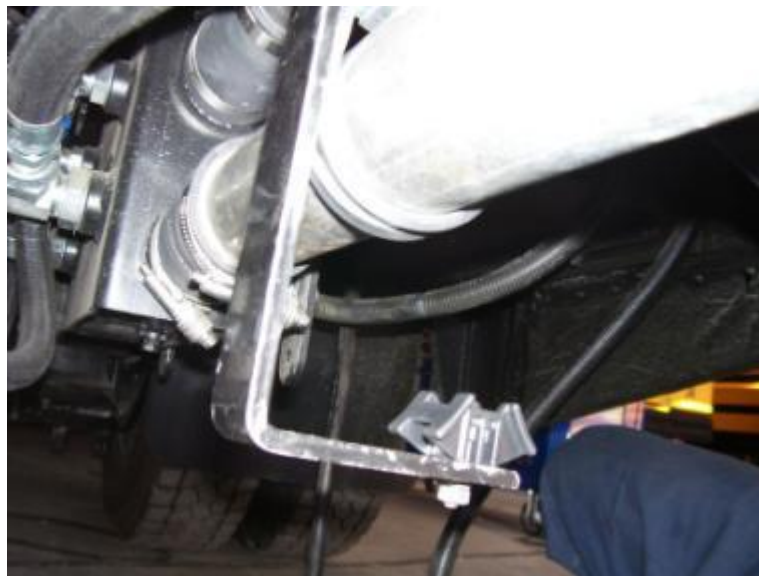
Figure 2a

4. Remove negative and positive battery cables from the starter if cable(s) are routed over or between the coolant pipes as outlined in step 2.
5. Remove coolant pipe and hydraulic hose p-clamps from frame mounted bracket rearward of the hydraulic fluid reservoir. Remove bracket from frame rail mounting points (3/8" hardware). Reinstall replacement bracket (3932762C1) and p-clamps. (Figure 2) Install a large dual saddle (3553742C1, hardware 25483R1, 120380 and 25519R1) to the top of the lower bracket. Saddle will be tightened in step 13. (Figure 2a)

- a. NOTE: Bracket installation can be performed by placing the bracket lengthwise between the frame and upper coolant pipe then rotate the bracket into final position.

- e. Install tie-strap to the negative and positive cables to the frame mounted coolant pipe bracket. (Re: Item 5, Figure 2a)
- f. Install tie-straps to the negative and positive cables to the reservoir mounted extension clip. (Re: Item 8, Figure 5)

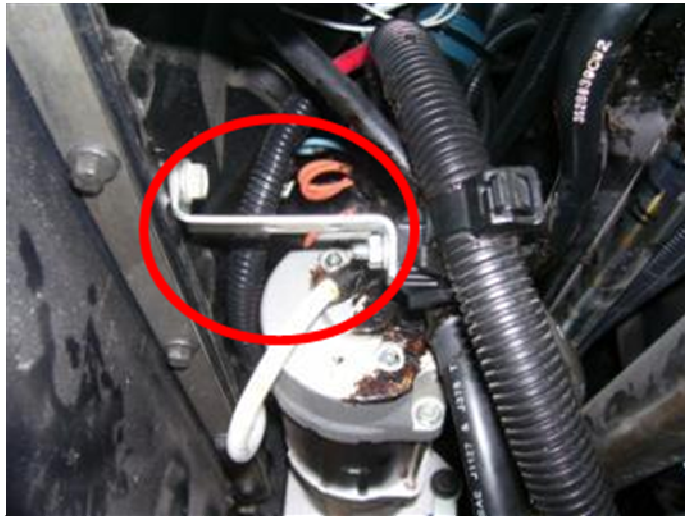
Figure 3

6. Loosely install single saddle (2041341C1, hardware 25483R1, 120380 and 25519R1) on extension clip (2002176C2) and install assembly to side of engine block using M8 bolt (3547776C1) and lock washer (934309R1). Saddle will be tightened in step 13. (Figure 3)

- c. Install tie-strap to positive cable to the engine block mounted extension clip and saddle. (Re: Item 6, Figure 3)
- d. Install tie straps to negative and positive cables to the lower coolant pipe p-clamp. Position p-clamp to allow consistent routing of the battery cables to eliminate any abrasion points prior to final tightening. (Re: Item 7, Figure 4)

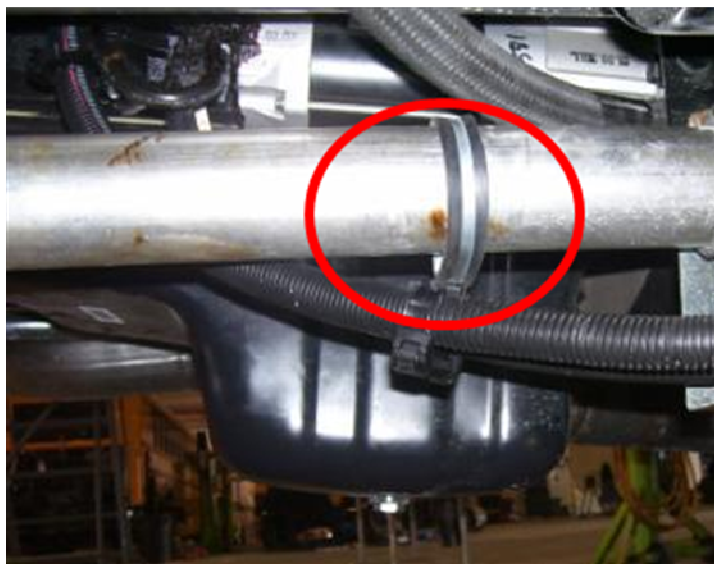
Figure 4

7. Install p-clamp (1677372C1) around lower coolant pipe approximately 8"-10" rearward of the frame mounted bracket replaced in step 5 and loosely install large dual saddle (3553742C1, hardware 25483R1, 120380 and 25519R1). Final location of p-clamp will be determined during final clipping of the battery cables. Saddle will be tightened in step 13. (Figure 4)

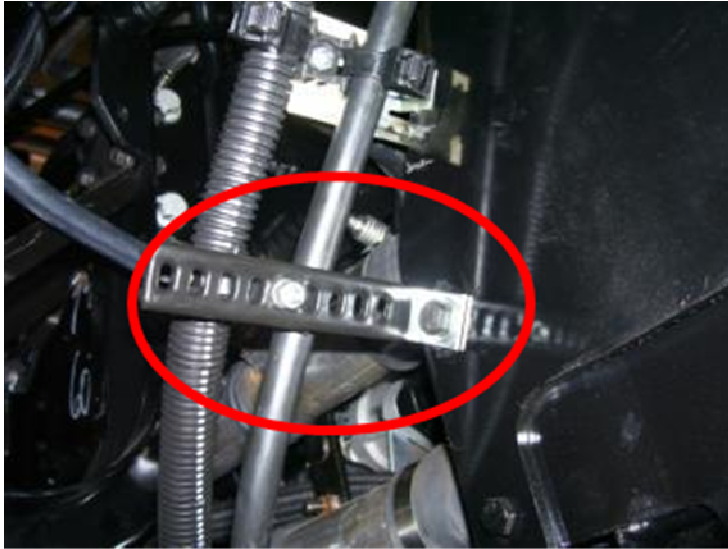
Figure 5

8. Remove upper rear hydraulic fluid reservoir mounting bolt (located between coolant pipes) and discard. Loosely install large dual saddle (3553742C1, hardware 25483R1, 120380 and 25519R1) on extension clip (3627806C2) and install assembly with new mounting hardware (9413979, 24841R1 and 25709R1). Saddle will be tightened in step 13. (Figure 5)

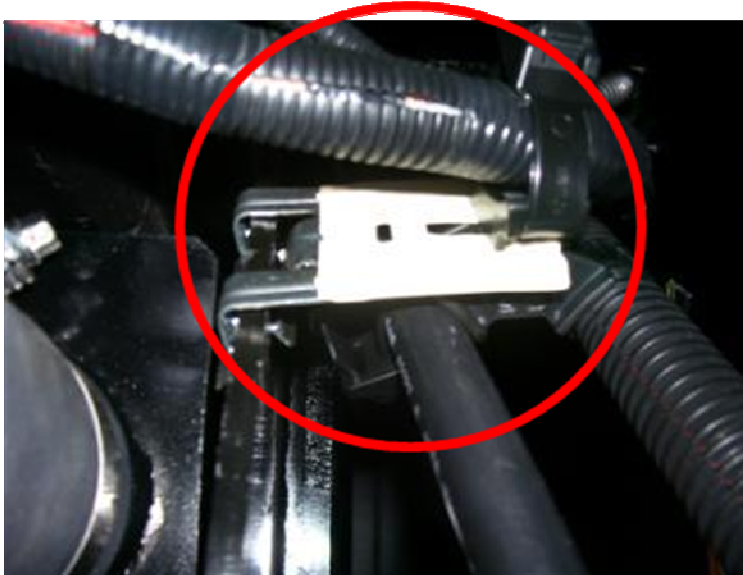
Figure 6

9. Assemble a single saddle (2041341C1) and large dual saddle (3553742C1, hardware 25483R1, 120380 and 25519R1) to spring clip (2012155C1) and install assembly on the rear upper slanted edge of the reservoir mounting bracket. Single saddle clamp is to be installed on the top, large dual saddle on the lower side of the spring clip. In the event edge trim was installed on the intended mounting surface, remove edge trim and discard. Tighten saddles in the position as shown in the below figure. (Figure 6)

- g. Install tie-straps to the negative and positive cables to the spring clip. (Re: Item 9, Figure 6)
- h. Install tie strap to clean power harness to the single saddle mounted on the spring clip. (Re: Item 9, Figure 6.)

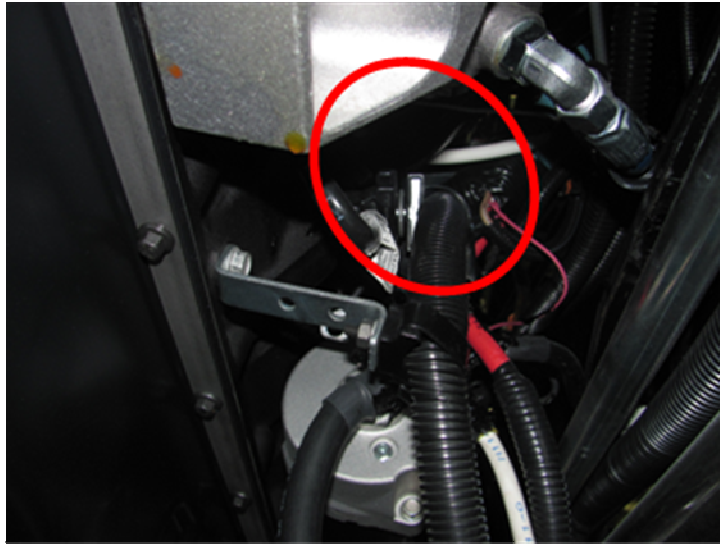
**Figure 8**

- a. Reconnect battery cable to starter connection points.
- b. Install a double swivel saddle (3554553C1) between the negative and positive cable near the rear of the starter. (Figure 8)

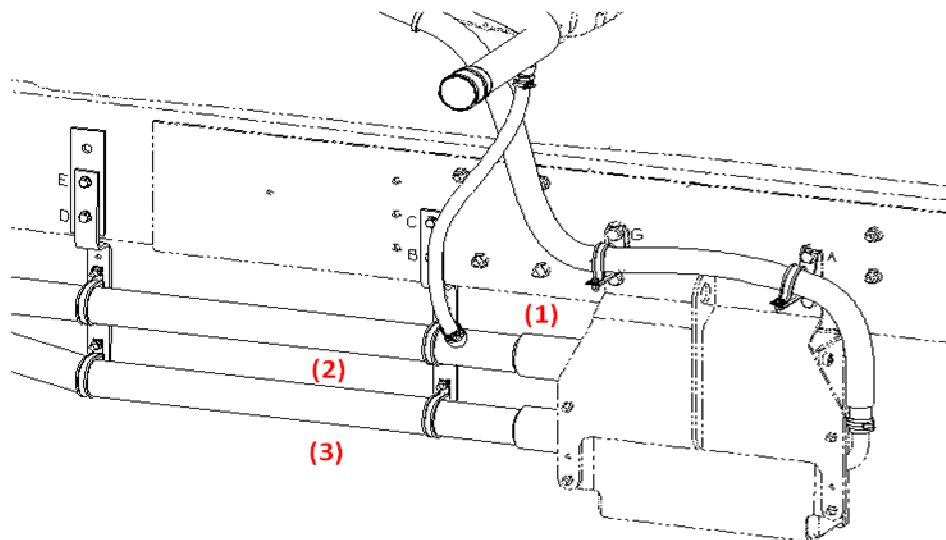
Figure 2

4. Remove all clipping points currently in place on the negative and positive battery cables from the battery box to the starter.
  - a. NOTE: If unit is equipped with an ammeter sensor on the negative battery cable, clip points may need to be removed to complete the following process and reinstalled at conclusion of repairs.
5. Battery cables will be routed under the coolant pipes. If the cables are currently routed over (1) or between (2) the coolant pipes, pull the cables out, toward the rear of the unit, to allow proper routing per the following instructions. (Figure 2)

Possible battery cable routing, over (1), between (2) or under (3) coolant pipes.

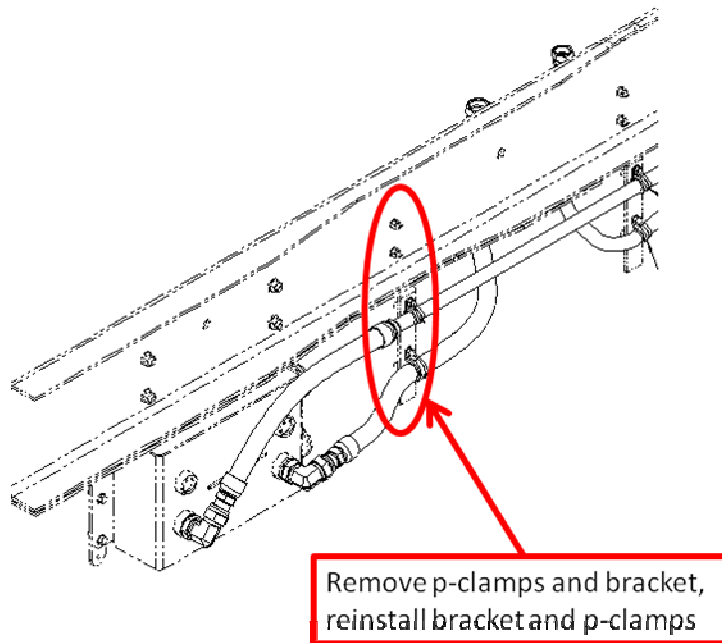
Figure 3

6. Remove coolant pipe and hydraulic hose p-clamps from frame mounted bracket rearward of the hydraulic fluid reservoir. Remove bracket from frame rail mounting points. Reinstall replacement bracket (3932762C1) and p-clamps. (Figure 3) Install a large dual saddle (3553742C1, hardware 25483R1, 120380 and 25519R1) to the top of the lower bracket. Saddle will be tightened in step 20. (Figure 3a)
  - a. NOTE: Bracket installation can be performed by placing the bracket lengthwise between the frame and upper coolant pipe then rotate the bracket into final position.

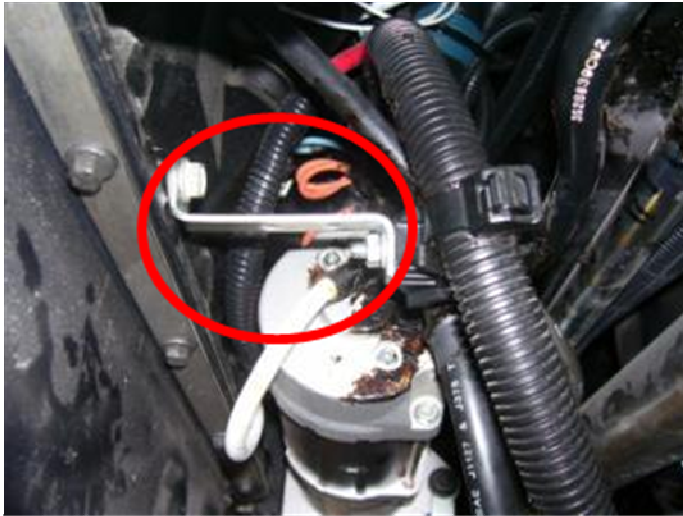
Figure 4

7. Loosely install single saddle (2041341C1, hardware 25483R1, 120380 and 25519R1) on extension clip (2002176C2) and install assembly to side of engine block using M8 bolt (3547776C1) and lock washer (934309R1). Saddle will be tightened in step 20. (Figure 4)

- b. Install tie-strap to positive cable to the engine block mounted extension clip and saddle. (Re: Item 7, Figure 4)
- c. Install tie straps to negative and positive cables to the lower coolant pipe p-clamp. Position p-clamp to allow consistent routing of the battery cables to eliminate any abrasion points prior to final tightening. (Re: Item 8, Figure 5)
- d. Install tie-strap to the negative and positive cables to the frame mounted coolant pipe bracket. (Re: Item 6, Figure 3, 3a)
- e. Install tie-straps to the negative and positive cables to the reservoir mounted extension clip. (Re: Item 9, Figure 6)
- f. Install tie strap to clean power harness to the single saddle mounted on the spring clip. (Re: Item 9, Figure 6.)
- g. Install tie-straps to the negative and positive cables to the spring clip. (Re: Item 10, Figure 7)

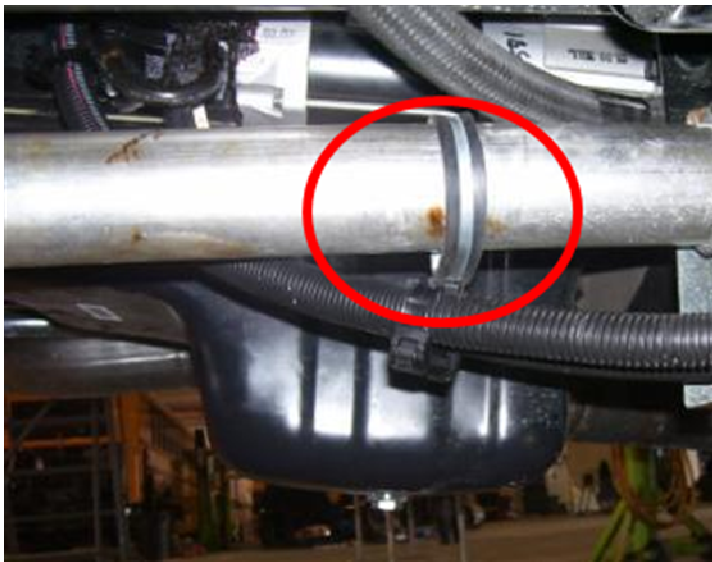
Figure 5

8. Install p-clamp (1677372C1) around lower coolant pipe approximately 8"-10" rearward of the frame mounted bracket replaced in step 6 and loosely install large dual saddle (3553742C1, hardware 25483R1, 120380 and 25519R1). Final location of p-clamp will be determined during final clipping of the battery cables. Saddle will be tightened in step 20. (Figure 5)

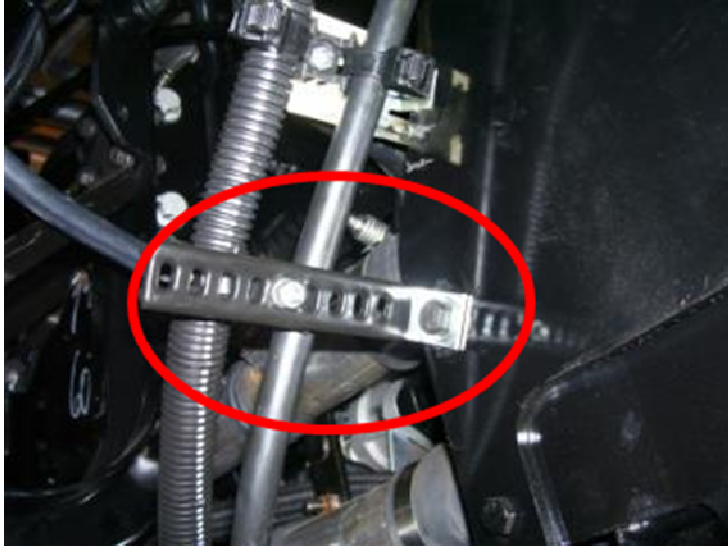
9. Remove upper rear hydraulic fluid reservoir mounting bolt (located between coolant pipes) and discard. Loosely install large dual saddle (3553742C1, hardware 25483R1, 120380 and 25519R1) on extension clip (3627806C2, hardware 9413979, 24841R1 and 25709R1) and install assembly. Saddle will be tightened in step 20. (Figure 6)

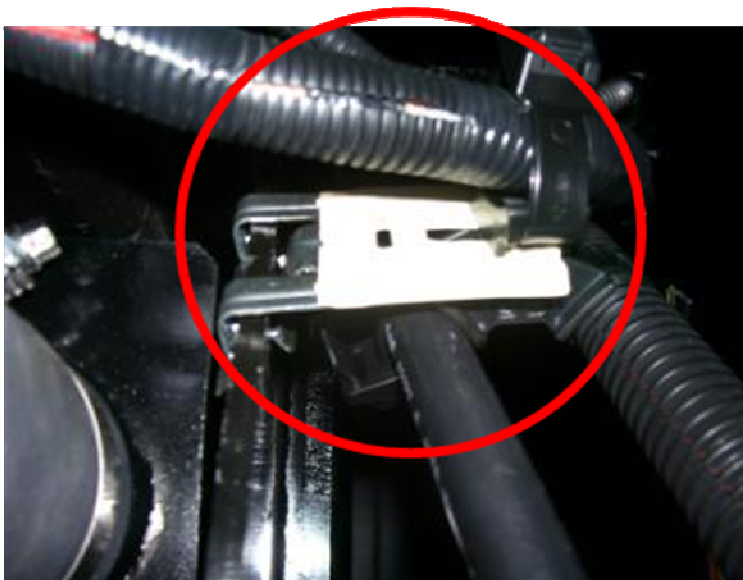
Figure 7

10. Assemble a single saddle (2041341C1) and large dual saddle (3553742C1, hardware 25483R1, 120380 and 25519R1) to the spring clip (2012155C1) and install assembly on the rear upper slanted edge of the reservoir mounting bracket. Single saddle clamp is to be installed on the top, large dual saddle on the lower side of the spring clip. In the event edge trim was installed on the intended mounting surface, remove edge trim and discard. Tighten saddles in the position as shown in the below figure. (Figure 7)

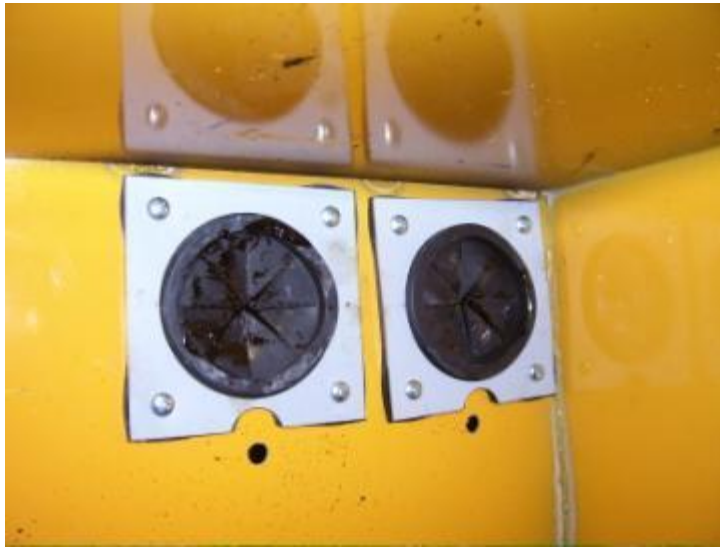
**Figure 9**

12. Position and install routing grommet and mounting plate (Qty 2 - 2212199C1 and 2212509C1) with self drilling screw (Qty 8 - 456107C1). (Figure 9)

- a. NOTE: Grommets and plates MUST be installed from the inside of the battery box.

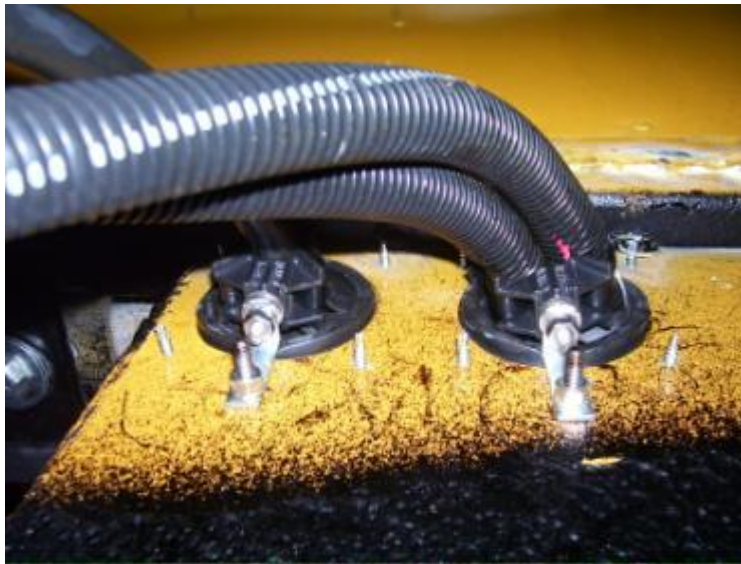
**Figure 10**

- 13.** Install two (2) saddles (3553742C1, hardware 25483R1, 120380 and 25519R1) on extension clip (454541C1). Install extension clip assembly (hardware 25483R1, 120380 and 25519R1) on the outside of the battery box using the holes drilled below the cable routing points. This step will require assistance from a second Technician. (Figure 10)

- h. Install tie-straps to negative and positive cables and clean power harness to the battery box mounted saddles. (Re: Item 13, Figure 10) If unit was equipped with disconnect switch, install tie-straps to the negative and positive cables to the additional bottom of battery box saddles. (Re: Item 13, Figure 10a)
- i. Install tie-strap to clean power harness to positive cable between rear of the battery box and spring clip. Inspect overall battery cable routing and add additional double swivel saddle (3554554C1) to eliminate any potential contact between battery cables. (Figure 12)

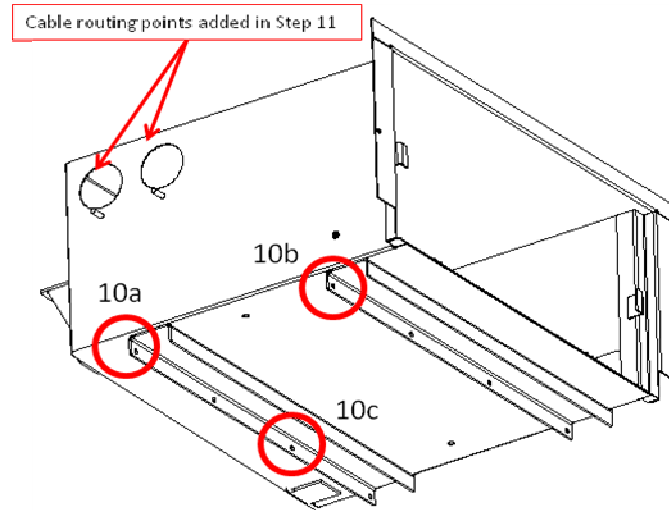
**Figure 10a**

- a) Loosely install large saddle (Qty 3 - 3553742C1, hardware 25483R1, 120380 and 25519R1) on extension clip (Qty 3 - 250537C1, hardware 25483R1, 120380 and 25519R1) and install assembly in holes 10a, 10b and 10c. Saddle will be tightened in step 20. (Figure 10a)
