SERVICE PROCEDURE

**G-11514
AUGUST 2011**

**SUBJECT: NONCOMPLIANCE RECALL
REAR EXIT DOOR REFLECTIVE TAPE on certain
BE, CE, and FE model school buses built 11/1/06
thru 5/31/11 with rear exit door feature code
47NWD**

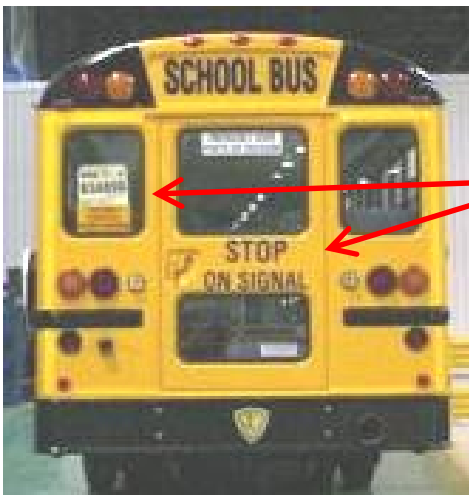
The suspect buses may have been built without reflective tape on either side of the rear exit door as required per FMVSS 217 S5.5.3(c). This noncompliance may reduce the conspicuity of the rear exit door reducing the ability of emergency personnel to identify and gain access to the rear exit and possibly increasing the passenger's risk of personal injury or death during an emergency.

As Built – No vertical reflective tape on the sides of the door.

1. Overview: The suspect buses may have been built without the required reflective tape adjacent to the vertical openings of the rear emergency door. The repair consists of installing this tape.

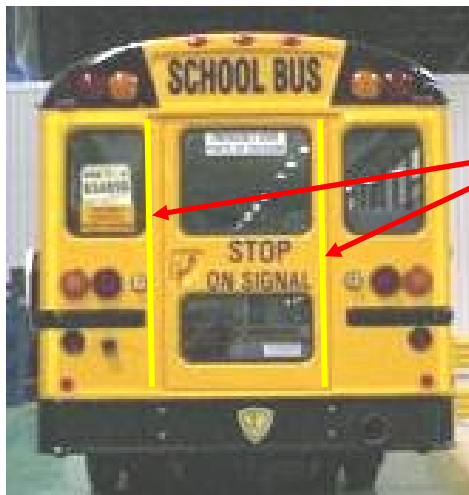
Repaired – Vertical reflective tape installed on the sides of the door.

2. Make sure that the surface to which the reflective tape will be applied is clean and free from any grease or foreign substance.
3. Cut a length of tape that will cover the vertical surface from the top of the door to the bottom. Do not overlap the existing striping.
4. Remove the film backing from the first two inches of the tape and attach the end of the tape to the bus starting at the top just below the doors drip trough.
5. Continue moving the film backing and smooth the tape into place starting at the attached end and moving to the other end.

6. Run over the reflective tape with a squeegee making sure all edges are affixed.
7. Repeat tape installation on the other side of the door.

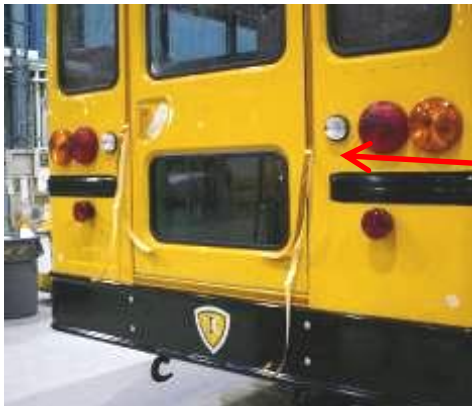
Work top to bottom, peeling off film backing and affixing it to the bus body
