## INSTRUCTION TO SERVICE

**ITS: 4974**

| <b>SUBJECT:</b> | Combining Gear Box Upgrade |

# ITS 4974

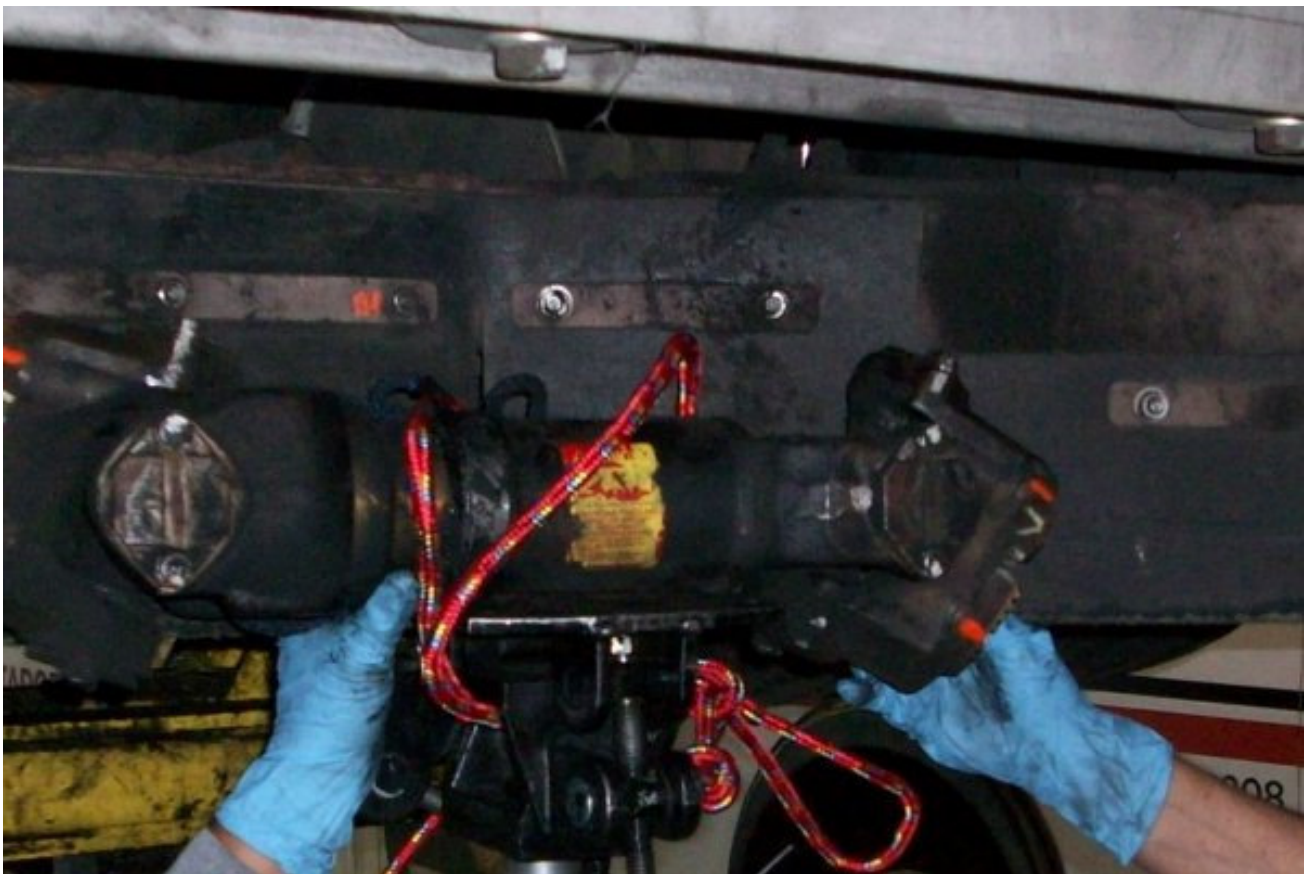
**FIGURE 1: DRIVESHAFT DISCONNECTION.**

1. Turn the main battery disconnect switch to the “OFF” position.
2. Raise coach in accordance with the New Flyer Service Manual.
3. Remove driveshaft guard. Retain hardware for reuse.
4. Apply strap though both ends of driveshaft at yokes to prevent extension.
5. Support driveshaft with stand.
6. Disconnect driveshaft from combination gearbox output flange. Retain bolts for reuse, discard locknuts.

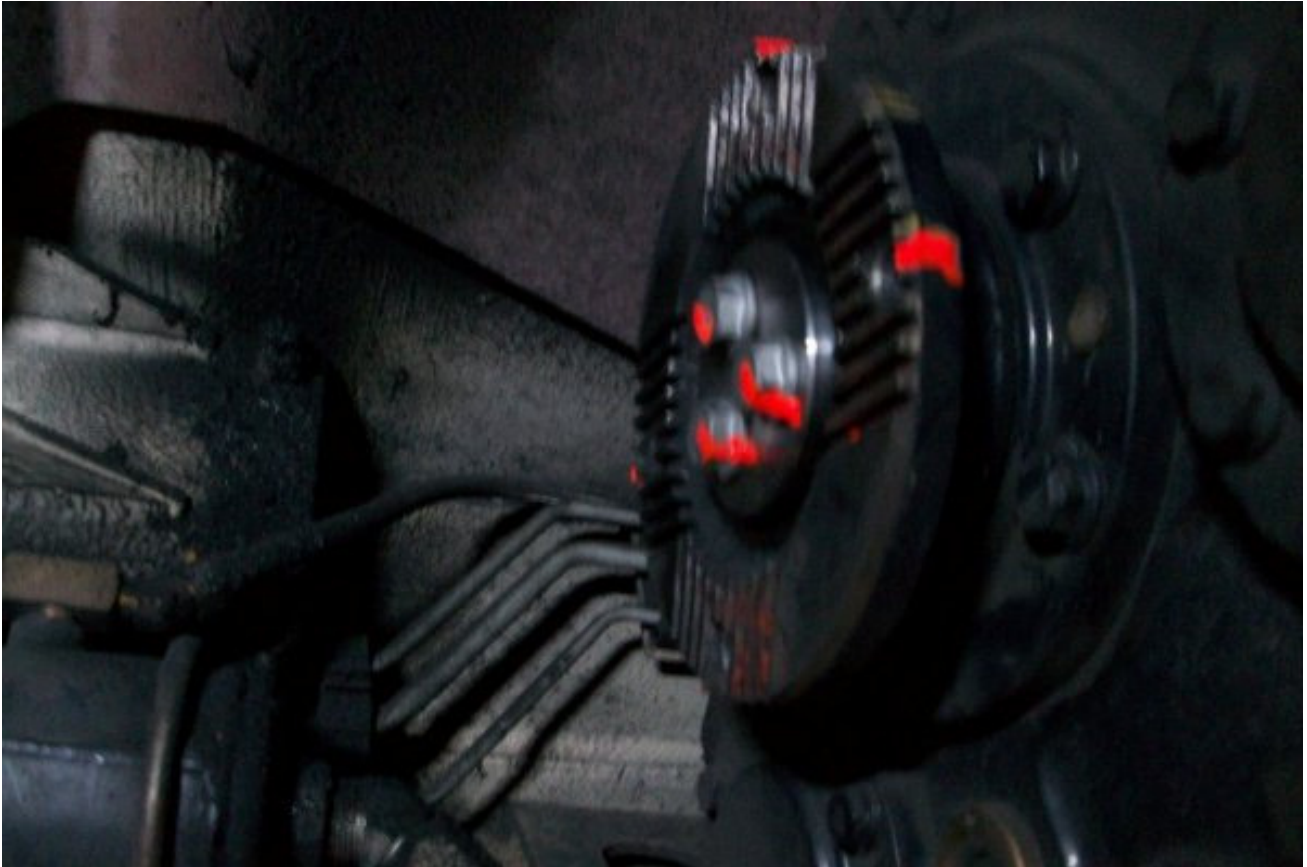
***FIGURE 2:*** GEARBOX OUTPUT FLANGE.

7. Remove and discard 3 bolts and retaining endplate from the output flange. **Refer to Figure 2.**
8. Run a tap onto bolt holes to remove old Loctite compound.

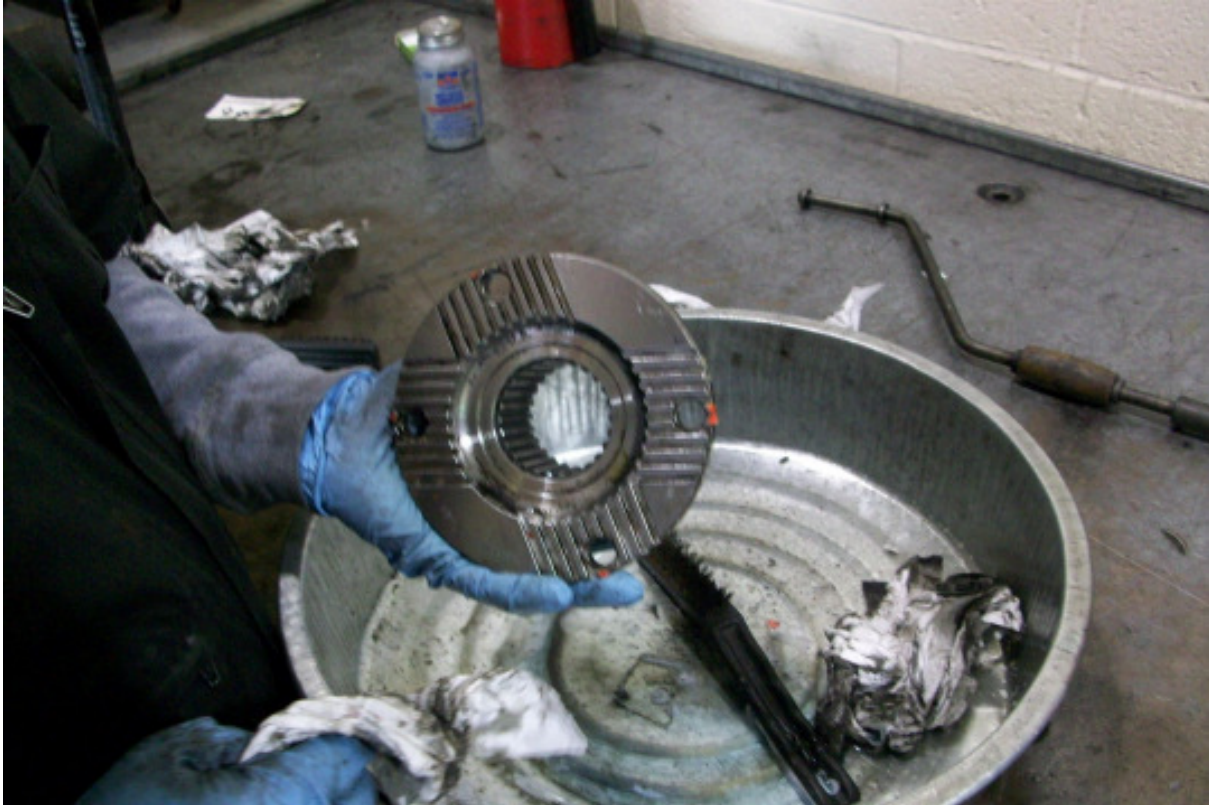
**FIGURE 3:** CLEAN OUTPUT FLANGE.

9. Remove and clean output flange with de-greasing solvent (NF PN: 6405975). Refer to Figure 3 and Appendix A (directions to use product).

1. Spray area generously with Loctite ODC-Free Cleaner & Degreaser.
2. Wipe surfaces when still wet with a clean cloth to remove all heavy contamination. If necessary, spray surfaces again to allow run-off of product.
3. Allow Loctite ODC-Free Cleaner & Degreaser to fully evaporate from parts prior to bonding to avoid solvent entrapment with the bond joint.
4. Apply the Loctite adhesive immediately after drying and assemble bond.

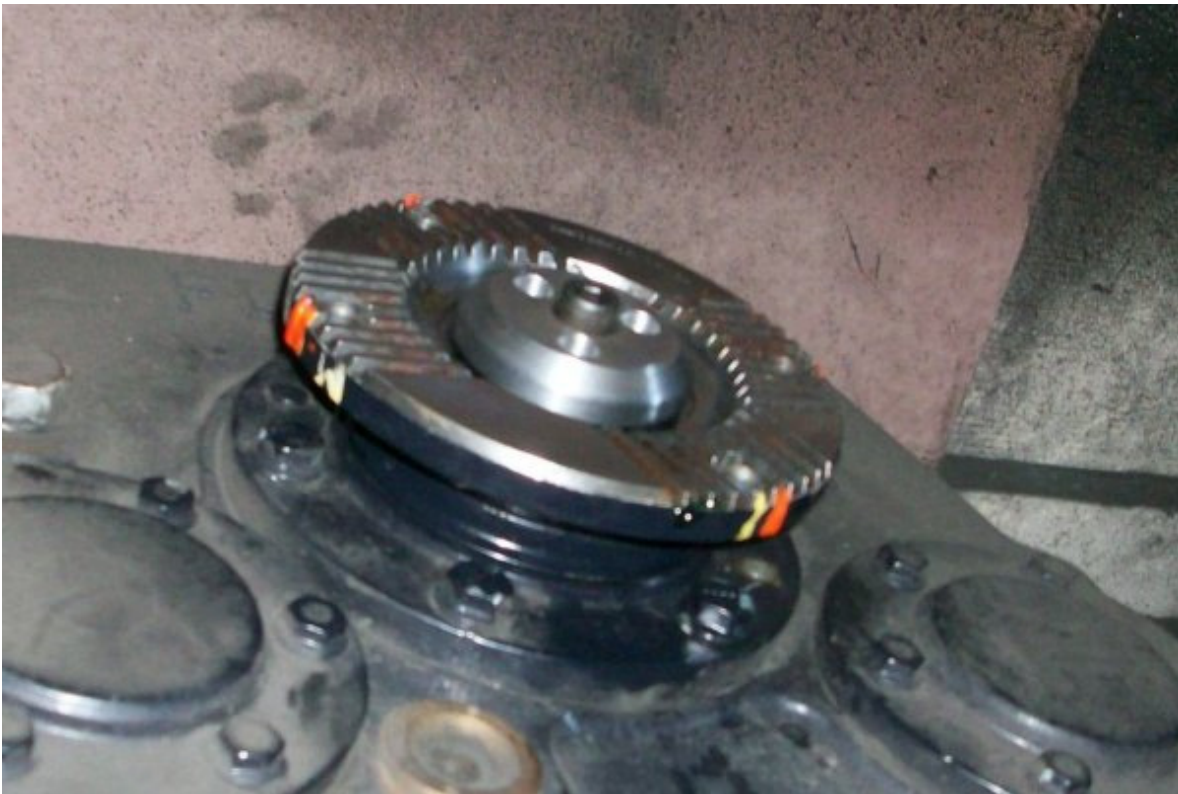
**FIGURE 6:** SHOWN VIEW OF NEW HARDWARE AND END PLATE.

14. Apply Loctite 242 (**NF PN: 8110440**) into the four mounting holes the new hardware is installed in (three M10x45 10.9 bolts, **NF PN: 6405972**, and one M10x30 12.9 bolt **NF PN: 6405973**). Loosely install with 4 bolt pattern endplate (**NF PN: 6404293**). The 30 mm bolt is for the center, the 45 mm bolts are for the 3 outer holes. **Refer to Figure 6.**

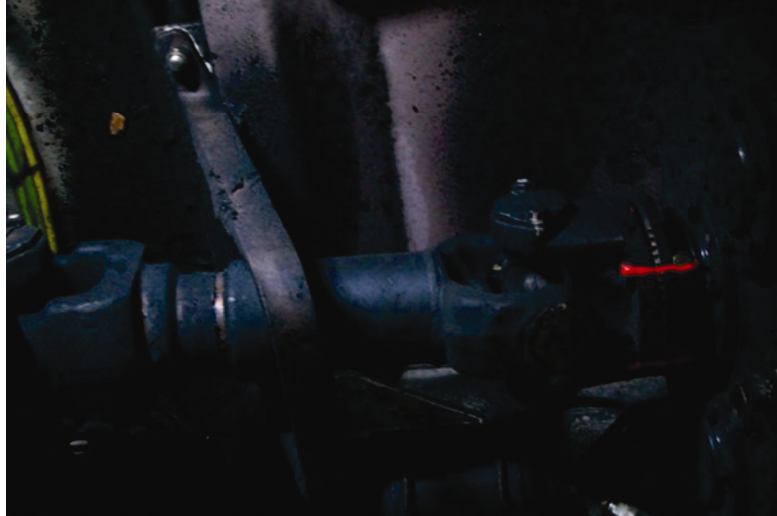
**FIGURE 9:** SHOWN APPLICATION OF THE DRIVE SHAFT RE-ATTACHED TO GEAR BOX.

17. Remove strap from driveshaft and reconnect the driveshaft to gearbox using bolts previously removed and new locknuts (**NF PN: 40N08000**). Torque hardware between **63-75 FT-LBS**. Apply torque strips on hardware. **Refer to Figure 9.**

Drive shaft re-attached to gear box with torque lines.
