PRODUCT CAMPAIGN BULLETIN

APPLICABILITY: 2002~07MY Impreza (except STI)
 2003~08MY Forester
SUBJECT: Front Lower Control Arm (Transverse Link) Corrosion

NUMBER: **WVX-34R**
DATE: Nov 2011
REVISED: **07/26/21**

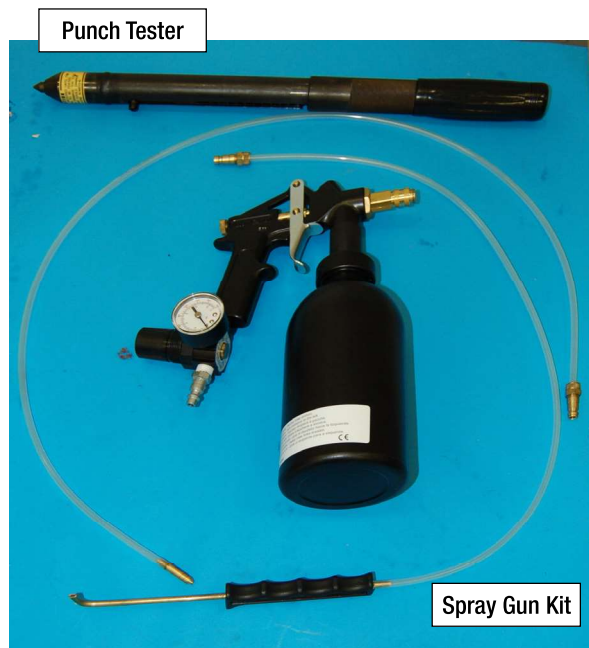
Punch Tester:

Each dealer that has been identified as having vehicles affected by this recall in their area will automatically be shipped, at no cost, one Punch Tester.

DESCRIPTION	PART NUMBER
WVX34 Punch Tester	SOA635099

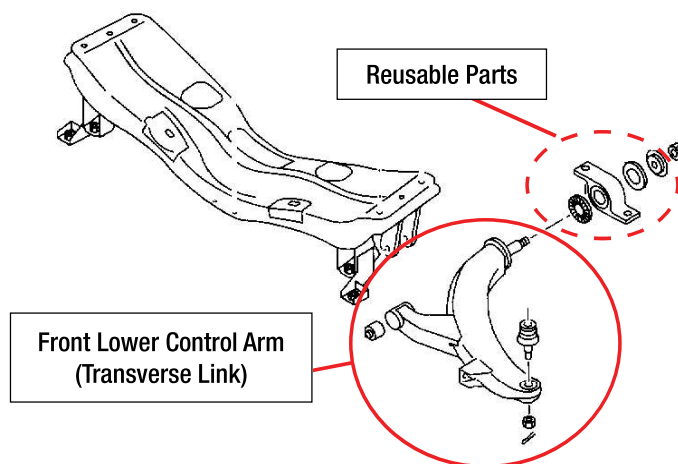
Replacement Front Lower Control Arms:

The following kits contain both left and right lower control arms along with replacement lock nuts.

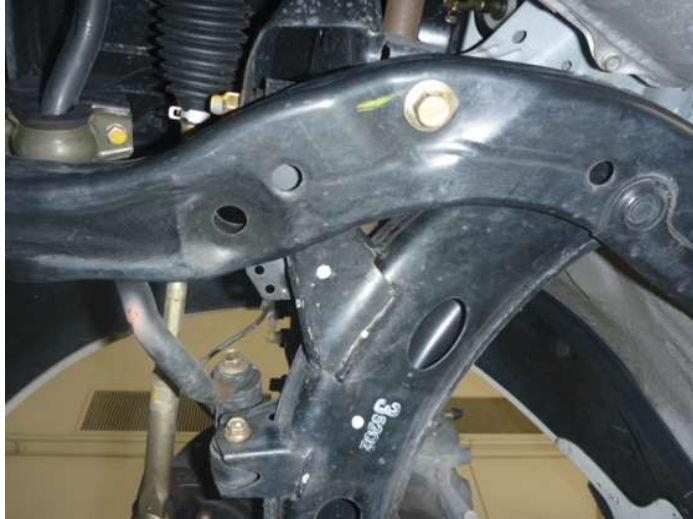
Right side, bottom

Starting on the right side, use a rag and remove any dirt, mud, surface rust or under coat from the top and bottom surfaces of the hanger bracket for measuring the location for punch testing.

Measure the bottom surface approximately 40mm from the weld to the center of the hanger bracket and make a mark.

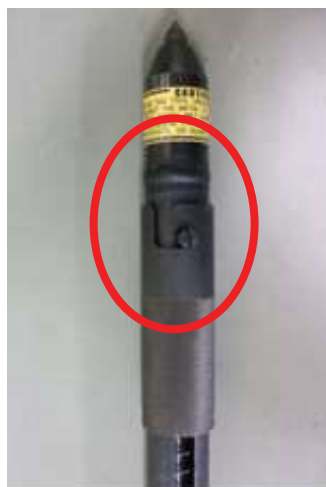
Slide the trigger tube toward the punch tip and set the lock pin to the trigger tube.

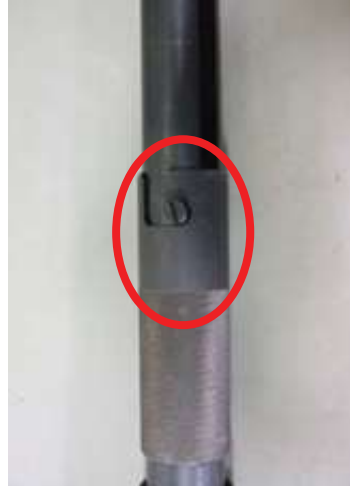
Draw the trigger tube downward and set the lock pin to the lock groove.

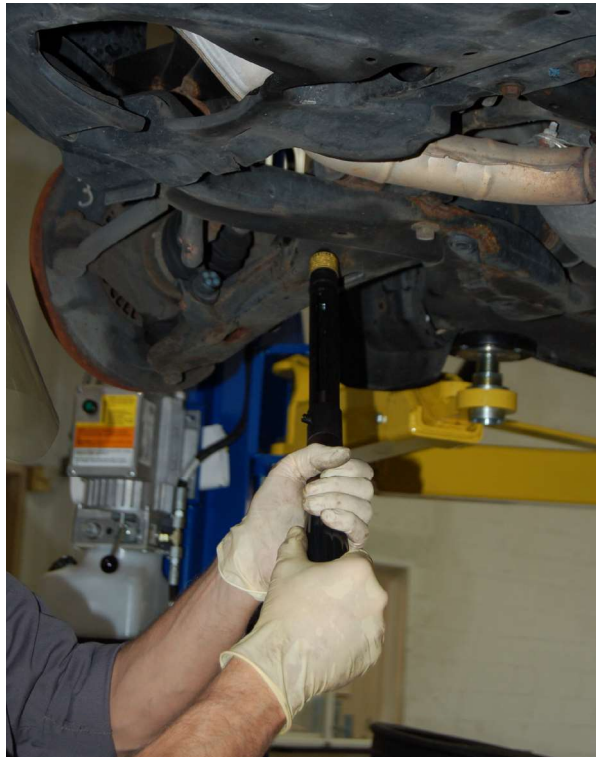
Lower punch test

Firmly, set the tip of the punch tester vertically at the previously marked point. While pushing up, hold the handle and twist the trigger tube clockwise to trigger punch test.

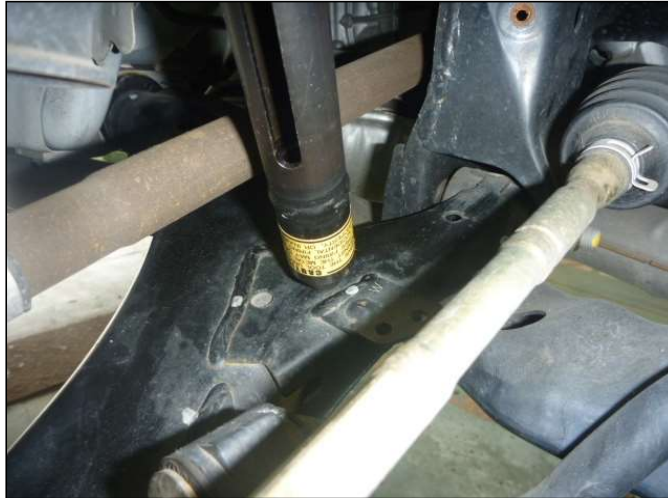
Upper punch test

Firmly set the tip of the punch vertically at the previously marked point. While pushing down, hold the handle and twist the trigger tube clockwise to trigger punch test.

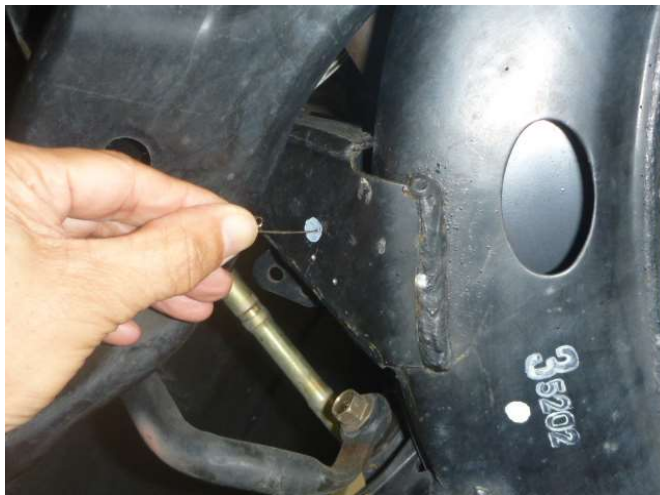
Using a paper clip, insert it into the indentation made by the punch tester. Work the paper clip back and forth in an attempt to penetrate the metal. If the paper clip cannot be inserted, perform the procedure on the upper surface.

If the paper clip can be pushed through the metal, the arm is failed.

If the right side is failed, replace both control arms.

If the left side is failed, replace both control arms.

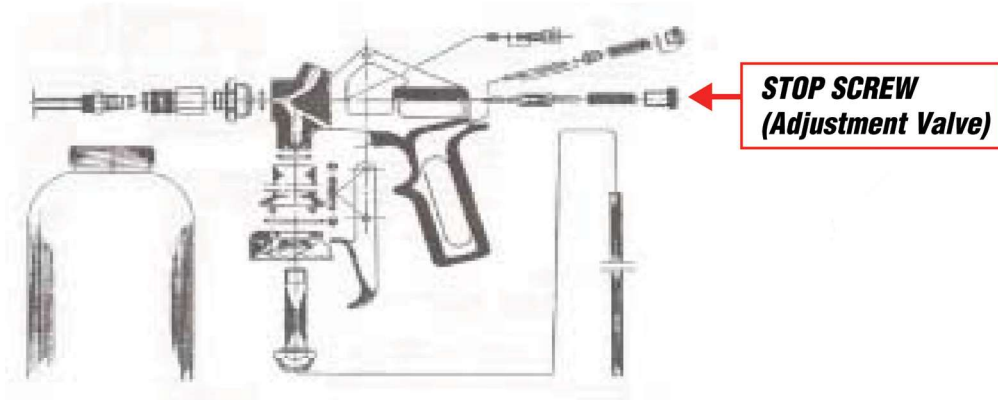
The pressure pot is equipped with a valve to adjust the ratio of product to air. This valve will have to be adjusted in order to achieve to optimal spray pattern for each material. The valve is described as the Stop Screw in the diagram below.

Before filling the gun with **Nox-Rust®** material, turn the stop screw clockwise until all the way closed. Use a marker pen or paint and make a mark at the 12:00 position. This line will be used to determine the number of turns needed for optimal spray of the waxes.

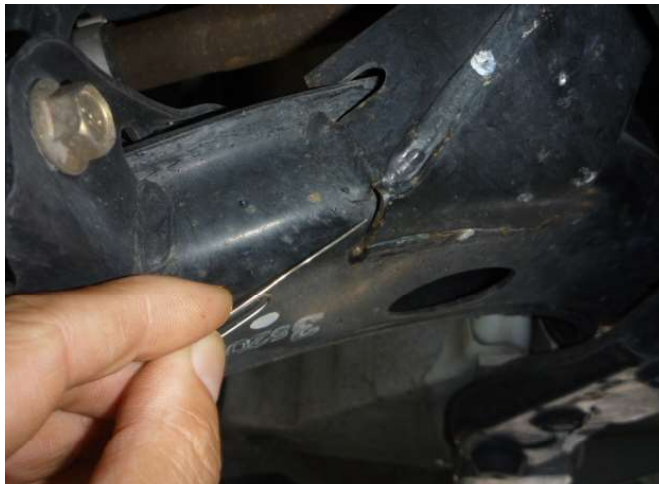
Insert a paper clip into the hanger bracket water drain hole and remove any rust particles and/or mud if clogged.

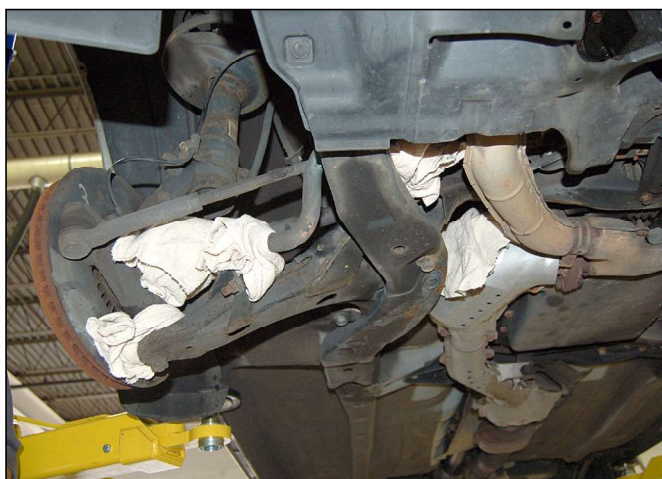
Wrap rags around stabilizer link, exhaust pipe, front control bushings, ball joint, steering gear box boot and axle shaft boots. Do the same on the opposite side.

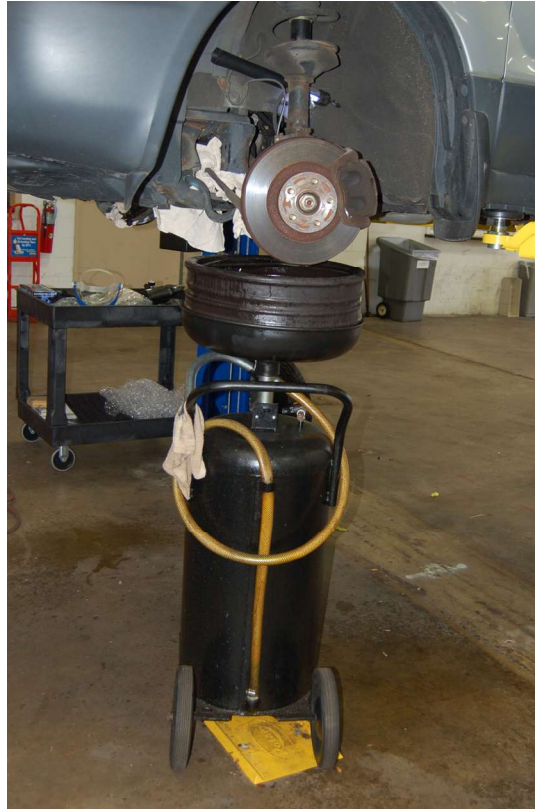
Position a suitable container under the control arm to catch any oil and wax during the application.

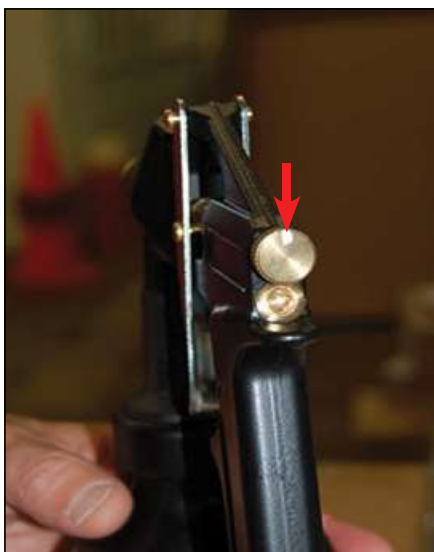
Close the spray gun stop screw to the fully closed position. Use a marker pen or paint and make a mark at the 12:00 position. Turn the stop screw counter clockwise one full turn.

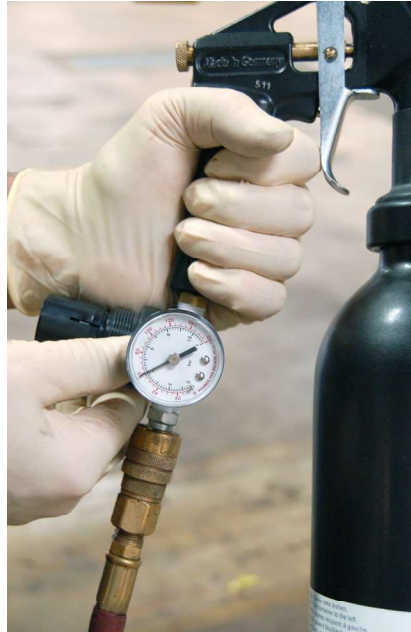
Attach air line to spray gun and adjust air pressure regulator to 60 PSI.

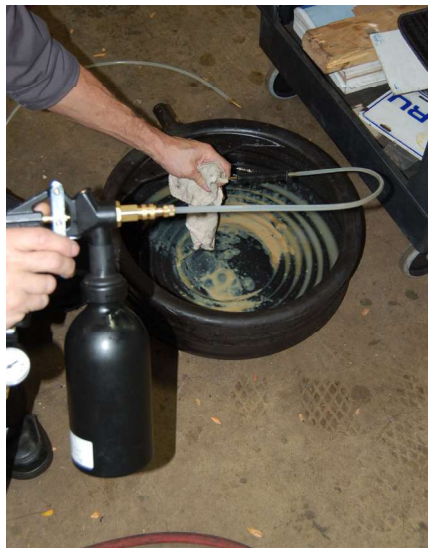
Test spray gun for proper operation. A rag and container should be used.

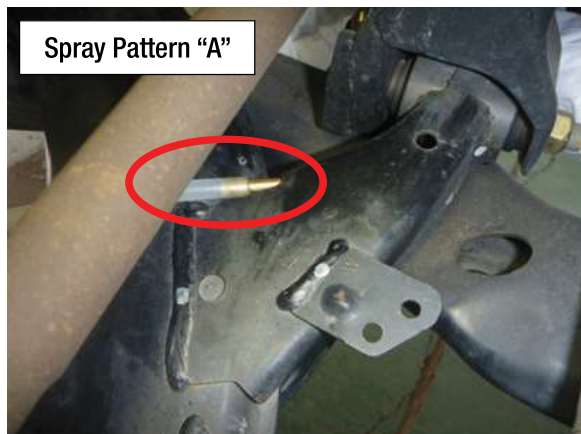
Spray Pattern “A”

- A) Insert the spray nozzle through the upper hole of the hanger bracket (insertion length: 75mm) until it contacts the front surface of the hanger bracket wall.

Pull the trigger of spray gun while holding the wand in position to confirm that oil leaks out of an opening in the hanger bracket. Pull out wand with a constant gradual speed while spraying for at least 4 seconds.

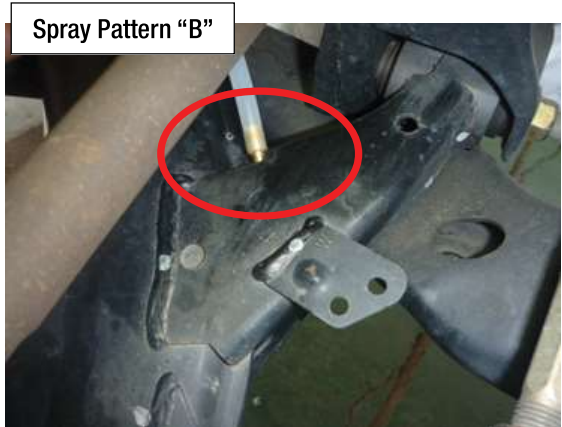
Spray Pattern "B"

- B) Insert the spray nozzle with its tip facing down through the upper hole of hanger bracket (insertion length: 65mm) until it contacts the bottom surface of hanger bracket wall. Pull the trigger of spray gun while holding the wand in position to confirm that oil leaks out of an opening in the hanger bracket. Pull out wand with a constant gradual speed while spraying for at least 2 seconds.

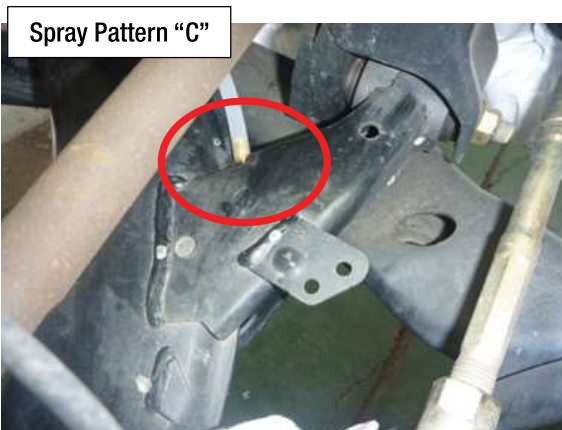
Spray Pattern "C"

- C) Insert the spray nozzle with its tip facing up through the upper hole of hanger bracket (insertion length: 72mm) until it contacts the top surface of hanger bracket wall. Pull the trigger of spray gun while holding the wand in position to confirm that oil leaks out of an opening in the hanger bracket. Pull out wand with a constant gradual speed while spraying for at least 2 seconds. Perform same procedure on opposite side of vehicle.

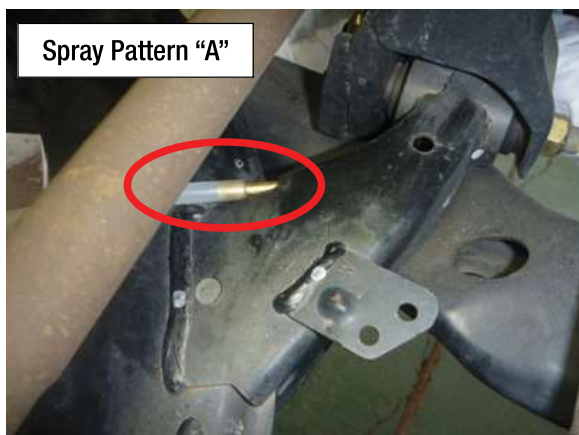
Spray Pattern "A"

- A) Insert the spray nozzle through the upper hole of the hanger bracket (insertion length: 75mm) until it contacts the front surface of hanger bracket wall.

Pull the trigger of spray gun while holding the wand in position to confirm that wax leaks out of an opening in the hanger bracket. Pull out wand with a constant gradual speed while spraying for at least 2 seconds.

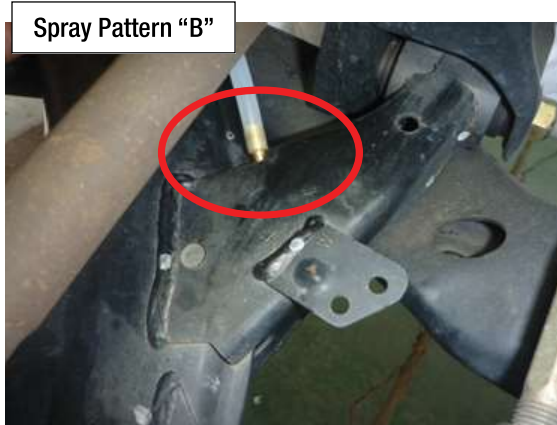
Spray Pattern "B"

- B) Insert the spray nozzle with its tip facing down through the upper hole of hanger bracket (insertion length: 65mm) until it contacts the bottom surface of hanger bracket wall. Pull the trigger of spray gun while holding the wand in position to confirm that wax leaks out of an opening in the hanger bracket. Pull out wand with a constant gradual speed while spraying for 1 second.

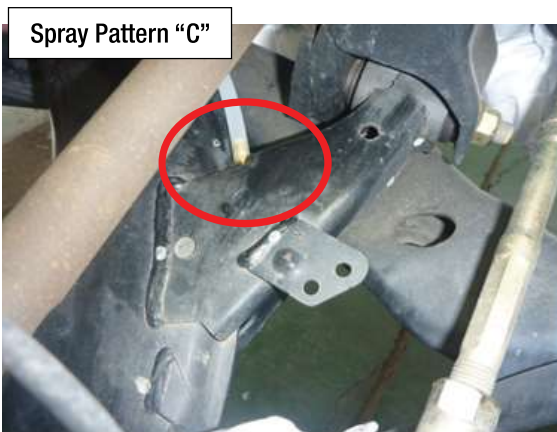
Spray Pattern "C"

- C) Insert the spray nozzle with its tip facing up through the upper hole of hanger bracket (insertion length: 72mm) until it contacts the top surface of hanger bracket wall. Pull the trigger of spray gun while holding the wand in position for 2 seconds; confirm that wax leaks out of an opening in the hanger bracket. Pull out wand with a constant gradual speed while spraying for at least 1 second. Perform same procedure on opposite side of vehicle.

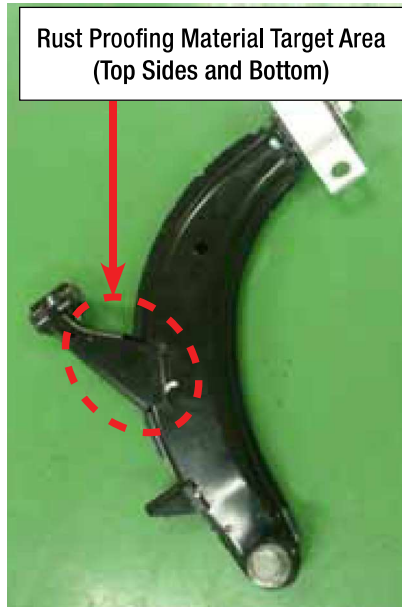
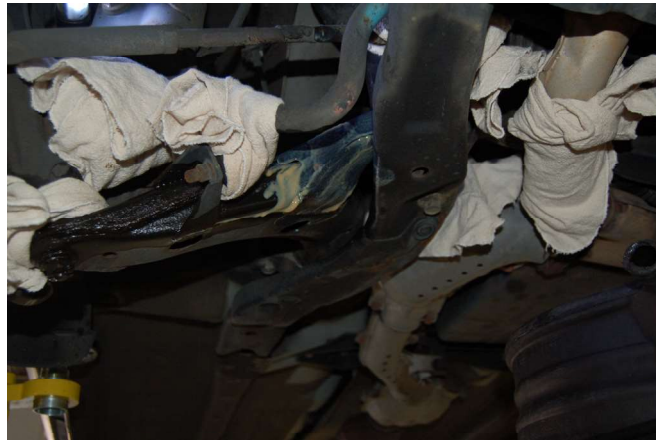
Spray anti-rust wax to the surface of the hanger bracket only, top, sides and bottom.

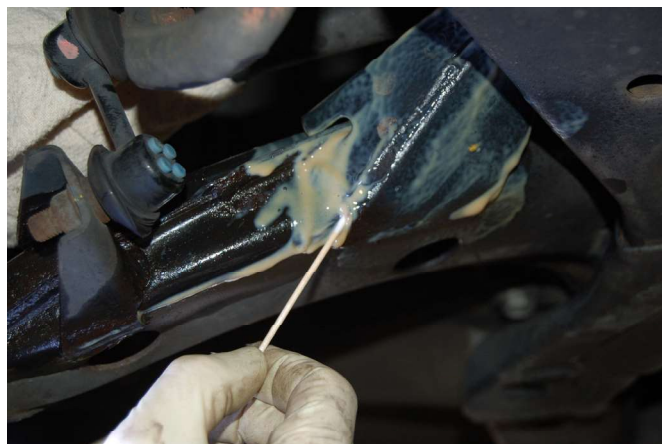
IMPORTANT: Remove rust-proofing wax from drain hole of hanger bracket using a cotton swab. Perform continuously until it can be confirmed that the hole is not clogged.

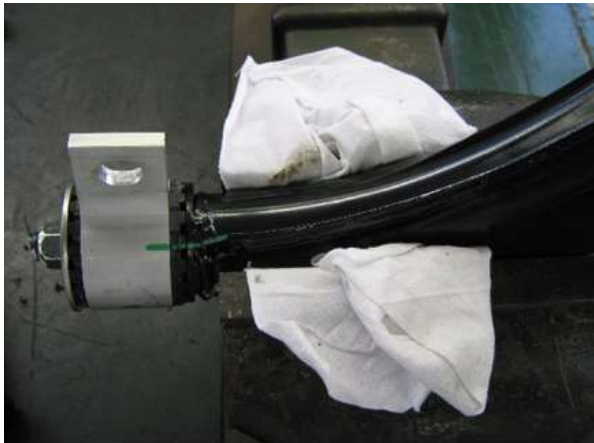
- Refer to “Front Transverse Link” of Subaru Service Manual for removal and reinstallation of rear bushing.
- Install rear bushing and front arm in the same angle as the original state before replacement.

Put a mark on rear bushing, at which it is aligned with front arm flange. When rear bushing is reinstalled to a new front arm, align the rear bushing mark with the front arm flange.

Be careful of installing order and direction.
