**REPAIRING FRAME CRACKS IN AXLE LOCATION**

## AXLE RETRO PROCEDURE

### FRAME FIX INSTRUCTIONS

| DWG. NO. | 218220FIX JT 340 FLR; TT | REV. <b>AD</b> |

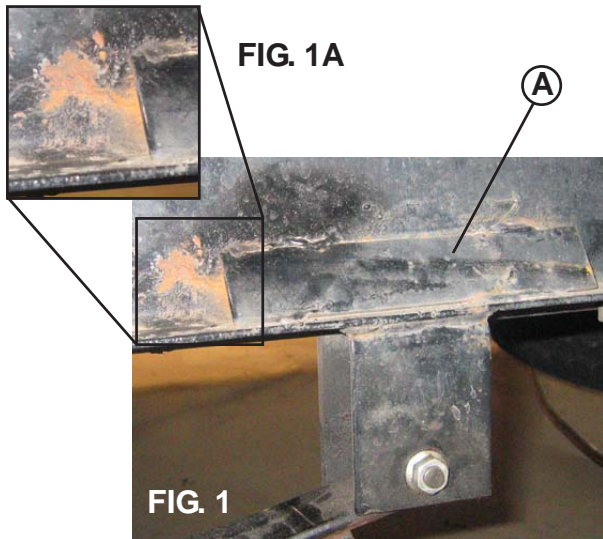
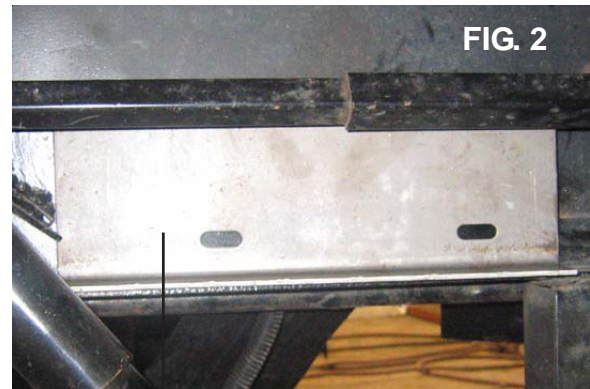
P/N - 106124

1. REMOVE WHEEL IN FRONT OF CRACKED FRAME AREA.
2. PULL UNDER BELLY TO INSPECT BACKSIDE OF FRAME RAIL AND FRAME CRACK AREA. BE SURE AREA IS CLEAR OF INSULATION, OBSTRUCTIONS OR FIRE HAZARDS.
3. REMOVE REINFORCEMENT PLATE, SEE FIG.1 (A).
4. INSPECT CRACK, FIG. 1A AND CHECK FOR LENGTH OF CRACK.
5. GRIND CRACK TO CLEAN AREA FOR BETTER WELD PENETRATION.
6. REPAIR CRACK BY ADDING A WELD TO BOTH SIDES OF THE FRAME RAIL.
7. WELD NEW REINFORCEMENT PLATE ON, SEE FIG. 2. WELD COMPLETELY AROUND THE ENTIRE PERIMETER OF THE PLATE.
8. PAINT NEW PLATE AND WELD AREA.
9. RE-INSTALL WHEEL.
10. PERFORM AXLE RETRO (AS NEEDED). SEE PAGE 2.

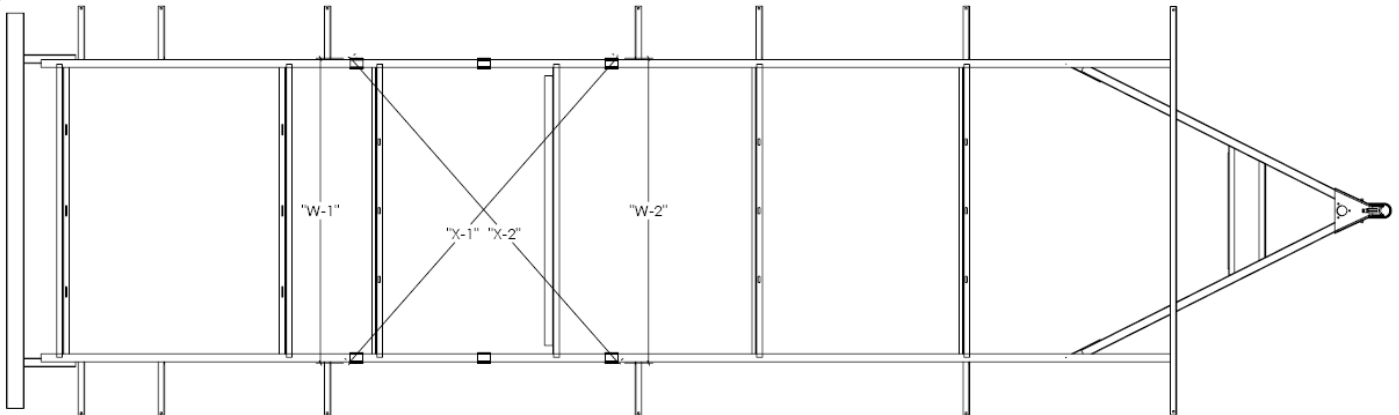
Fig. 1

1. UNIT MUST PULLED INTO WORK SPACE STRAIGHT AND EVEN.
2. WHEN MEASURING AXLE HANGER, MEASURE WHERE HANGER MEETS I-BEAM, SEE FIG. 3a & 3b.  
**NOTE - BE SURE TO MEASURE AS HIGH ON THE HANGER AS POSSIBLE IF OTHER COMPONENTS INTERFERE WITH MEASUREMENT POINT ON THE HANGER.**
3. ON MEASUREMENTS W1 & W2, BE SURE TO MEASURE TOP OF HANGER.
4. WHEN MEASURING X1 AND X2, BE SURE TO MEASURE FROM THE TOP OF THE HANGER ON BOTH ENDS.
5. MEASURE Y1 AND Y2 (Y3 ON TRIPLE AXLES) ON CENTER OF BOLT.
6. MEASURE Y4 (OUTSIDE OF FRONT HANGER TO OUTSIDE OF REAR HANGER). FIG. 2.

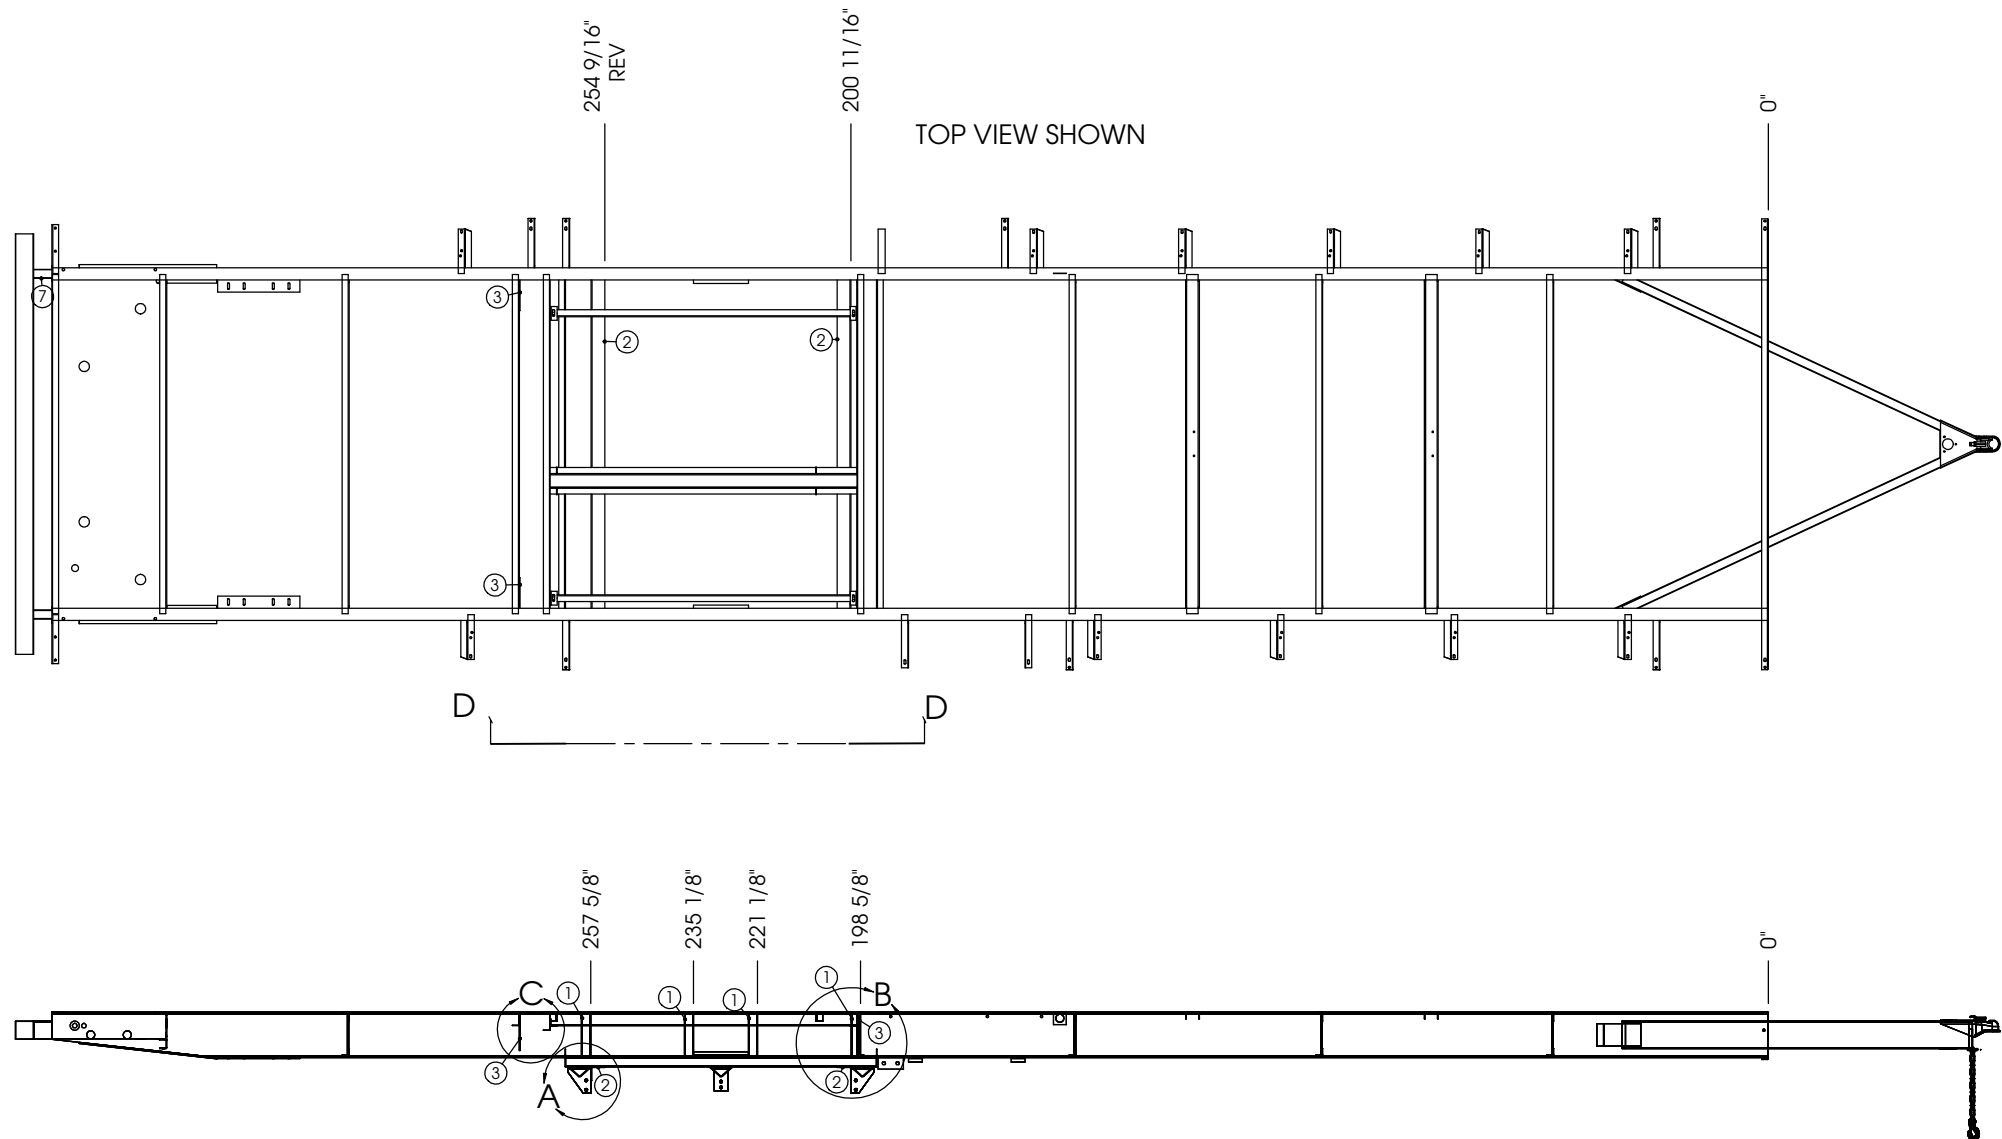
- 1) JACK UP REAR OF COACH SO CAMBER IS NOT LOST DURING REPAIRS
- 2) CHECK HANGERS FOR SQUARE, IF FRAME IS DAMAGED RESQUARE
- 3) ADD ANGLES FROM HANGER TO HANGER
- 4) ADD TRIANGLE GUSSETS TO CROSSMEMBERS
- 5) ADD TUBES TO OUTSIDE OF MAIN RAILS
- 6) CHECK FOR COLLAPSED OUTRIGGERS IN THE AXLE AREA AND REPAIR AS NEEDED
- 7) SPRAY PAINT ALL COMPONENTS BLACK

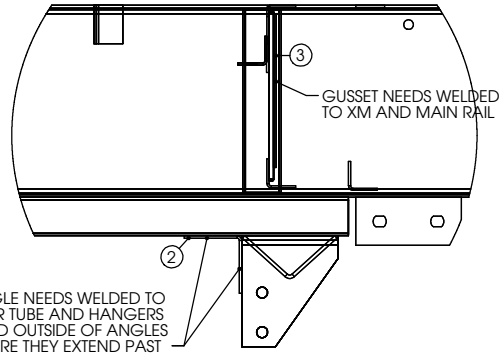
DETAIL B  
SCALE 1 : 10

ANGLE NEEDS WELDED TO RISER TUBE AND HANGERS WELD OUTSIDE OF ANGLES WHERE THEY EXTEND PAST
