Safety Recall

Code: 23J9

**Subject: 2009-2012 Model Year Jetta, Jetta Sportwagen (U.S.)/
Golf Wagon (CAN)
2010-2012 Model Year Golf
Diesel Fuel Injection Lines**

October 4 2011

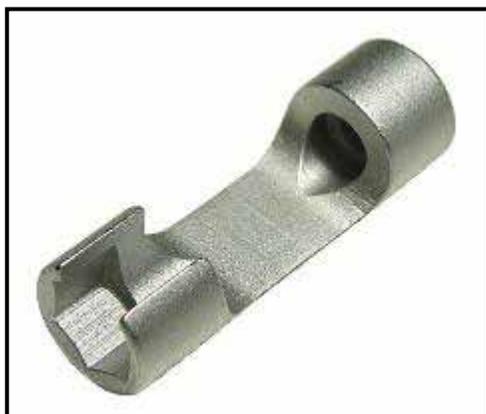
- T40055 – Socket (or equivalent)

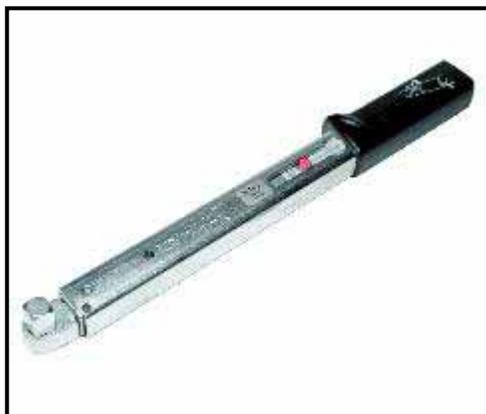
- VAG 1331 – Torque Wrench 5-50Nm (or equivalent)

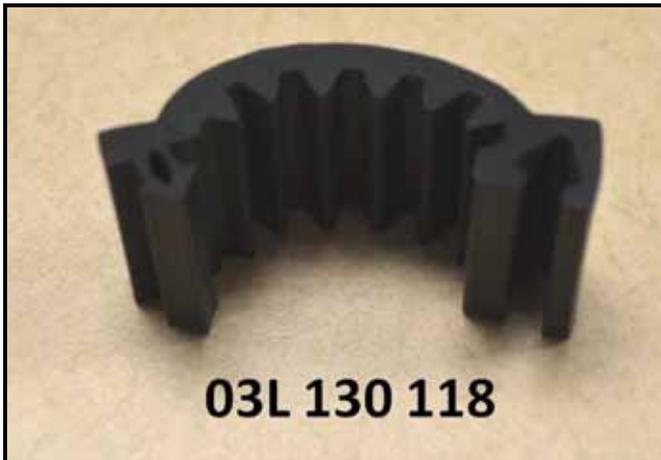
- 03L 130 118 – Fuel Line Dampener

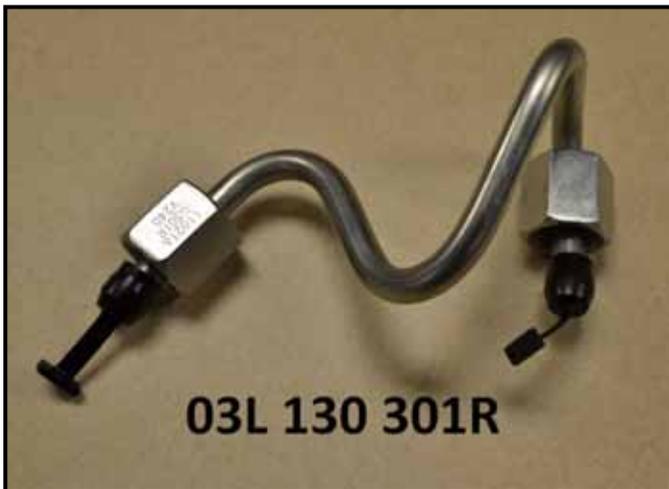
- 03L 130 301R - #2 Fuel Line (for Criteria 01 vehicles ONLY)

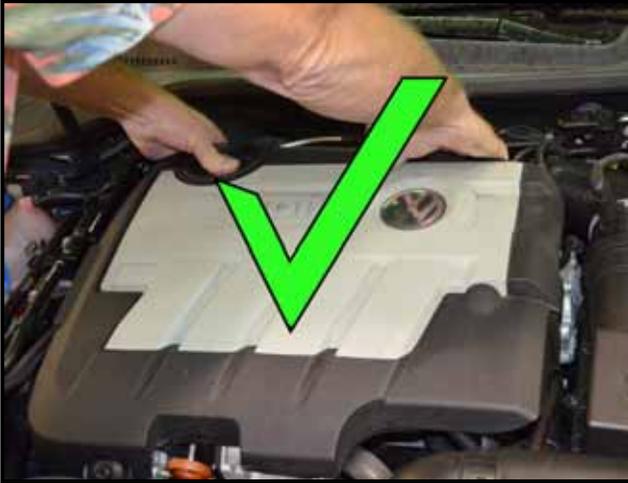
- Turn key off and remove key from ignition
 - Open hood
- ← Remove engine cover from the rear <as shown> by steadily and gently pulling up at each mounting point

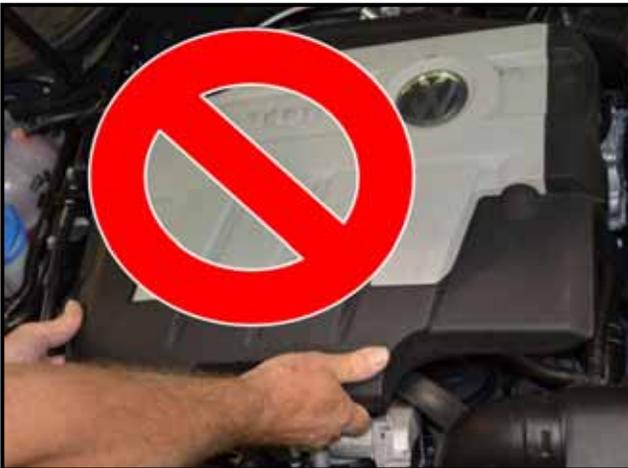
DO NOT remove engine cover by pulling from the front <as shown> as this will result in damage to engine cover that is not covered under this action

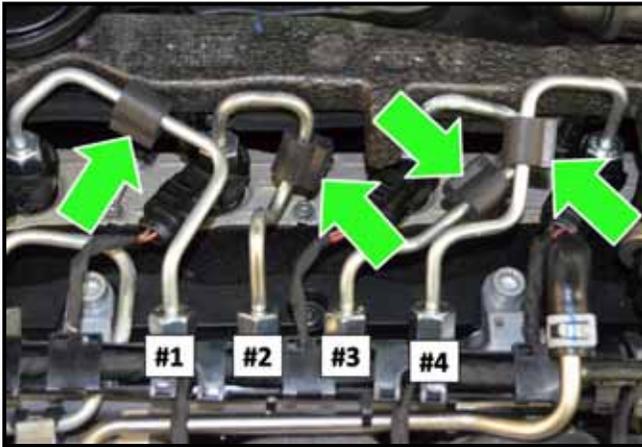
- If Dampeners <arrows> are already installed, WORK COMPLETE
- If Dampeners <arrows> are not installed, continue work procedure

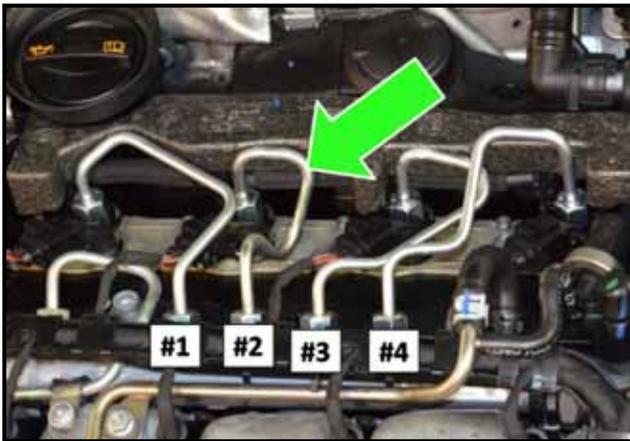
• Take the new #2 fuel injector line (03L 130 301R) out of the packaging and remove the plugs from each end

⇐ Install the #2 line between the rail and injector immediately <arrow>

• Hand-tighten the union nuts for the #2 fuel injector line without using any tools and ensure the line is seated correctly and without tension

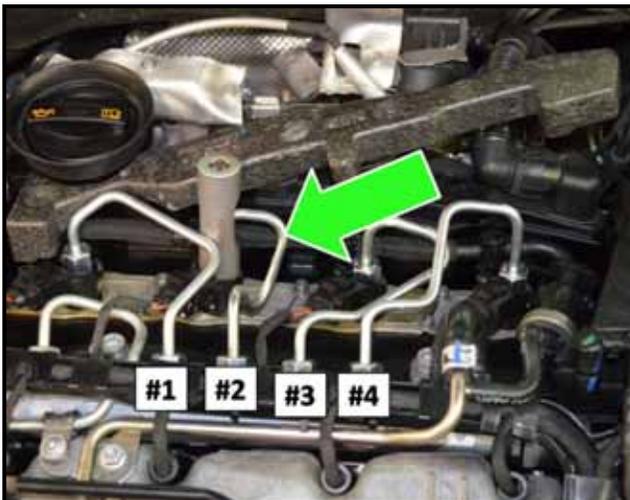
⇐ Gently lift the foam strip and tighten the union nuts for the #2 fuel line <arrow> to 28Nm using torque wrench <VAG 1331> equipped with socket <T40055> or equivalent

• Gently push foam strip back into position

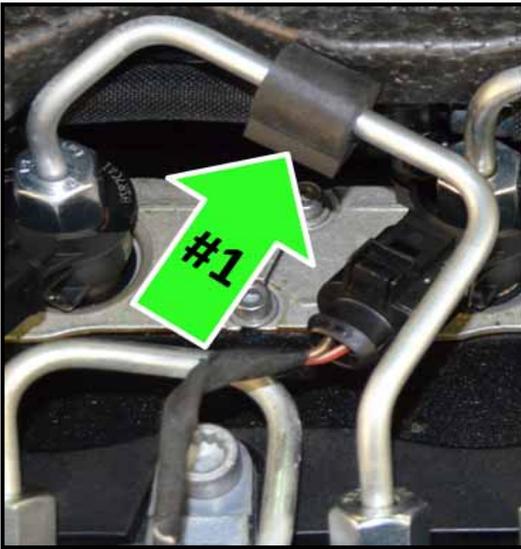
⇐ Install fuel line Dampener (03L 130 118) in the center of #1 fuel line as shown <arrow>

It is critical that the dampener is placed in the center of fuel line in the area as shown <arrow>

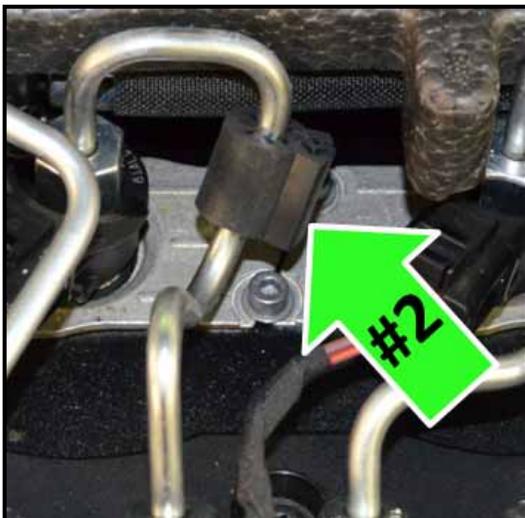
⇐ Install fuel line dampener (03L 130 118) in the center of #2 fuel line as shown <arrow>

It is critical that the dampener is placed in the center of fuel line in the area as shown <arrow>

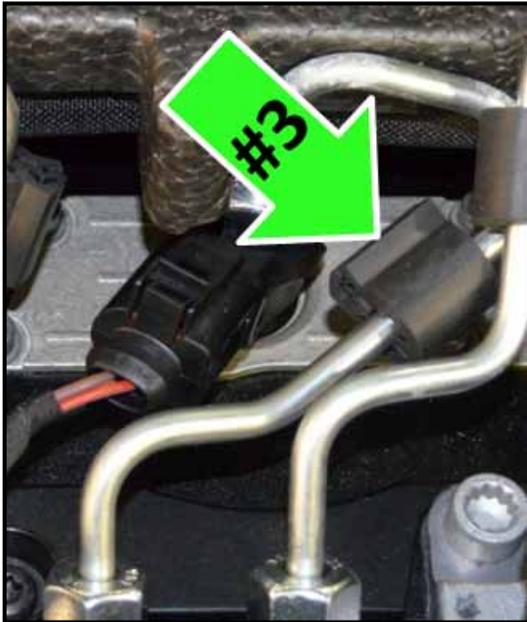
⇐ Install fuel line dampener (03L 130 118) in the center of #3 fuel line as shown <arrow>

It is critical that the dampener is placed in the center of fuel line in the area as shown <arrow>

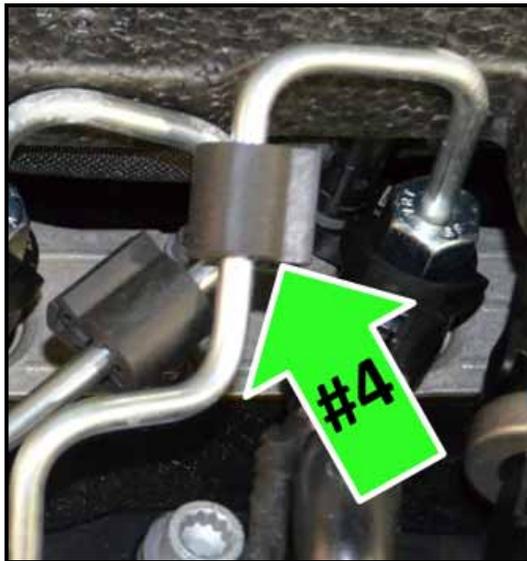
⇐ Install fuel line dampener (03L 130 118) in the center of #4 fuel line as shown <arrow>

It is critical that the dampener is placed in the center of fuel line in the area as shown <arrow>

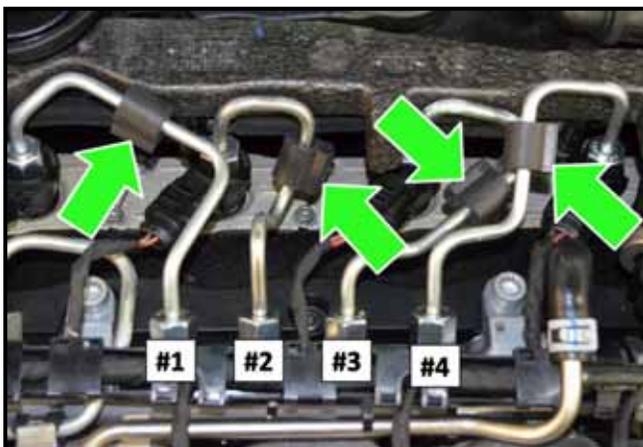
Picture on left shows overview of each dampener located properly. Ensure dampeners are located properly as shown <arrows>
