RECALL CAMPAIGN BULLETIN

NTB11-104

VOLUNTARY SAFETY RECALL CAMPAIGN 2011 ROGUE EPS CONTROL UNIT INSPECTION

CAMPAIGN ID #: R1113
NHTSA #: 11V-565
APPLIED VEHICLES: 2011 Rogue (S35)

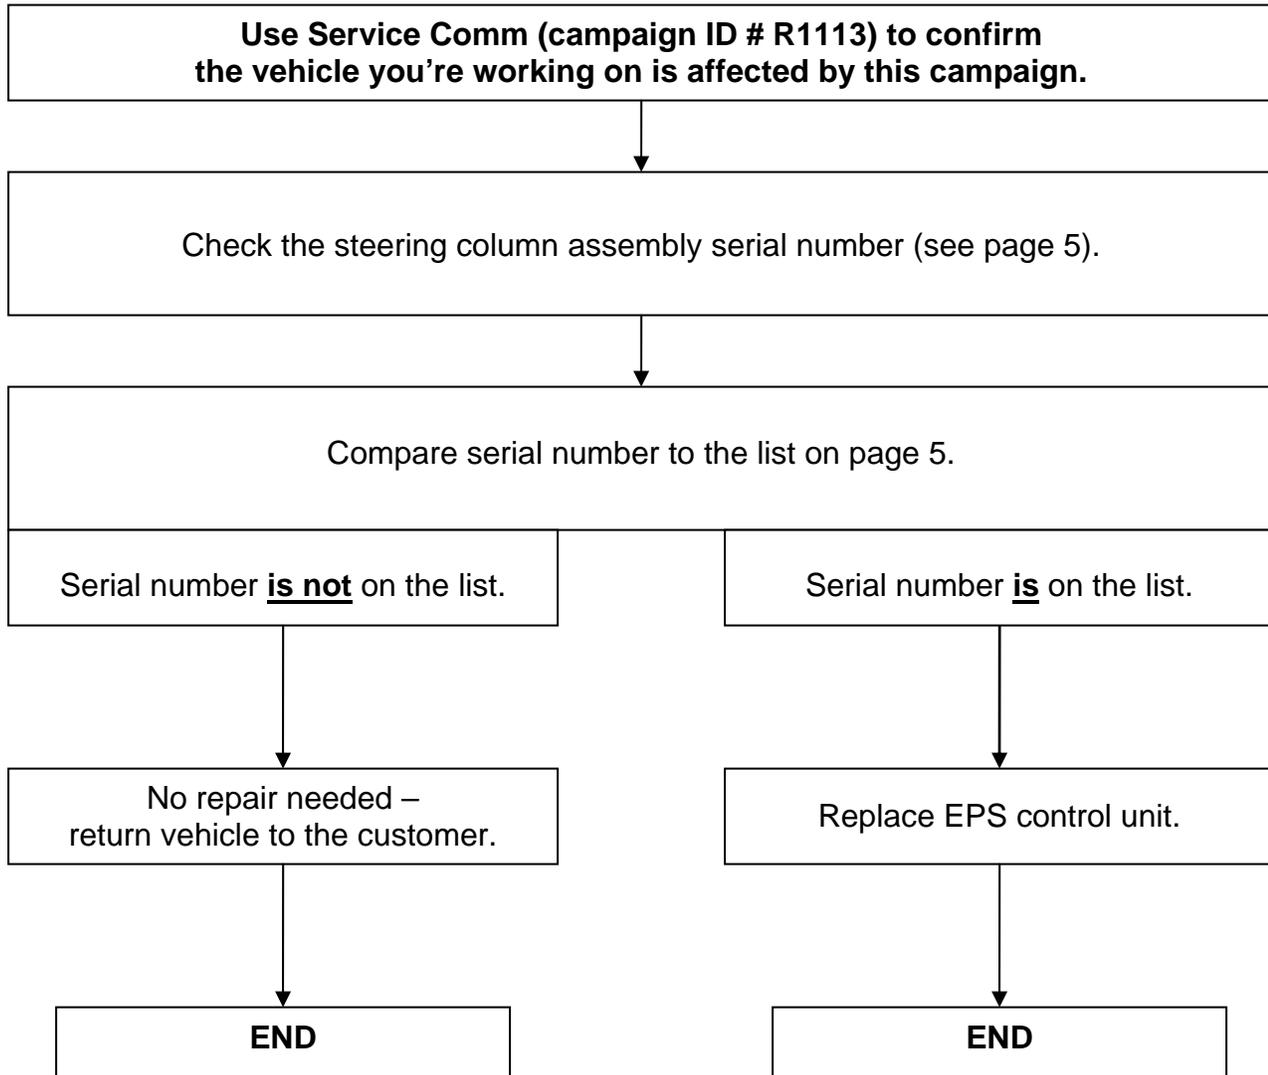
REPAIR OVERVIEW

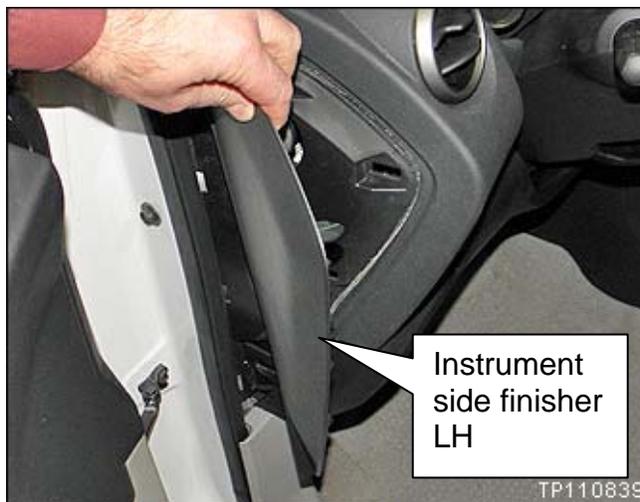
Figure 1

1. Remove the instrument side finisher LH.

- Use a plastic trim tool to snap loose and remove.

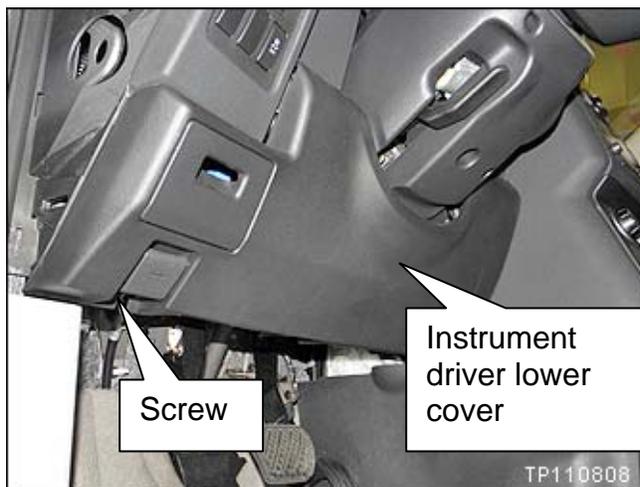
Figure 2

2. Remove the instrument driver lower cover.

- a. Remove the screw near the hood release handle.
- b. Use a plastic trim tool to snap loose the instrument driver lower cover.

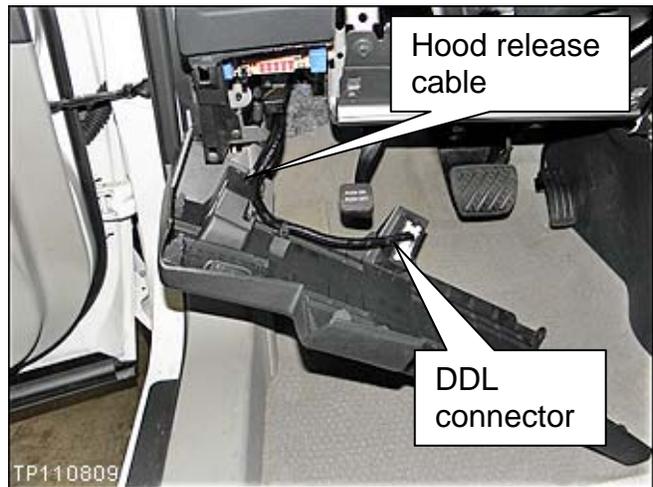
Figure 3

3. Disconnect the DDL connector and Harness from the instrument driver lower cover.
4. Disconnect the hood release cable from the instrument driver lower cover.

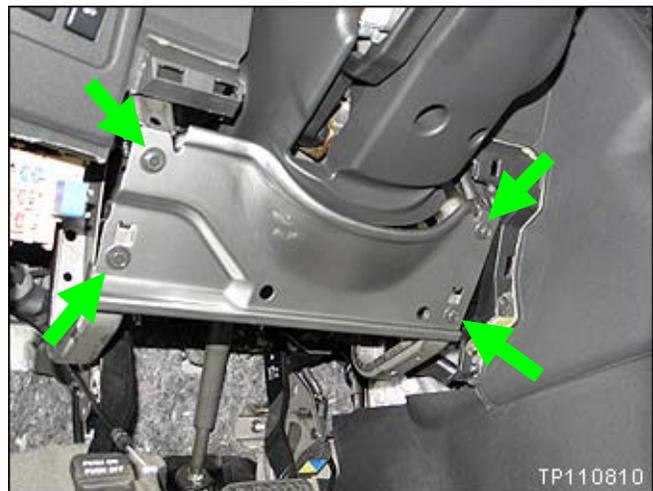
Figure 4

5. Remove the knee protector.
 - Knee protector is held on with 4 bolts.

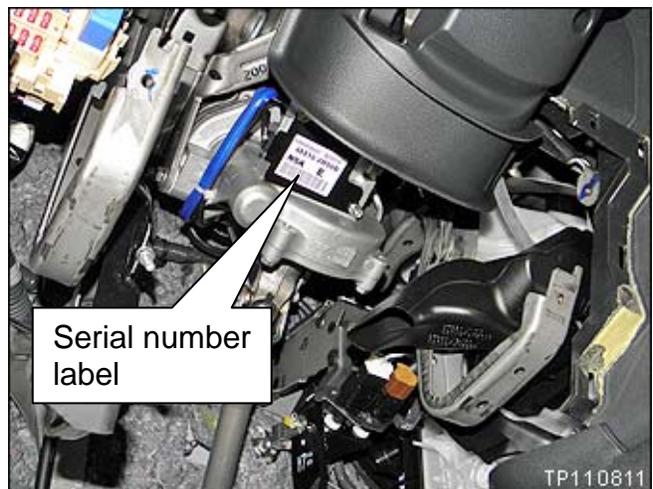
Figure 5

6. Look under the steering column and locate the serial number label shown in Figure 5.

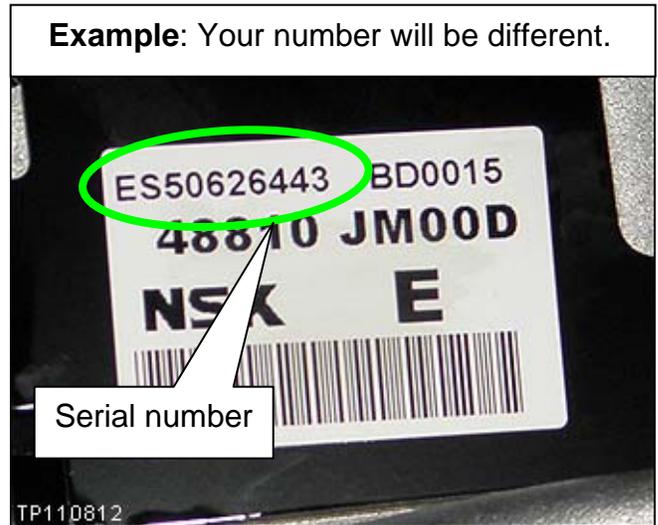
Figure 6

7. Compare the serial number of the vehicle you are working on to the list below.

If your serial number **is not** on the above list – no repair is needed:

If your serial number **is** on the above list – replace the EPS control unit:

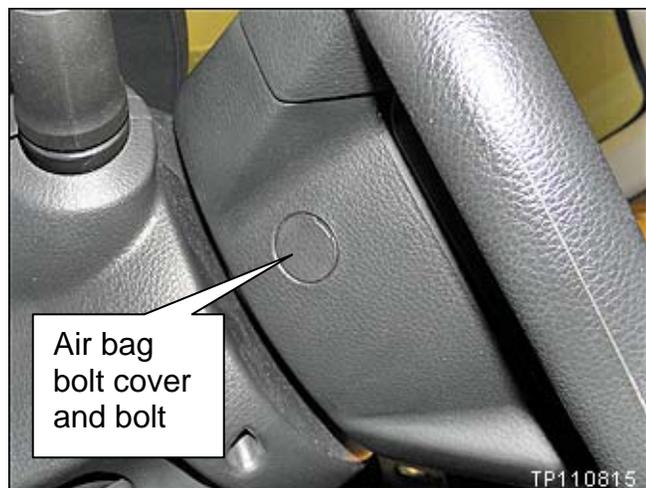
Figure 7

4. Remove the air bag module from the steering wheel.
 - Remove bolt covers and then remove the 2 mounting bolts.
 - Location of left side cover and bolt shown, remove right side also.
 - Do not reuse air bag mounting bolts – replace with new ones.

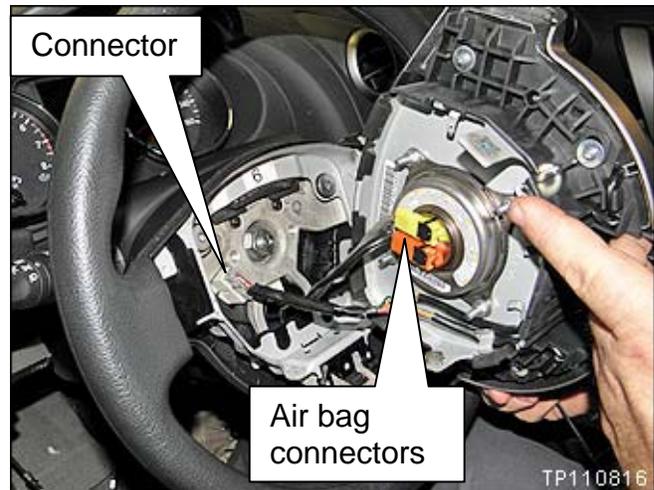
Figure 6

5. Disconnect the electrical connectors shown in Figure 6.

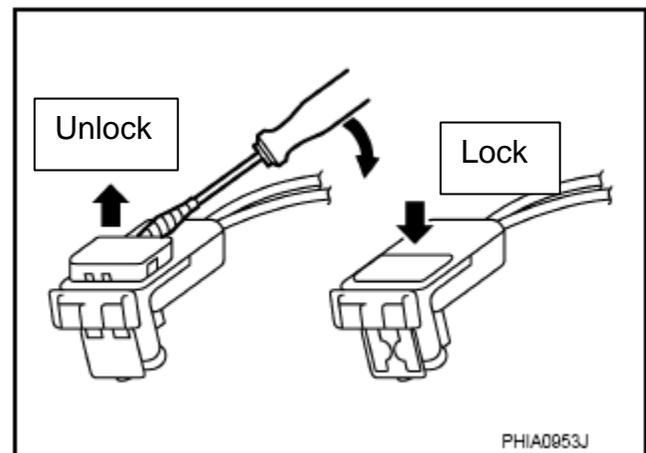
Figure 7

- Unlock and lock air bag connectors as shown in Figure 7.

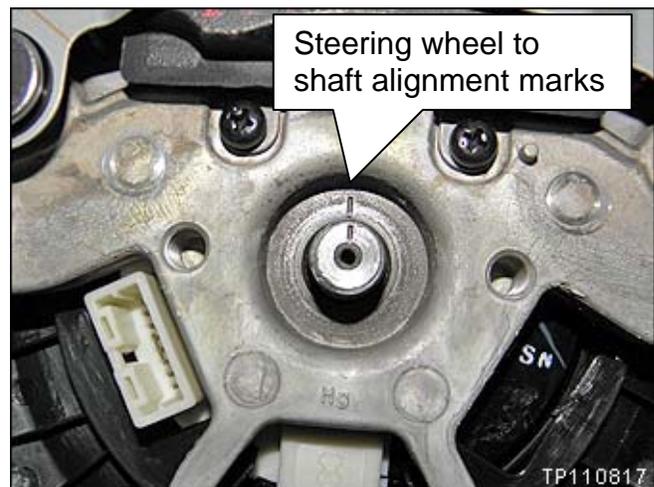
Figure 10

6. Remove the steering wheel mounting nut.
7. Make sure the steering wheel and steering shaft marks are aligned.
8. Remove the steering wheel.
 - Use a steering wheel puller.

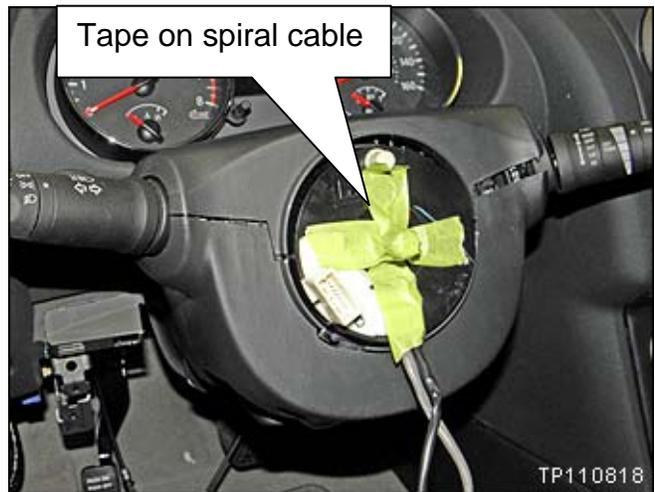
Figure 11

9. Apply tape to the spiral cable.

- Tape will prevent the spiral cable from moving (turning) while removing the steering column covers.

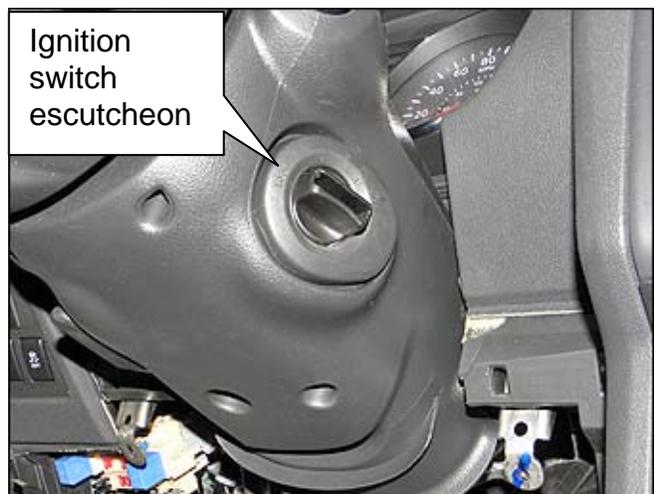
Figure 12

10. Remove / pull off the ignition switch escutcheon.

- Use a plastic trim tool.
- Equipped with Intelligent Key shown.
- Non Intelligent Key is slightly different.

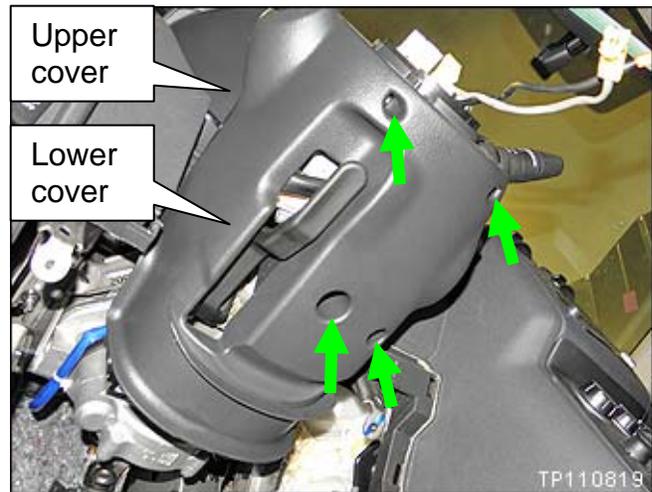
Figure 13

11. Remove 4 screws from the steering column lower cover.

12. Remove the steering column lower cover.

13. Remove the steering column upper cover.

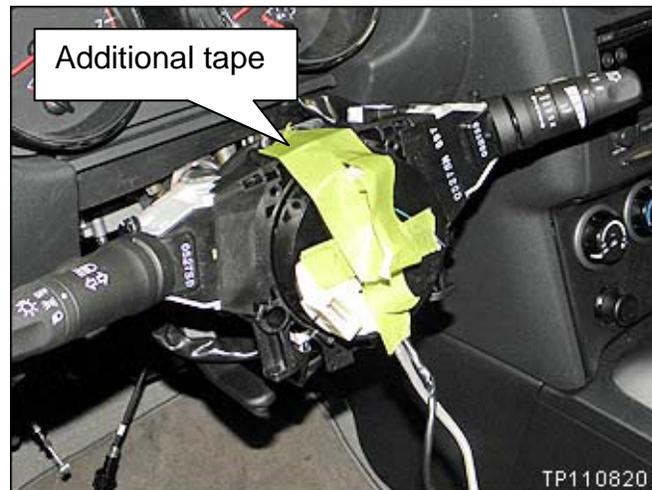
Figure 14

14. Apply additional tape across the top of the spiral cable.

- Additional tape will prevent the spiral cable from moving (turning) during the remainder of the procedure.

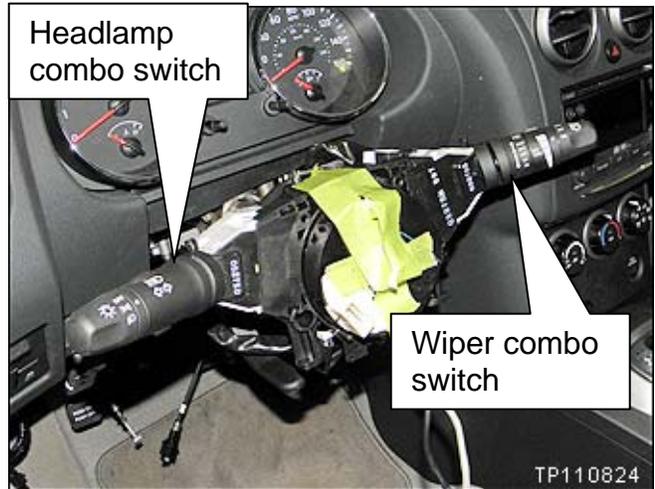
Figure 15

15. Remove the headlamp combination switch.

- Release lock tabs and pull out

16. Remove the wiper combination switch.

- Release lock tabs and pull out.
- Disconnect the electrical connector for the wiper combination switch.

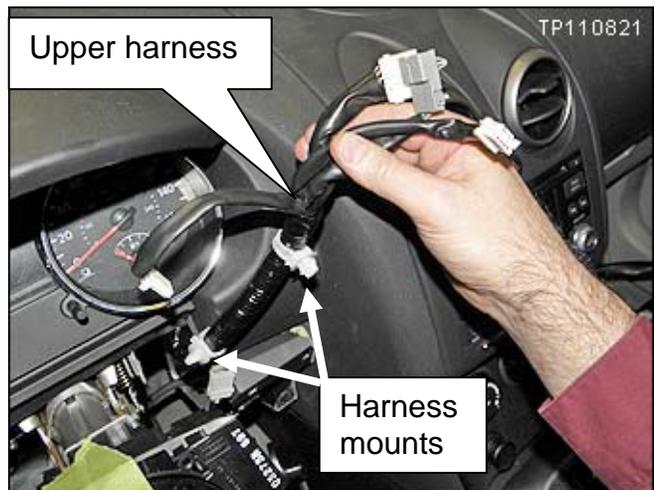
Figure 16

17. Disconnect the harness connectors and harness mounts for the upper column harness.

18. Position the upper harness out of the way.

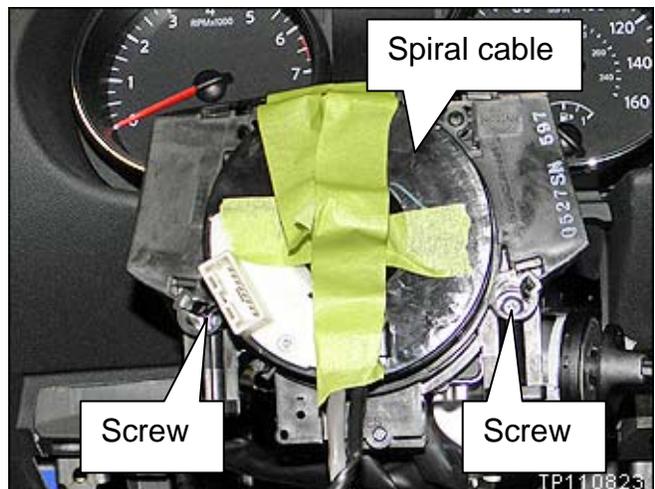
Figure 17

19. Remove the 2 spiral cable mounting screws.

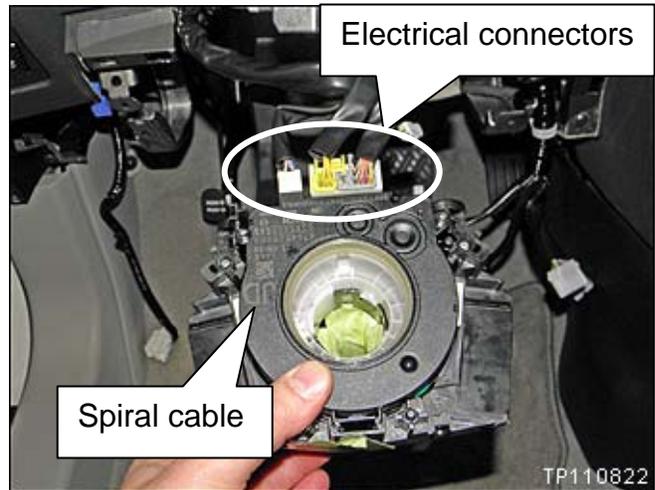
Figure 18

20 Remove the spiral cable and disconnect the 3 electrical connectors.

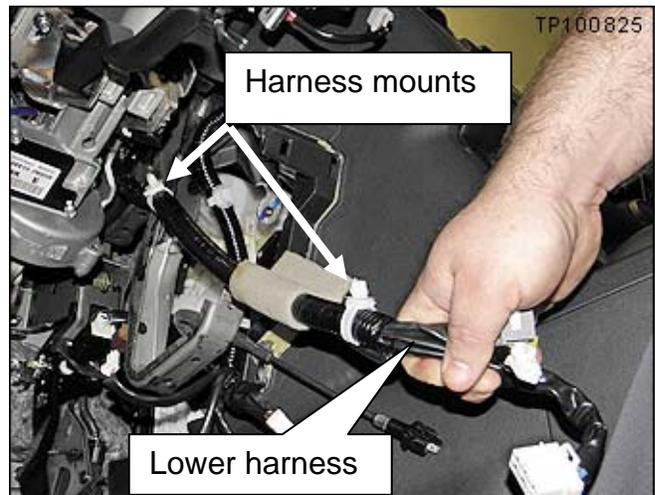
Figure 19

21. Disconnect the harness connectors and harness mounts for the lower column harness.

22. Position the lower harness out of the way.

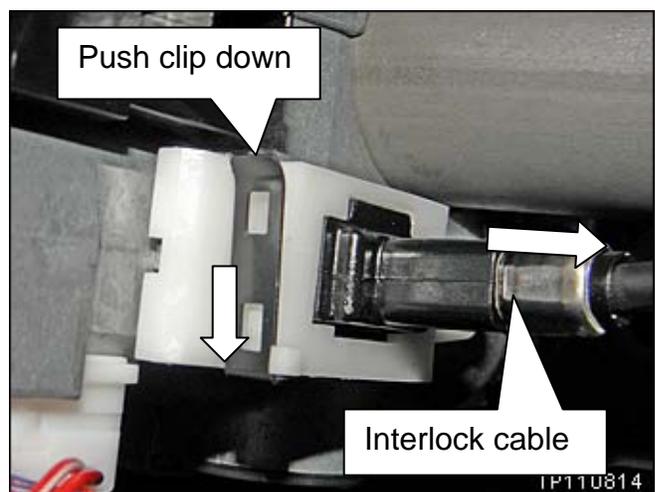
Figure 20

23. Disconnect the shift interlock cable from the ignition.

- a. Push down on the locking clip to remove it.
- b. Pull out on the interlock cable.

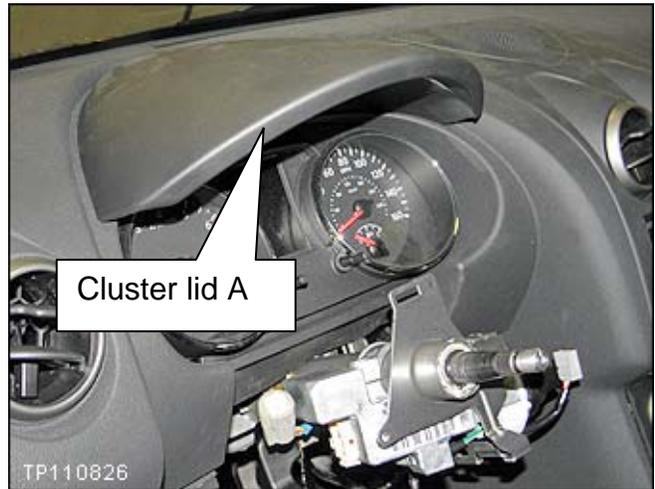
Figure 21

24. Snap loose and remove cluster lid A.

- Use a plastic trim tool as needed.

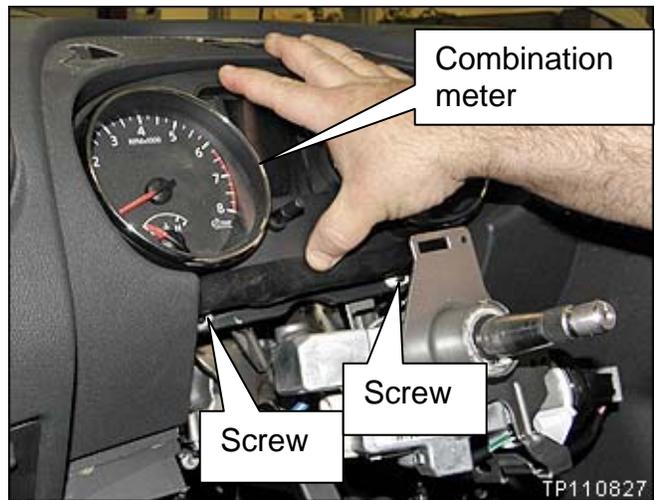
Figure 22

25. Remove the 2 combination meter mounting screws.

26. Remove the combination meter.

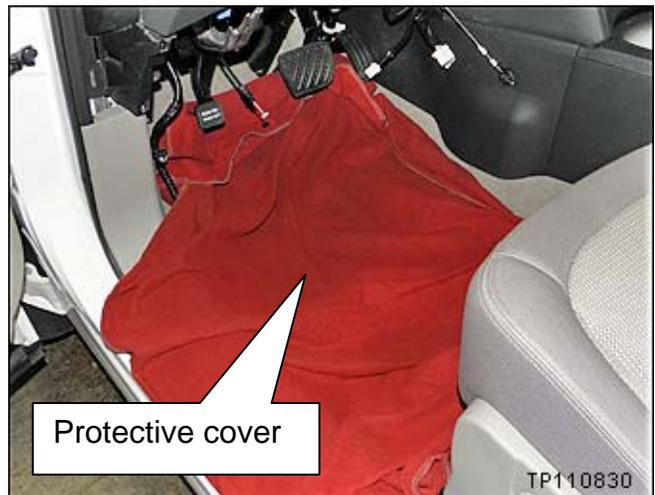
Figure 23

27. Place a protective cover on the driver side floor.

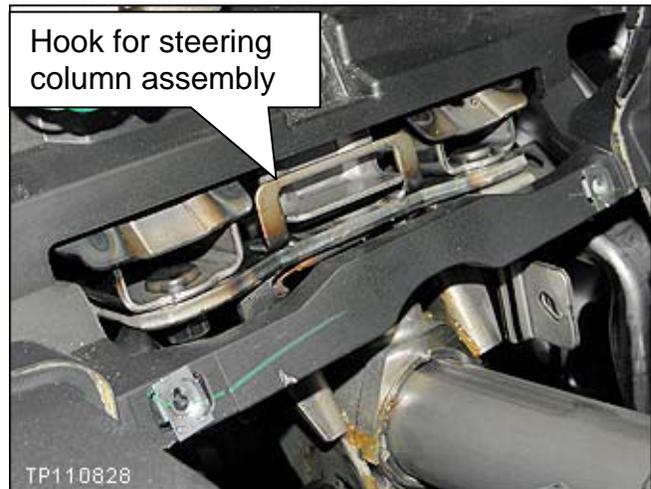
Figure 24

- When the mounting bolts are removed, the steering column assembly will be supported by the hook shown in Figure 24.
- The mounting bolts can be removed without concern for the column assembly falling.

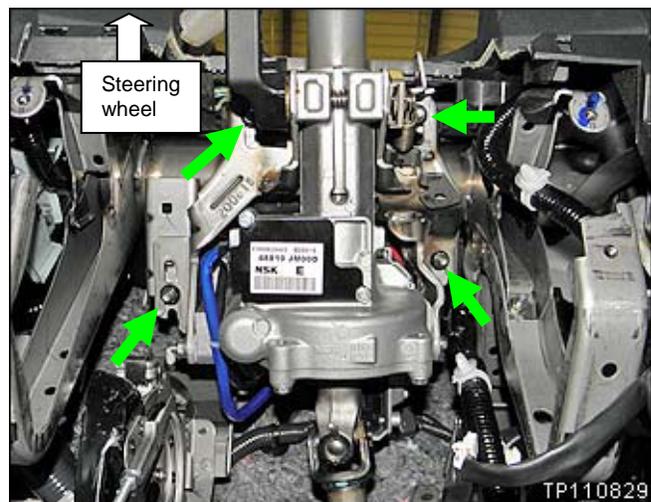
Figure 25

28. Remove the 4 steering column assembly mounting bolts shown in Figure 25.

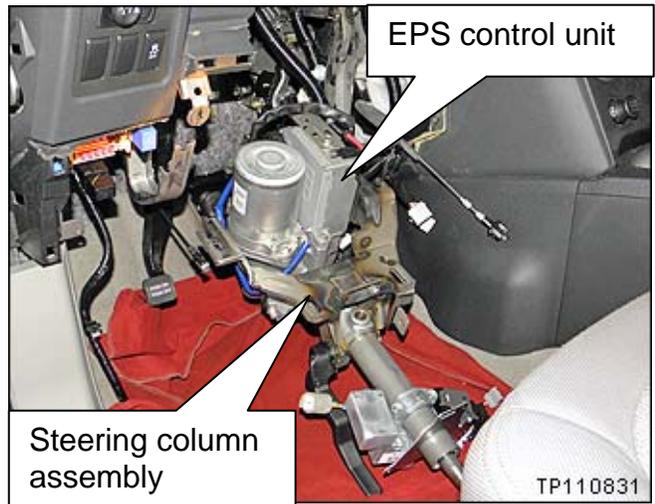
Figure 26

29. Carefully unhook the steering column assembly and set it on the floor.

- **CAUTION:** The assembly is heavy.
- Let the steering shaft rest on top of the brake pedal.

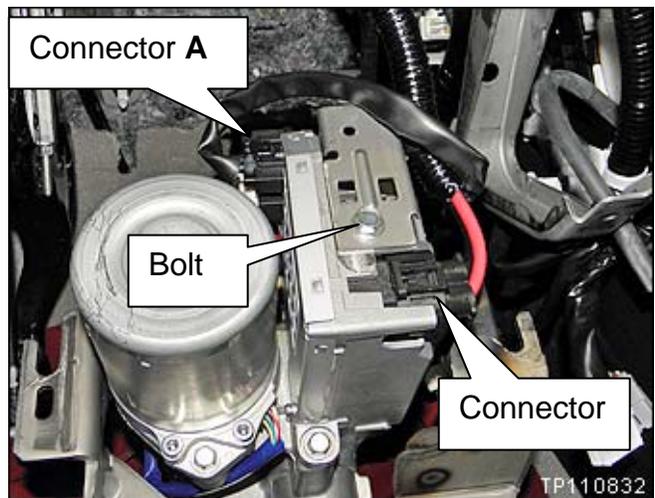
Figure 27

30. Disconnect the 2 electrical connectors shown in Figure 27.

31. Remove the bolt shown in Figure 27.

- Discard the bolt; use a new bolt for reassembly.

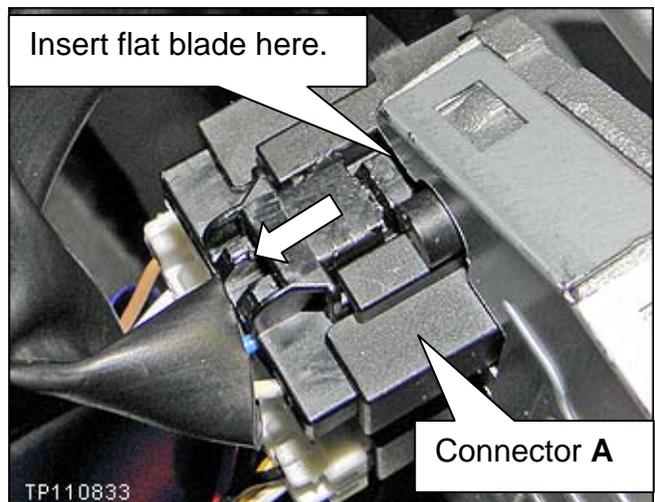
Figure 28

NOTE: To release connector A:

- Insert a small flat blade screwdriver between the connector and the metal body of the EPS control unit.
- Then push the connector away from the EPS control unit.

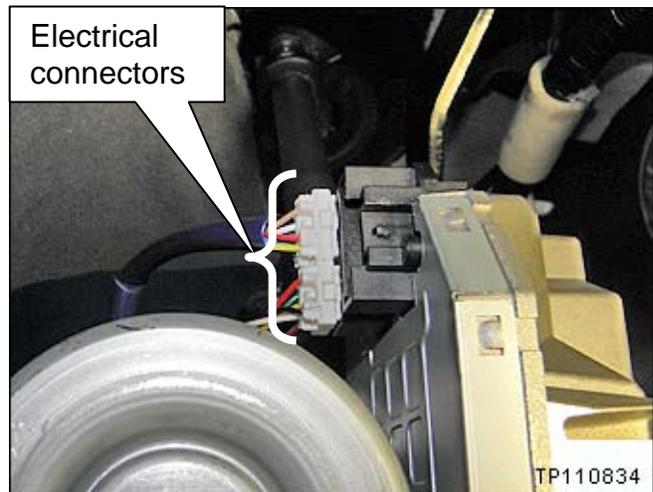
Figure 29

32. Disconnect the electrical connectors shown in Figure 29.

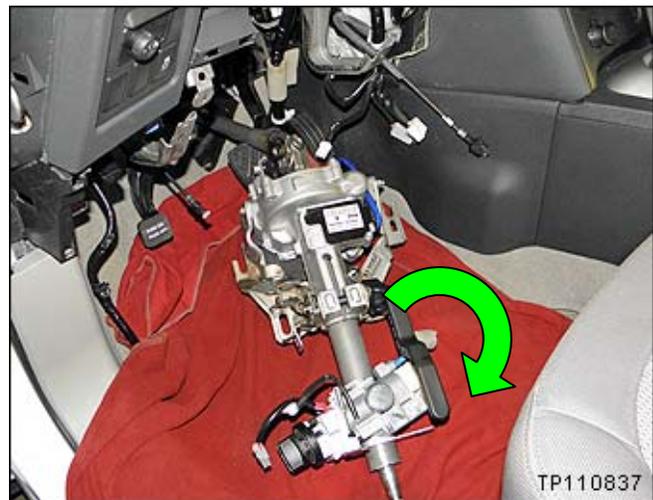
Figure 30

33. Carefully rotate the column assembly 180 degrees so it is upside down.

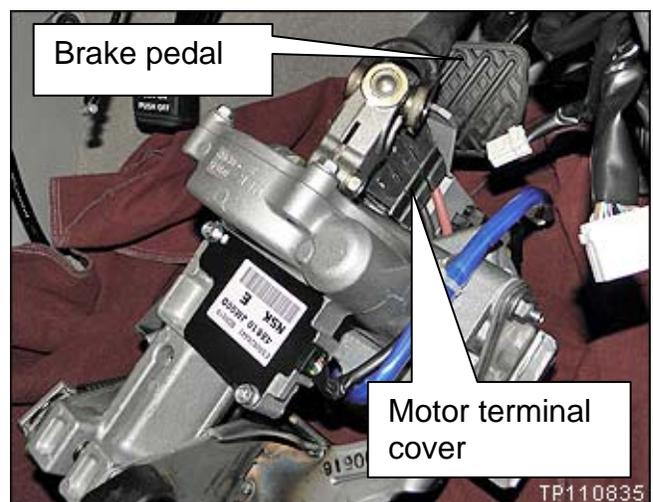
Figure 31

34. Locate and remove the plastic motor terminal cover shown in Figure 31.

- This covers 3 electrical terminals.
- The cover snaps loose.
- Discard the cover; use a new cover for reassembly.

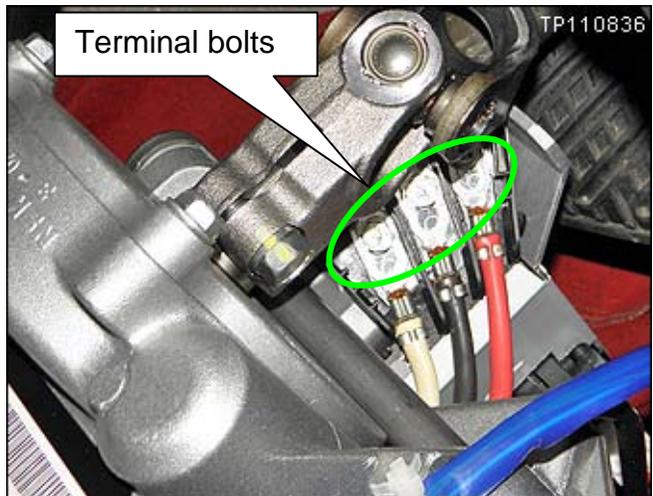
Figure 32

35. Remove the 3 motor terminal bolts.

- Discard the bolts; use new bolts for reassembly.

NOTE: These wires are stiff and will likely stay in position. During reassembly, make sure they have not moved.

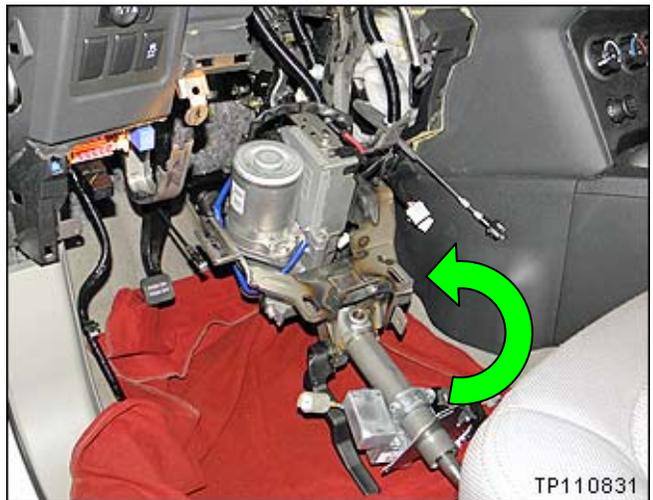
Figure 33

36. Carefully rotate the column assembly 180 degrees so it is right-side up (back to its original position).

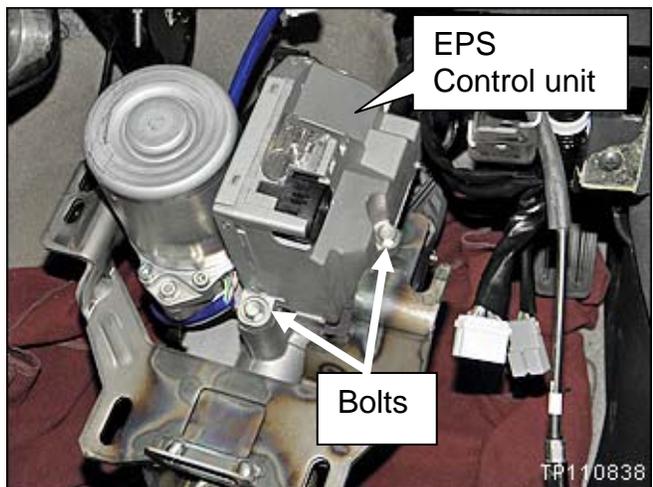
Figure 34

37. Remove the 2 EPS control unit mounting bolts.

- Discard the bolts; use new bolts for reassembly.

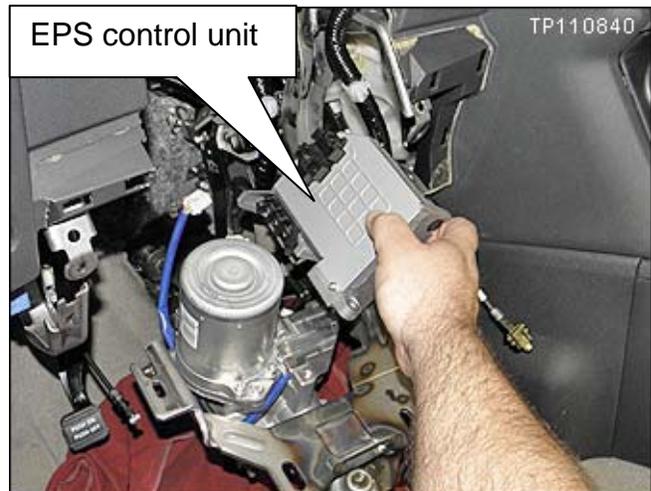
Figure 35

39. Install the **new** EPS control unit in reverse order.

- Use **new** mounting bolts. Torque to 14 N•m (1.4 kg-m, **10 ft-lb**)
- Use **new** terminal bolts. Torque to 3.6 N•m (0.37 kg-m, **32 in-lb**)
- Use a **new** plastic terminal cover.

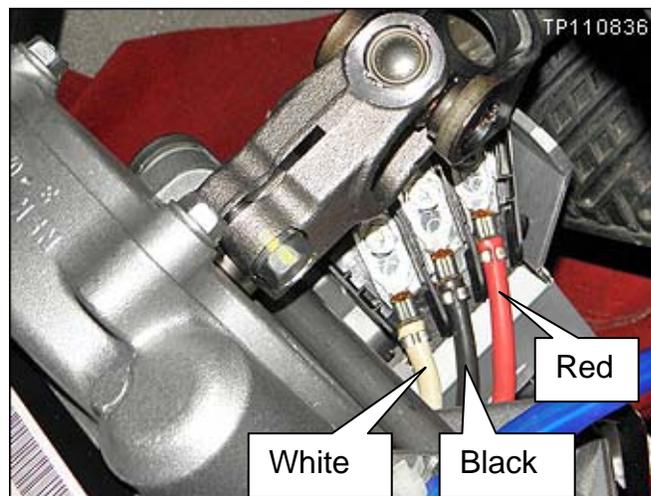
Figure 36

NOTE: Make sure motor terminal wires are installed in the correct locations.

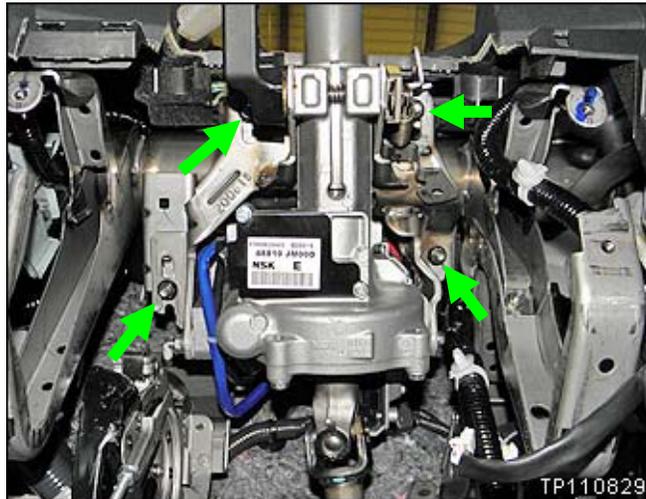
Figure 37

40. Reinstall all other parts in reverse order.

- Torque for assembly mounting nuts is 16.7 N•m (1.7 kg-m, **12 ft-lb**).

- When installing the steering wheel:
 - Make sure the spiral cable locating tab is correctly in place.

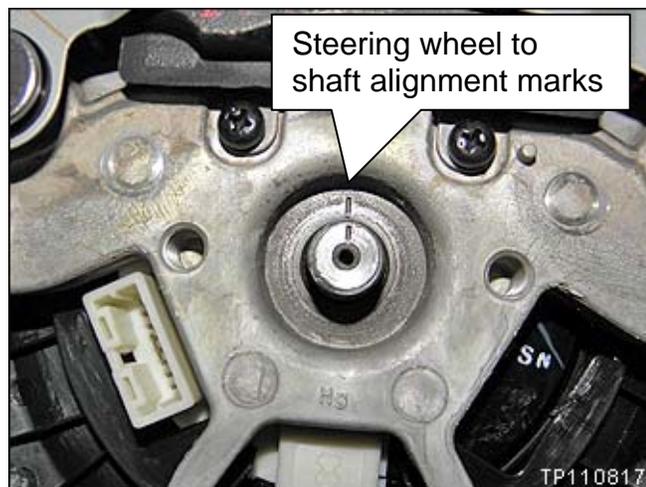
Figure 38

- Make sure the steering wheel and steering shaft marks are aligned.

- Torque for steering wheel mounting nut is 34.3 N•m (3.5 kg-m, **25 ft-lb**).
- Use **new** mounting bolts for the air bag on the steering wheel.
Torque to 9.3 N•m (0.95 kg-m, **82 in-lb**).
