Audi

Safety Recall

Code: 69I5

Subject: Model Year 2012 Audi A6
Sideguard® Head Curtain Airbag

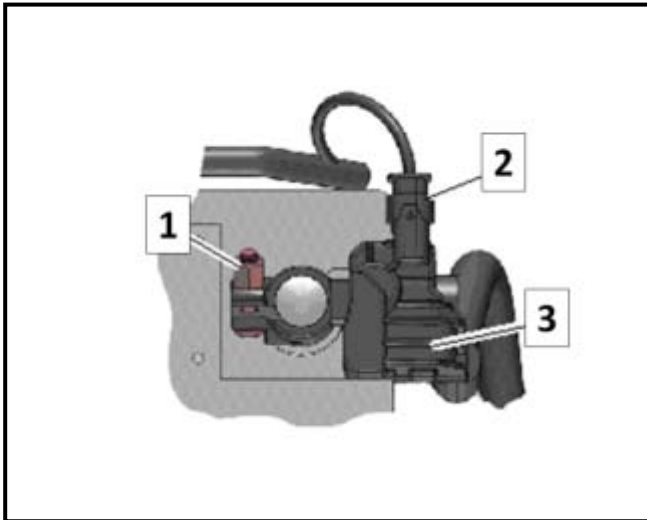
- If equipped, open the sunroof
 - Ensure ignition remains switched ON
 - Tilt front seats backward 45°
 - Close all doors and windows other than sunroof
 - Open trunk
 - Lift luggage compartment floor covering by the handle and fold it forward
 - Remove spare wheel
 - Remove luggage compartment tool kit
 - Open the cover over the battery negative terminal
- ⇐ Loosen the nut <1> several turns and remove the ground wire terminal clamp from the battery terminal

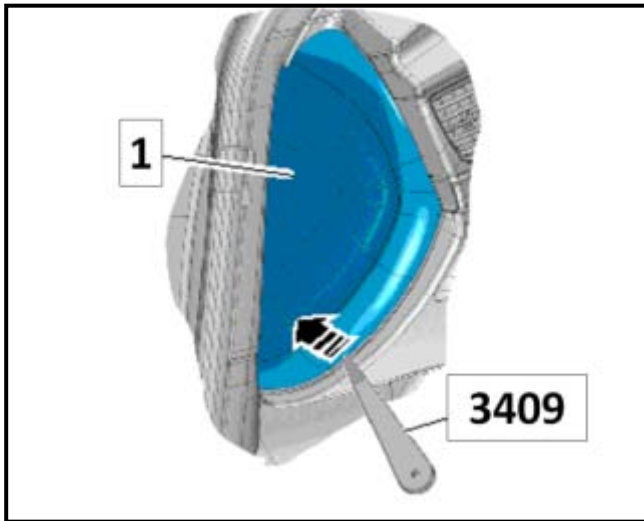
⇐ Pry the instrument panel side cover <1> off using the trim removal wedge 3409 (or equivalent) <arrow> and remove it

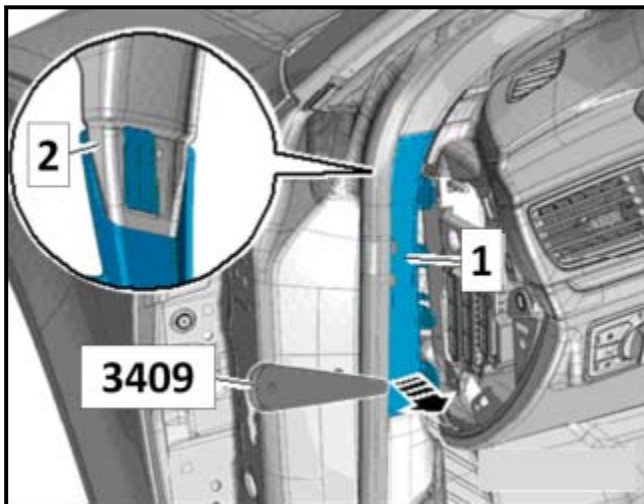
⇐ Unclip the lower gap cover <1> from the A-pillar using trim removal wedge 3409 <arrow> and remove it from the A-pillar trim <2> downward

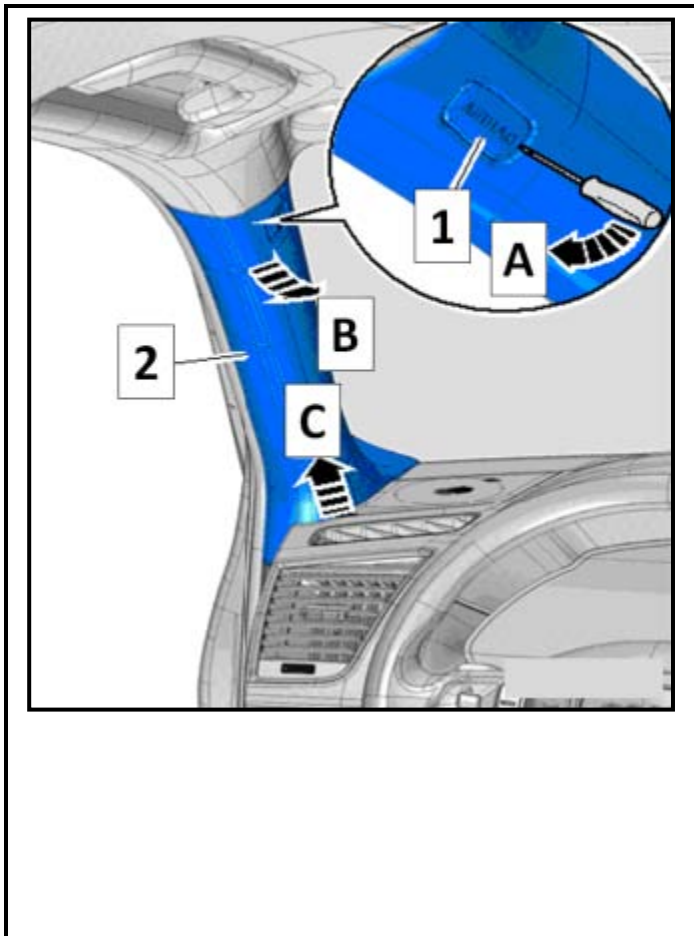
⇐ Pry out the expanding cap <1> with the “AIRBAG” symbol about 4mm with a screwdriver <arrow A>

⚠ Note: Two clamps in the A-pillar trim contain hooks (barbs) and can only be detached up to their first catch. These clamps will not come out with the trim.

⇐ Carefully unclip the upper A-pillar trim <2> up to the first catch of the clamps beginning at the top using a pry lever 80-200 (or equivalent) <arrow B>

⇐ Pull the trim upward <arrow C> to disengage the trim from the clamps

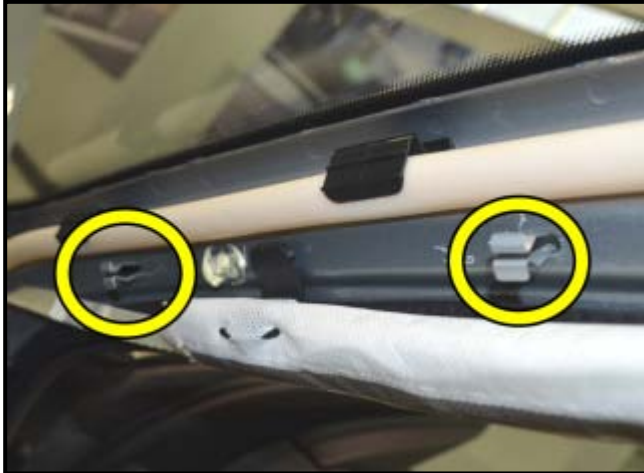
- Remove and discard clamps <circles>

⚠ Note: These clamps <circles> MUST NOT be reused

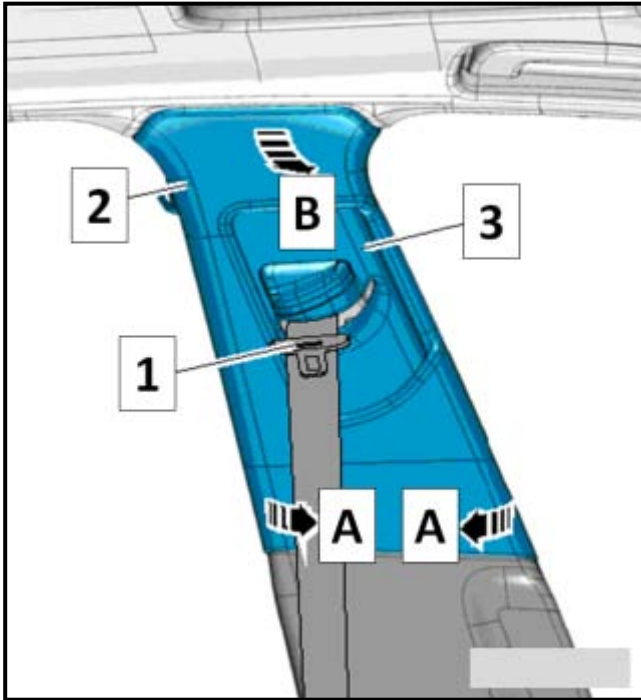
- ⇐ Move seat belt height adjuster <3> to its lowest position
- ⇐ Position the trim removal wedge 3409 (or equivalent) at the bottom edge of the upper B-pillar trim <2> and unclip the trim <in direction of arrows A> by sliding trim downward slightly to disengage it from the B-pillar
- Vehicle with a vent: disconnect the electrical connector on rear of B-pillar trim
- Lower the upper B-pillar trim and set trim to the side with seat belt still attached
- Repeat on opposite side of vehicle

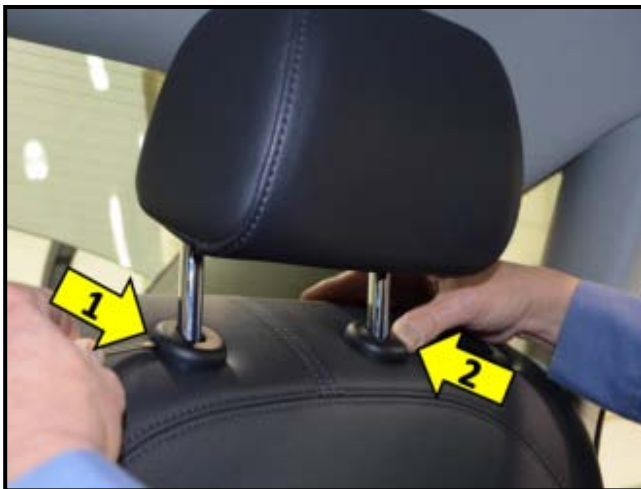
- ⇐ On rear seats, press the release button <arrow 1> using a small screwdriver, then press the release button <arrow 2>
- At the same time lift the head restraint out of the seat
- Repeat for all rear head restraints

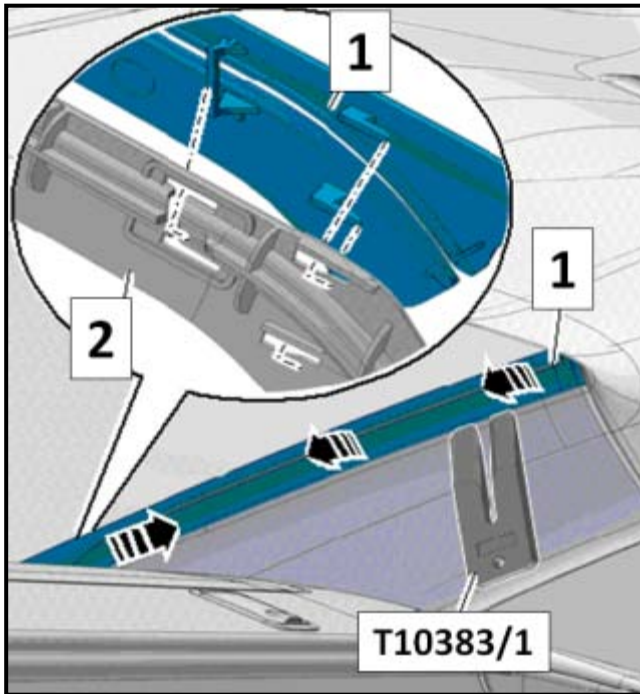
- ⇐ If equipped with rear window shade: starting at the top, use the wedge T10383/1 (or equivalent) to unclip the trim panel <1> for the rear window shade guide strip <arrows>
- ⇐ Pull the lower part of the trim upward and out of the rear window shade guide strip <2>; then remove it from the inside
- Repeat on opposite side

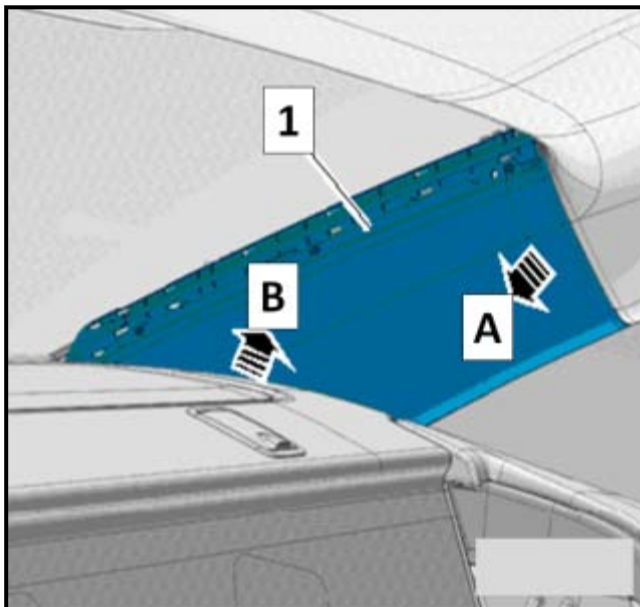
- ⇐ Unclip the rear D-pillar trim <1> using the T10383/1 trim removal wedge (or equivalent) <arrow A>
- ⇐ Pull the rear D-pillar trim upward from the rear shelf <arrow B> and remove
- Repeat on opposite side

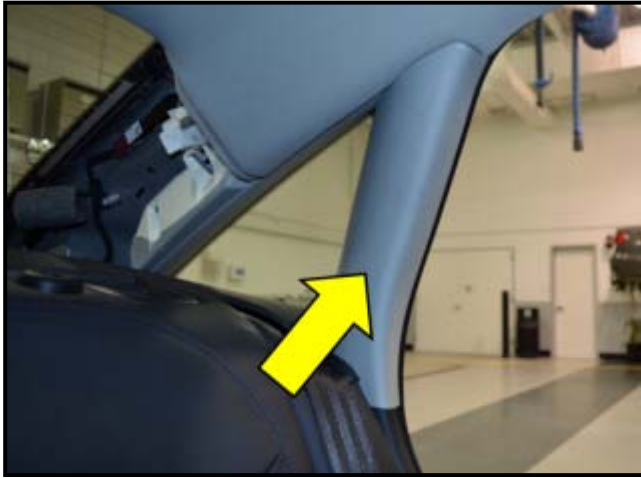
⚠ Note: The C-pillar trim shown left <arrow> does NOT need to be removed as headliner can be lifted over the trim

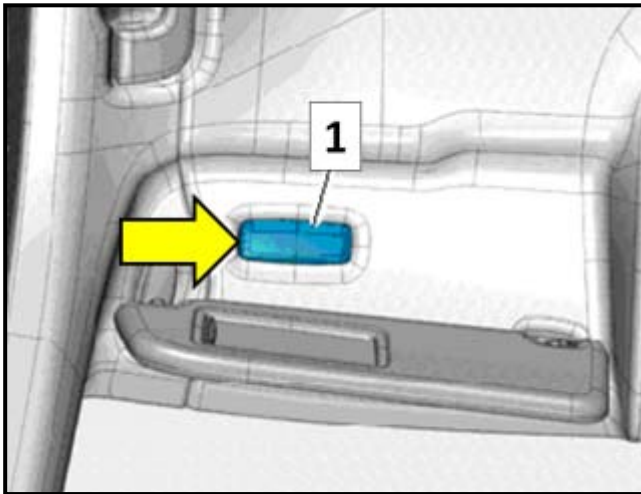
⇐ Pry out the vanity mirror illumination <1> at the cut-out <arrow > using a flat-blade screwdriver

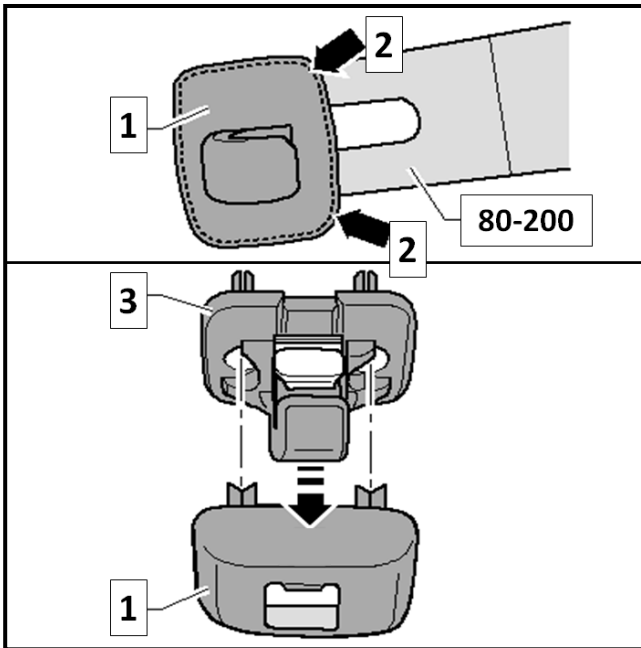
⇐ Unclip the sun visor center bracket cover <1> by sliding the pry lever 80-200 (or equivalent) only approximately 1mm under the cap <arrows 2>

ⓘ Tip: If pry lever 80-200 is shoved too far underneath, it will become lodged under the center bearing for the sun visor. At that point, it is not possible to pry off the cover

- ⇐ Remove the sun visor center mount <3>
- Repeat on opposite side

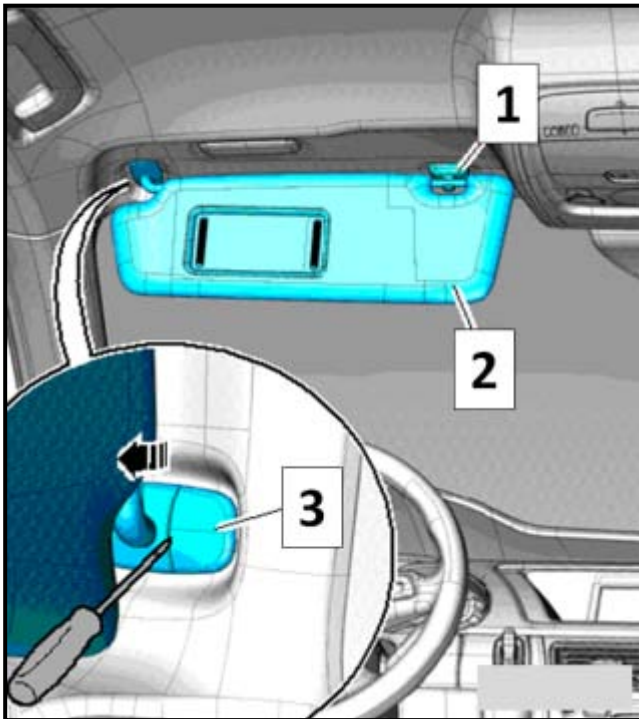
- ⇐ Unclip the expanding cap <3> using a screwdriver
- ⇐ Remove the sun visor mount downward <arrow> out of the opening in the body
- Disconnect the electrical connector and remove the sun visor
- Repeat on opposite side

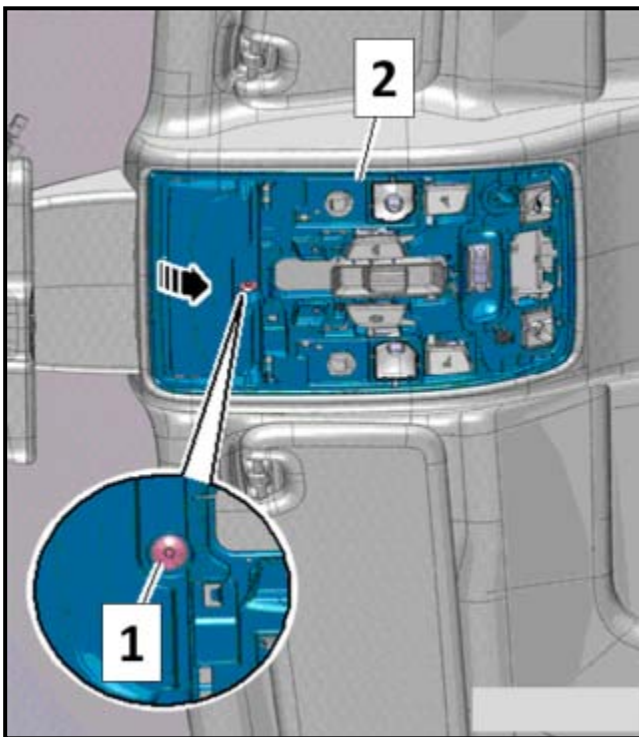
- If equipped, open the eyeglass compartment
- ⇐ Remove bolt <1>
- ⇐ Move the interior lamp/reading lamp <2> forward and down <arrow> and disengage it
- Disconnect electrical connectors

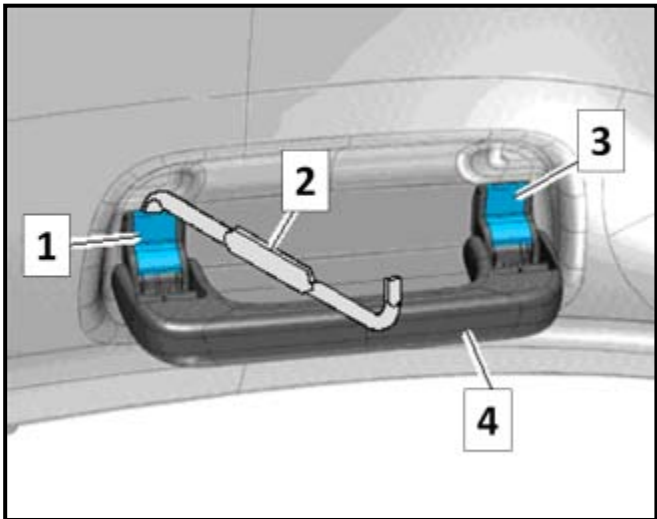
! Note: Unclip the expanding caps <1> and <3> only up to their first initial lock position. DO NOT pull them all the way out as this will damage the grab handle

- ⇐ Unclip expanding caps <1> and <3> slightly to their first locking position using VAS 6543 (or equivalent offset screwdriver) <2>
- ⇐ Remove the roof grab handle <4> from the body opening
- Repeat on remaining grab handles

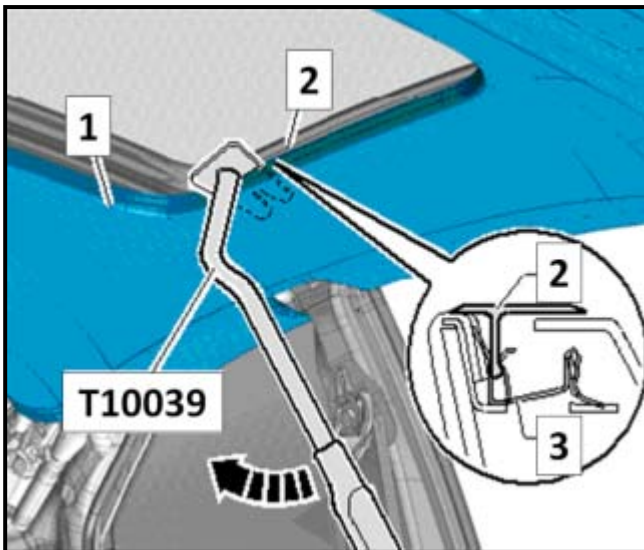
- ⇐ Slide the release lever T10039 (or equivalent) between the cover frame <2> for the sunroof opening and the headliner <1> until it touches one of the clips <3>
- ⇐ Open the clips, one after the other, using the release lever T10039 (or equivalent) as illustrated <arrow>

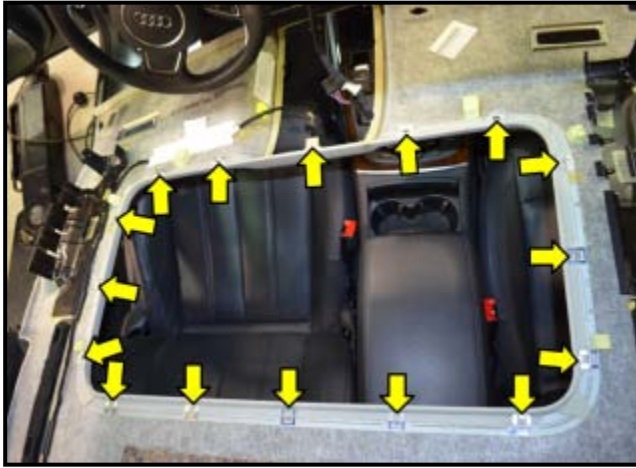
Tip: Picture on left shows location of 16 headliner clips <arrows> around sunroof frame

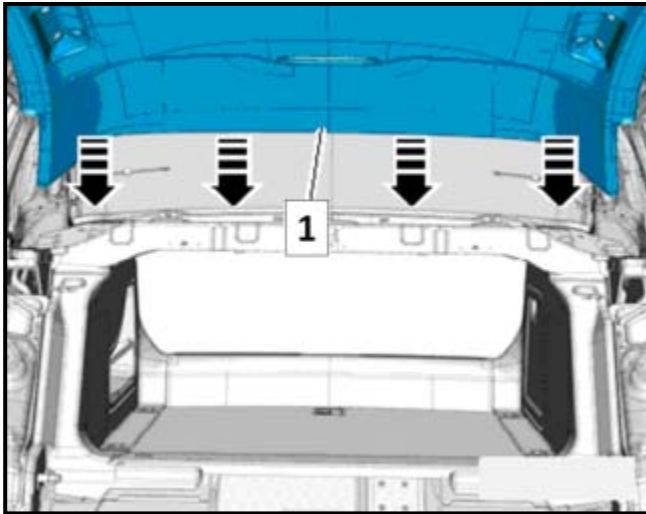
⇐ Separate the rear section of the headliner <1> from the body using the release lever 80-200 (or equivalent) <arrows>

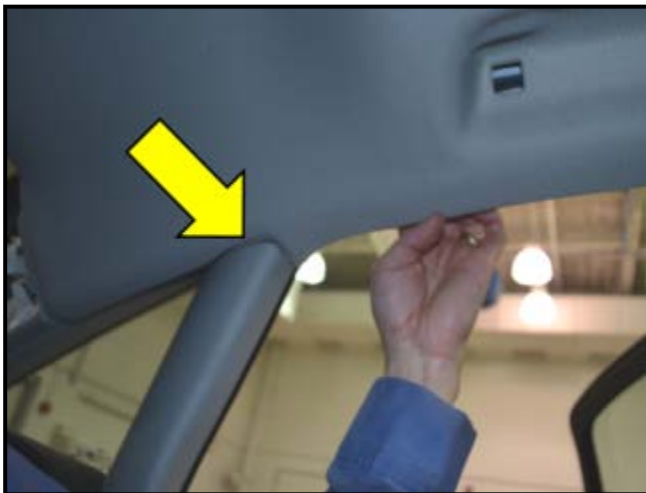
⇐ Lift the headliner carefully over the remaining C-pillar trim <arrow>

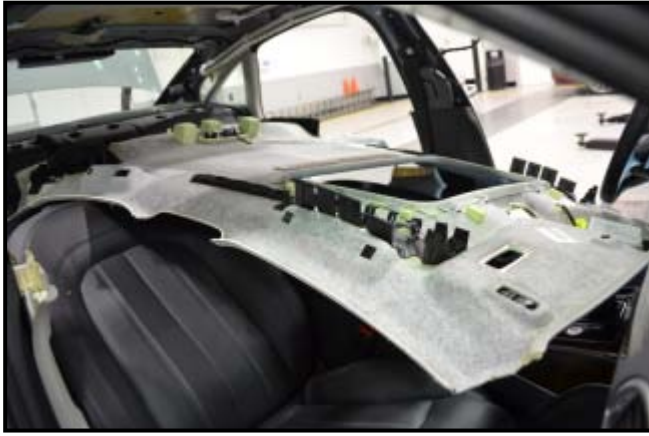
! Note: Two technicians are needed to disconnect the last connections on the headliner. Be very careful when lowering the headliner as it bends easily

⇐ Carefully lower the headliner <as shown>, bracing and supporting where necessary to prevent damage

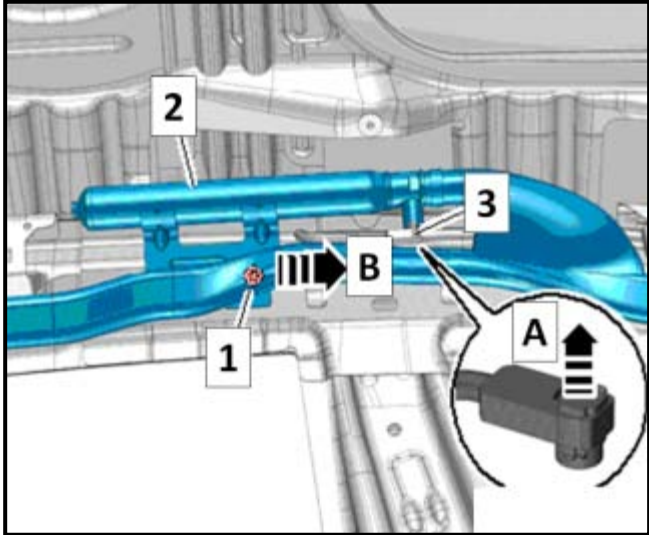
⇐ Release the connector lock <arrow A> using a small screwdriver and disconnect the connector <3>

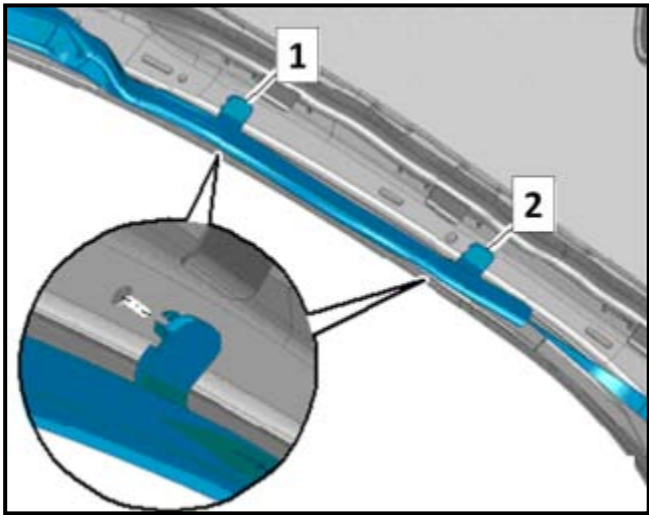
⇐ Remove the clips <1> and <2> from the A-pillar

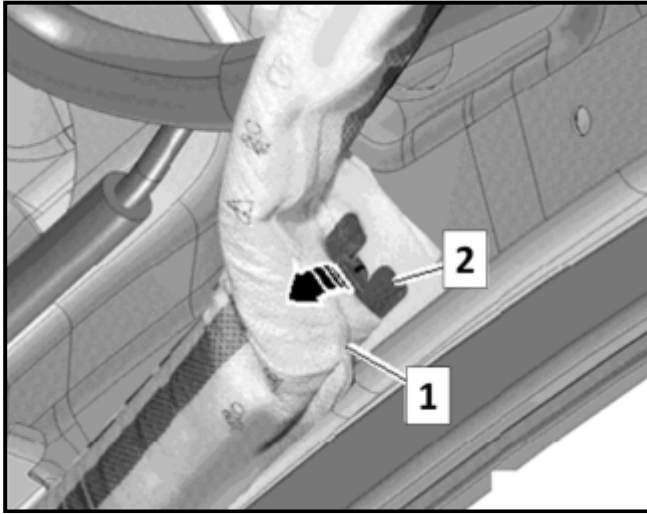
⇐ Carefully disengage the head curtain airbag <1> from each of the clips <2> <arrow>

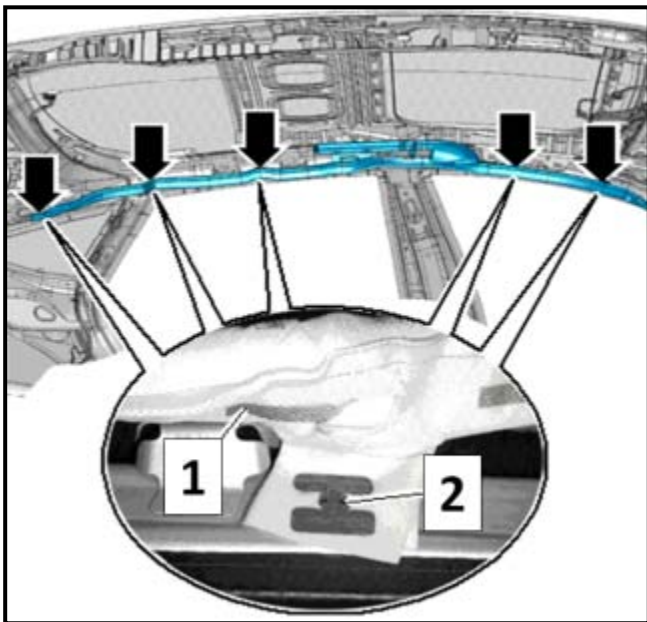
⇐ Remove the clips <arrows> from the head curtain airbag <1> with pliers

⚠ Note: The clips <2> will become damaged during the removal

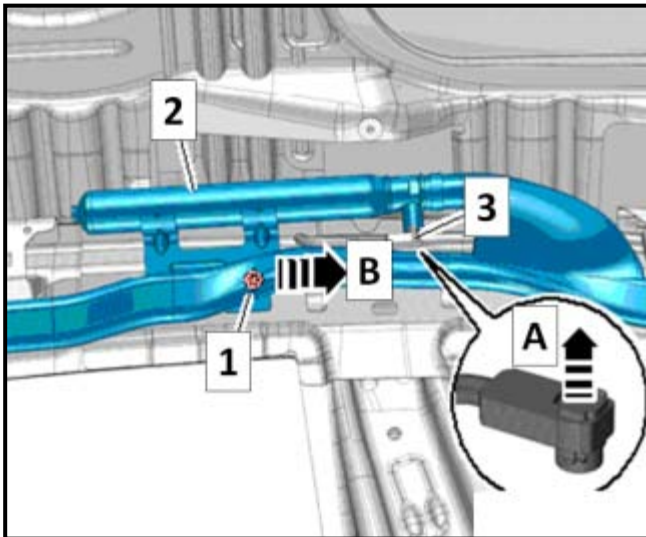
- ⇐ Remove and discard the bolt <1> from the gas generator
- ⇐ Push the head curtain airbag <2> forward <arrow B> and remove it from the mount

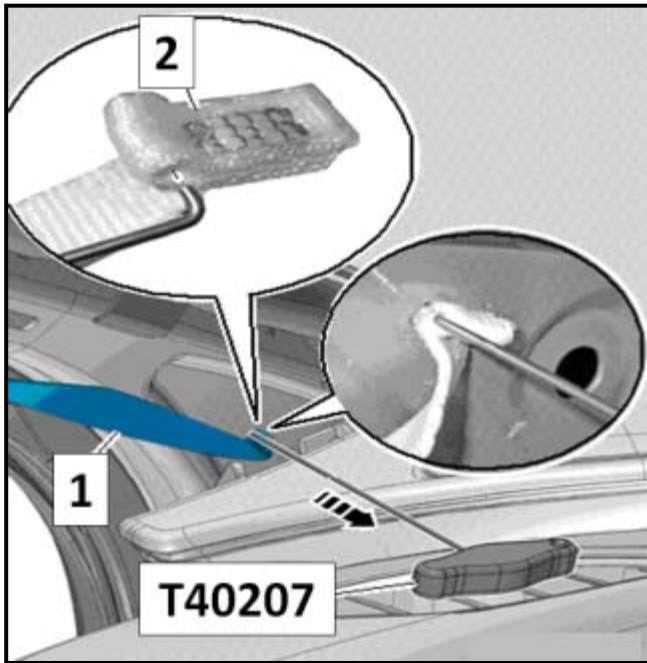
- ⇐ Remove the head curtain airbag limiting strap <1> from the A-pillar
- ⇐ Carefully position the hook T40207 (or equivalent) and then guide it into the opening in the body
- ⇐ Attach the hook T40207 to the loop <2> on the head curtain airbag limiting strap and carefully pull it straight out <arrow>
- Set airbag safely to the side

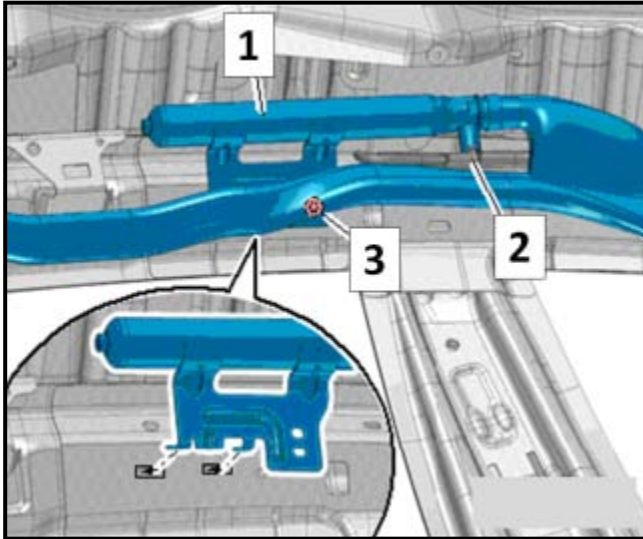
- ⇐ Attach the gas generator <1> to the body <arrows>
- ⇐ Install new screw part number (N 911 202 02) and tighten the bolt <3> to 5Nm
- ⇐ Connect the connector <2> to the head curtain airbag igniter
 - Press in the connector lock

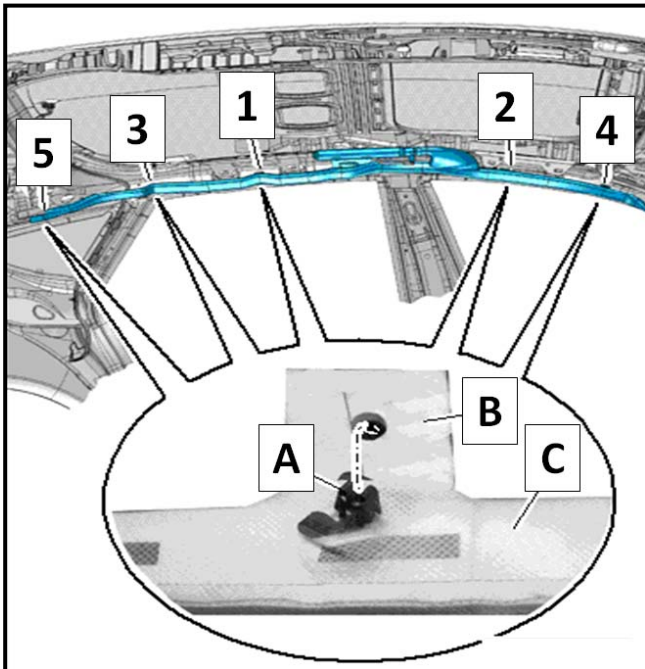
- ⇐ Insert the clip <A> carefully into the head curtain airbag <C>, then attach tab to the clip <A>
- ⇐ Install the clips for the head curtain airbag in sequence <1,2,3,4,5> and ensure that each clip engages audibly into the body

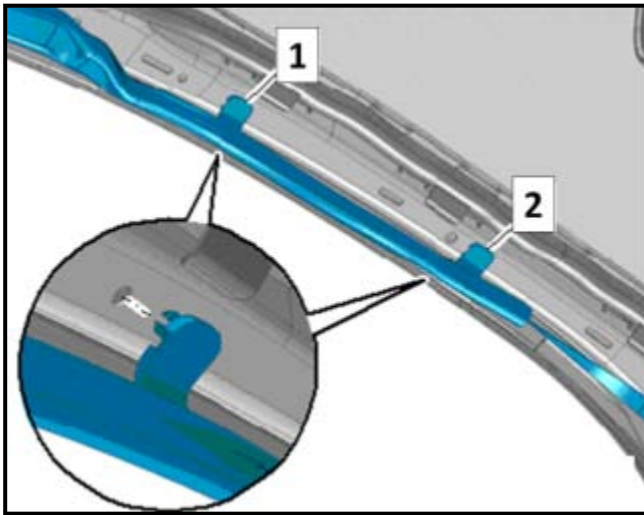
⇐ Install the clips <1> and <2> in the A-pillar and ensure that the “black line” is visible the entire length

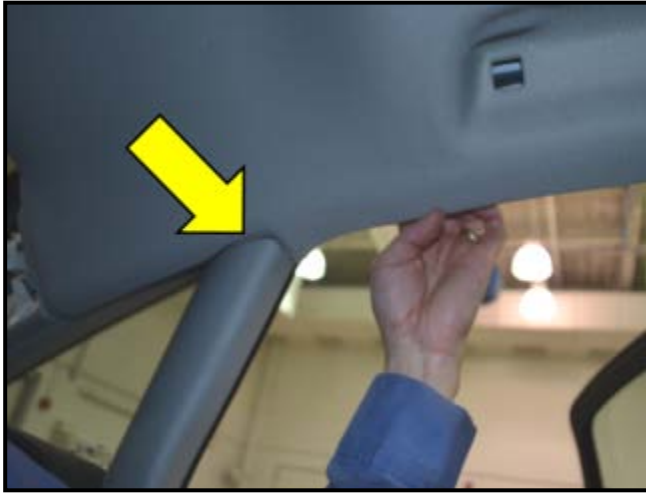
⇐ Lift the headliner over the C-pillar trim <arrow>

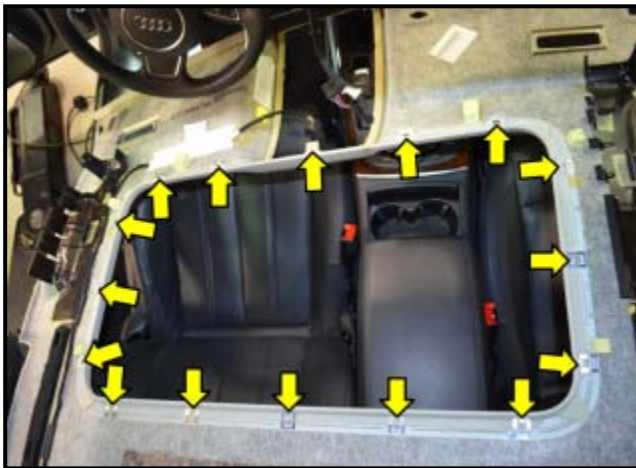
Tip: Picture on left shows location of 16 headliner clips <arrows> around sunroof frame

⇐ Reattach clips <arrows> to sunroof frame until they snap into place

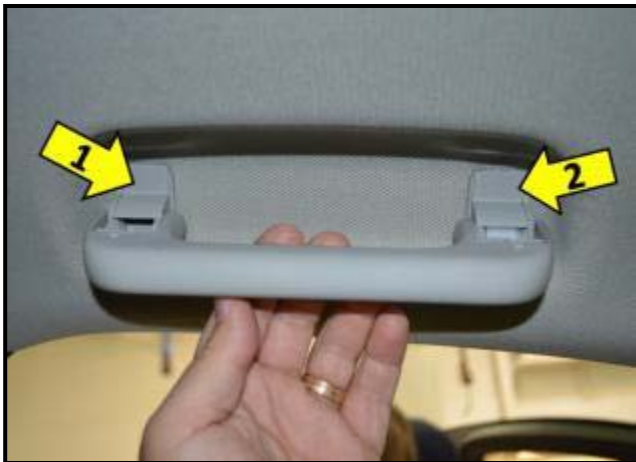
- Reinstall the roof grab handle into the body opening and clip the expanding caps <arrow 1> and <arrow 2> properly back into position

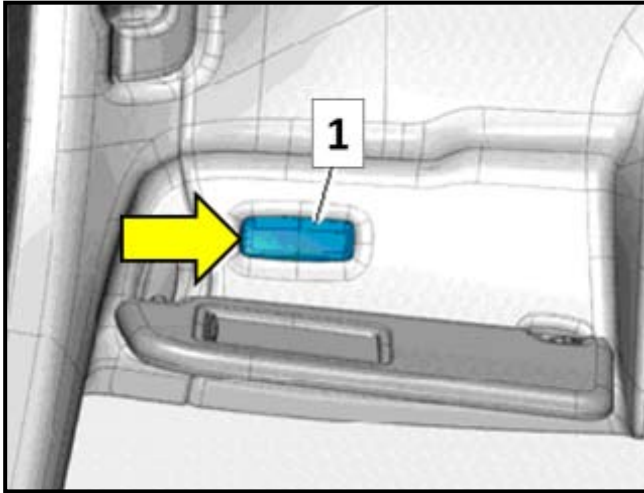
⇐ Reconnect electrical connector for the vanity mirror illumination <1> and clip properly into position

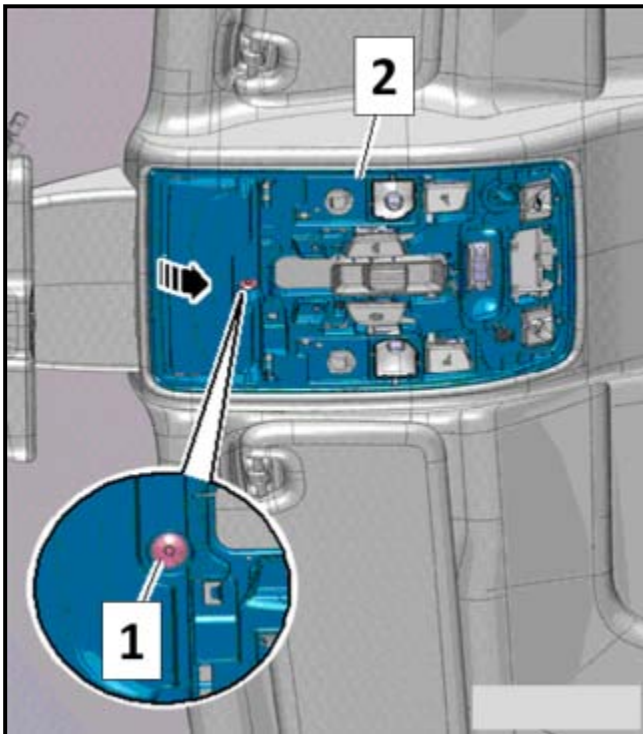
⇐ Place the interior lamp/reading lamp <2> into position and reconnect electrical connectors

⇐ Reinstall bolt <1> and torque to 2Nm

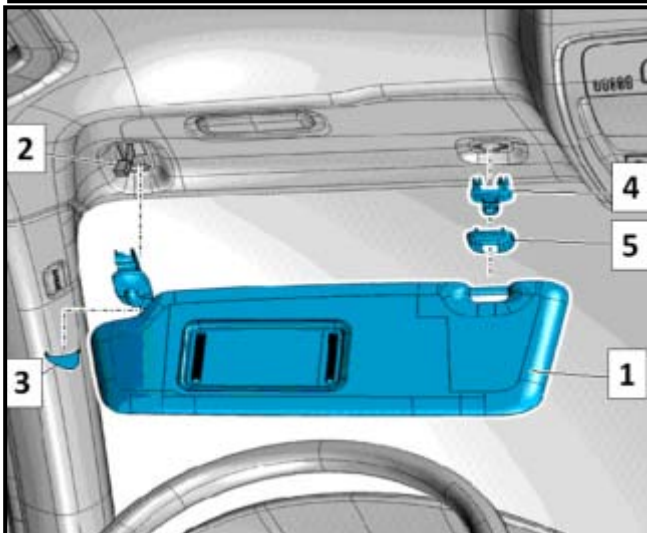
⇐ Reconnect the electrical connector <2> for the sun visor <1>

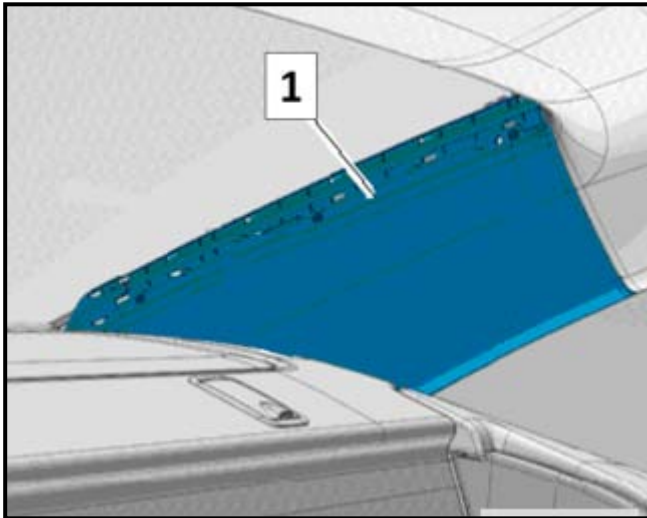
⇐ Reinstall the D-pillar trim <1> and ensure clips engage properly in place

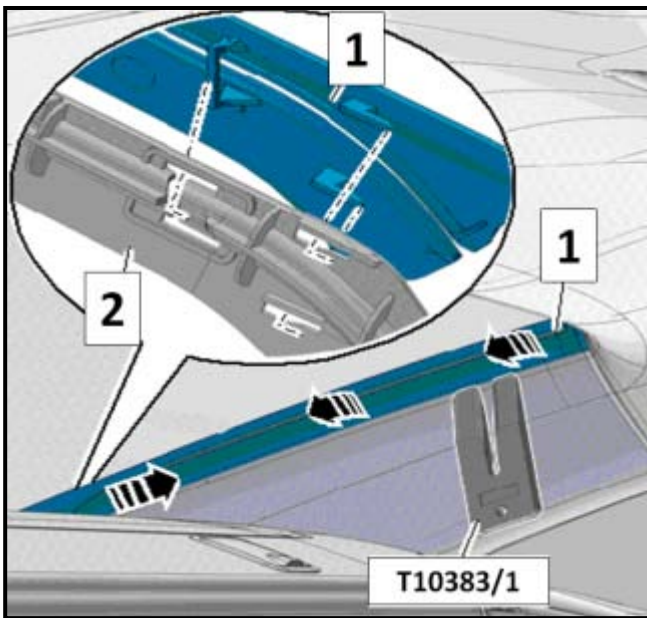
⇐ If equipped with rear window shade: reinstall the trim panel <1> for the rear window shade guide strip and ensure clips properly engage

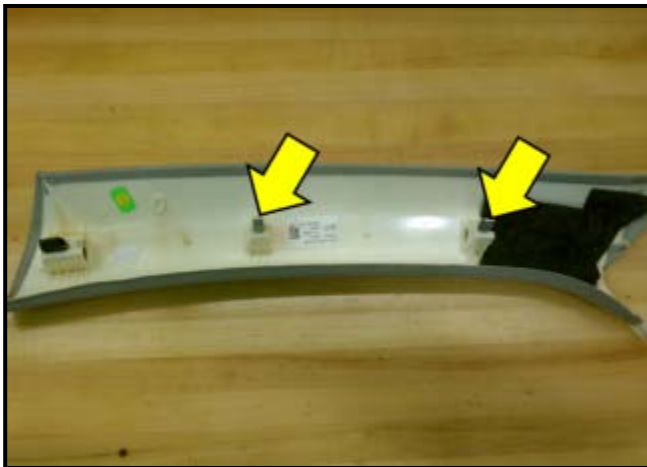
- ⇐ Insert two new clamps <arrows> part number (8Z0 867 276) into each A-pillar trim piece

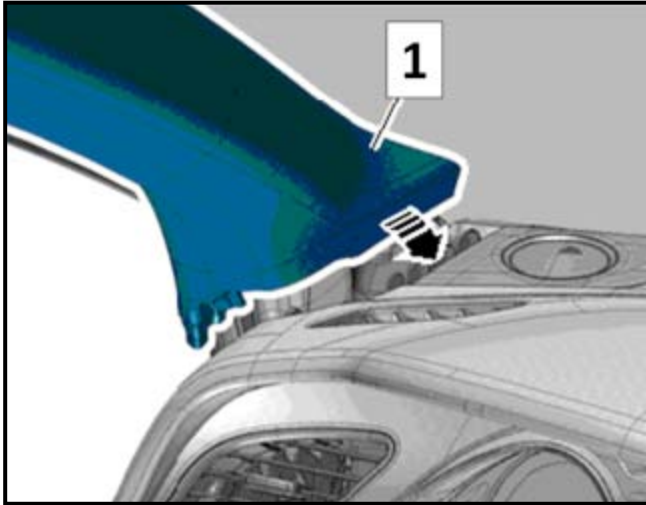
⇐ Reinsert the upper A-pillar trim <1> in the mount of the instrument panel <arrow>

- Clip the upper A-pillar trim in so that all three clips are seated properly and firmly into position
- Stretch the door seal lip over the trim
- Repeat on opposite side

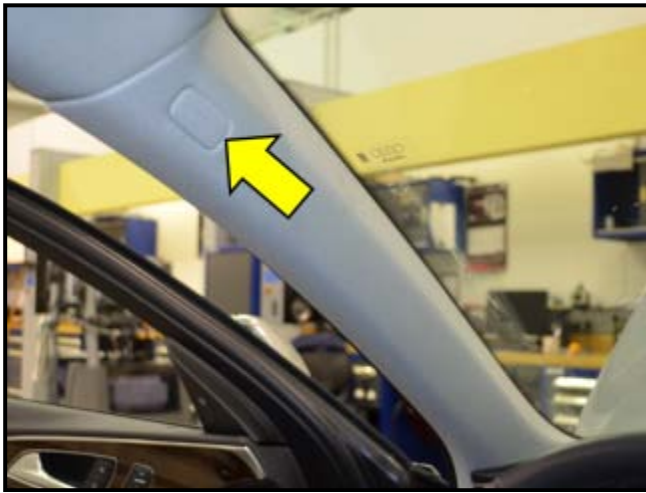
⇐ Reinsert the expanding cap <arrow> with the "AIRBAG" symbol

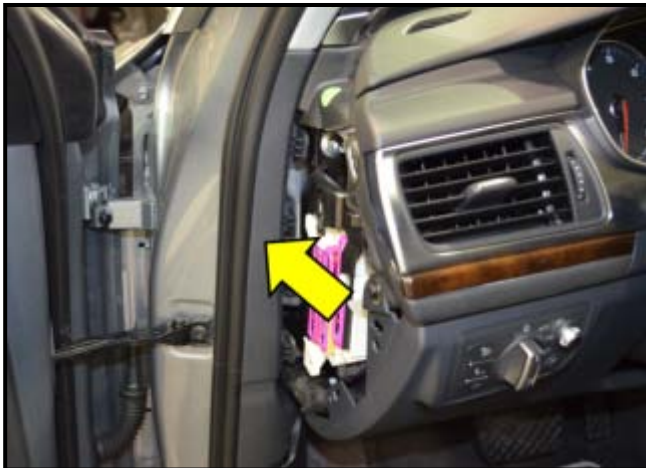
⇐ Reinstall both of the A-pillar gap covers <arrow> into the A-pillar and then stretch the door seal lip over them

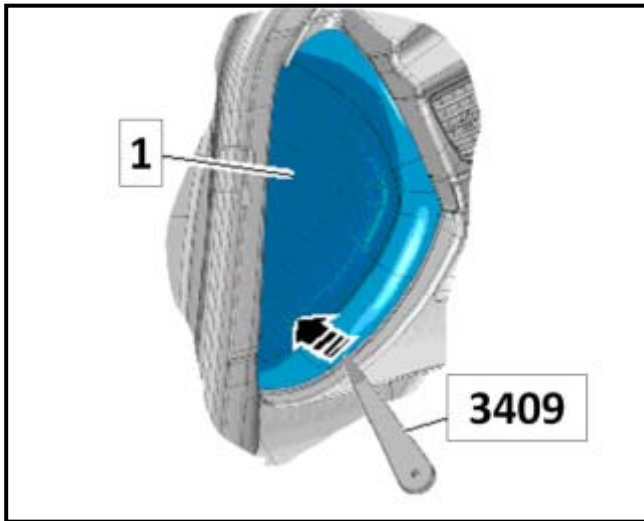
⇐ Reinstall both instrument panel side covers <1>

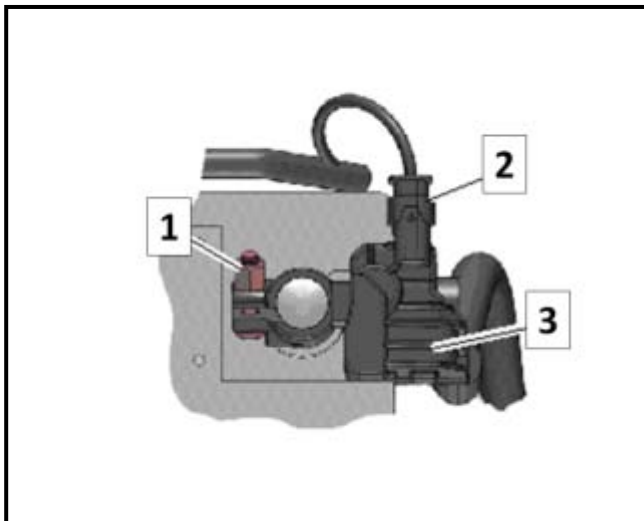
- Close all doors (windows other than sunroof should already be closed)
- Ensure that no one is inside of vehicle
- ⇐ Reconnect the ground terminal to the battery negative pole “-“ by hand and tighten the nut <1> to 5Nm
- Reinstall luggage compartment tool kit
- Reinstall spare wheel
- Close trunk
- Activate the one-touch up/one-touch down power window regulators
- Check all DTC memories and erase the “undervoltage” DTC if necessary using the Vehicle Diagnostic Tester
