# SAFETY RECALL BULLETIN

## NHTSA RECALL 12V-046

AUTOCAR, LLC SAFETY RECALL A-1201

Temporary Fix to Bendix ATR-6 Valve

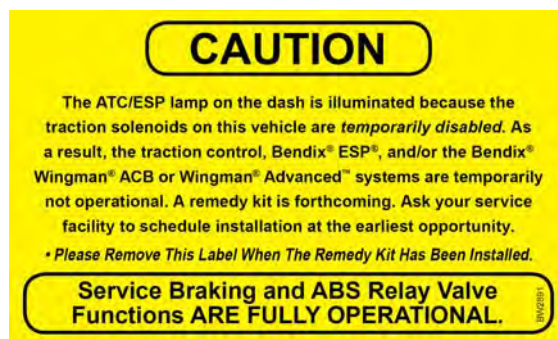
The kit contains this windshield cling caution sign that should be placed inside the cab when the temporary remedy is installed. The label should be removed when the permanent remedy kit is installed.

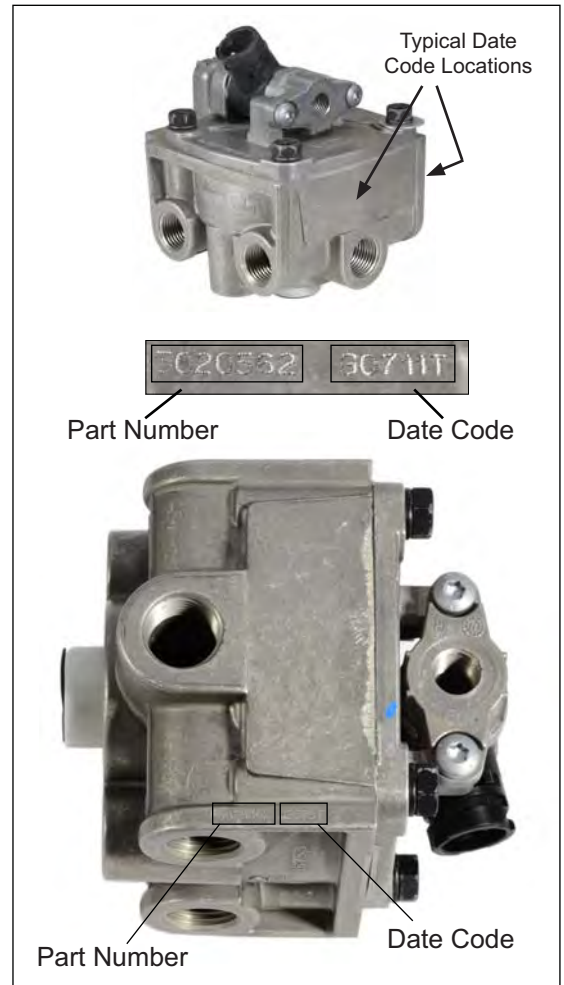
December 2, 2010 through January 18, 2012  
 That is, M0210T through A1812T.

Codes for December 2010	<p>example: M0310T</p>
Codes for all of 2011	<p>examples: A3011T F2511T</p>
Codes for January 2012	<p>example: A0312T</p>
