PRODUCT CAMPAIGN BULLETIN

APPLICABILITY: 2009-2012MY Subaru Forester
SUBJECT: Rear Seat Center Seatbelt

NUMBER: WQA-37
DATE: March 2012

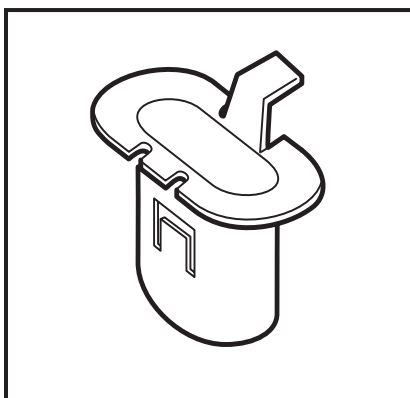
Cushion Anchor Hook

Caution: If the cushion anchor hooks (either two or three, see drawings above) on the vehicle body side are disengaged (remain on the seat cushion) when removing the rear seat cushion, always replace with new cushion anchor hooks to prevent any reduction in the retention force.

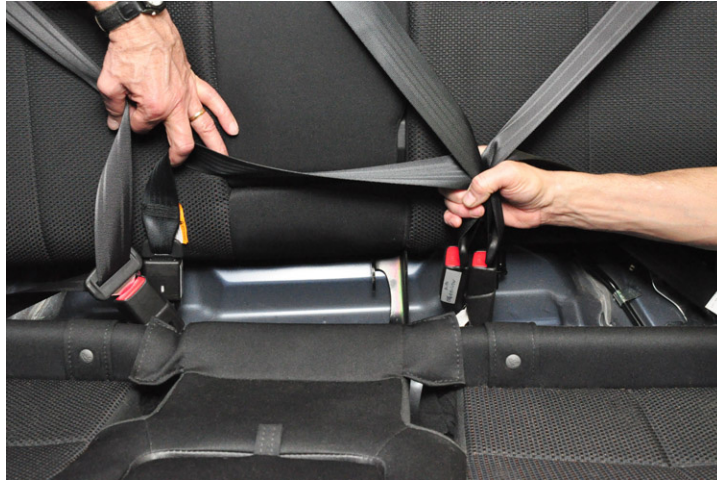
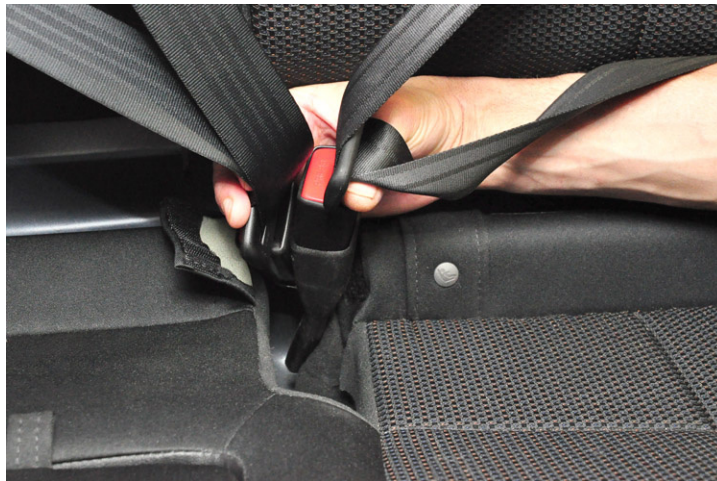
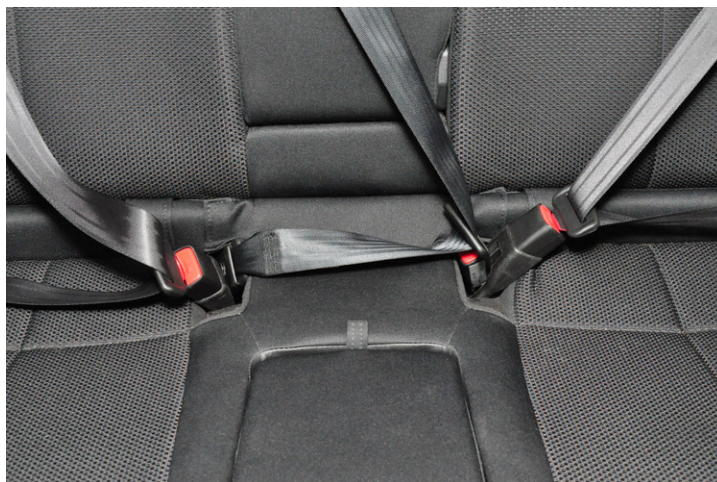
9. Reinstall the seat cushion. To facilitate positioning of the seatbelts in the cushion, connect all of the seatbelts. The next step will require an assistant. With each person holding the left and right seatbelts respectively, slide the cushion into place while pulling the belt buckles into position in the seat cushion opening.

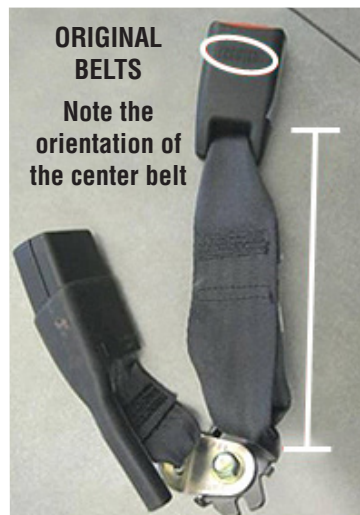
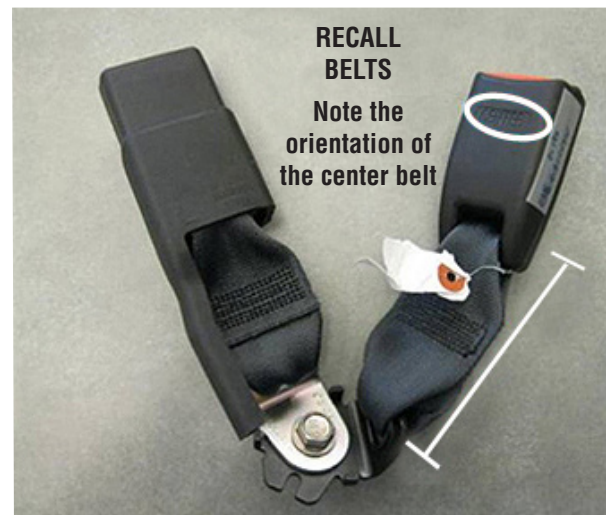
This page should clarify two areas of the Campaign and does not represent any change in procedure. The first clarification is the length of the recall belt. By design, the recall replacement belt is shorter than the original belt.

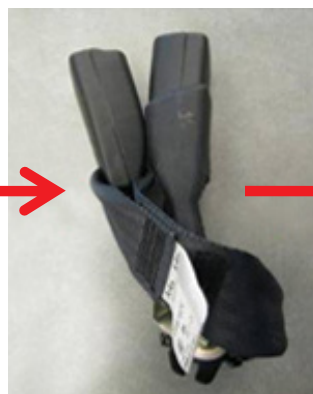
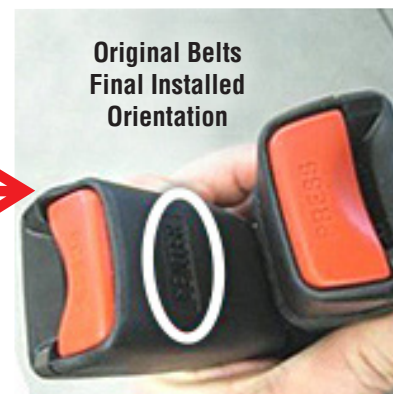
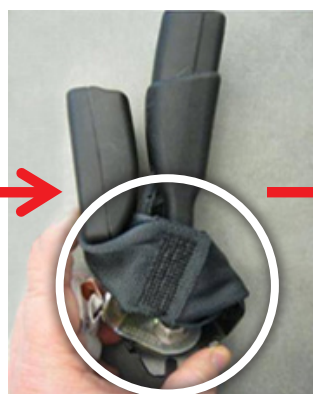
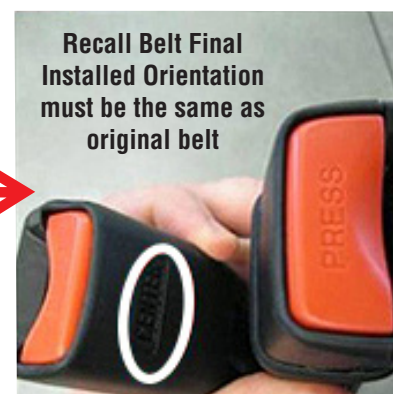
The second clarification is the final buckle/ latch orientation for the center belt. The red latch release button must face away from the seating position it services. Access to the red latch release button must not be blocked by the belt when it is latched in place for use.

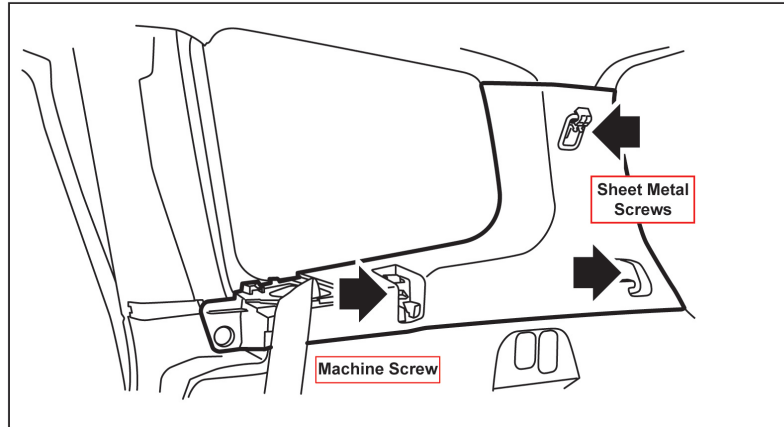
3. Remove the front machine screw and 2 rear sheet metal screws from the right rear quarter panel trim.

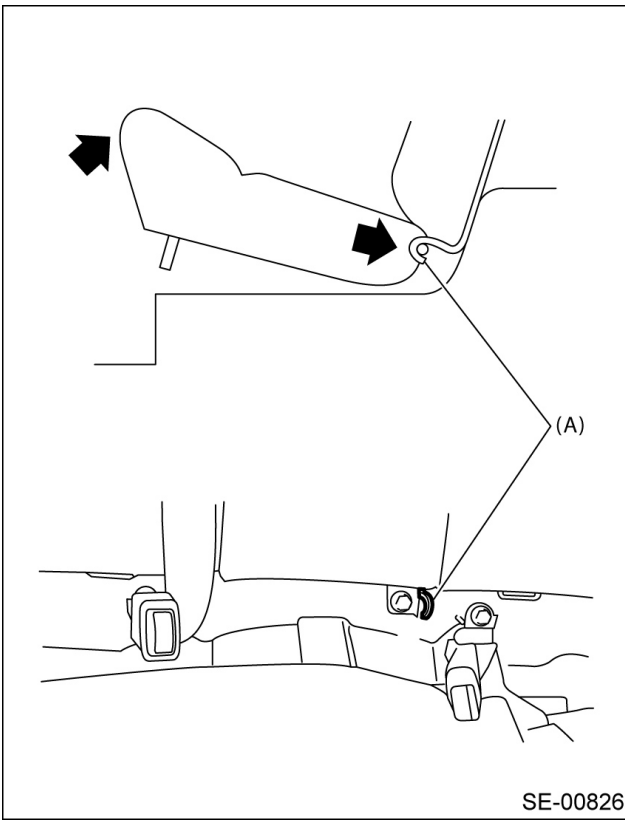
2. Disengage the backrest hook (A) by pushing it back while lifting the front side of the seat cushion. Perform the same procedure on the opposite side. Remove seat cushion from vehicle.

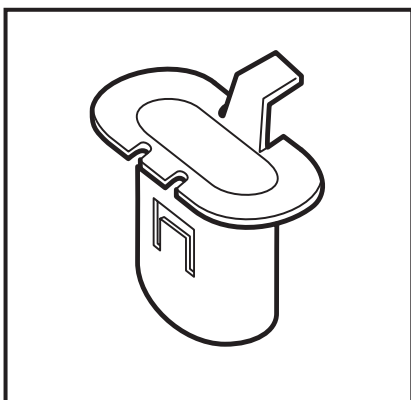
Cushion Anchor Hook

Caution: If the cushion anchor hooks (either two or three, see drawings above) on the vehicle body side are disengaged (remain on the seat cushion) when removing the rear seat cushion, always replace with new cushion anchor hooks to prevent any reduction in the retention force.

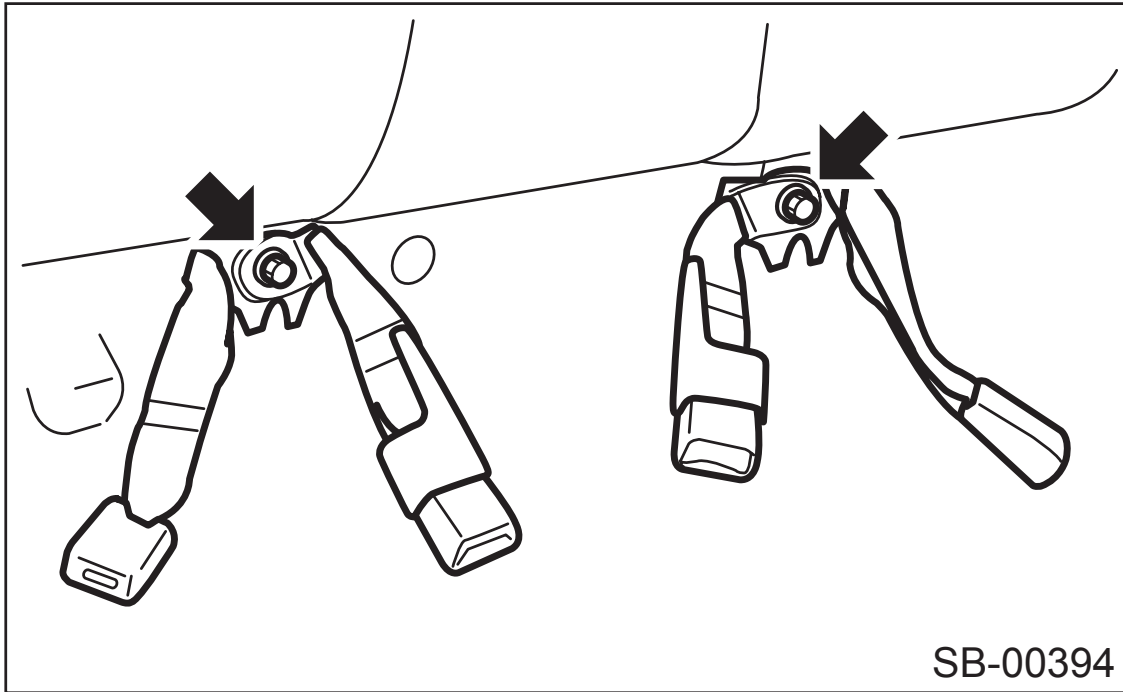
3. Remove the retaining bolts and remove the center seat belt assemblies.

- During re-installation, make sure that the seat belts are not twisted.
4. Install new seat belts and torque bolts to spec: **30 N-m (3.06 kgf-m, 22.1 ft-lb)**.

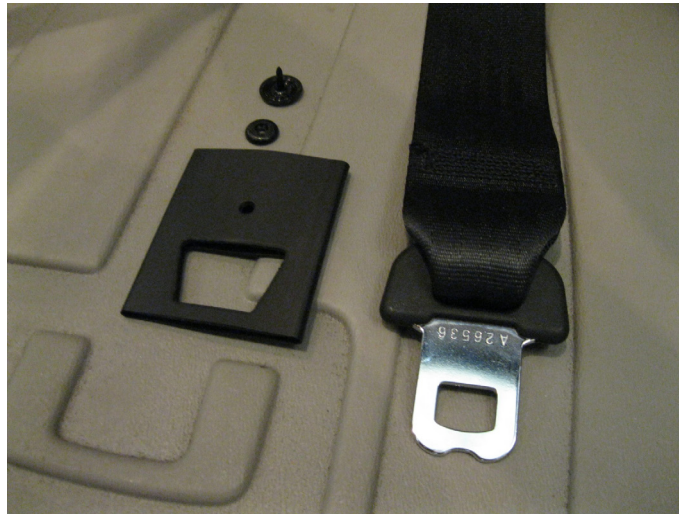
9. Center Seat Belt Tongue Stiffener Installation.

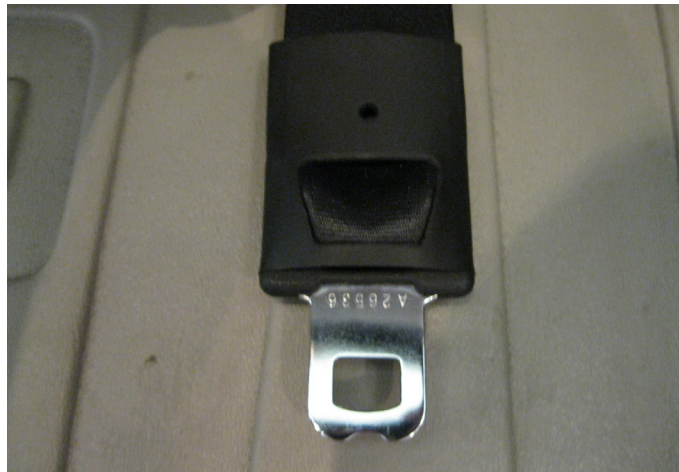
- a. Insert the Center Seat Belt Tongue into the stiffener, centering the opening in the stiffener over the bulge of belt material.

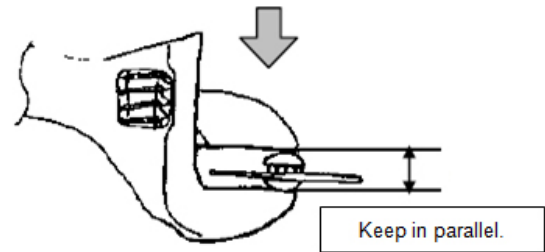
- c. Place the female collar of the tack onto the pin from the other side.
d. Using an adjustable wrench as shown, clamp the assembly together and compress the pointed end by first tightening the jaws of the adjustable wrench by hand as far as possible.

NOTE: Keep male and female portions of the tack assembly parallel while compressing them.

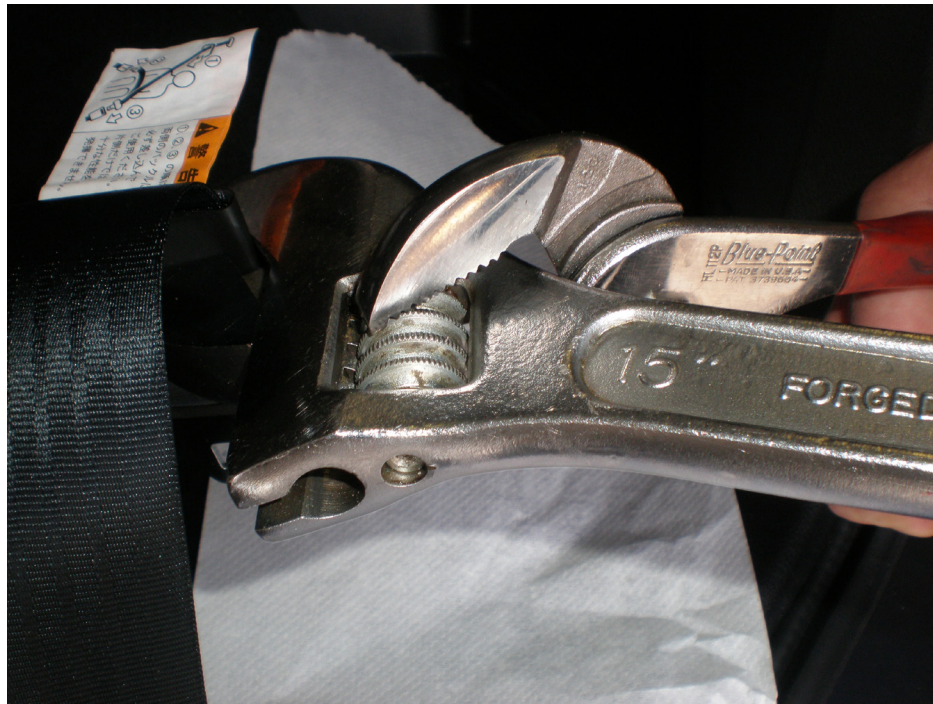
- e. Next, using channel lock pliers, tighten the adjustable wrench gear until the combined height of the tack and belt assembly is ~9.5 to 10.0 mm.

Figure 9: Seating the Tack Collar
