SAFETY RECALL NOTICE

Re: Brake Pedal Connecting Rod Pins Replacement

Campaign no.: 2010-0014

April 16th, 2012Subject: **Spyder™ RT Brake Pedal Connecting Rod
Pins Replacement**No. **2010-11**

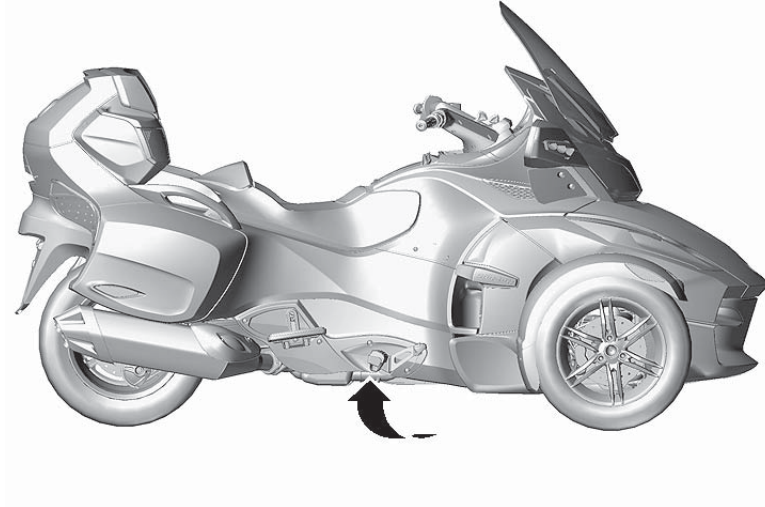
1

Work from underneath the RH side of the vehicle.

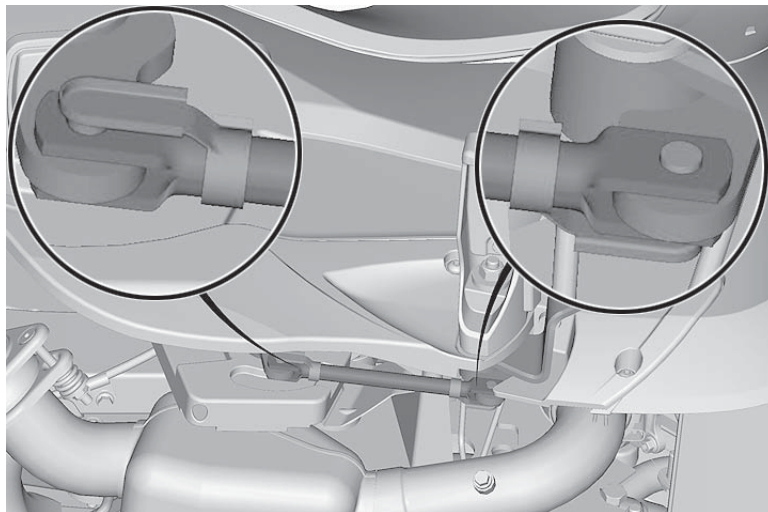
2

ORIGINAL RETAINING PINS TO BE REPLACED

Replace **both** brake pedal connecting rod retaining pins as follows.

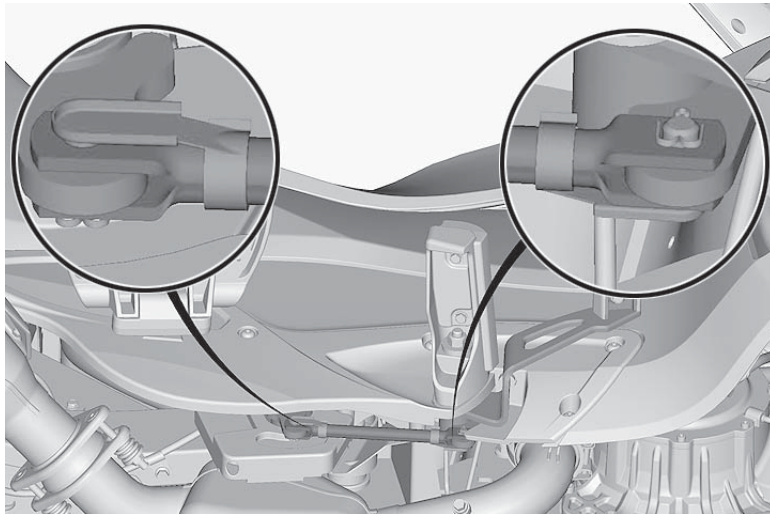
8

NEW RETAINING PINS PROPERLY INSTALLED

IMPORTANT: Replace **both** retaining pins.
