## QUARANTINE NOTICE

<b>To:</b> All North America Dealers <b>For the attention of:</b> Service Manager/After Sales Manager <b>Please copy to:</b> Dealer Principal Sales Manager Warranty Administrator Aston Martin Technician(s) Parts Manager	<b>Reference</b> QN-03-0017V2  <b>Issued:</b> 23 October 2013
<b>Model:</b> All Models from 11 November 2007 thru 3 October 2013 but not New Vanquish or Cygnet	<b>Page 1 of 12</b>
<b>VIN Range:</b> Refer to the separately published list of VINs	
<b>Subject:</b> Throttle Pedal Lever - Incorrect Material Specification and Adjustment of the Footwell Scuff-Plate on Left Hand Steering Vehicles

### Reason for this Quarantine Notice (QN-03-0017V2) which supersedes QN-03-0017

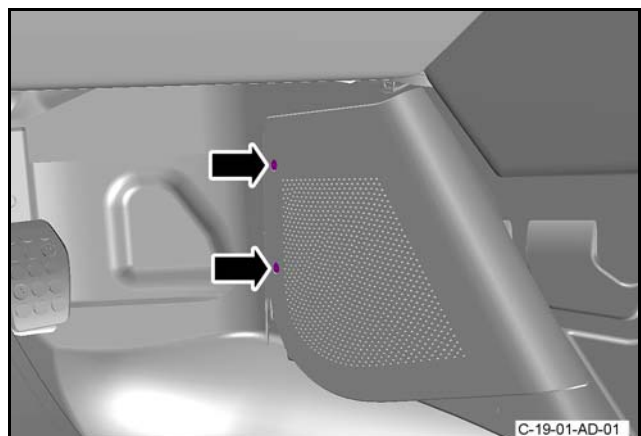
Figure 3

16. On vehicles with B&O™ audio, do steps 17 thru 19 that follow:
17. Remove the two screws that attach the grille for the driver's side front footwell speaker (footwell speaker) to the bracket (refer to Figure 3).

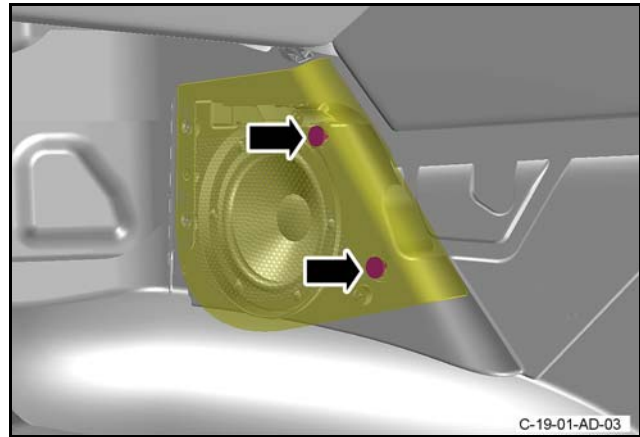
Figure 4

18. Release the grille for the footwell speaker from the two tabs that attach it to the footwell speaker and remove the grille (refer to Figure 4).

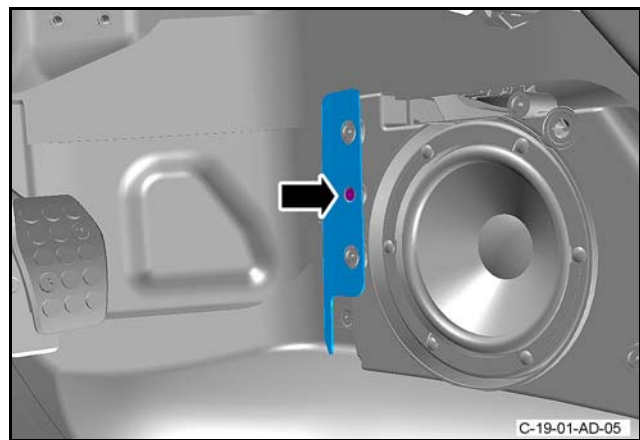
Figure 5

19. Remove the screw that attaches the bracket to the footwell speaker and remove the bracket. (refer to Figure 5).

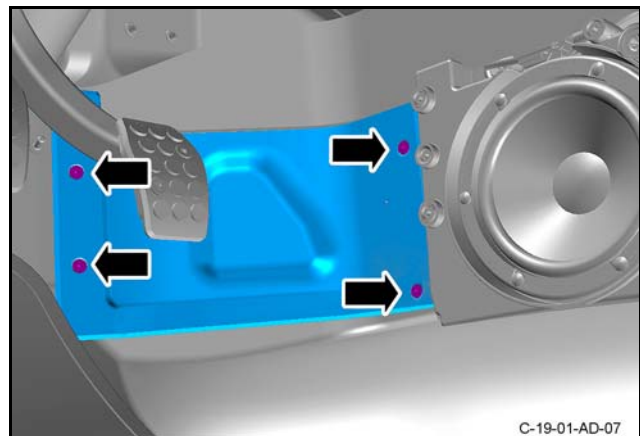
Figure 6

20. On all vehicles, remove the four screws that attach the accelerator scuff-plate (scuff-plate) to the body and remove the scuff-plate (Figure 6).

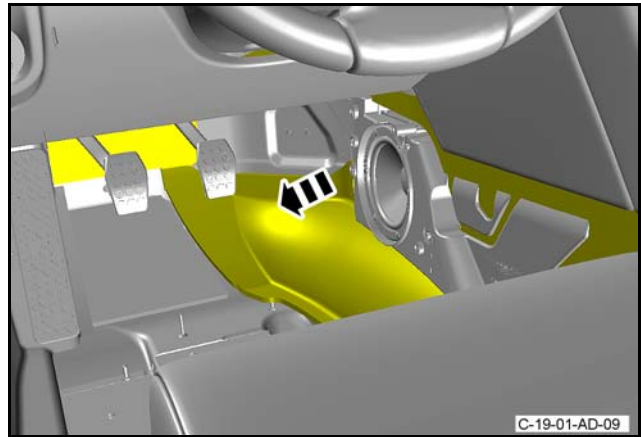
Figure 7

22. Move the side tunnel carpet away from the front footwell speaker (refer to Figure 7).

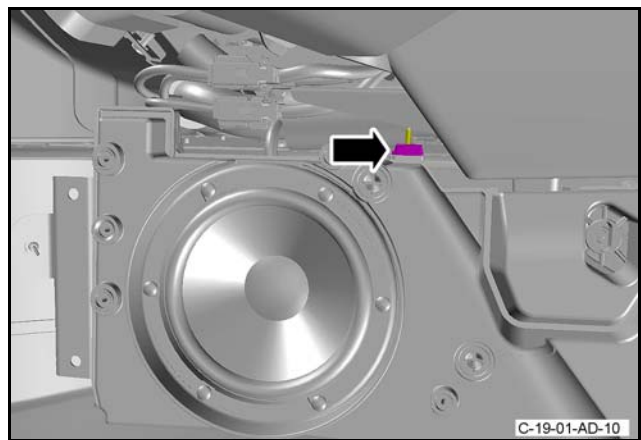
Figure 8

23. Disconnect the electrical connector from the footwell speaker (refer to Figure 8).

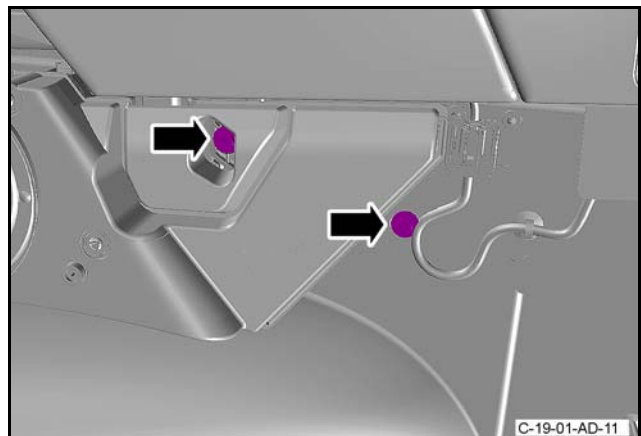
Figure 9

24. Remove the two screws that attach the footwell speaker to the body and remove the footwell speaker (refer to Figure 9).

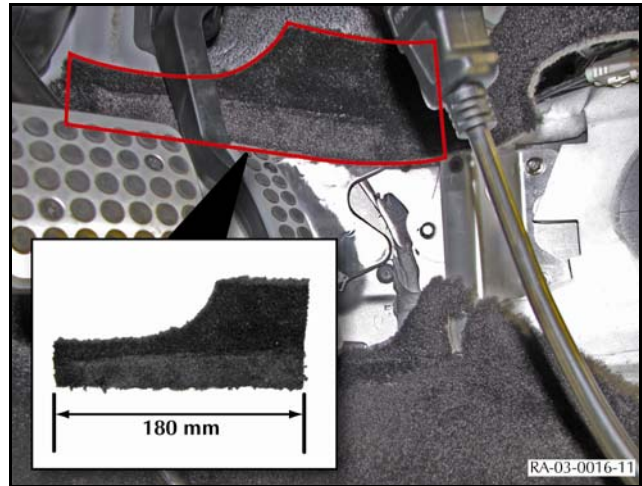
Figure 10

- 25. Cut and remove the piece of carpet that is above the position for the scuff plate (refer to Figure 10). Discard the removed carpet.

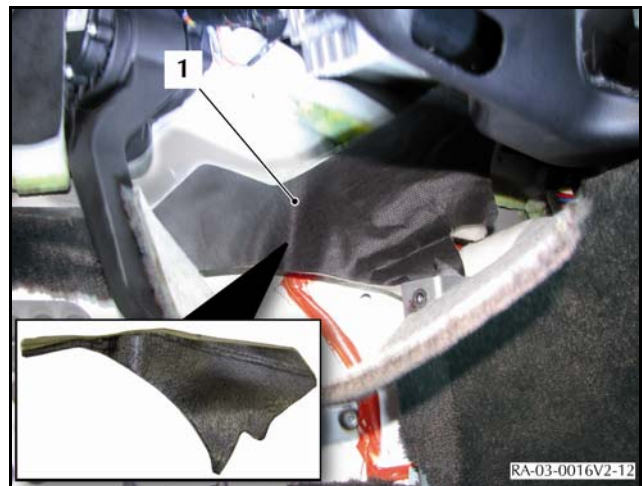
Figure 11

- 26. Cut and remove the piece of insulation (1) that is above the position for the scuff-plate, shown in Figure 11. Discard the removed insulation.

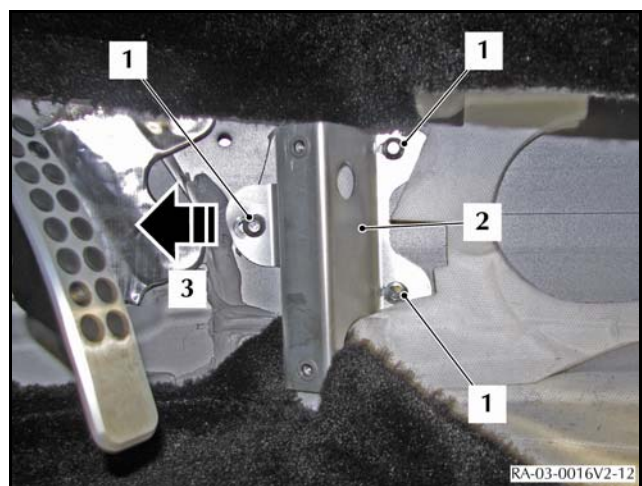
Figure 12

- 27. Loosen, but do not remove the three screws (1) that attach the bracket for the scuff plate (2) to the body (refer to Figure 12).
- 28. Move the bracket (2) fully towards the front of the vehicle (3).
- 29. Tighten the three screws (1) that attach the bracket (2).

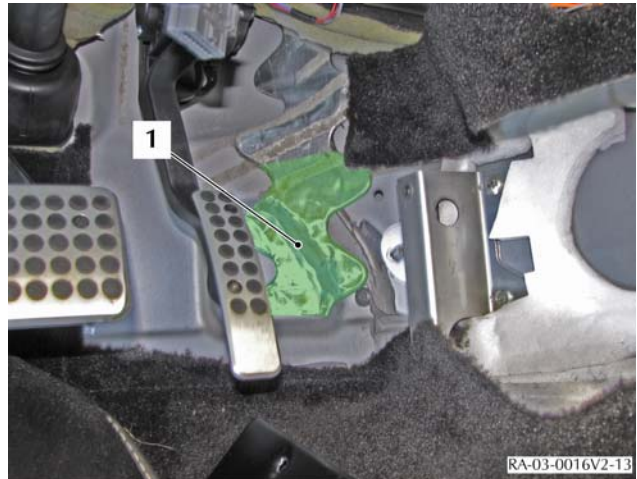
Figure 13

30. Make sure that there is no NVH material (1) on the body where the scuff plate is attached. Remove all NVH material (1) from this area (refer to the example shown coloured green in Figure 13).

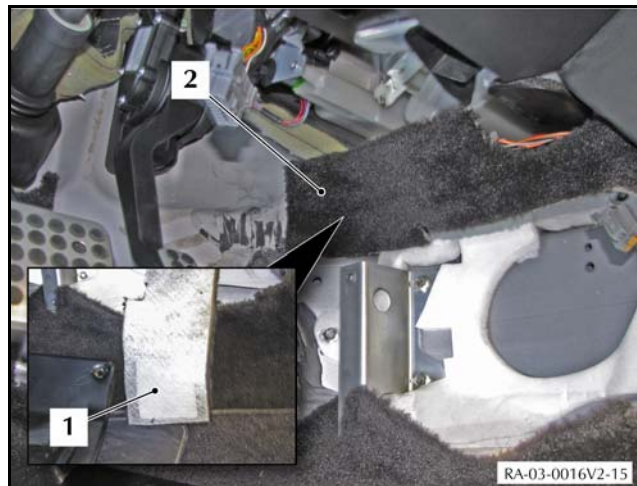
Figure 14

31. Use a piece of double-sided adhesive carpet tape approximately 50 mm square (1) to attach the loose end of the carpet to the tunnel (2) (refer to Figure 14).

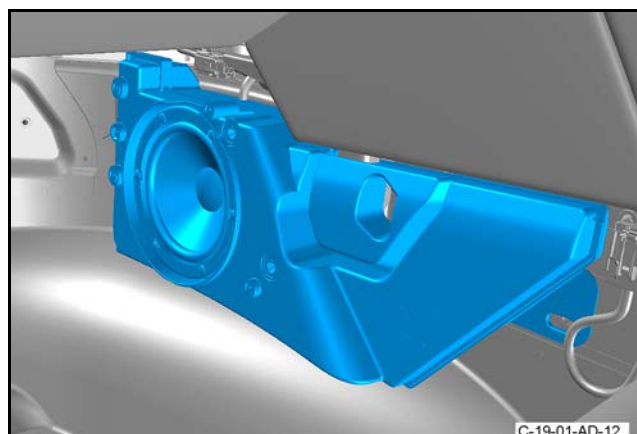
Figure 15

32. On vehicles that have B&O™ audio, do steps 33 thru 35 that follow:
33. Put the footwell speaker in position (refer to Figure 15).

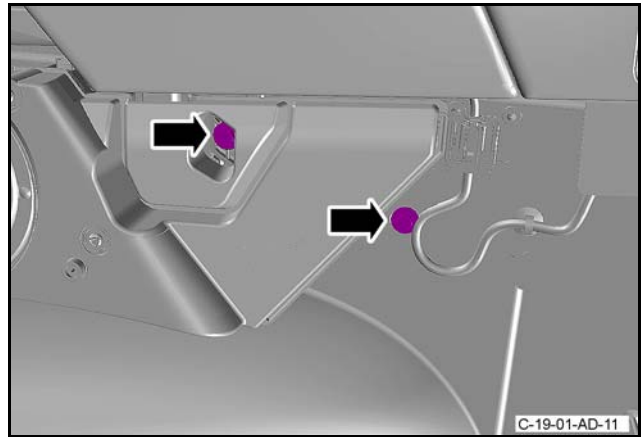
Figure 16

- 34. Install the two screws that attach the footwell speaker (refer to Figure 16).

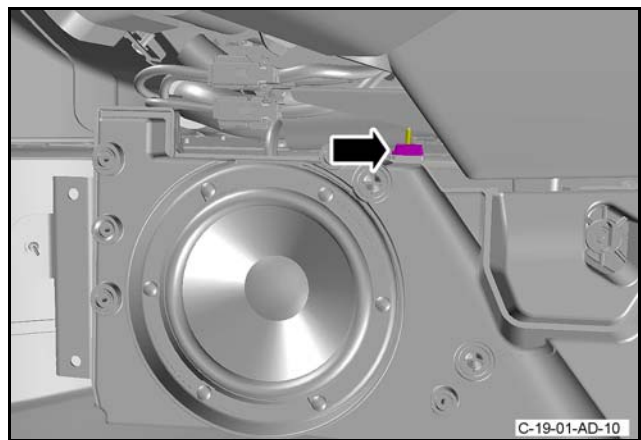
Figure 17

- 35. Connect the electrical connector to the footwell speaker (refer to Figure 17).

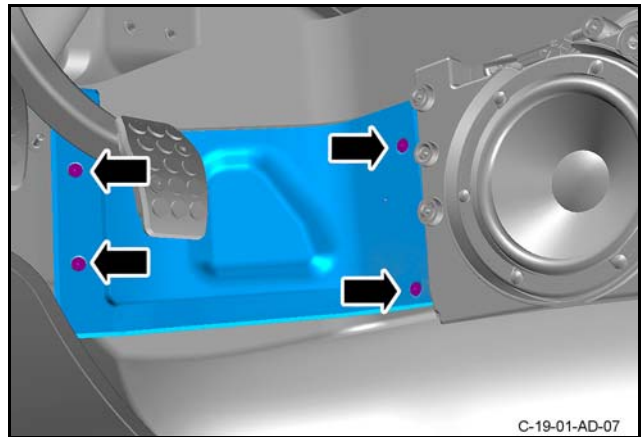
Figure 18

- 36. On all vehicles, put the scuff-plate into position (refer to Figure 18).
- 37. Install and tighten the four screws that attach the scuff-plate.

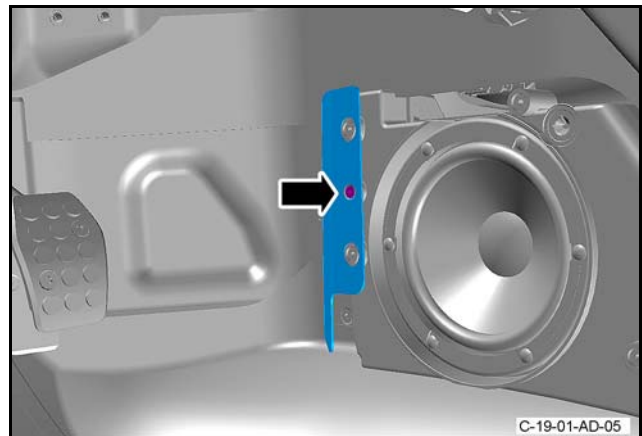
Figure 19

39. Put the bracket in position at the front of the footwell speaker (refer to Figure 19).

40. Install the screw that attaches the bracket to the footwell speaker.

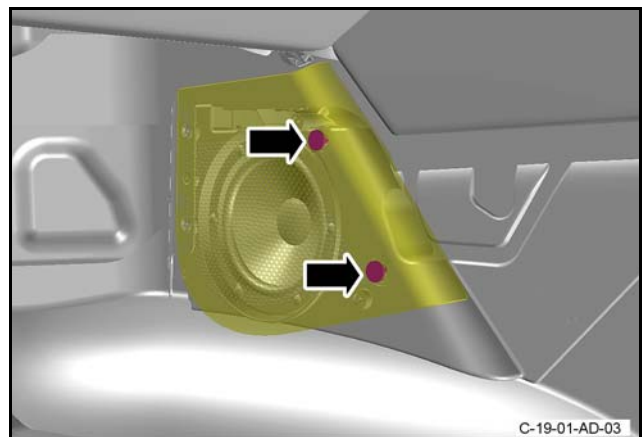
Figure 20

41. Engage the two tabs on the grille for the footwell speaker that attach it to the footwell speaker and attach the grille (refer to Figure 20).

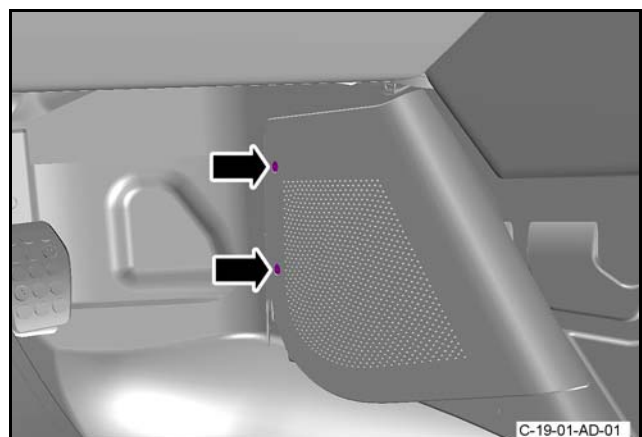
Figure 21

42. Install and tighten the two screws that attach the grille to the footwell speaker (refer to Figure 21).
