# SAFETY RECALL BULLETIN

## NHTSA RECALL 12V-394

AUTOCAR, LLC SAFETY RECALL A-1202

Xpeditor 2008-2012 Seat belt Assembly and Bracket Interference

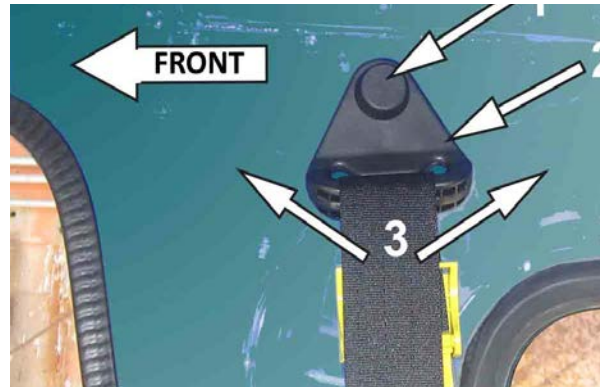
4.1 Remove and discard the bolt cover (See Figure 5 [Item 1]) from the upper seat belt loop guide (See Figure 5 [Item 2]).  
 4.2 Unfasten the captive T-50 bolt (See Figure 6 [Item 1]) and remove the seat belt shoulder loop guide.  
 4.3 Discard the 'Z' tether bracket and the retractor.

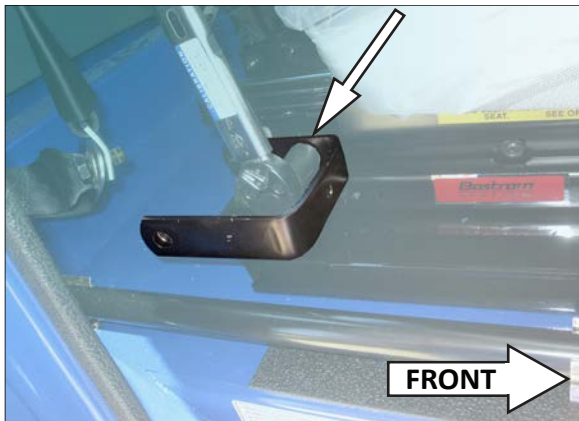
- 6.1 Position the **S5201001-001 'U' Tether Bracket** ('U' bracket) to the seat base with the open side to the rear of the cab (See Figure 8 and Figure 9).
- 6.2 Apply blue thread-locking compound to the (2) **GM410408AJ07-000 Hex Screws** ('8mm hex screws'). Install the 8mm hex screws through the 'U' bracket (See Figure 8 [Item 1 and Item 2]), and torque to 20 Ft-lb (27 Nm) (See Figure 9).

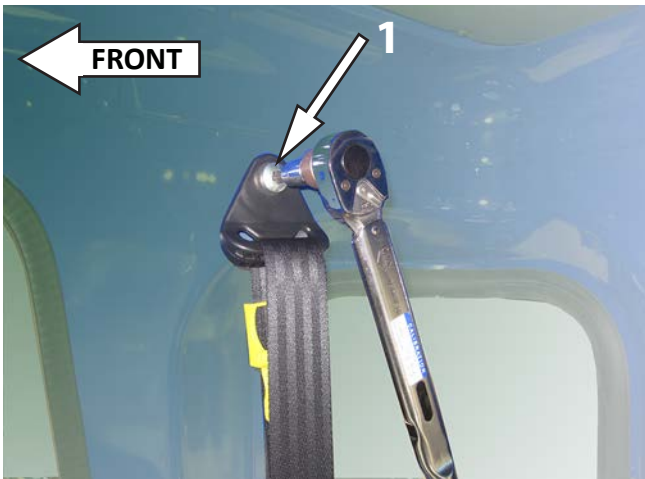
**Figure 13**

- 8.2 The shoulder loop web guide features a captive T-50 bolt (See Figure 13 [Item 1]) which should be started finger-tight, and then torqued to 43 Ft-lb (58 Nm).

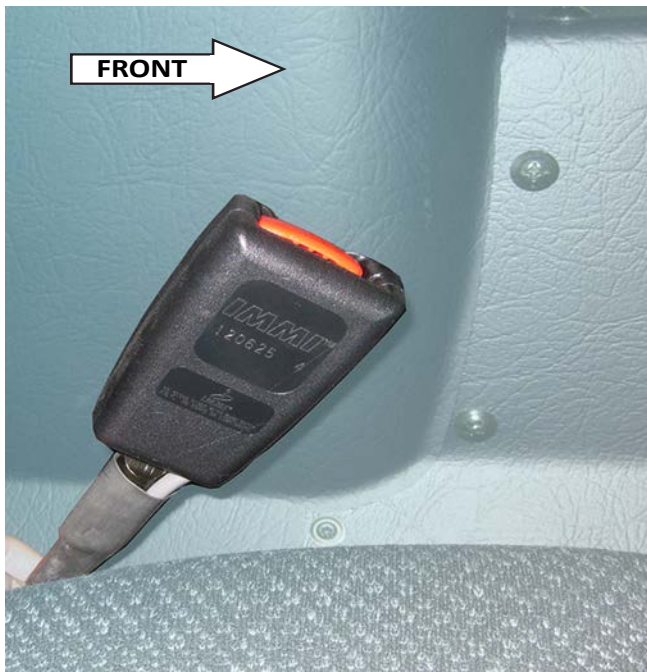
**Figure 19**

- 11.1 Position the inboard seat belt sub-assembly to the seat base. Apply blue thread-locking compound to the two 8mm hex screws. Install the two 8mm hex screws through the 'U' bracket. Secure the hex screws finger-tight, and then torque each to 20 Ft-lb (27 Nm).
- 11.2 Slide the inboard seat belt toward the front, between the vehicle's center console and the seat back adjust handle, so that the seat belt buckle clears the handle (See Figure 2 [Item 9]), and the inboard seat belt is positioned correctly between the right-hand seat and the center console (See Figure 19).

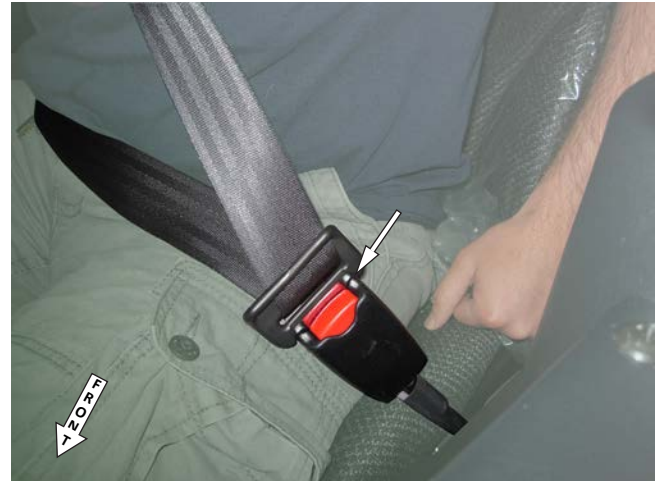
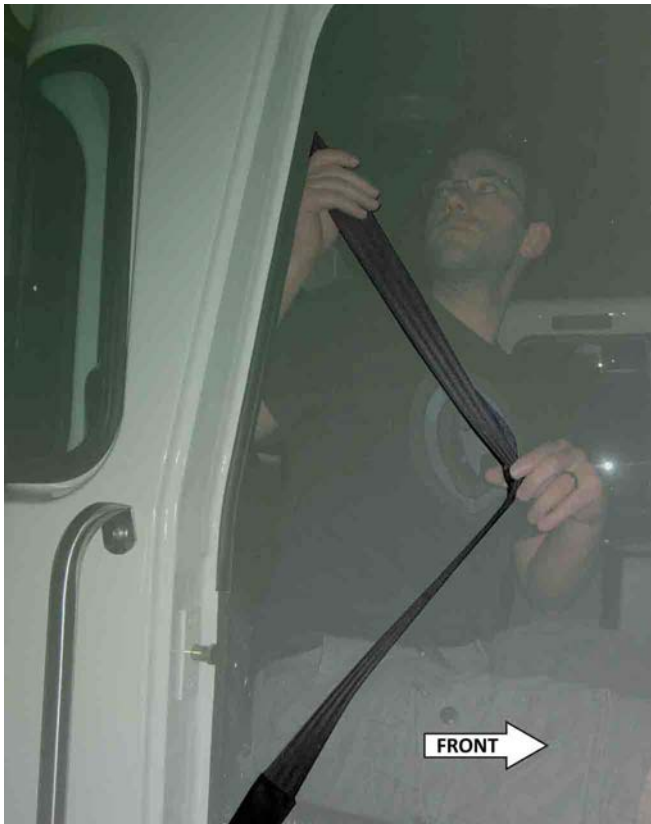
- 16.1 Fully extend the shoulder belt and buckle it (See Figure 25 and Figure 26).
- 16.2 Unbuckle and retract the seat belt to ensure that it functions properly.
- 16.3 If equipped, ensure that the seat belt warning lamp (See Figure 27) on the instrument panel illuminates when the seat belt is unfastened and that the warning lamp extinguishes when the seat belt is buckled (requires the key to be in the ON position).
