Re: Toyota Safety Recall 12V-542 Dealer Notification - Remedy Phase 2

Subject: Safety Recall C0V **Remedy Notification Phase 1 & 2**  
2001 through 2004 Model Year Tacoma Vehicles  
Originally Sold in and/or Currently Registered in the Cold Climate States  
Excessive Corrosion of the Spare Tire Carrier Lift Plate

**C0V - Certain 2001 through 2004 Model Year Toyota Tacoma Vehicles  
Excessive Corrosion of the Spare Tire Carrier Lift Plate  
SAFETY RECALL NOTICE (Remedy Available)**

**SPARE TIRE CARRIER INSPECTION/REPLACEMENT**

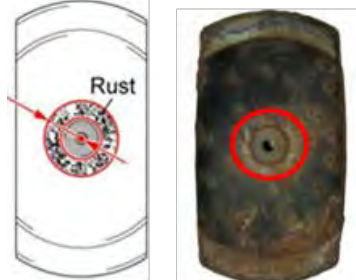
80% Rust Corrosion in Center Area

**REPLACE THE SPARE TIRE CARRIER**

PROCEED TO SPARE TIRE CARRIER REPLACEMENT (Section VI)

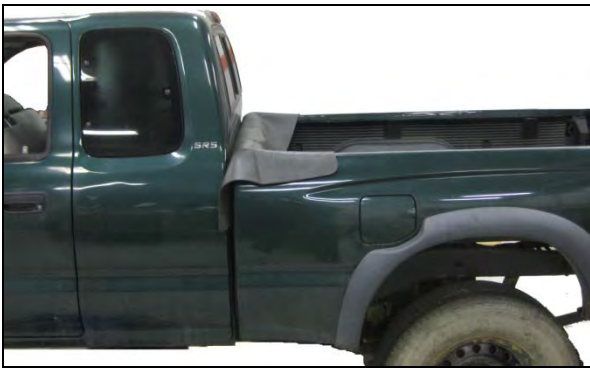
#### 2. PROTECT THE BED AND CAB ASSY

- a) Place a blanket or pair of fender covers between the cab and bed assy to protect the paint.

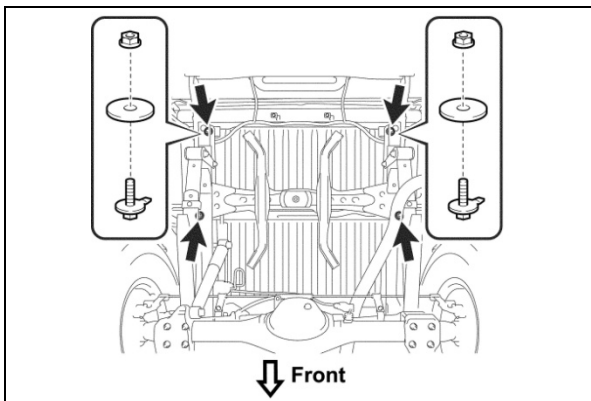
#### 2. MAKE SPACE FOR THE REMOVAL/INSTALLATION OF THE SPARE TIRE CARRIER BOLTS

- a) Remove the 2 bolts, 2 nuts, and 2 washers located on the rearward portion of the bed.

**Note:** it is not necessary to remove the 2 bolts located at the front of the bed.

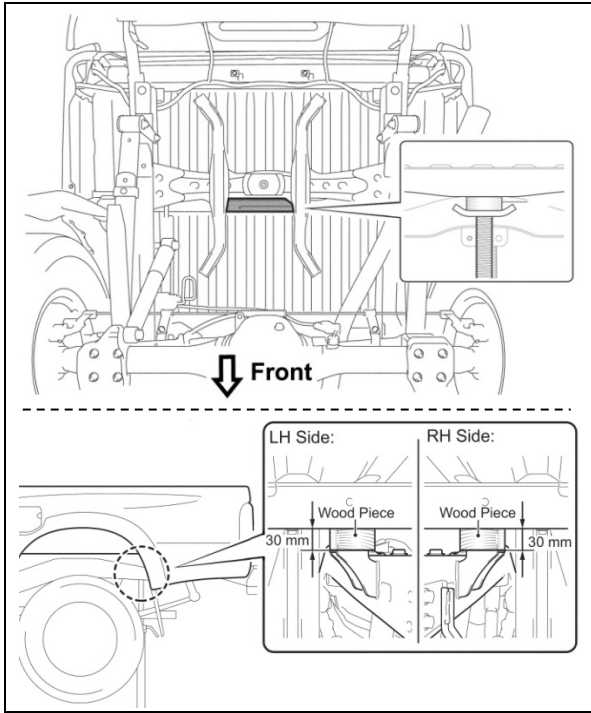
### 3. LIFT THE BED ASSEMBLY

- a) Using a screw jack and a wood block as an intermediary lift the bed carefully by approximately 30mm.

- Be careful not to have your finger pinched.
- Ensure not to pinch the wire harness with the wood/shims.
- Do not lift the bed assy too high; otherwise damage could occur to the wire harness, cab, or bed assy.
