**SUBARU**

## REPAIR PROCEDURE

**APPLICABILITY:** 2009-2012MY Forester  
 2010-2011MY Legacy and Outback  
 2006-2012MY Tribeca

**SUBJECT:** Preliminary Inspection and Repair Procedure  
 for Puddle Light Campaign WQE-41

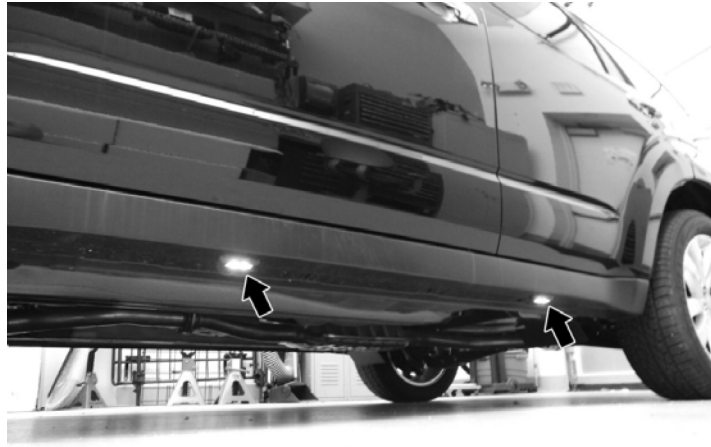
CHECK FOR FUNCTIONING PUDDLE LIGHTS

2. Verify the operation of all 4 puddle lights (2 lights per side, 2 LED bulbs per light). The lights may be activated by opening the driver's door. Inspect both sides at this time.
3. Complete the next steps starting with the driver's side of the vehicle and then repeat on the passenger side. Both sides must be completed for this campaign. All current replacement puddle light harnesses include an in-line mini fuse.

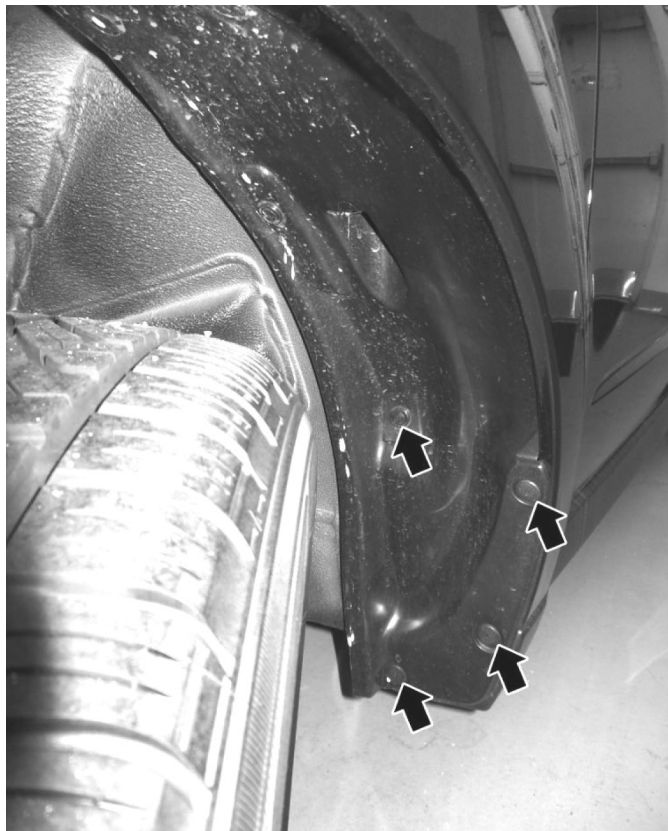
1. Raise the vehicle as necessary to access the inner fender splash shields. Wheel removal is generally not required.
2. Remove the accessory splash guard (if equipped) and the retaining clips at the rear portion of the front wheel opening. Move just enough of the splash shield to expose the puddle light wiring and body harness connectors

- A Forester is shown in the photo on pg. 4 for illustration only.
- Splash guard removal may also be required for access to the splash shield retaining clips.
- Retaining clip locations will vary by model.
- See **Appendix B** for samples of retaining clip locations by model.
- The photos below show a puddle light harness without the in-line mini-fuse on the left and the current replacement harness with the in-line mini-fuse on the right.

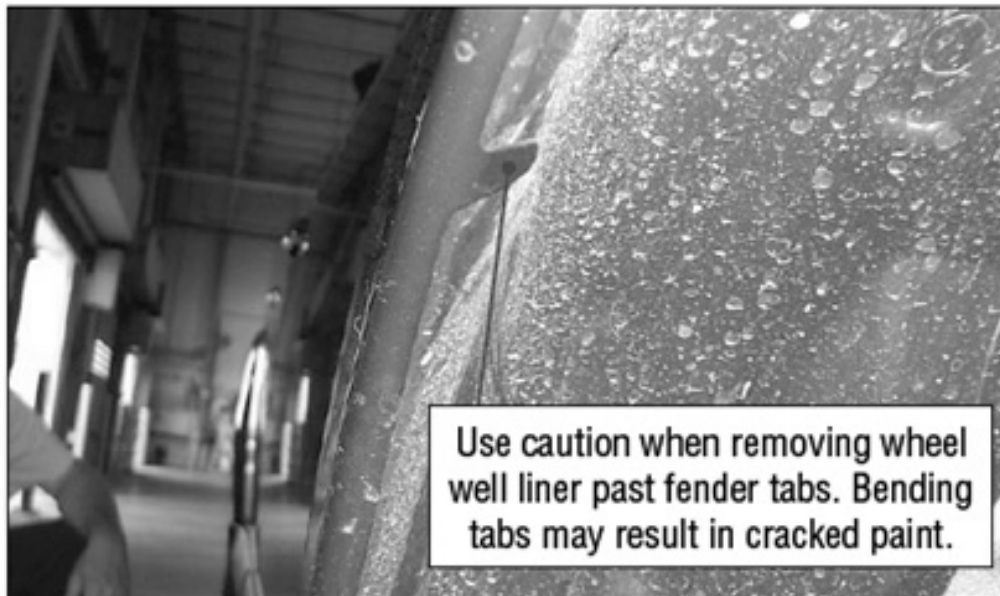
On Legacy, Outback and Forester models, locate the two metal tabs along the inside edge of the front fender. Use caution and support these small painted fender tabs inside the wheel arch when removing the splash shield. These tabs are painted body color and cracking of the paint is likely if the tabs are bent. Place one hand on the tab to secure it while pushing the splash shield up and over the tab with your other hand. Use the same method when you reinstall the splash shield. Touch-up any damaged tabs to minimize any future possibility of rust.

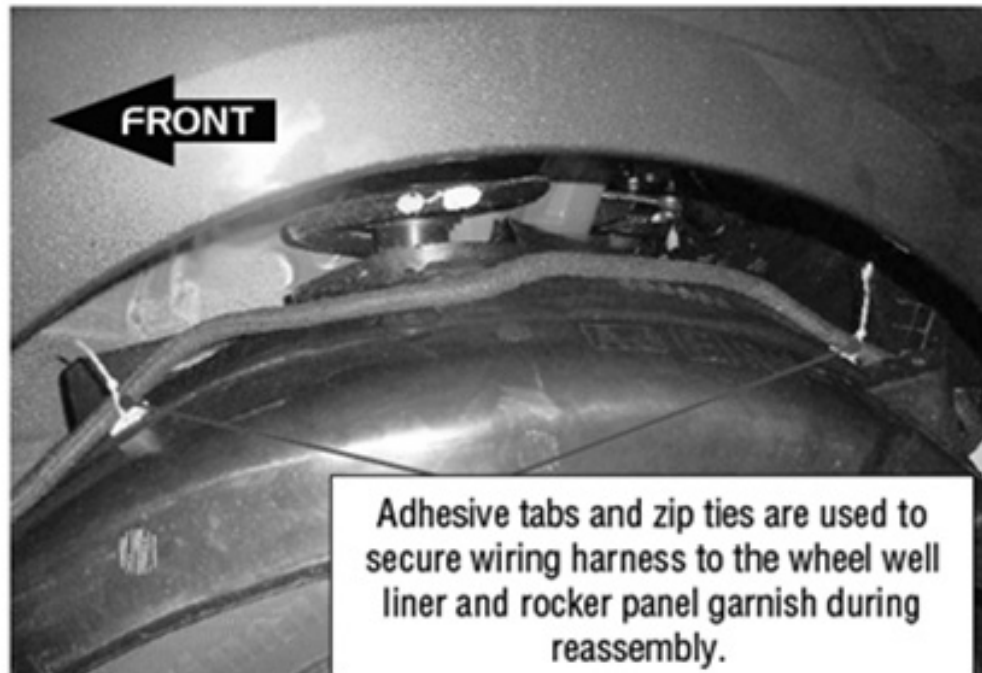
- On Legacy and Outback models, use caution when moving the splash shield as the body harness for the puddle lights is secured to it at two points as shown below. It is not required to drop the entire splash shield. Simply move enough of the shield to gain access to the connection which is located at the rear of the wheel opening. This information and photo are provided as a reference only.

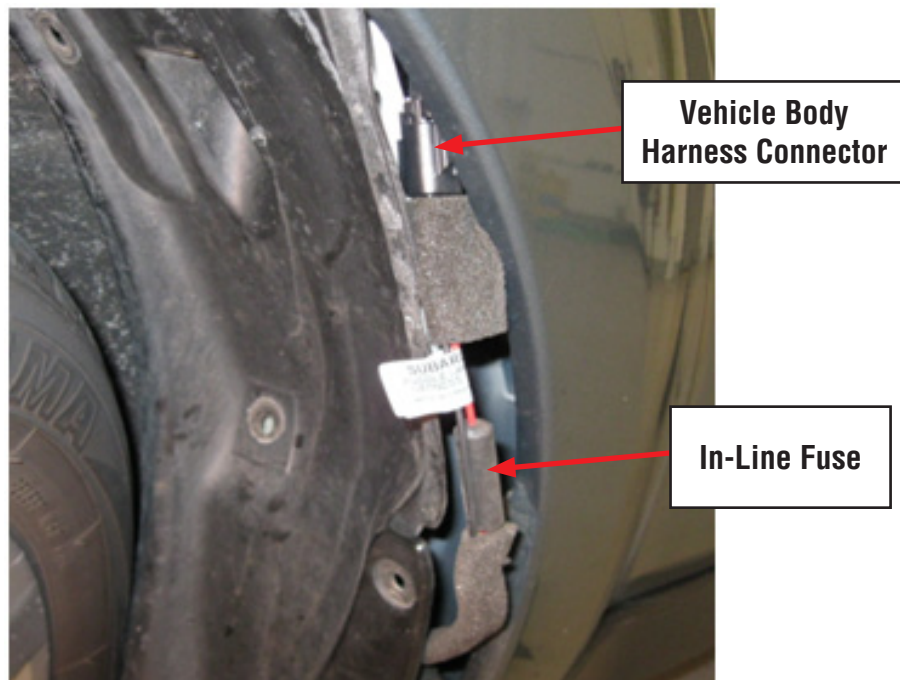
3. Once the splash shield has been moved enough for access, inspect the puddle light harnesses.
  - a. If the vehicle already has an in-line fuse in the red power wire within a few inches of the vehicle connector as shown in the photo below and both lights (all 4 LED bulbs) operate, no further action is required on that side.

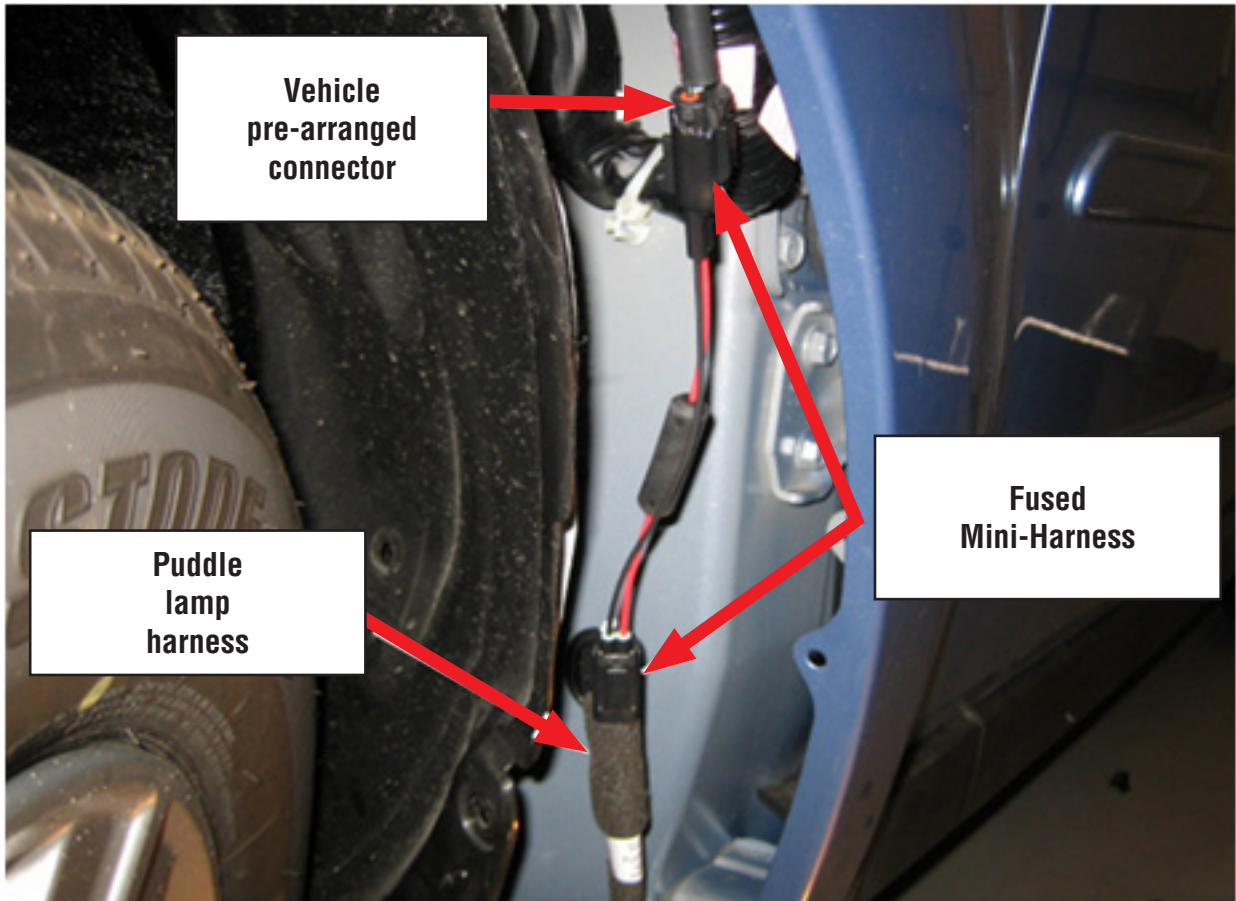
- b. Proceed to check the other side of the vehicle starting again at Step 2. Once inspection of both sides of the vehicle is complete, proceed to Step 5.
- c. If no in-line fuse or Fused Mini-Harness is present, unplug the puddle light harness connector from the vehicle body harness connector and install the Fused Mini-Harness as shown in the reference photos below.

Route the completed harness behind the splash shield. Use electrical tape to secure any excess harness out of the way avoiding any areas where it may be exposed to sharp edges or become pinched. **Do not reassemble yet.** Once both sides of the vehicle have been completed, proceed to the next step.

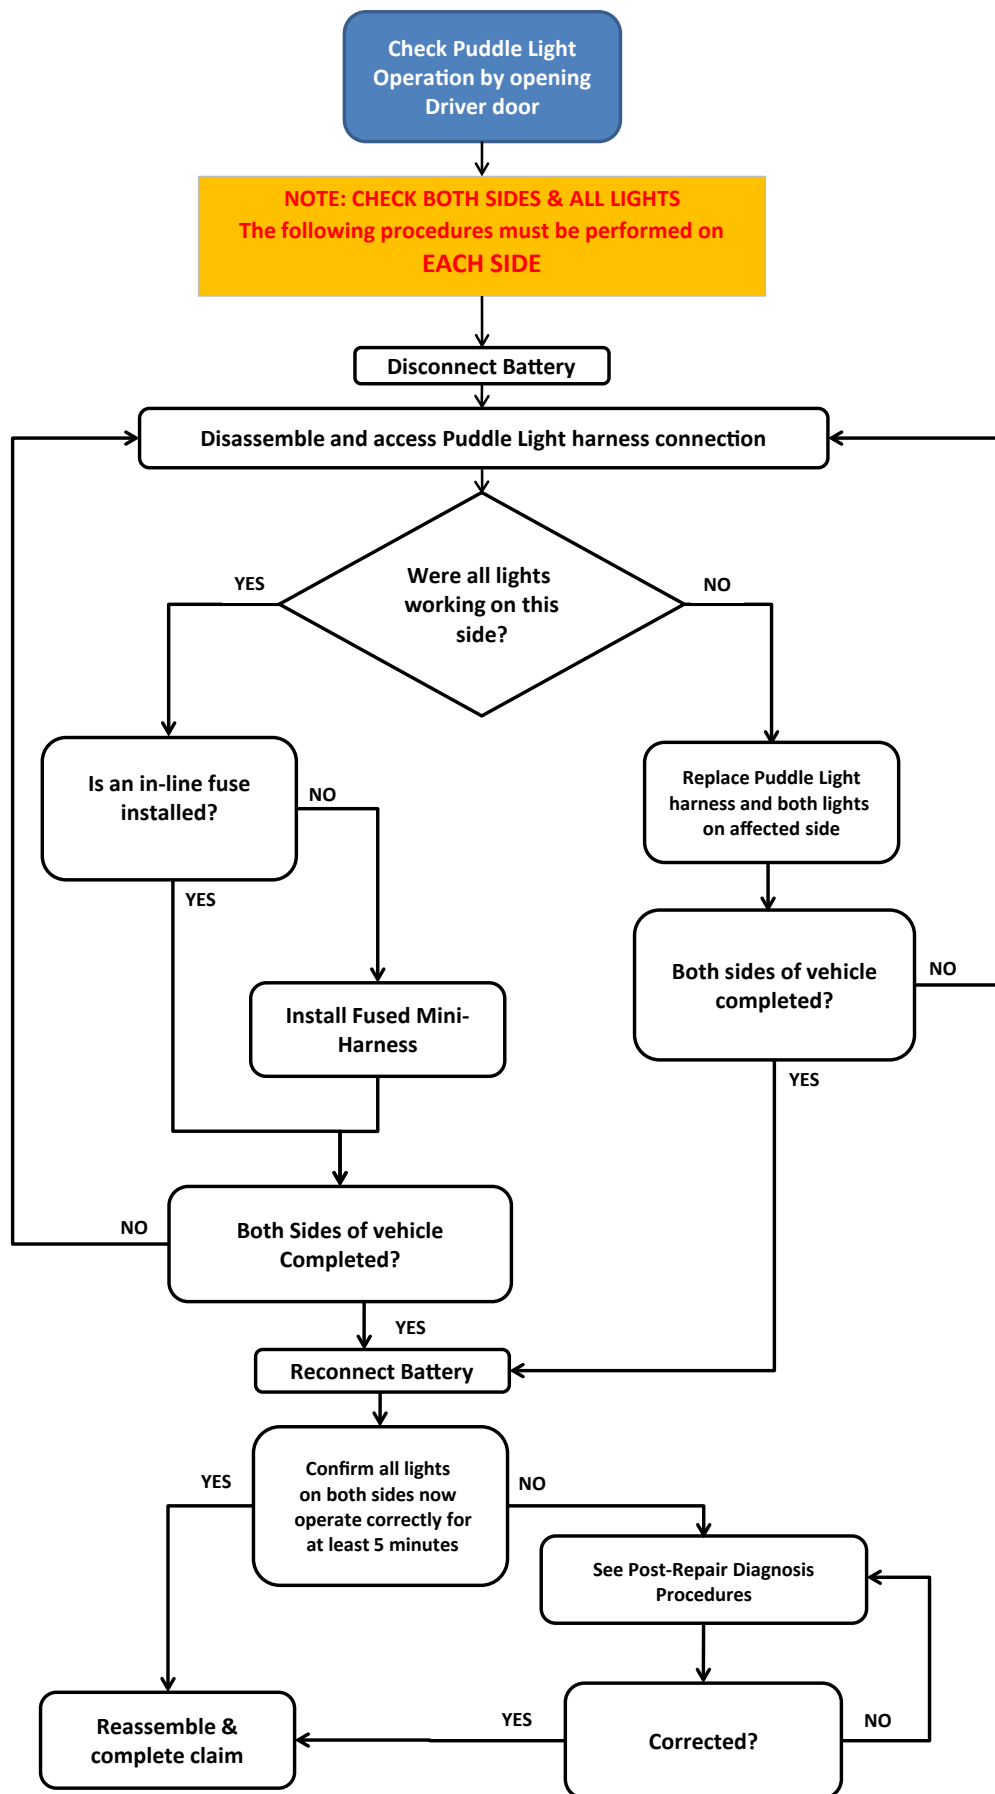
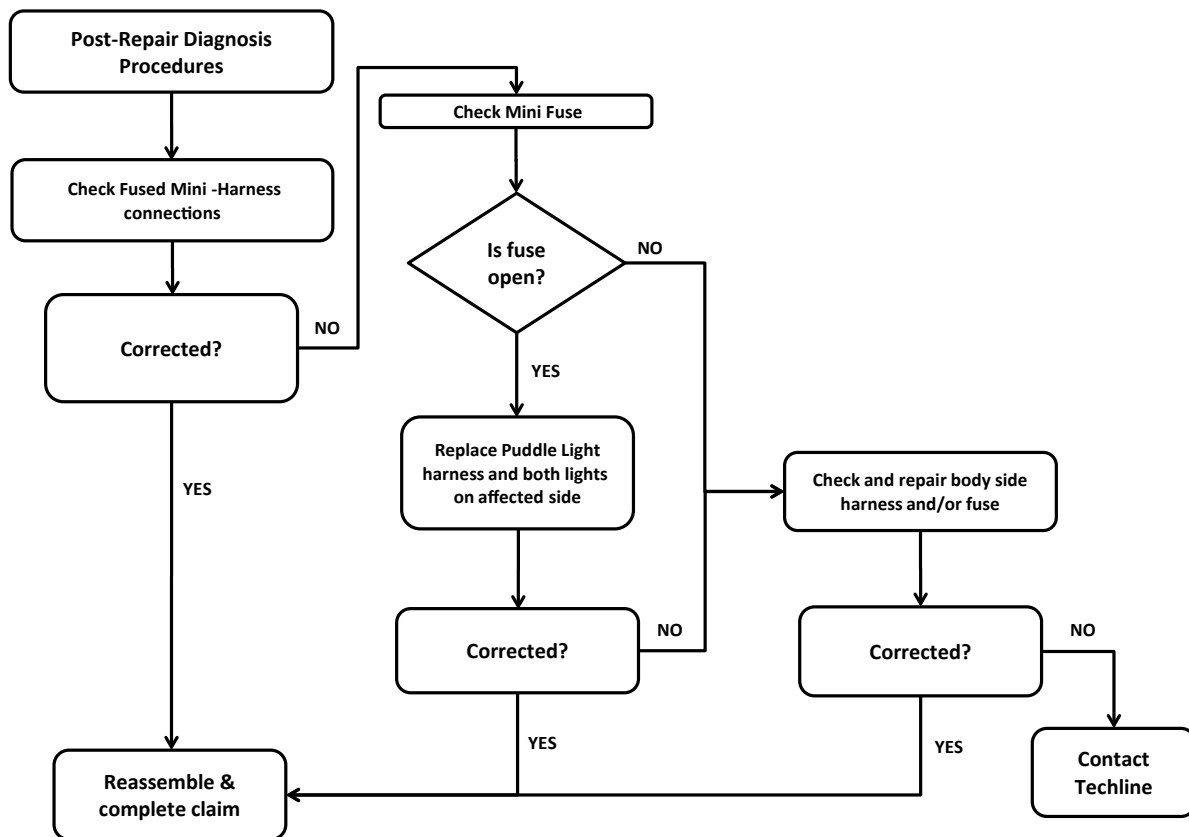
## Appendix C - Summary and Post-Repair Flow Charts

- See **Appendix C** for a summary flow chart of the following procedure. Be sure to follow the detailed written procedure below in its entirety. The flow chart only provides a summary. In addition, a Post-Repair Diagnosis flow chart is provided for reference if needed.
  - Read through and understand this complete procedure before beginning any repairs.
1. **Confirm the vehicle is equipped with optional Genuine Subaru puddle lights.** If the vehicle is not equipped, no correction is required. Return the vehicle to the Customer.

4. After completing installation of the Fused Mini-Harness on both sides of the vehicle, reconnect the battery and confirm that all the puddle lights operate normally by leaving the driver's door open with the puddle lights on for at least 5 minutes.
  - a. If any of the lights fail to operate as designed, review all connections to ensure they are secure.
  - b. If the mini-fuse in the Fused Mini-Harness or puddle light harness has become open, replace the puddle light harness and both lights on that side of the vehicle. Refer to applicable accessory installation guide for detailed instructions for harness and light installation. **NOTE:** All current replacement puddle light harnesses include an in-line fuse. In this case, installation of the Fused Mini-Harness would not be required.
  - c. If not resolved, by a and / or b, see the Post-Repair Diagnostic Flow Chart in **Appendix C**.
