**SUBARU**

## PRODUCT CAMPAIGN BULLETIN

**NUMBER:** WQE-41  
**DATE:** February 2013

**SUBJECT:** Optional Genuine Subaru Puddle Lights

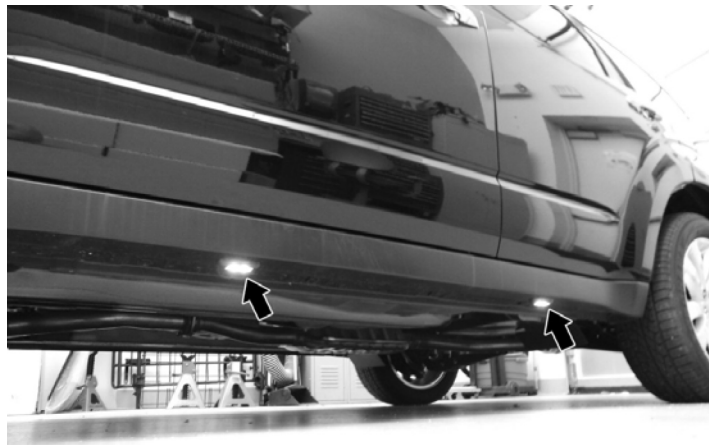
CHECK FOR FUNCTIONING PUDDLE LIGHTS

If the vehicle **IS** equipped with Genuine Subaru puddle lights:

2. Verify the operation of all 4 puddle lights (2 lights per side, 2 LED bulbs per light). The lights may be activated by opening the driver's door. Inspect both sides at this time.
3. Complete the next steps starting with the driver's side of the vehicle and then repeat on the passenger side. Both sides must be completed for this campaign. All current replacement puddle light harnesses include an in-line mini fuse.

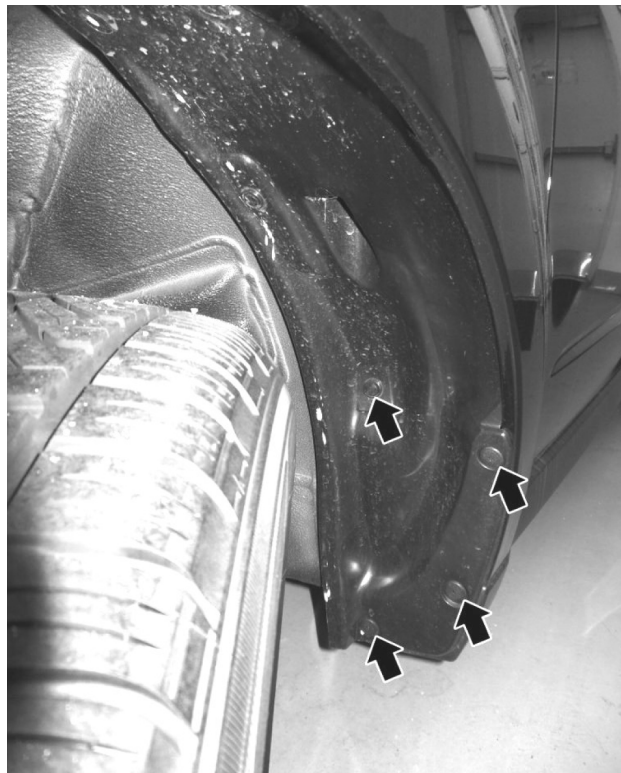
1. Raise the vehicle as necessary to access the inner fender splash shields. Wheel removal is generally not required.
2. Remove the accessory splash guard (if equipped) and the retaining clips at the rear portion of the front wheel opening. Move just enough of the splash shield to expose the puddle light wiring and body harness connectors

- A Forester is shown in the photo on pg. 4 for illustration only.
- Splash guard removal may also be required for access to the splash shield retaining clips.
- Retaining clip locations will vary by model.
- See **Appendix B** for samples of retaining clip locations by model.
- The photos below show a puddle light harness **without** the in-line fuse on the left and the current replacement harness **with** the in-line fuse on the right.

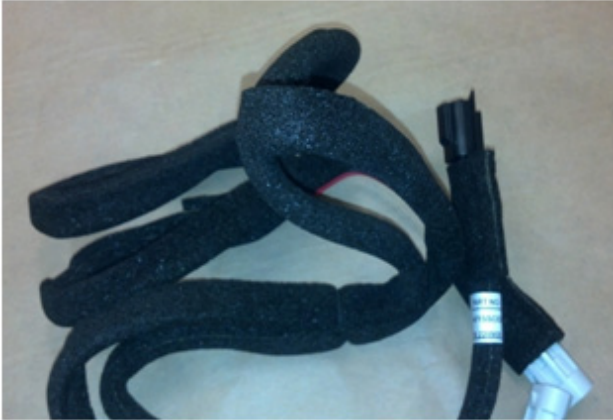
**No in-line fuse installed**

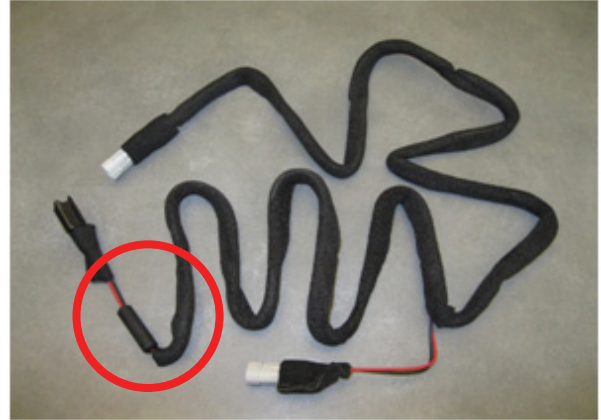
**With in-line fuse installed**

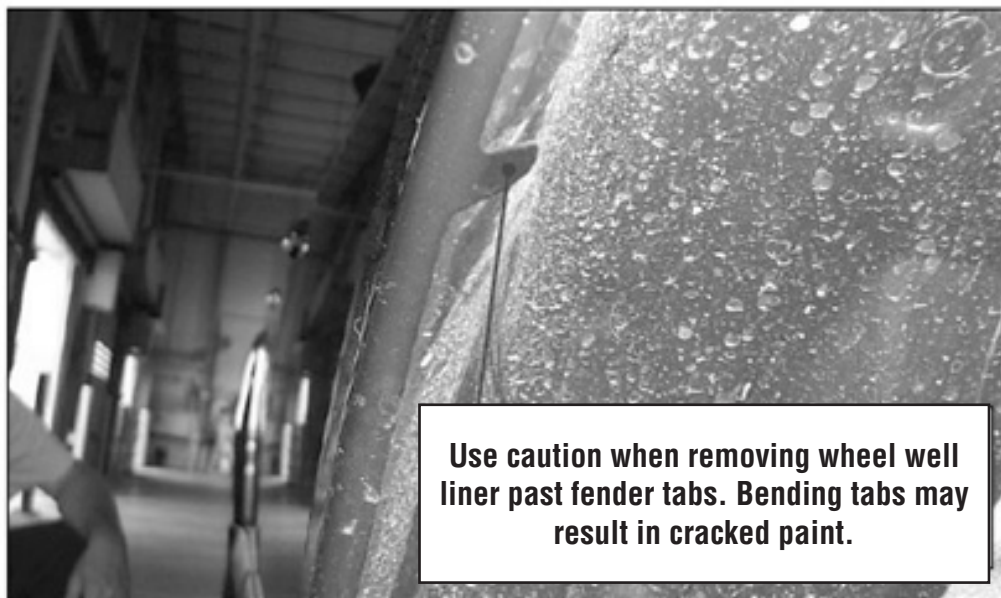
On Legacy, Outback and Forester models, locate the two metal tabs along the inside edge of the front fender. Use caution and support these small painted fender tabs inside the wheel arch when removing the splash shield. These tabs are painted body color and cracking of the paint is likely if the tabs are bent. Place one hand on the tab to secure it while pushing the splash shield up and over the tab with your other hand. Use the same method when you reinstall the splash shield. Touch-up any damaged tabs to minimize any future possibility of rust.

**Use caution when removing wheel well liner past fender tabs. Bending tabs may result in cracked paint.**

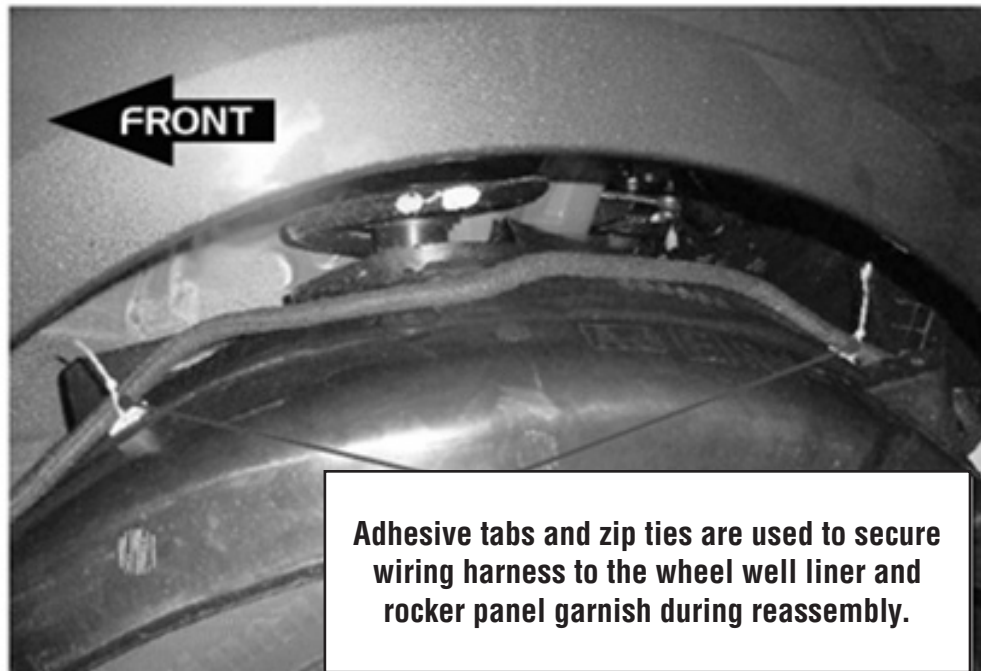
- On Legacy and Outback models, use caution when moving the splash shield as the body harness for the puddle lights is secured to it at two points as shown below. It is not required to drop the entire splash shield. Simply move enough of the shield to gain access to the connection which is located at the rear of the wheel opening. This information and photo are provided as a reference only.

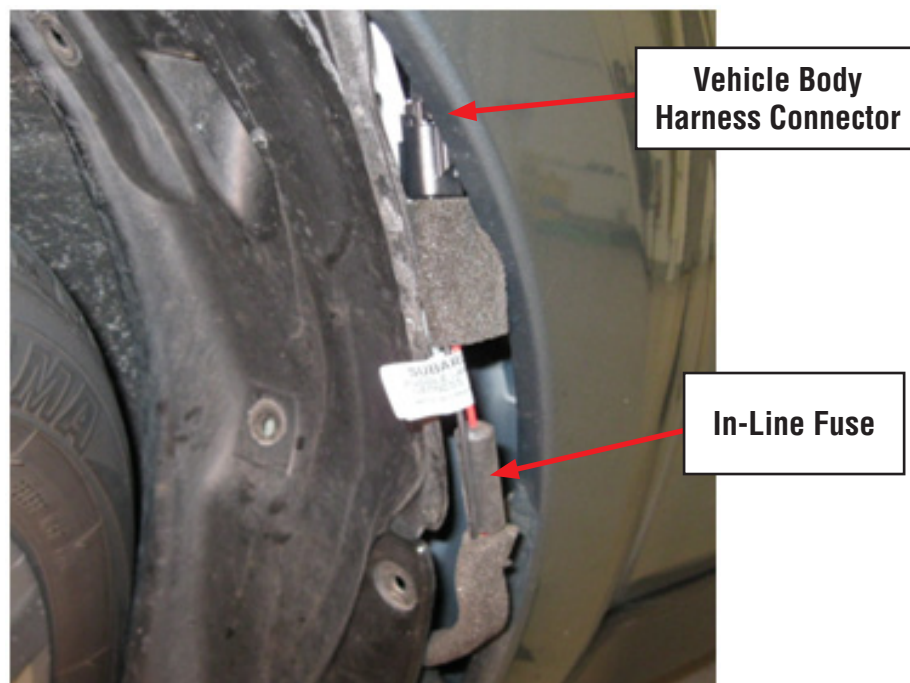
3. Once the splash shield has been moved enough for access, inspect the puddle light harnesses.
  - a. If the vehicle already has an in-line fuse in the red power wire within a few inches of the vehicle connector as shown in the photo below or a Fused Mini-Harness as shown in the photo on pg. 7 and both lights (all 4 LED bulbs) operate, no further action is required on that side.

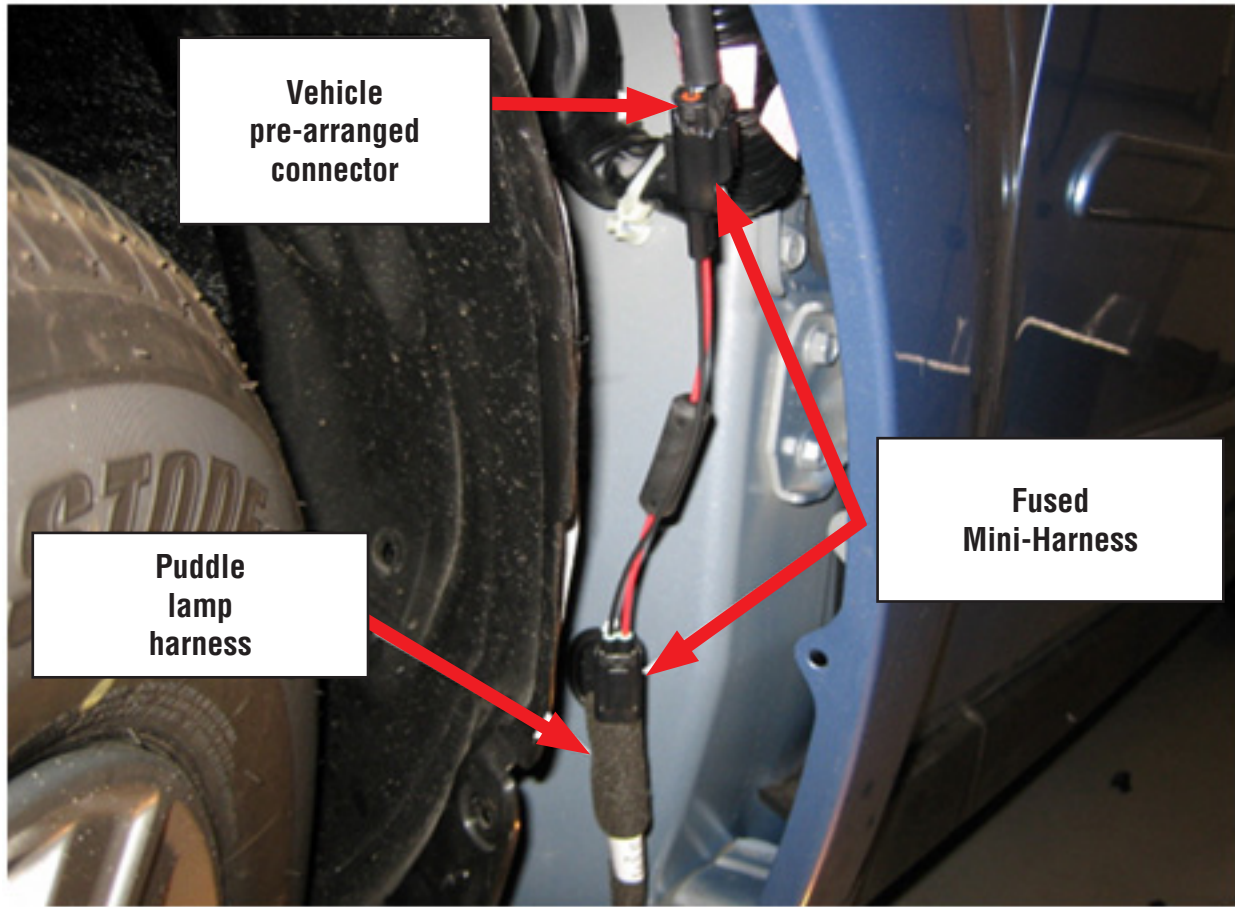
**Fused Mini-Harness**

- b. Next, check the other side of the vehicle starting again at Step 2. Once inspection of both sides of the vehicle is complete and fuses are confirmed to be on **BOTH** sides of the vehicle, proceed to Step 5, otherwise see “c” below.
- c. If no in-line fuse or Fused Mini-Harness is present, unplug the puddle light harness connector from the vehicle body harness connector and install the Fused Mini-Harness as shown in the reference photos below.

Route the completed harness behind the splash shield. Use electrical tape to secure any excess harness out of the way avoiding any areas where it may be exposed to sharp edges or become pinched. **Do not reassemble yet.** Once both sides of the vehicle have been completed, proceed to the next step.
