September 2012

#### **PREVOST SAFETY RECALL CAMPAIGN SR12-57: Emergency Exit Window"**

## ADDITION OF AN EMERGENCY EXIT WINDOW 9700 (B13R)

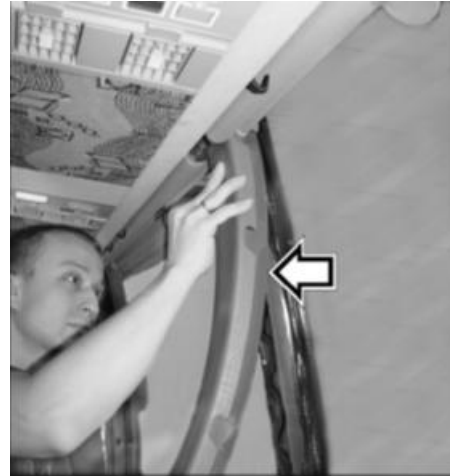
2.

Remove the moldings around the windows inside the bus

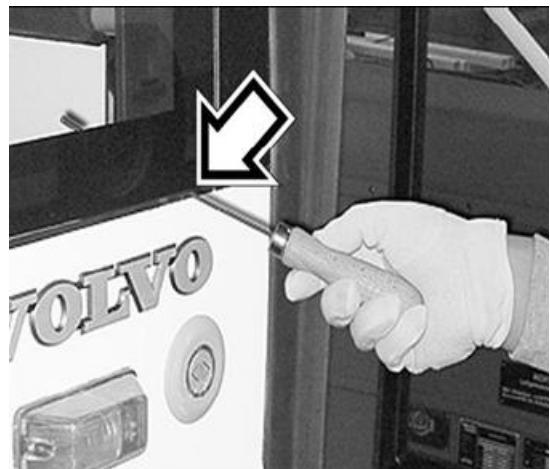
7.

Insert an awl into the split.

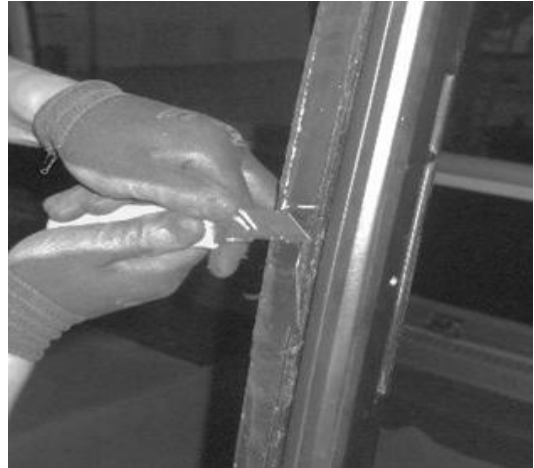
## 11.

Clean and remove the remaining old glue from the frame.

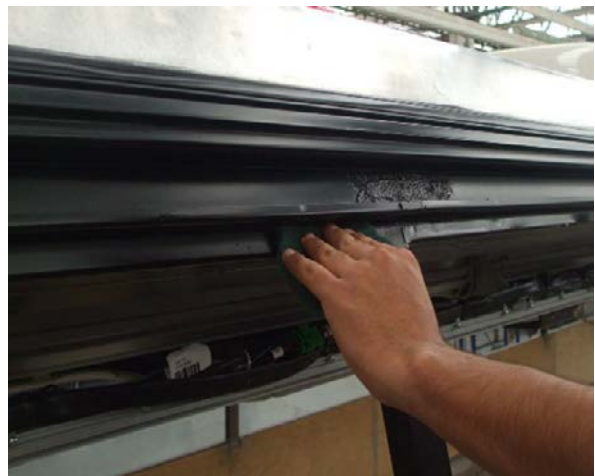
### 13.

On the bus frame, scour around the frame surface with a heavy duty scour pad to promote adhesion. To apply Sika Aktivator **683661**; substrate must be clean, dry, free of oil and grease; thoroughly remove all loose particles and residues.

Wipe bond face with a clean, lint-free cloth moistened with Sika Aktivator. Apply sparingly, wiping once only. Wipe off with a clean dry cloth or paper towel.

Allow to dry 10 minutes but not more than two hours before applying adhesive. If adhesive cannot be applied within two hours of priming, repeat application.

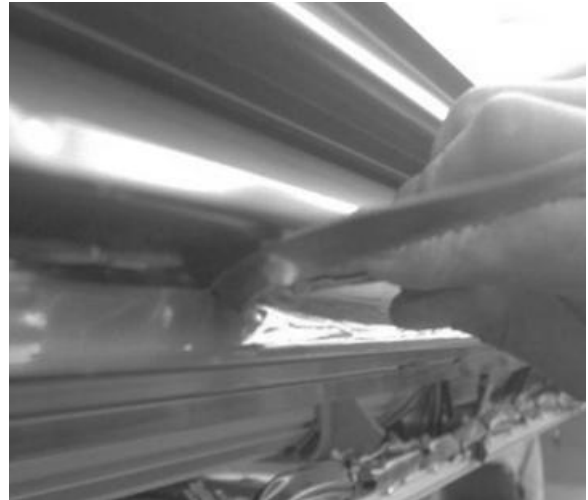
## 14.

Stick double sided tape **20844257** in the upper edge frame (only).

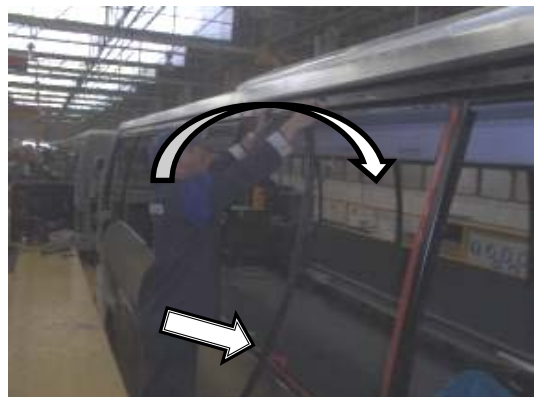
## 15.

Remove the protective layer and stick the rubber molding **21289374** all around the inner edge of the frame for emergency window.

Start at the middle of the bottom edge of the window's frame, radius at the corners as small and smooth as possible, check the good adhesion of the rubber molding. Cut the molding to join with the star end of the molding, glue the butt joint with cyanoacrylate adhesive.

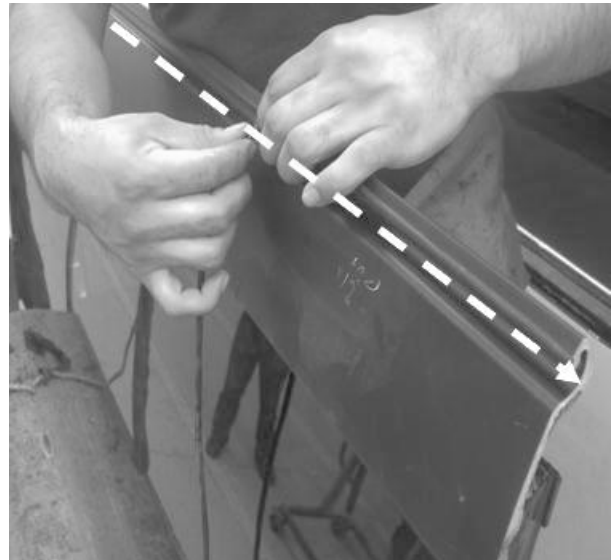
17.

Install the Insulating bushing **20707763** on the upper round edge of the aluminum molding of the emergency window, as is shown in the image.

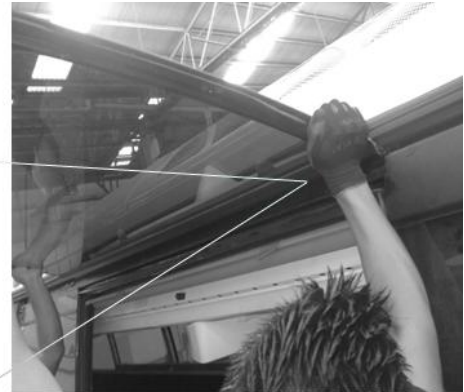
**18.**

Insert the new emergency window assembly into the upper aluminum molding of the bus.

For this step 2 people are needed.

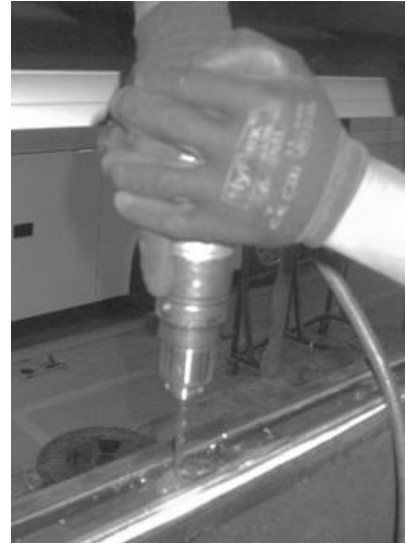
22.

Once the window is closed and aligned, open completely the emergency window mechanism and find the lock pin **21320062** final position in one side, mark the position of the holes for the both screws to fit the lock pin; do the same for opposite side.

Open emergency window, hold open the emergency window and drill four **5mm** holes.

**Note:** Use a center punch to avoid drill walk and result in an inaccurate hole position.

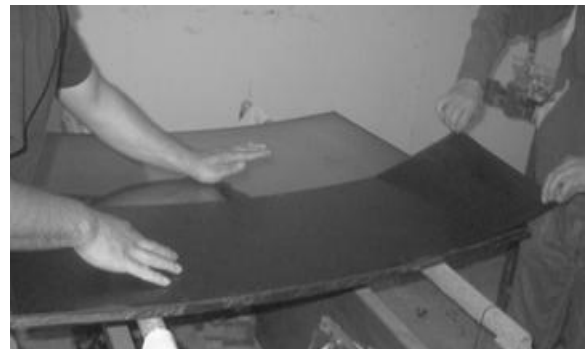
24.

Before installing the next window Remove all traces of old glue and clean perfectly, remove the black adhesive layer.

Install a new strip of black adhesive layer **70364951**, place at the same position than old one. See images

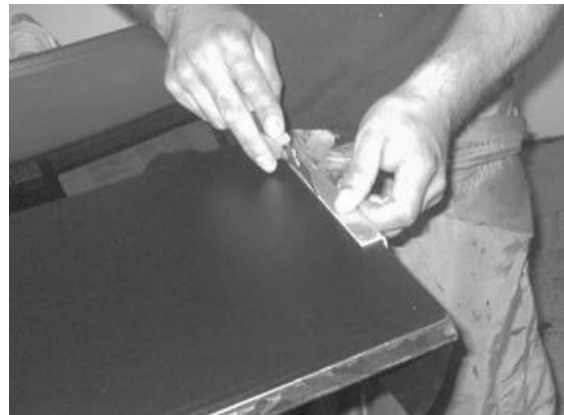
25.

All around the window pane cut the Adhesive Layer 1". We recommended using an L profile as shown in the images.

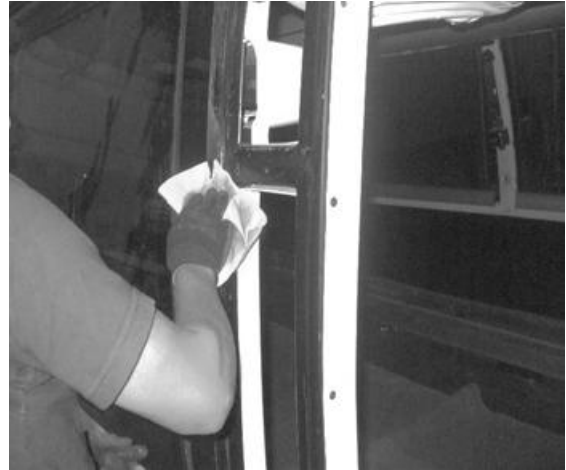
27.

Apply Sika Aktivator to the entire surface of window frame following the instructions in the previous step.

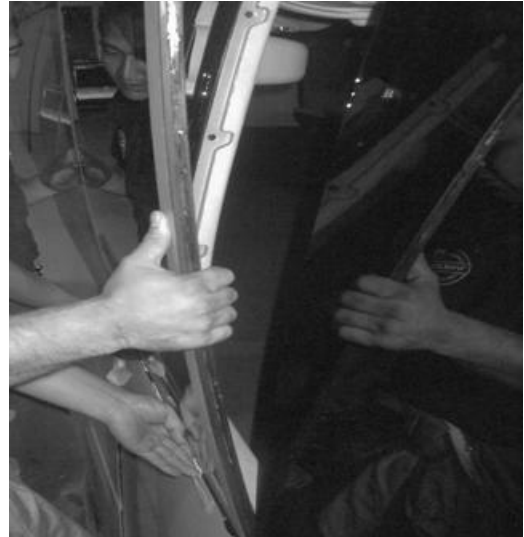
30.

Install the window pane in position

**Note:** Check that the window pane is in the same level and aligned with the rest of window panes.

**Note:** Be sure to set first the lower side of window pane.

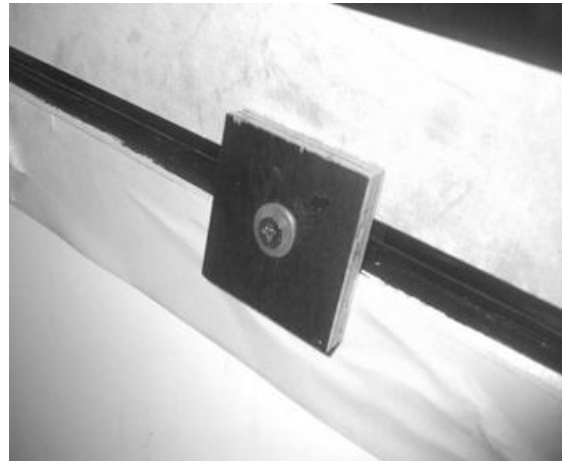
31.

Put some pieces of wood to hold the side window pane (and adjust it) in its position. Use self-drilling screws, 45 mm length.

**Note:** Before filling the joint gap let the sealer dry at least **\*\*24\*\*** hours.

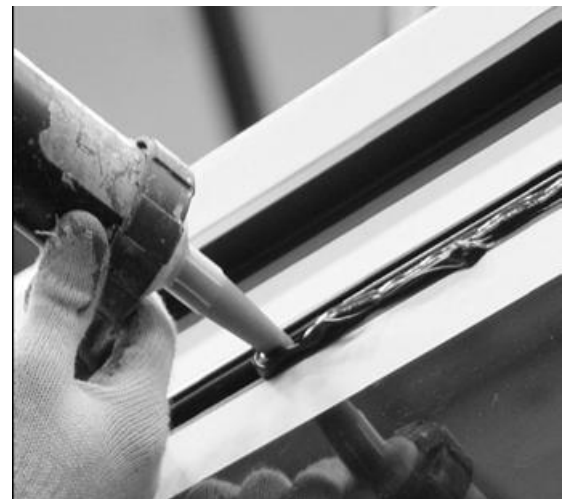
32.

After 24 hours, remove pieces of wood and seal the joint gap. To seal the emergency window side open the emergency window and put black sealant **8714348** along the interior window edge.

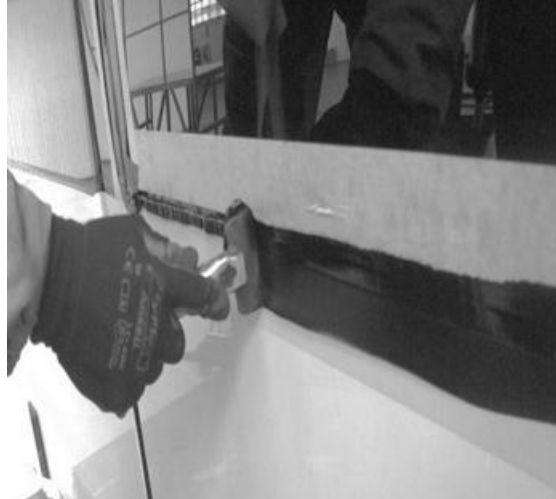
**33.**

Remove adhesive **8714348** excess using a rubber scraper and apply soapy water to obtain a good smooth finishing.

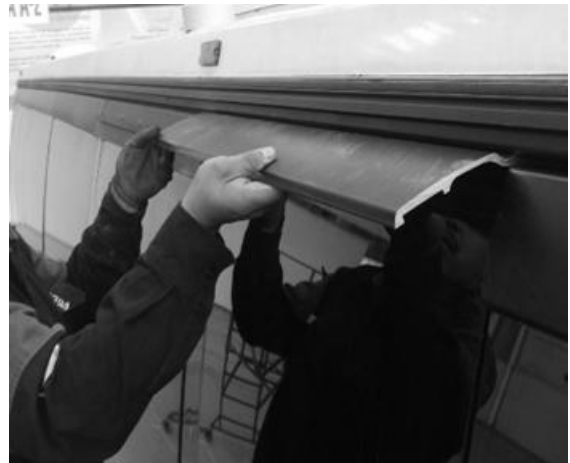
**34.**

Install the upper window molding. Use the molding removed at the beginning and cut it according to the window width. To cut use a cut off tool.

**Note:** Use the molding previously removed and cut to fit window pane size.

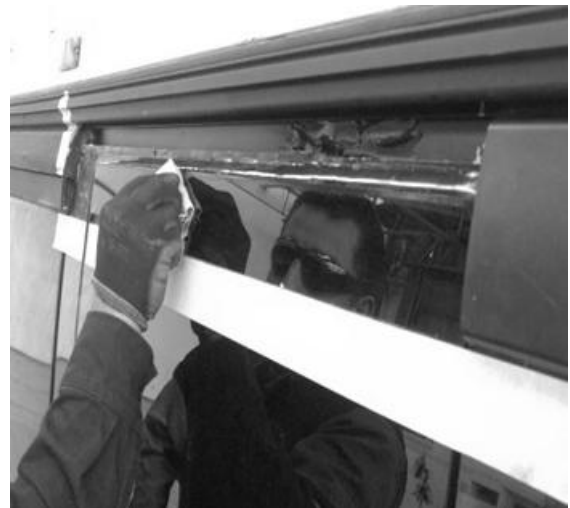
**35.**

Remove dirt and dust from window surface by cleaning with Sika Cleaner. Allow 10 minutes to dry, no more than 2 hours, apply Sika Aktivator. If Aktivator cannot be applied within 2 hours repeat application.

Wipe bond face with a clean, lint-free cloth moistened with Sika Aktivator. Apply sparingly, wiping once only. Wipe off with a clean dry cloth or paper towel.

Allow 10 minutes to dry but not more than 30 minutes before applying adhesive. If adhesive cannot be applied within 30 minutes of priming, repeat application.

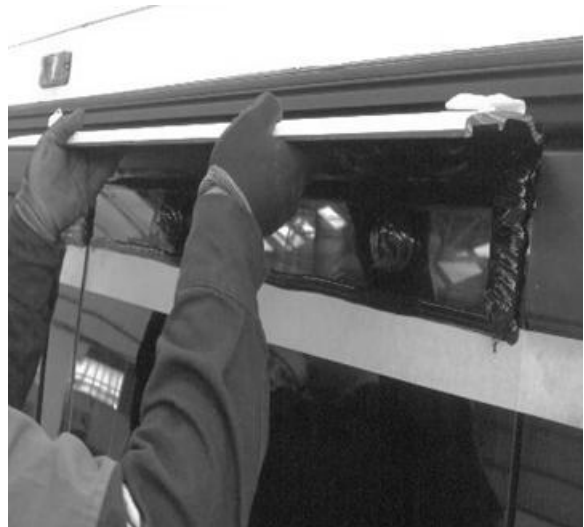
**37.**

Before installing the molding, protect the window and molding all around with masking tape (3").

Install the molding.

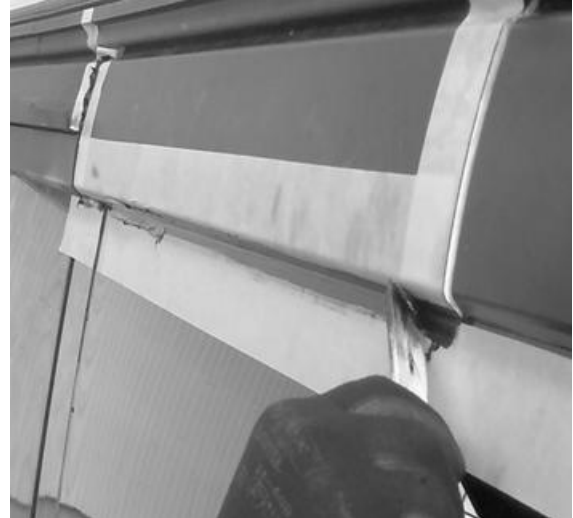
**38.**

Remove the remaining adhesive **8714348** and apply soapy water to obtain a good smooth finish.

**Note:** Ensure the moulding gaps are cleaned of any remaining adhesive.

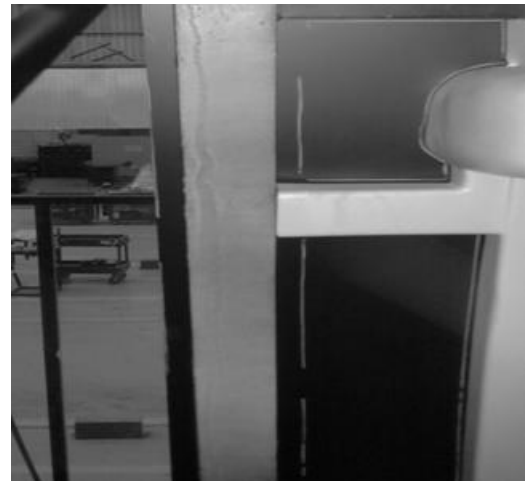
**39.**

Once the window pane has been installed go to the bus interior, mark window perimeter and cut the Adhesive Layer Black strap, use a ruler.

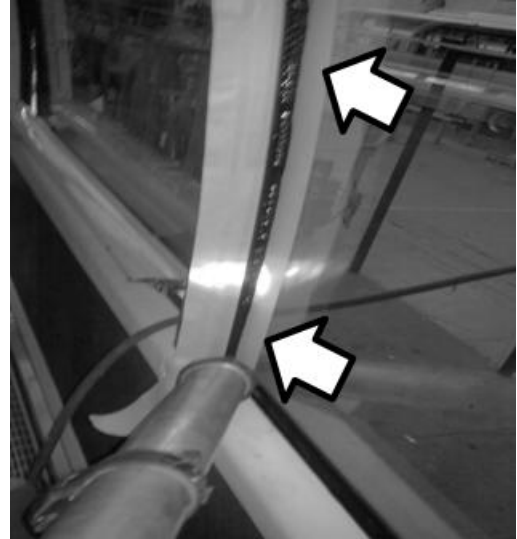
40.

Seal the side window pane (interior side), then apply soapy water to obtain a good smooth finish. Remove the adhesive tape.

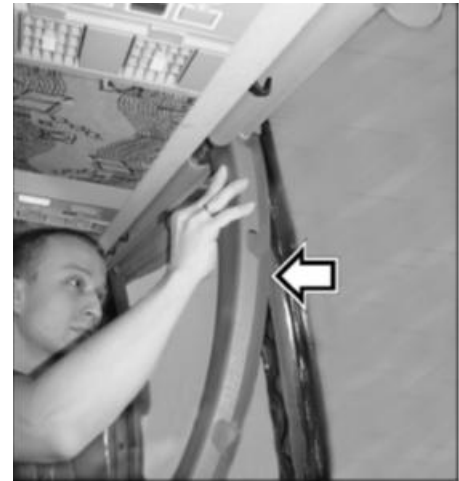
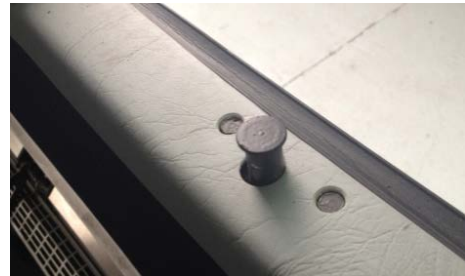
42.

Install all moldings removed inside the bus.

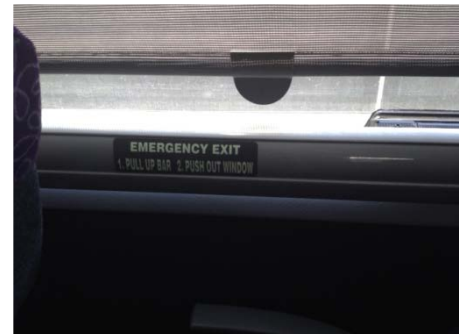
43.

Place a decal **21655877** 13 3/8" from each end of the pull bar.

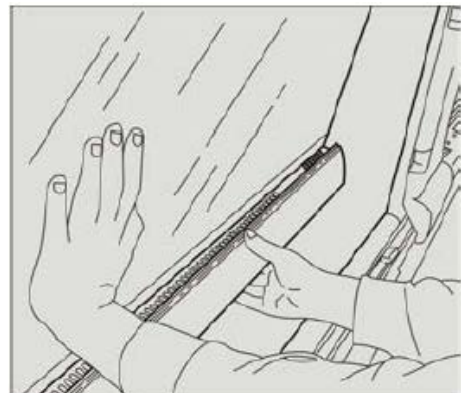
44.

Check the emergency window for proper operation. Lift the window release bar push the window open from the bottom. To close, lift the release bar and pull the window into position. Push down on release bar to lock the window shut.

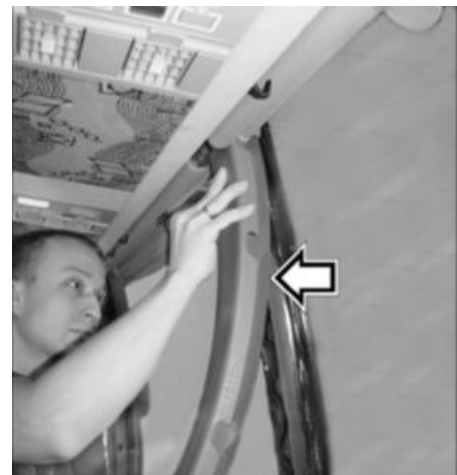
1.

Remove the interior right side moulding in column D.

Be sure not to damage the moulding.

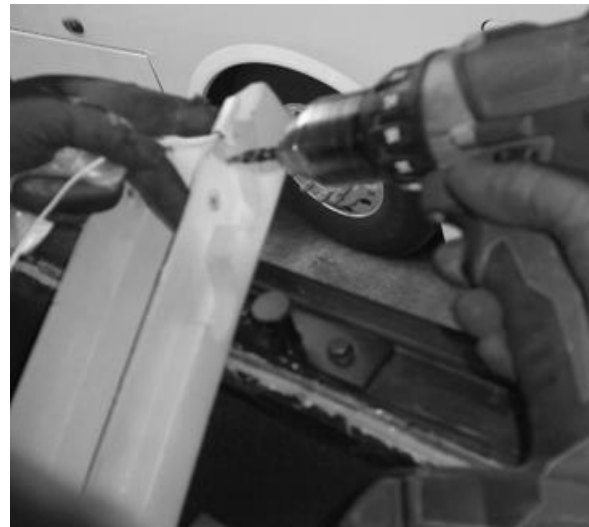
3.

Drill the moulding. Use 1/8" (3mm) drill bit.

Be sure to use low speed to drill the moulding.

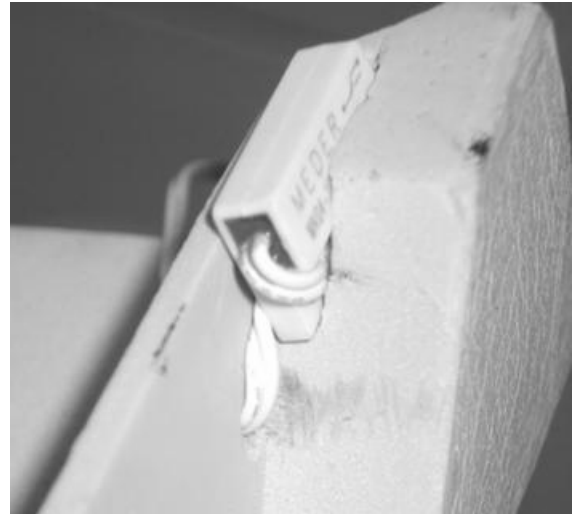
4.

Set the sensor **21721793** in the notch. Remove additional material if needed. Pass the cable through the holes as shown in image.

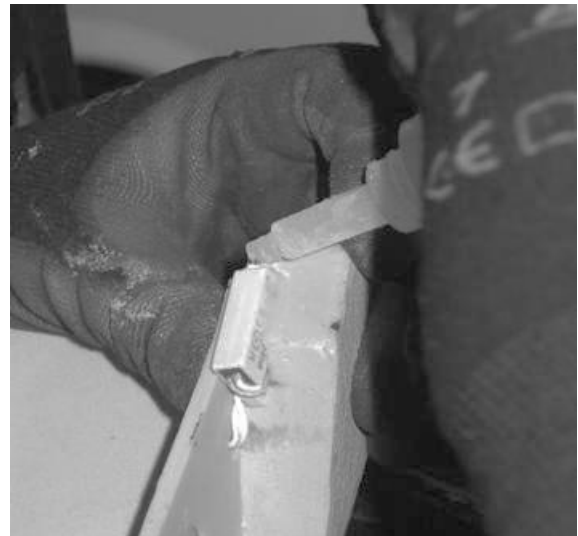
5.

Set the sensor **21721793** in position according the image and secure with glue.

Use a mix of Loctite 404 or other cyanoacrylate adhesive and sodium bicarbonate (baking soda) as a gap filler compound.

First apply a layer of cyanoacrylate adhesive, sprinkle with sodium bicarbonate, and then apply a new layer of cyanoacrylate adhesive.

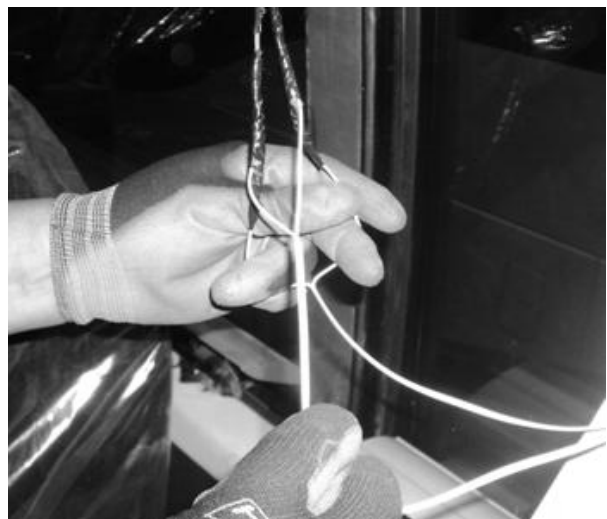
6.

Remove the insulation tape of the first emergency window wiring harness.

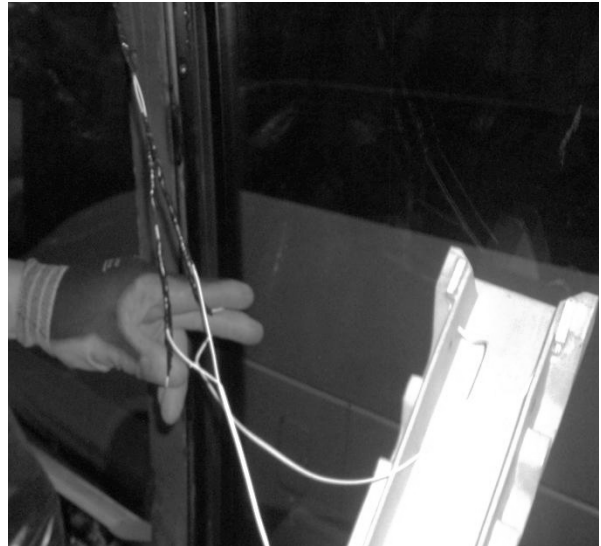
8.

Join the sensor cables and the wiring harness

**Note:** Switch is not polarized

Tape the harness connection to avoid contact with the window frame.

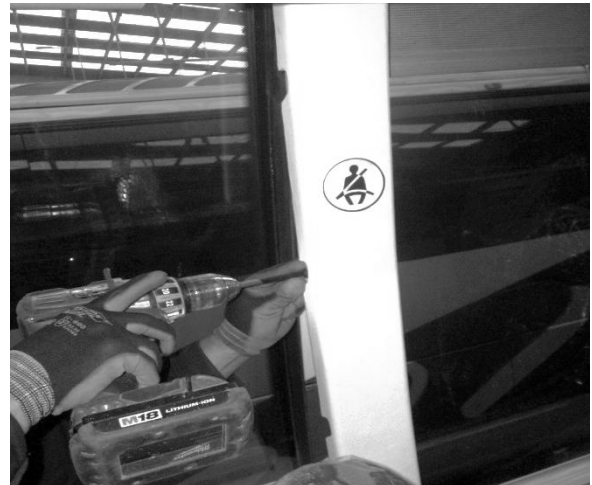
9.

Set the moulding in the original position and hide the sensor harness between the window frame and the moulding. Secure the moulding with screws.
