SAFETY DEFECT / NONCOMPLIANCE NOTICE

PREVOST SAFETY RECALL CAMPAIGN SR12-69 "Wheelchair Lift Cylinders and Maintenance Safety Pins"

**WHEELCHAIR LIFT: SERIAL NUMBER AND MAINTENANCE
SAFETY PIN INSPECTION
9700 (B13R)**

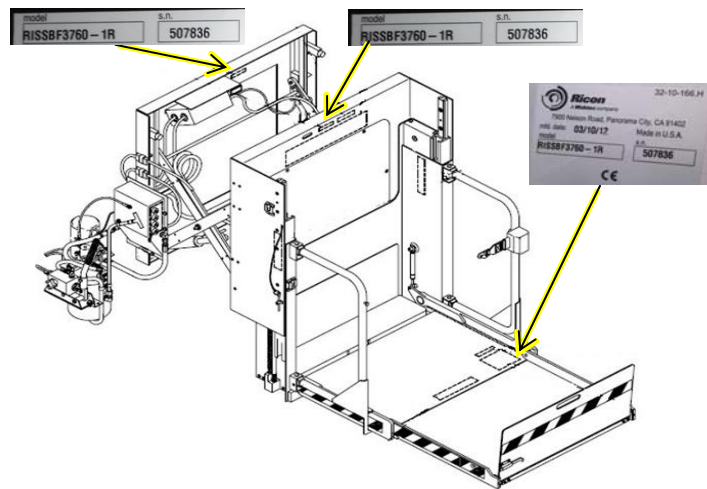
- 1) Locate the wheelchair lift decals.

- 2) Serial number on the decals should end with '60-1R'.

If not, please replace them.

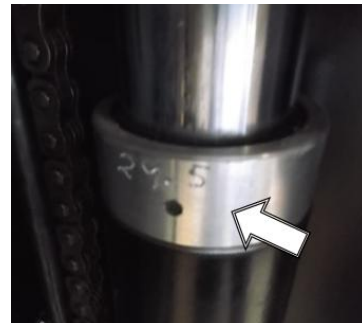
- 3) Check that both cylinders are marked with '29.5' **Note:** this marking could be on the "back side" of the cylinder, in which case an inspection mirror might be necessary.

If not, please contact your nearest Prevost Service Center or Service Manager to organize replacement of cylinders

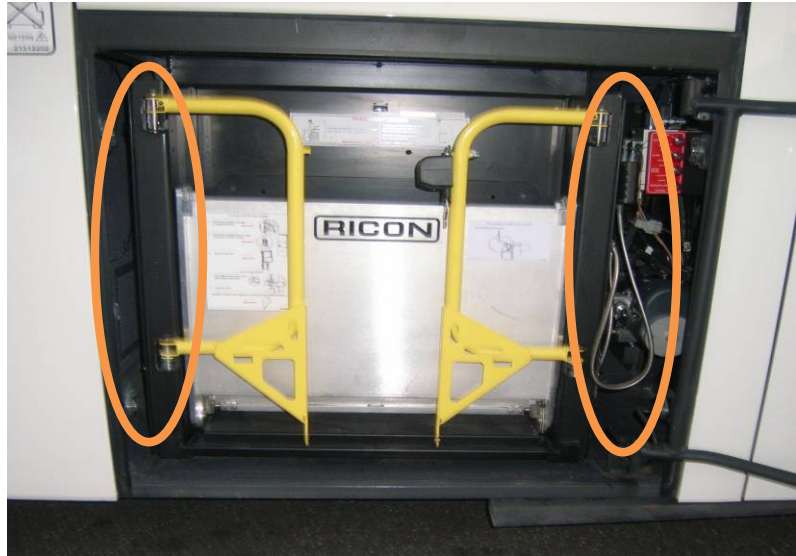
- 4) Open the Wheelchair lift door;
- 5) Make sure there are maintenance safety pins on each side of the wheelchair lift unit.

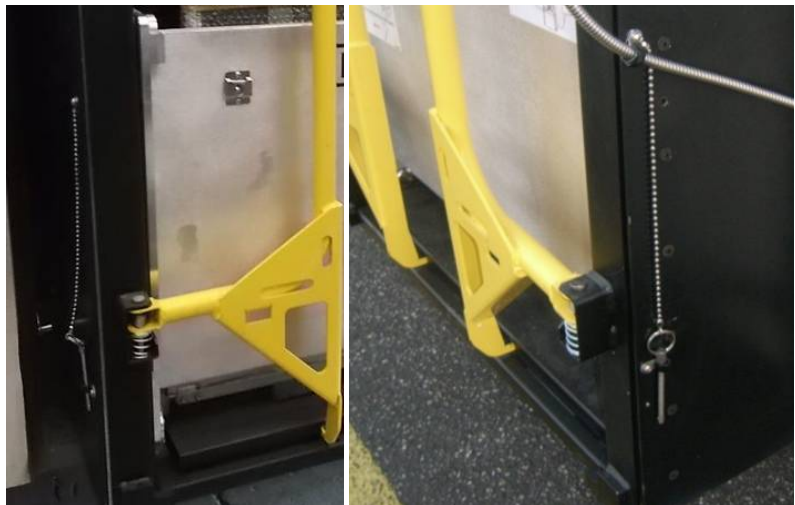
- 6) If maintenance safety pin or chain is missing, please install it.

At left side fix at the top with a screw 19718 and at the bottom with 3/8" long screw 865023 and 3/16" p-clamp 865021.

On the right side, fix together with the cable of the control pendant with a screw 19718 and the existing clamp, and at the bottom with 5/16" long screw N8892943 and 3/16" p-clamp 865021.

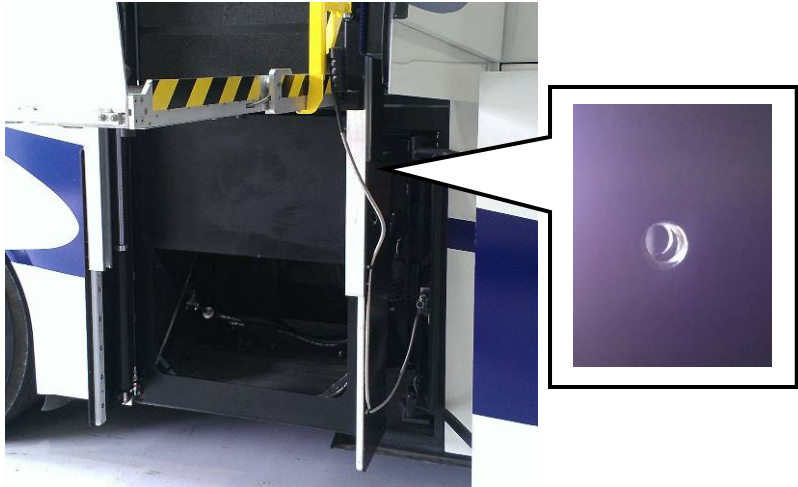
- 7) Check the maintenance safety pin can be inserted easily.

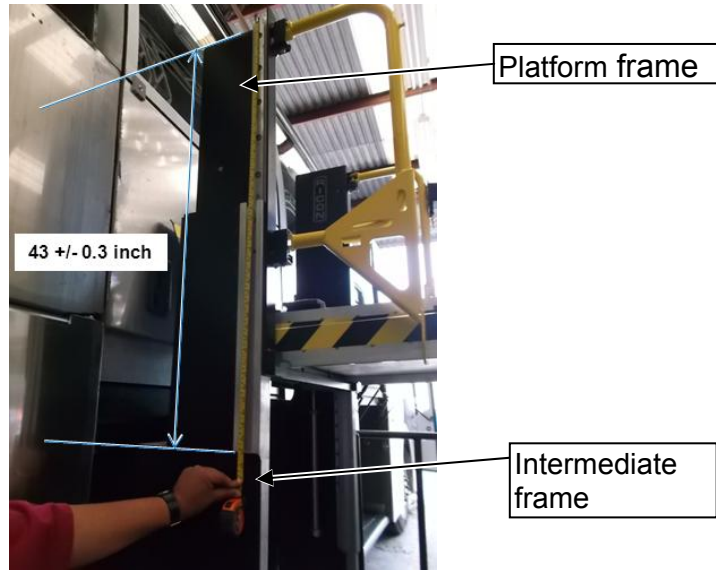
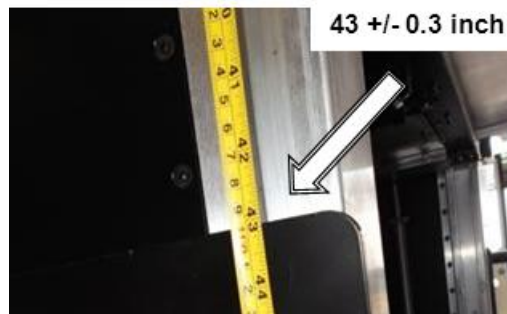
- 1) Lift the Platform frame up to get 43 +/- 0.3 inches between Platform frame and Intermediate frame.

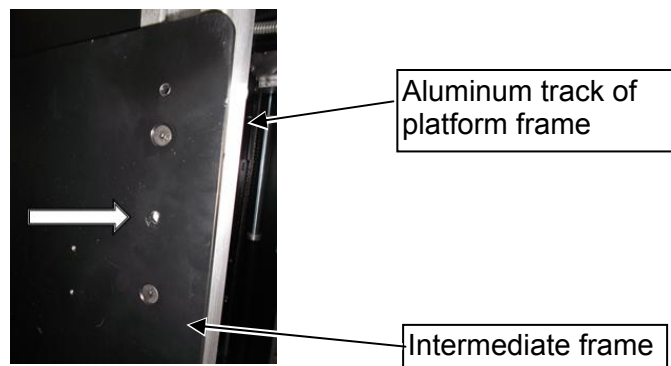
- 2) Check that holes of Intermediate frame and aluminum track of platform frame are aligned, if not, on the aluminum track make a hole of 5/16 in using the intermediate frame hole as guide.

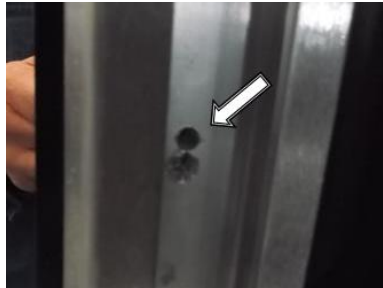
- 3) Check that new hole is free

of burrs.

Note! New hole always will be on the top of old one.

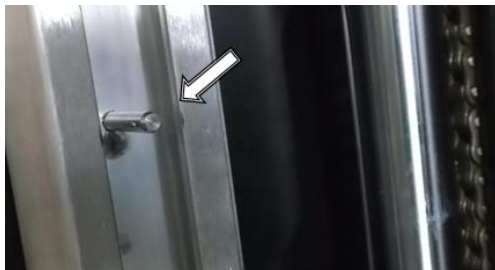
- 4) Check that maintenance safety pin goes through the new hole easily.
