## SAFETY RECALL INTERIM NOTICE G-12530

JANUARY 2013

Navistar has decided that a defect which relates to motor vehicle safety exists in certain ProStar® and TranStar® model trucks built 1 August 2011 thru 12 June 2012 with feature code 0504501, 0504504, or 04EWM.

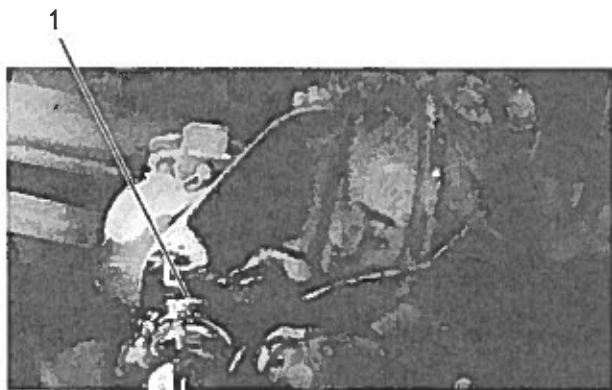
**Figure 1. S-Cam Tube and Wing Bracket.**

1. Area between S-Cam tube and Wing bracket.

To prevent the occurrence of this defect in the interim period when performing your pre-trip inspection, inspect for cracks between the S-Cam tube and wing bracket joint as illustrated on the back side of this letter. If any cracks are found, bring your truck to the nearest International® dealer for repair. Or at your option, you may also have your International® dealer perform this inspection during the interim period.

**Inspect entire area between the S-Cam tube and wing bracket for cracks (Figure 1, Item 1 and Figure 2, item 1).**
