# **SERVICE PROCEDURE**

G-12501  
APRIL 2012

**SUBJECT: SAFETY RECALL**

The brake line P-clip on certain 3200 IM and HC bus models built 08/16/2004 thru 05/13/2010 with an integrated mobility unit.

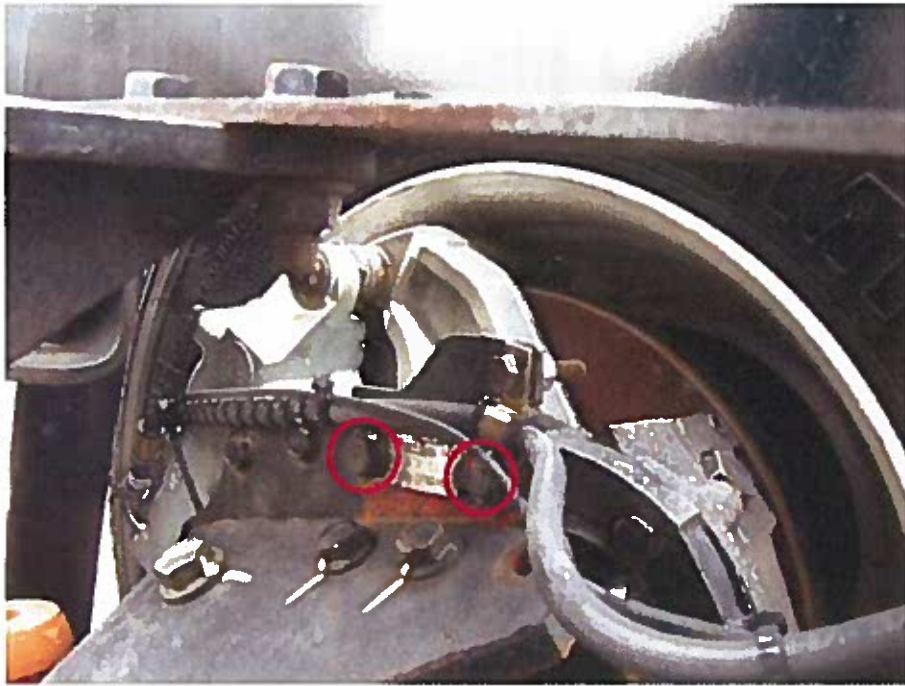
**Figure 2**

3. Remove and retain the two rear wheel-end housing brake line support bracket mounting bolts. Refer to Figure 2.

**NOTE:** If an information tag is present, please retain for installation during step 8.

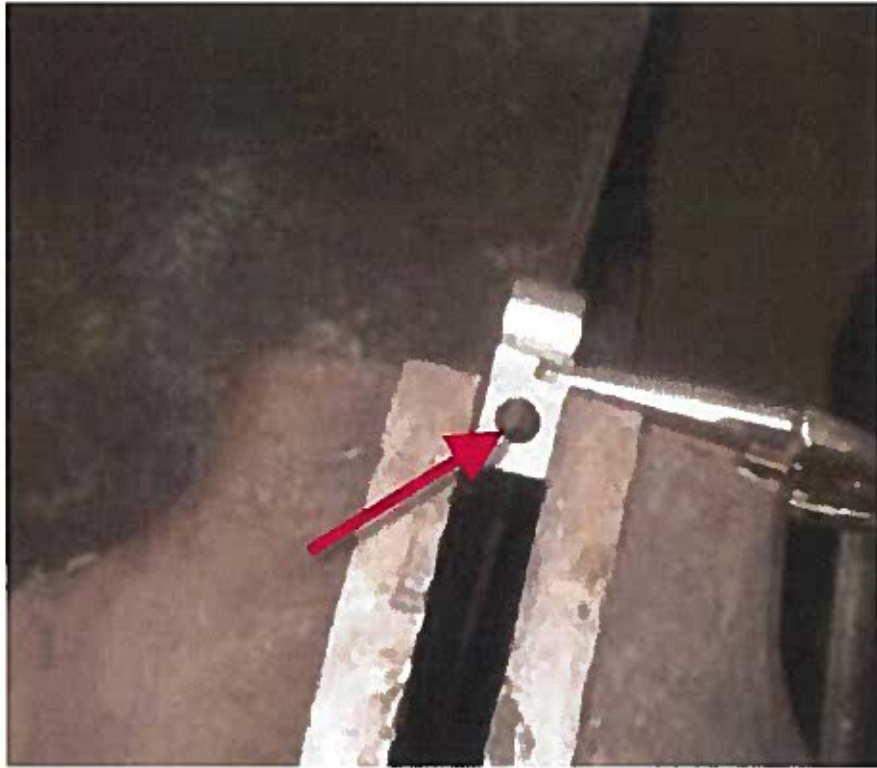
**Figure 4**

6. Securely clamp the mounting tabs of the P-clip together with a needle-nose vise grip and make sure the mounting hole of each tab is aligned. Secure the P-clip in a vise and use a drill and a 7/16 in. drill bit to enlarge the mounting hole from the original size to 7/16 in. Make sure the drill bit is centered in the mounting hole to maximize the remaining edge distance. Refer to Figure 4.
