## Maserati Technical Bulletin

Date: Feb., 2012  
Bulletin Number: MTB – 201201  
Supersedes: N/A  
Section: Compliance

**Model Type:** Granturismo & Granturismo Convertible Models  
**Model Year:** 2008, 2009, & 2010  
**Subject:** **Vehicle Safety Recall Campaign 198, Rear Tail Lamp Assemblies**

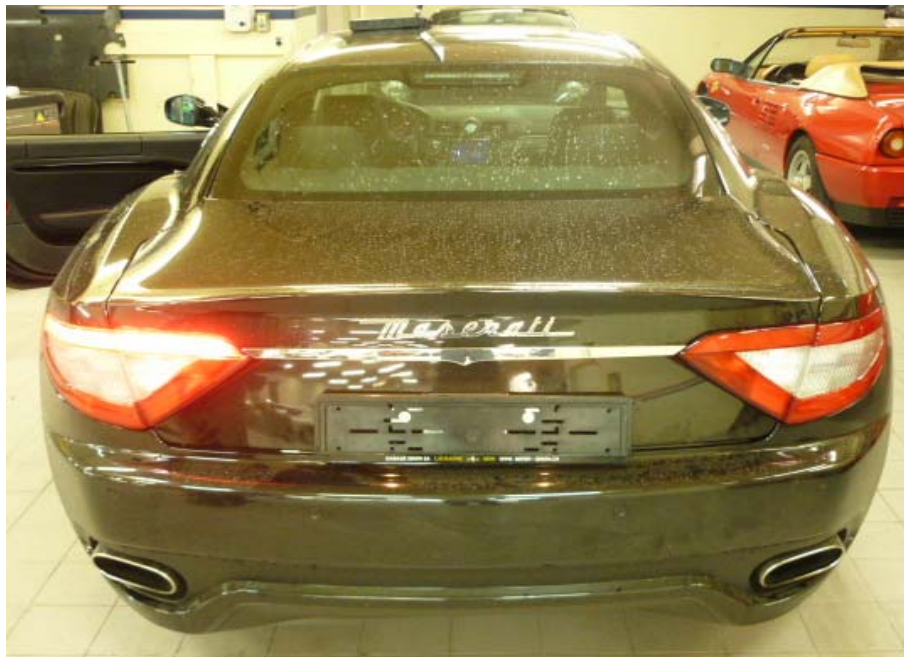
Maserati S.p.A. has determined that certain model year 2008, 2009 and 2010 Granturismo and Granturismo Convertible models were potentially manufactured with rear tail lamp assemblies which may fail due to a loss of functionality resulting in loss of operation which may lead to a reduction of vehicle visibility and an accident. This **Safety Recall Campaign** involves the removal, checking and possibly replacement of the rear tail lamp assemblies (both right and left side). The illustration below shows one side operative and the other inoperative.

**If rear tail lamp assembly requires replacement, this will be done free of charge to the customer.**

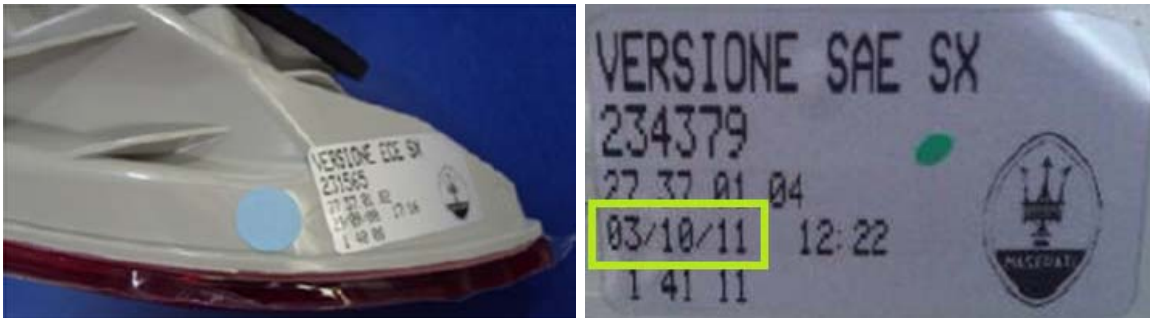
1. Ensure that the vehicle is involved in the action and if the campaign has not been previously performed.
2. Remove both rear tail lamp assemblies (fixed side) from the vehicle.
3. Check the production date of the tail lamp assembly (Please note it is written in European format: DD/MM/YY).

4. If the rear tail lamp production date label indicates a date earlier than 15/01/10 (January 15<sup>th</sup> 2010), install a new rear tail lamp onto the vehicle (**otherwise re-install the original rear tail lamp assemblies back onto the vehicle**).
5. The Recall Procedure completed.
