Bendix ATR-6 Valve

RVXX1202, Bendix ATR-6 Valve

(February 2012)

**How to Temporarily Disable the Solenoid of
Bendix® ATR-6™ Traction Relay Valves (Kit K070706)**
(Valve Retains Service Braking and ABS Relay Valve Functions)

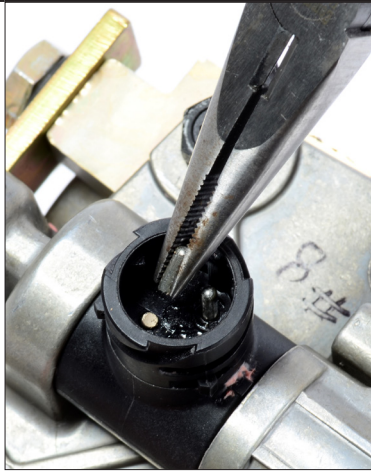
1. Remove the harness connector(s).
Grasp one of the connector pins using needle-nose pliers, or a similar tool.*

Rock back and forth, or twist, the pin to break it off flush at the base. See the Photo.

*An alternate method for breaking off the pin(s) is to carefully insert a 1/2 inch drill bit and turn it by hand (using vice-grips or similar); the pins will snap off.

CAUTION: Do not drill into the solenoid - only break off the pins.

2. **Verify that the pin(s) have broken off flush at the bottom and have been removed. Check that any remaining pin(s) are not bent.**
3. Re-install the harness connector(s) to prevent corrosion and/or damage. Verify that you can fully close the connector(s).
4. Use a tie-wrap (or similar) on the valve(s) to visually indicate that the solenoid has been temporarily disabled.

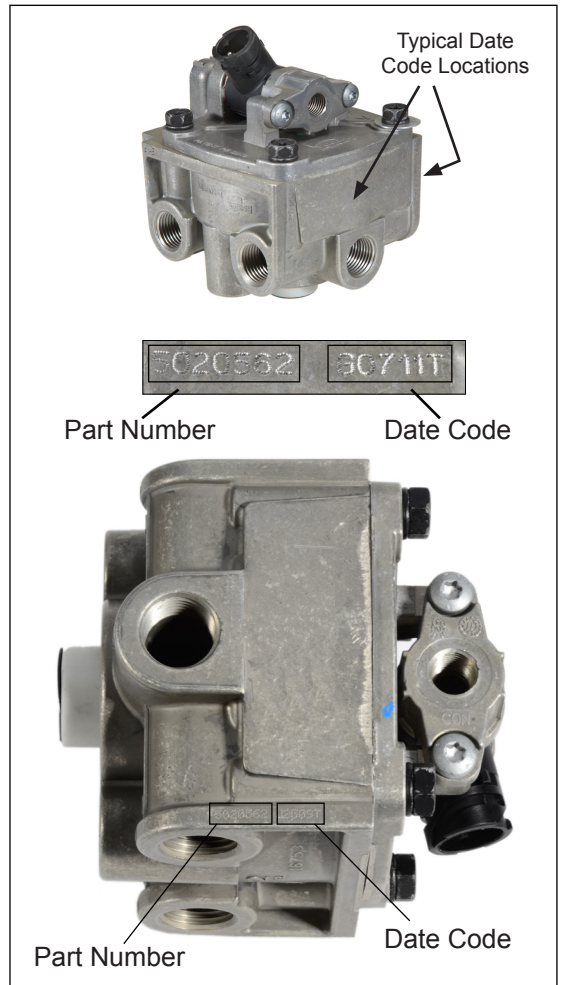
Verifying the Bendix® ATR-6™ Valve's Date Code.

Look for the date code that is pin-stamped (not cast) on the valve, following the part number. *(Remove the paint coating, if necessary, to read the code.)*

- The first field is the month (A=January, B=February, etc. — excluding the letter I — , so that J=September, and so on).
- The next two fields are the date (e.g. 04=4th day of the month)
- The next two fields are the year (e.g. 11=2011).
- The final code in the sequence is the Plant Code (T), in all cases.

Valves included in this field action were manufactured during the period:

December 2, 2010 through January 18, 2012
 That is, M0210T through A1812T.
