March 2012

Safety Recall M01 / NHTSA 12V-042

Headlamp & ABS/ESC Wiring

2011 – 2012 (LD) Dodge Charger

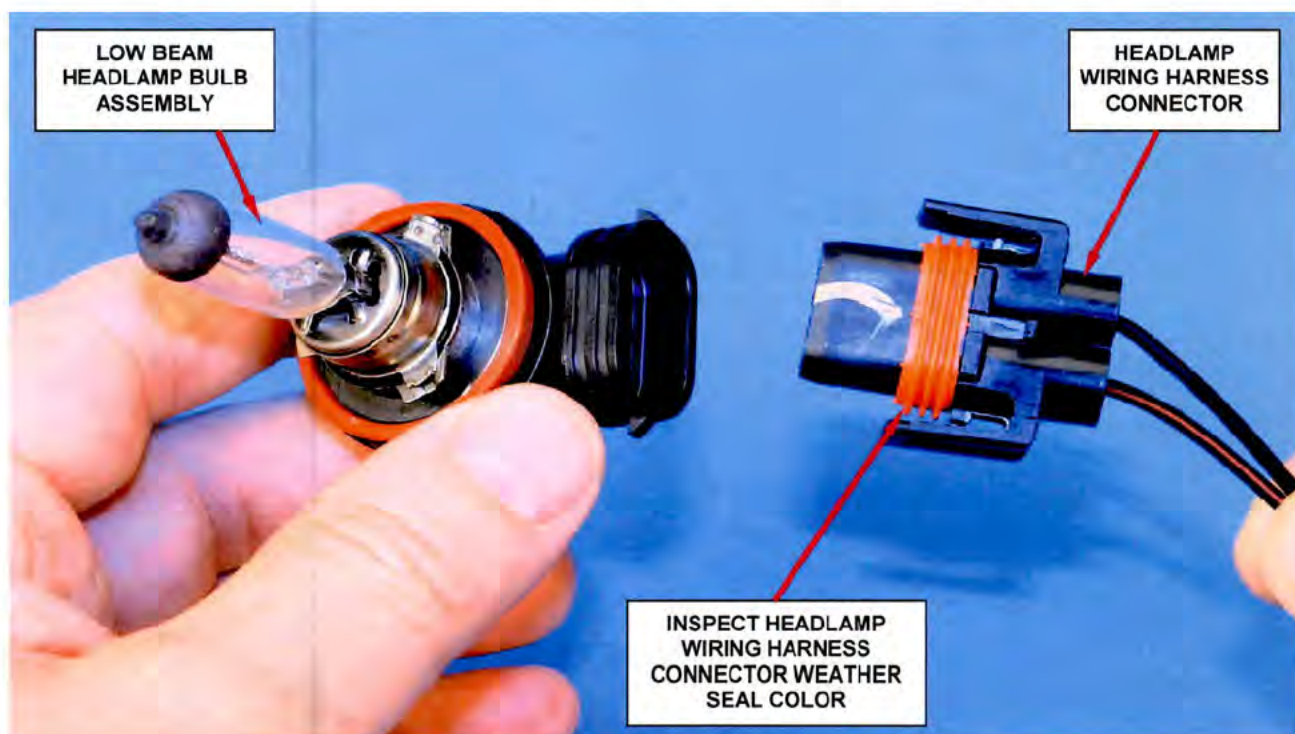
Figure 1 – Inspect the Headlamp Wiring Harness Connector Seal

5. Disconnect the headlamp wiring harness from the headlamp bulb:
 - If both the right and left side weather seal on the headlamp wiring harness connectors are red, no further action is required. Assemble the headlamp assemblies and continue with **Section C. Inspect and/or Relocate Antilock Brake System (ABS)/Electronic Stability Control (ESC) Fuse.**
 - If the right and/or left weather seal is black, the headlamp wiring harnesses must be replaced. Continue with **Section B. Replace Headlamp Wiring Harness.**

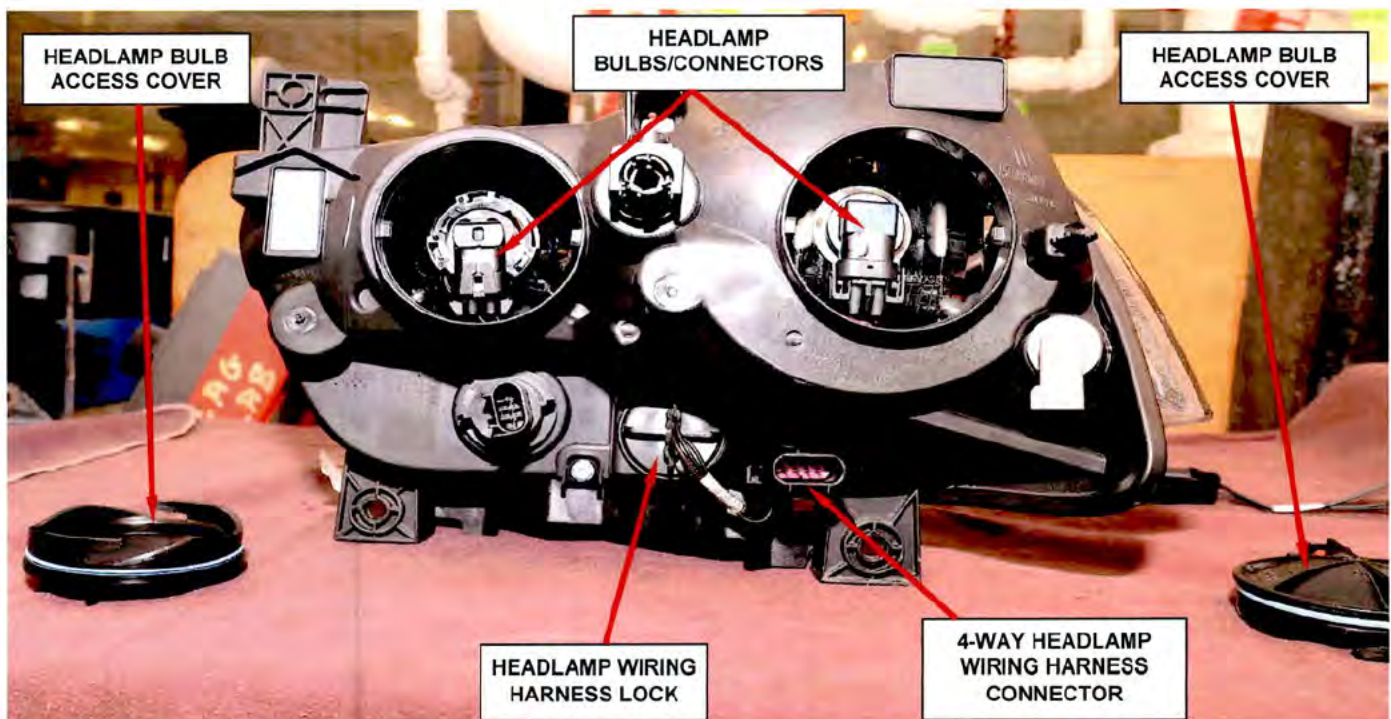
Figure 2 – Headlamp Assembly Bulb Access Covers

1. Open the trunk and disconnect the negative battery cable at the battery.
2. Open the hood.
3. Remove and save the high beam bulb access cover.
4. Disconnect the 4-way headlamp wiring harness connector from the body wiring harness (Figure 2).

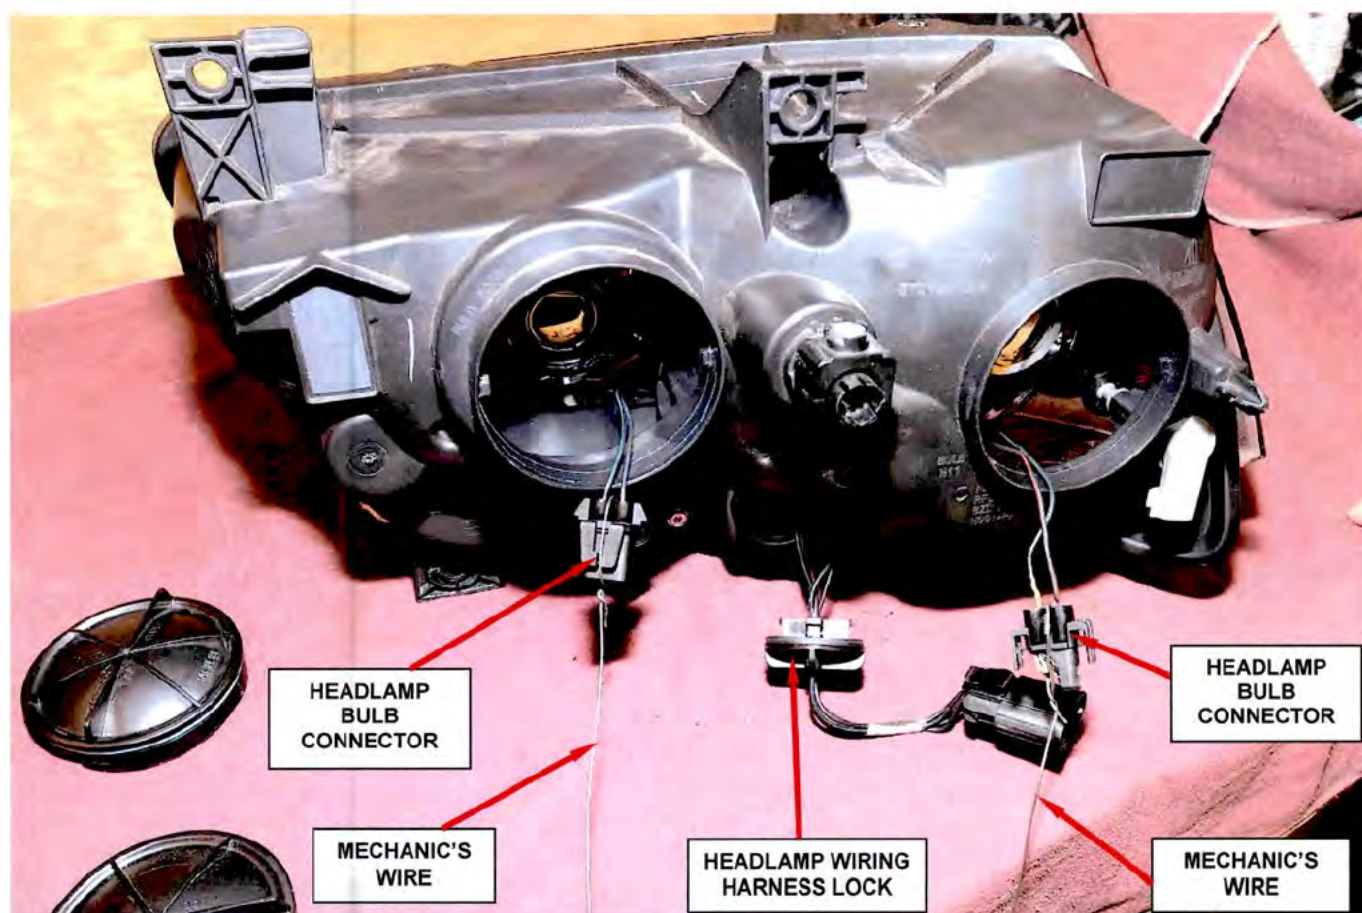
Figure 3 – Attach Mechanic's Wire to Headlamp Bulb Connectors

5. Using two 24 inch long pieces of mechanic's wire (or equivalent), connect one end of the mechanic's wire to each of the headlamp bulb connectors (Figure 3).
6. Unclip the 4-way headlamp wiring harness connector from the back of the headlamp housing (Figure 3).
7. Disengage the headlamp wiring harness lock on the headlamp housing by turning it $\frac{1}{4}$ turn counterclockwise (Figure 3).

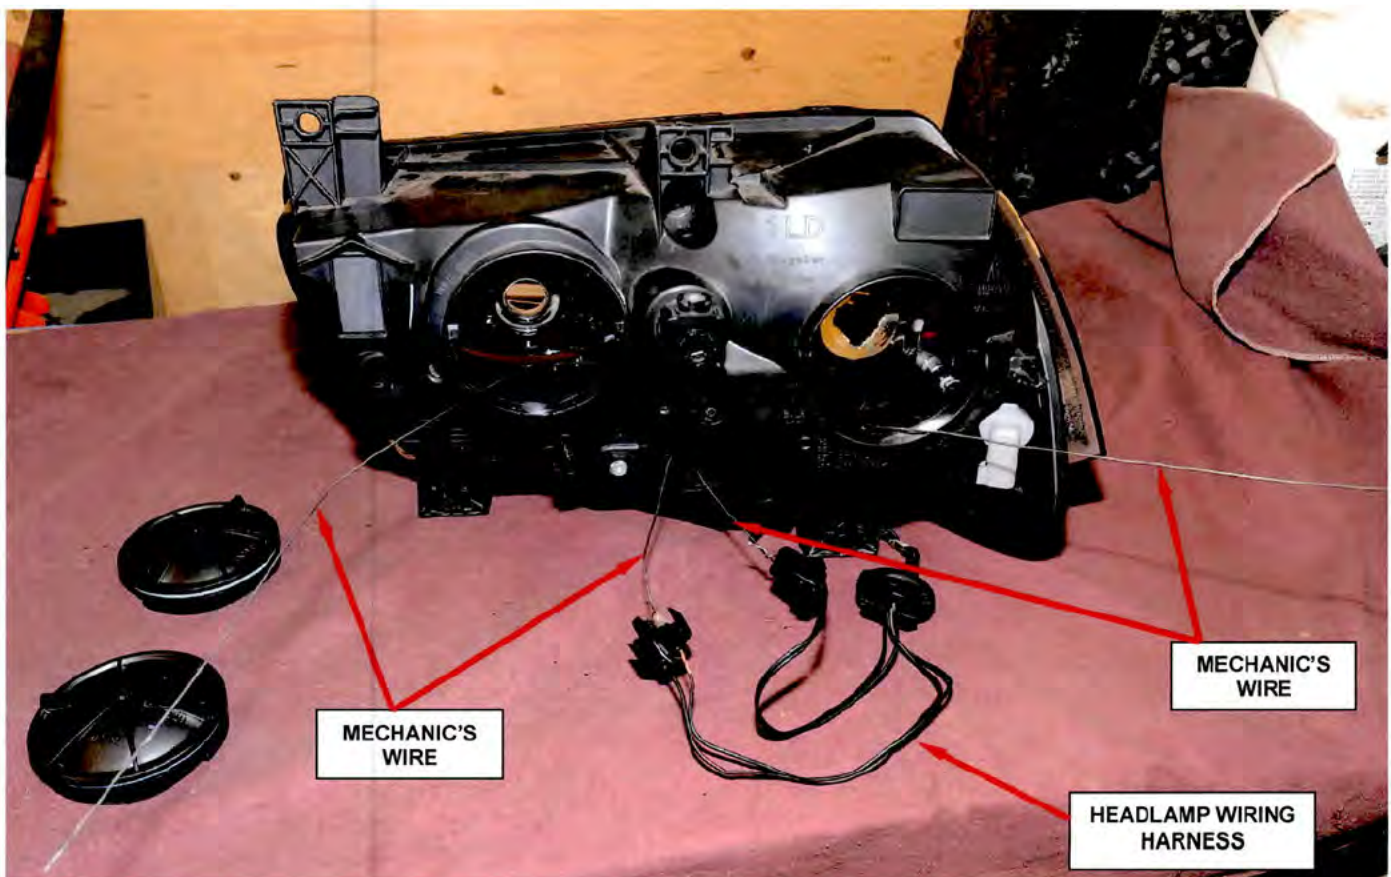
Figure 4 – Remove Original Headlamp Wiring Harness from Headlamp Assembly

8. Carefully guide the headlamp bulb wiring harnesses out of the headlamp housing with the mechanic's wire attached (Figure 4).
9. Disconnect the mechanic's wire from the original headlamp bulb connectors.
10. Discard the original headlamp wiring harness.
11. Connect the new headlamp wiring harness to the mechanic's wire.

12. Using the mechanic's wire, pull the new headlamp wiring harness into position inside the headlamp housing (Figure 4).
13. Disconnect and save the mechanic's wire from each headlamp bulb connector.

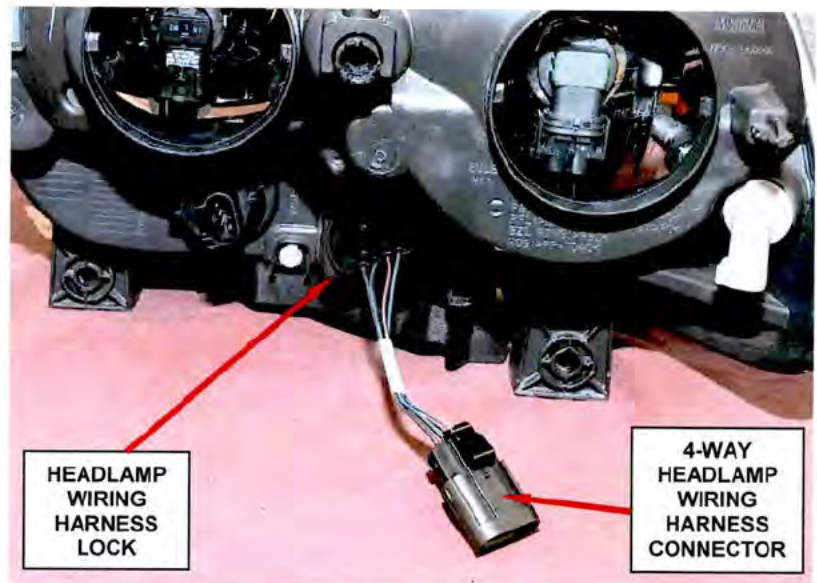
Figure 5 – Headlamp Wiring Harness Lock

14. Inspect both low beam headlamp bulbs for damage. Replace low beam headlamp bulb(s) if damage or corrosion is found.
15. Install the headlamp bulbs into the headlamp bulb connectors. Then install the headlamp bulb connectors into the headlamp housing.
16. Engage the headlamp wiring harness lock into the headlamp housing (Figure 5).
17. Clip the 4-way headlamp wiring harness connector to the headlamp housing (Figure 6).
18. Install the headlamp bulb access covers.
19. Connect the 4-way headlamp wiring harness connector to the body wiring harness.
20. Repeat Steps 3 through 18 on the other headlamp assembly.
21. Install the air cleaner housing.
22. Continue with **Section C – Inspect and/or Relocate Antilock Brake System (ABS)/Electronic Stability Control (ESC) Fuse**.

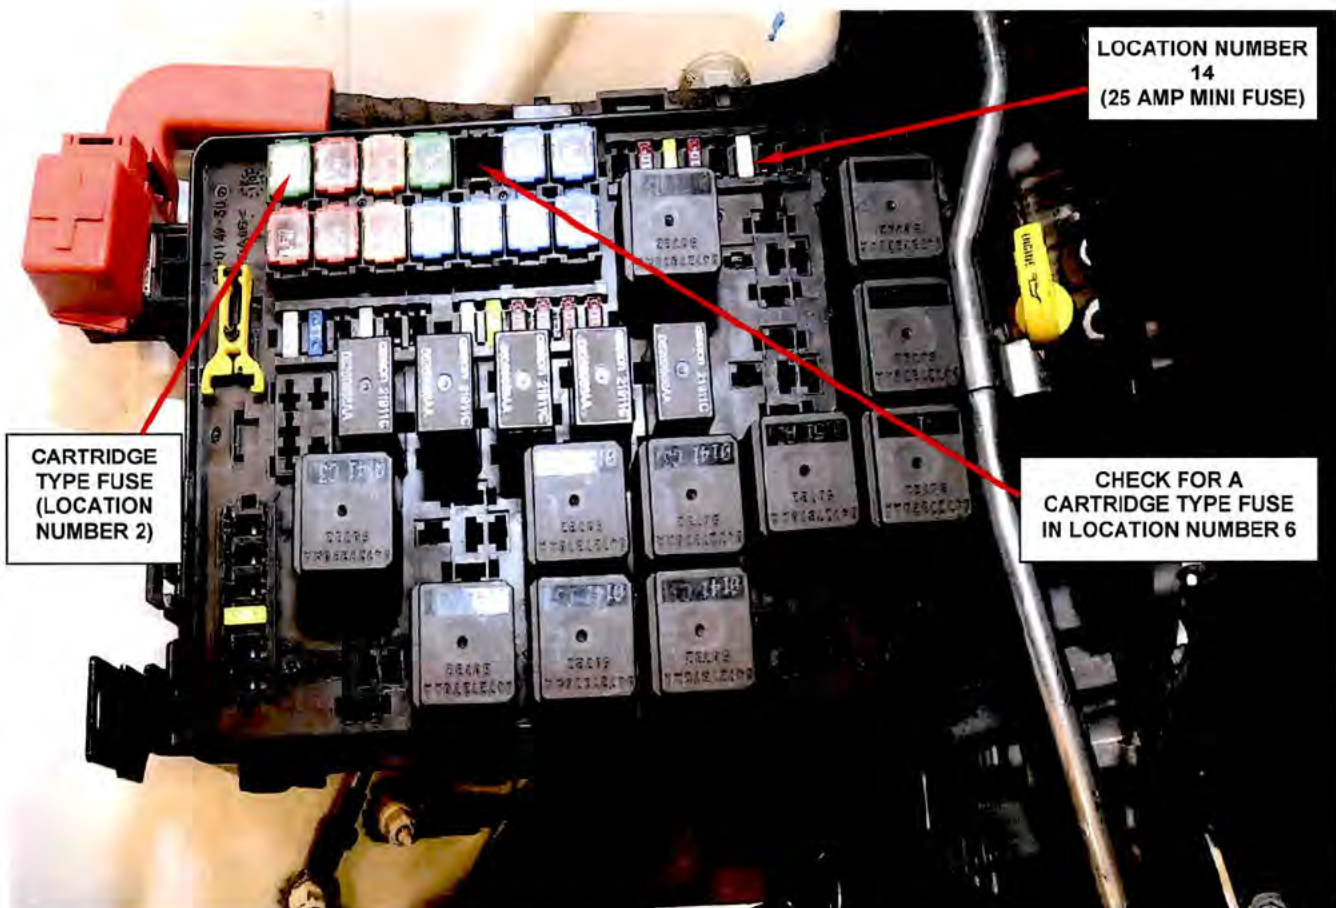
Figure 7 – PDC Cartridge Fuse Location

1. Remove the Power Distribution Center (PDC) cover.
2. Check for the presence of a 25 amp cartridge fuse (Figure 7) in PDC location number 6:

- If PDC location number 6 **has** a 25 amp cartridge fuse, a **fuse upgrade is not required**. Install the PDC cover and continue with:

- If PDC location number 6 **does not have** a 25 amp cartridge fuse, a **fuse upgrade is required**. Continue with Step 3 of this procedure.

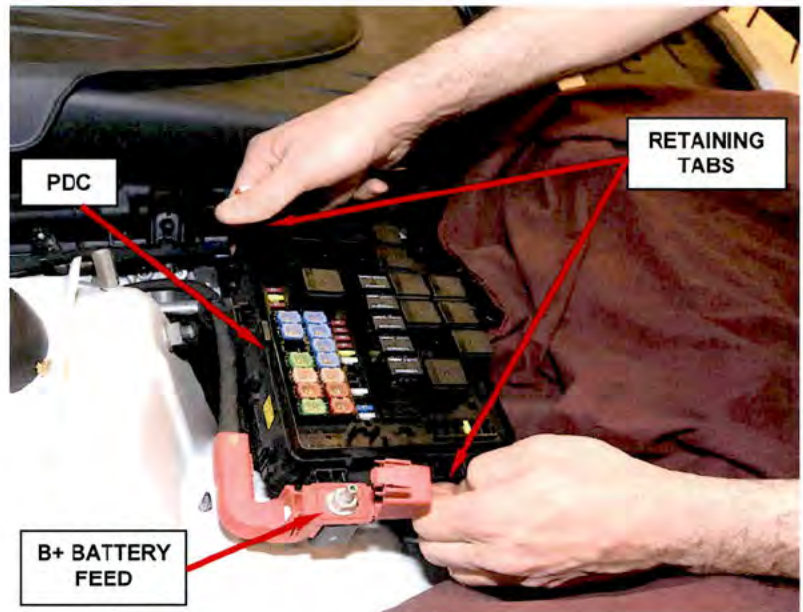
**Figure 8 – PDC Retaining Tabs**

3. Disengage the retaining tabs that secures the PDC to the mounting bracket (Figure 8).
4. Disconnect the main B+ battery feed wire on the PDC (Figure 8).
5. Remove and save the PDC mounting bracket.
6. Turn the PDC over to expose the bottom side of the PDC.
7. Carefully open the PDC bottom cover (Figure 9).

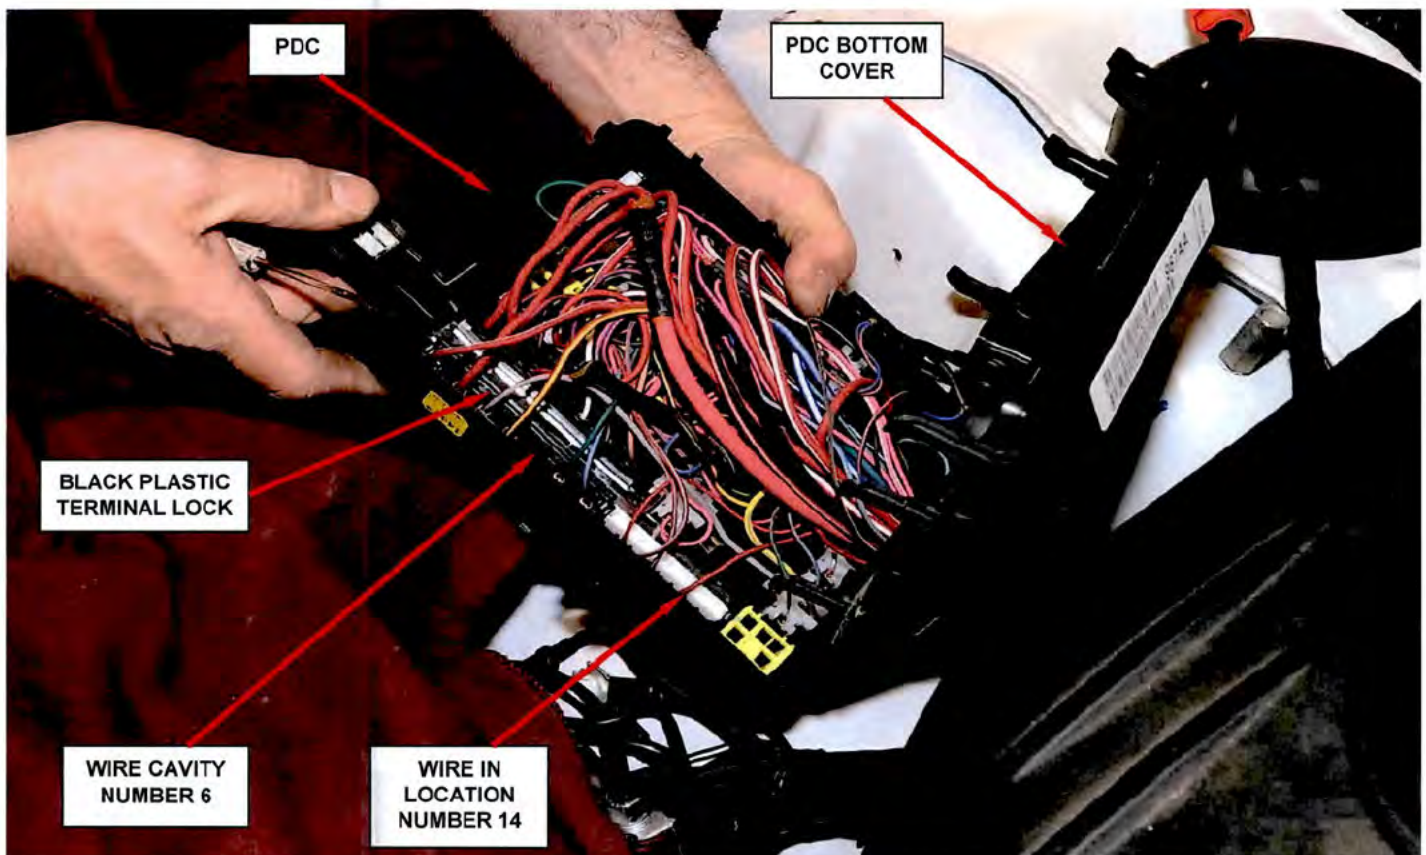
**Figure 9 – Black Plastic Terminal Lock**

8. Using a small pick tool, remove and discard the black plastic terminal lock (Figure 9).

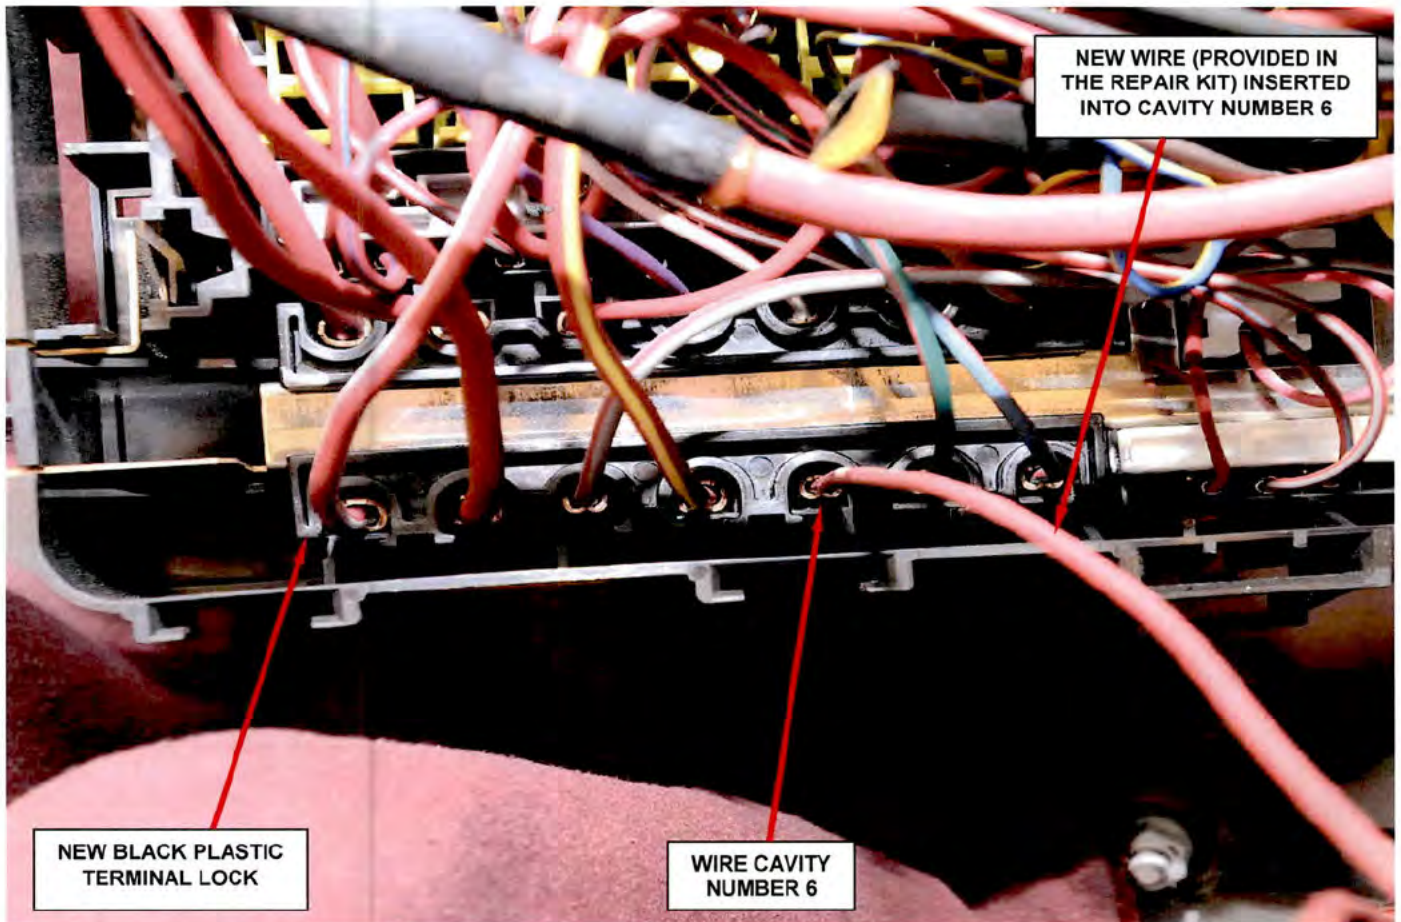
Figure 10 – Cavity Number 6

9. Insert the blade terminal provided in the repair kit into cavity number 6 of the PDC (Figure 10).
10. Install the new black plastic terminal lock provided in the repair kit (Figure 10).

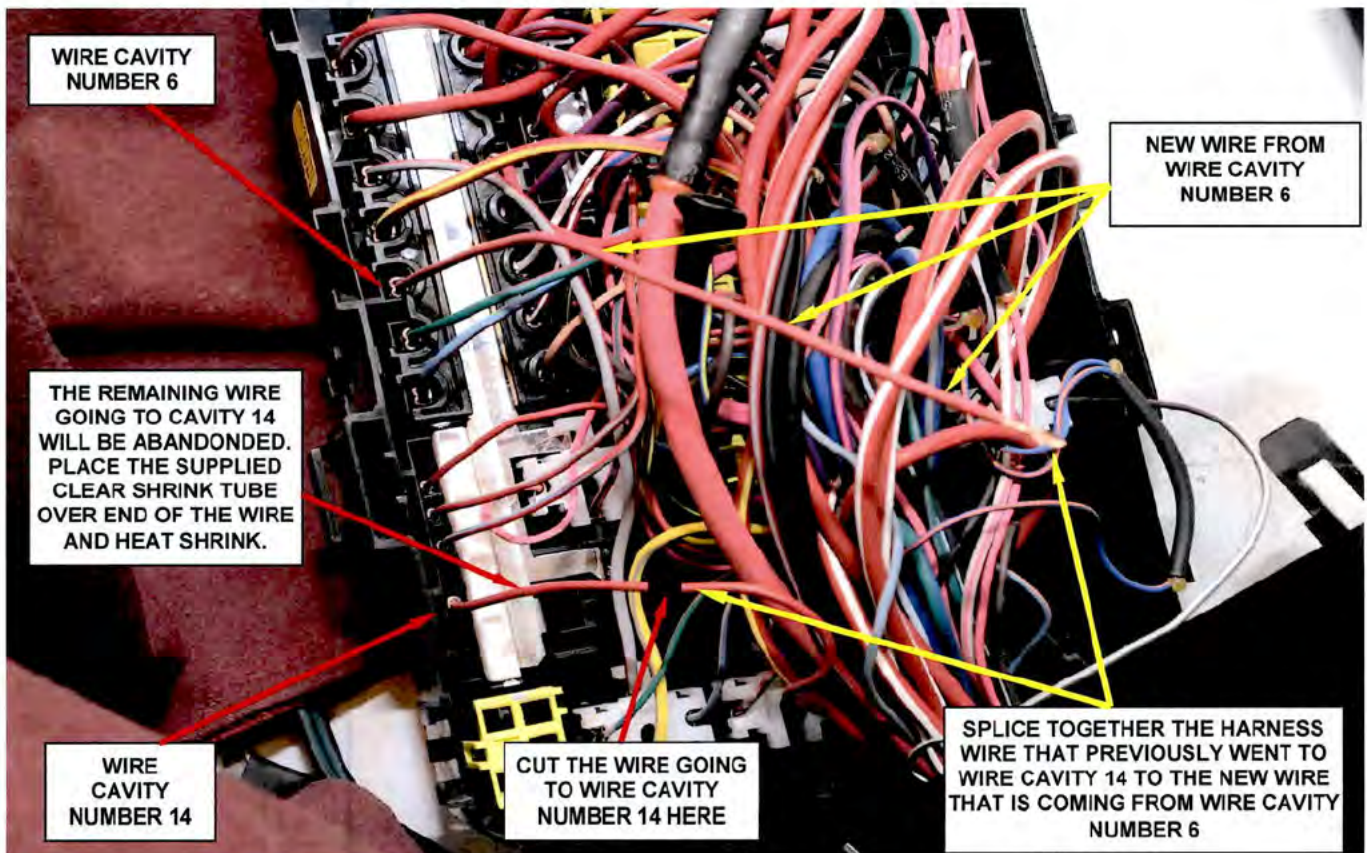
**Figure 11 – Cavity Number 14 Wire**

11. Locate the red wire located in cavity 14 (Figure 11). Place a mark on the wire approximately 35 mm up from the blade terminal.
12. Cut the wire at the mark made in Step 11.
13. Place the clear shrink tube provided in the repair kit over the remaining wire in cavity 14 of the PDC. Apply heat to the shrink tube to seal the end of the wire (Figure 11).
14. Strip approximately 10 -15 mm of insulation from the end of the remaining cut wire.
15. Place the black shrink tube provided in the repair kit over the remaining cut wire.

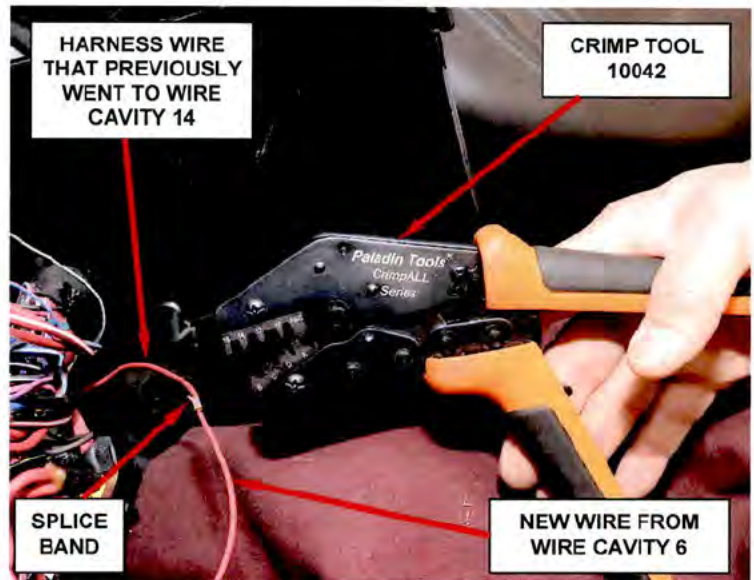
Figure 12 – Install Splice Band Clamp

16. Using the supplied splice band clamp and crimp tool 10042, crimp the wire that had the insulation stripped in Step 14 to the wire that was added in Step 9 (Figure 12).

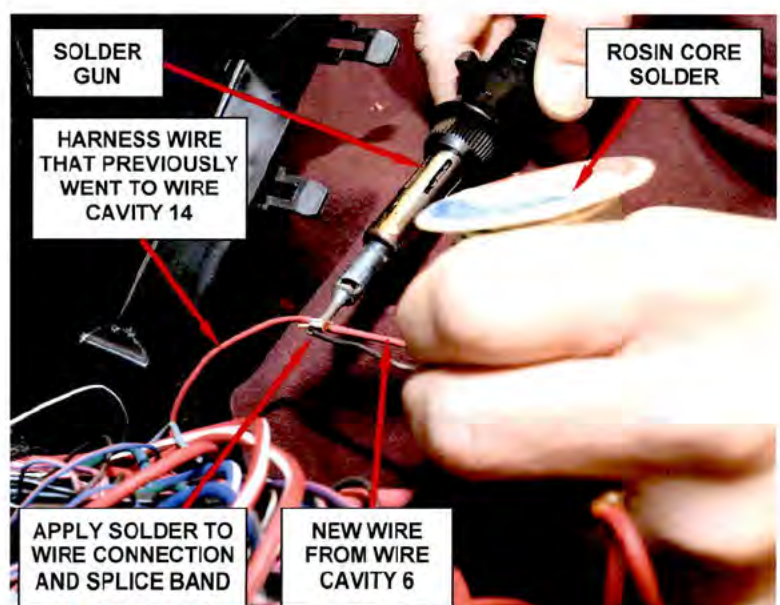
Figure 13 – Solder Wire

17. Solder the crimp installed in Step 16 with rosin core solder (Figure 13).
18. Slide the shrink tube over the splice and apply heat to the shrink tube until glue comes out of both ends of the shrink tube.

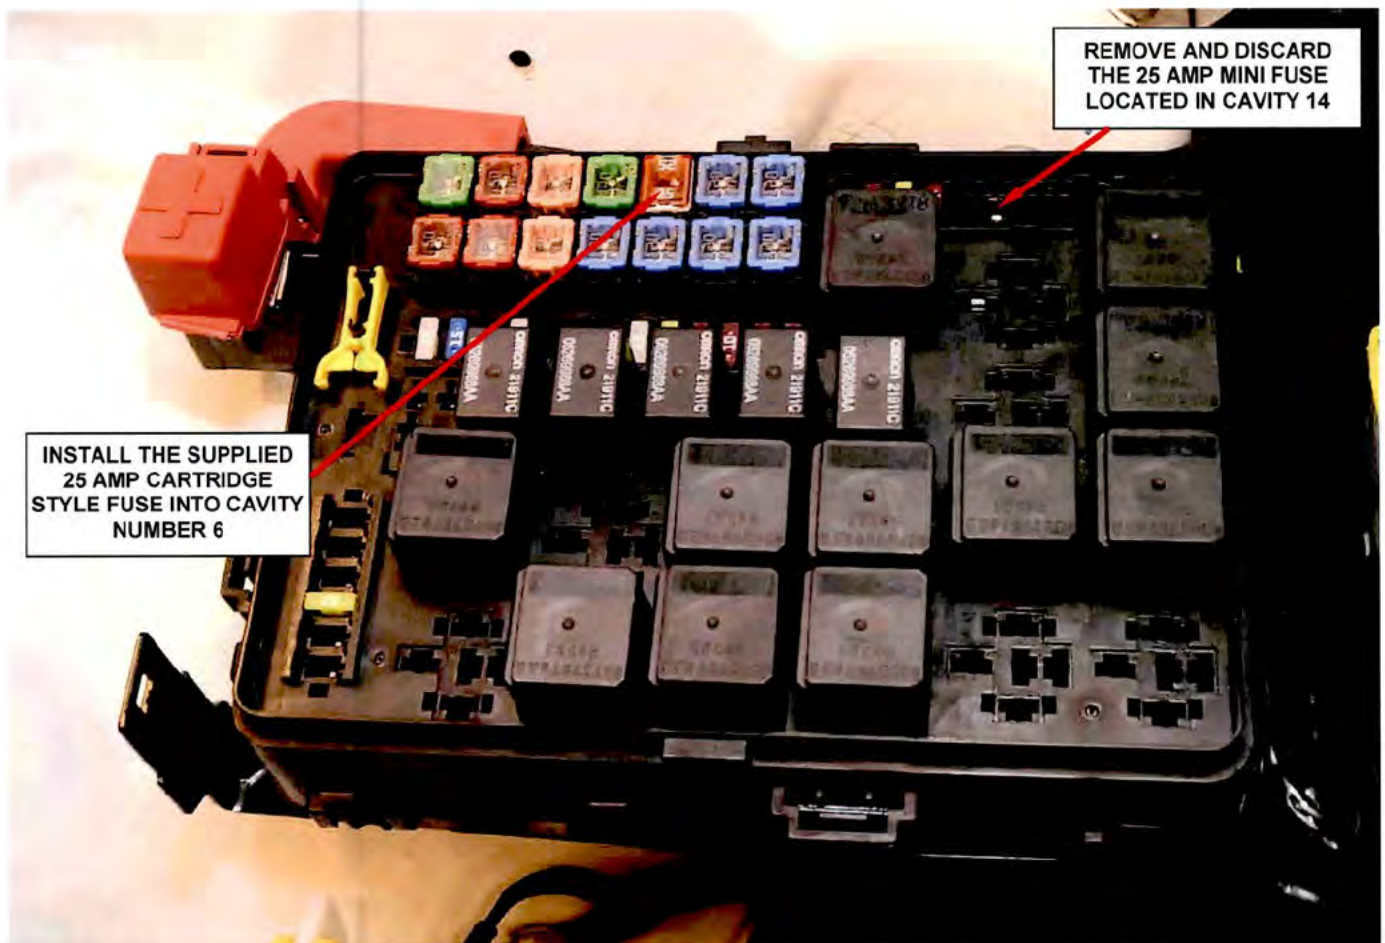
Figure 14 – Fuse Removal and Installation

23. Remove and discard the white 25 amp mini fuse located in cavity number 14 of the PDC (Figure 14).
24. Install the new fuse supplied in the repair kit into cavity number 6 of the PDC (Figure 14).

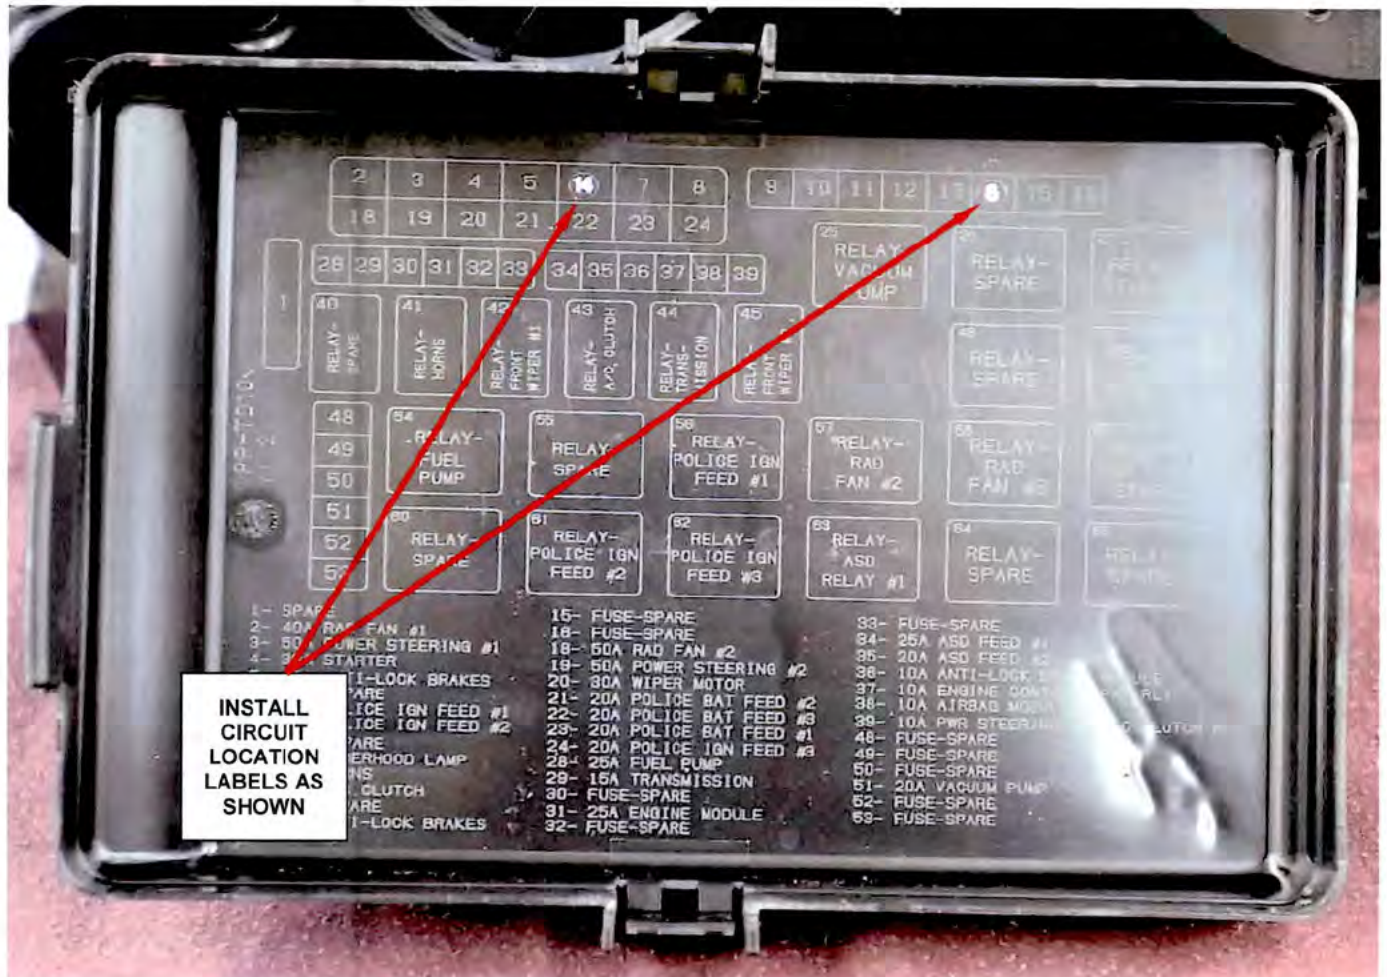
**Figure 15 – Install Circuit Location Labels**

25. Install the new fuse location stickers supplied in the repair kit onto the fuse location diagram on the inside of PDC cover (Figure 15).

NOTE: Four stickers are supplied in the kit, but only two are required.

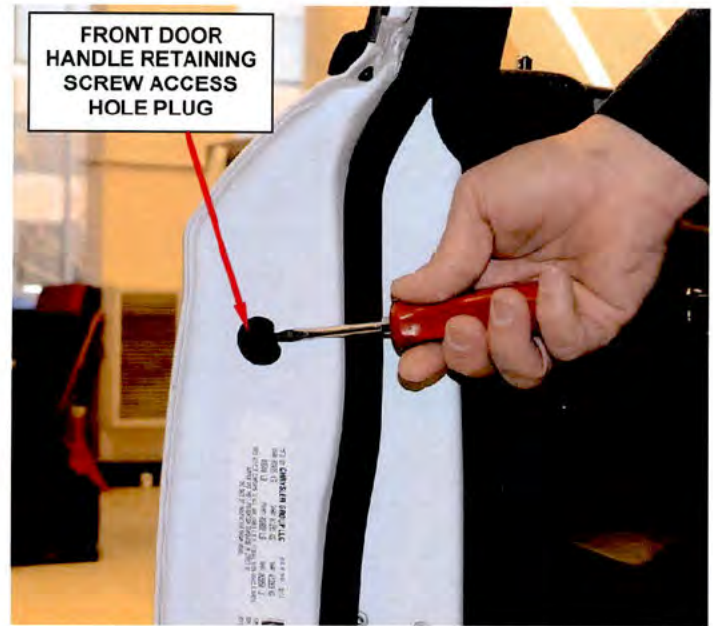
Figure 16 – Access Hole Plug

1. Open the driver's front door.
2. Remove and save the front door handle retaining screw access hole plug (Figure 16).
3. Using a T20 Torx driver, loosen (but do not remove) the exterior front door handle retaining screw (Figure 17).

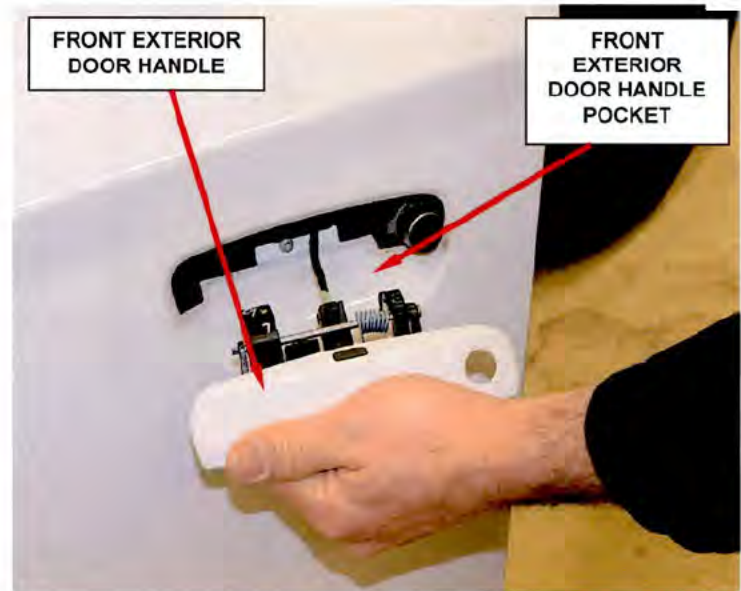
**Figure 18 – Exterior Door Handle Removal**

4. Carefully pull the front exterior door handle out of the exterior door handle pocket (Figure 18).
5. Disconnect the electrical connector from the front exterior door handle electrical receptacle (Figure 19).
6. Remove and discard the original front exterior door handle.
7. Place the new front exterior door handle up to the front door and connect the electrical connector to the front exterior door handle electrical receptacle (Figure 19).
8. Place the new front exterior door handle into position in the front exterior door handle pocket (Figure 18).
9. Carefully tighten the front exterior door handle retaining screw (Figure 17).
10. Install the front door handle retaining screw access hole plug (Figure 16).
11. Repeat steps 1 through 10 on the passenger side front exterior door handle.
12. Return the vehicle to the customer.
