## PRODUCT CAMPAIGN BULLETIN

**APPLICABILITY:** 2009-2012MY Subaru Forester  
**SUBJECT:** Rear Seat Center Seatbelt

**NUMBER:** WQA-37  
**DATE:** March 2012

**REVISED:** 10/29/14

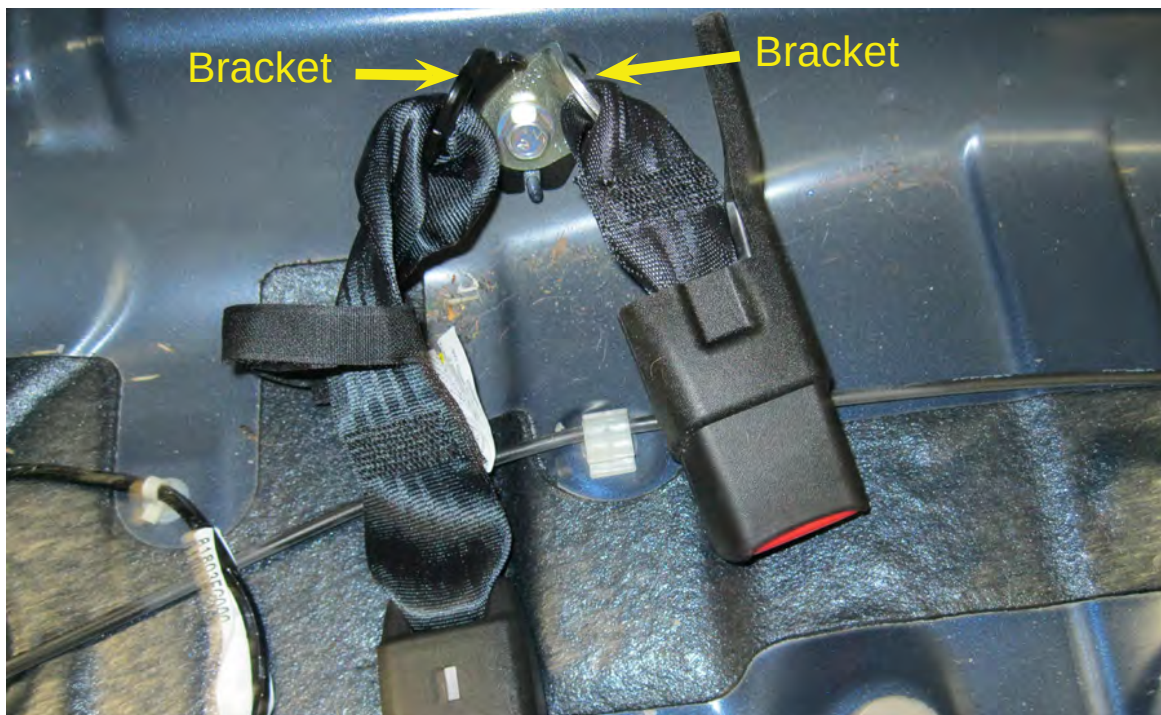
**Note: Make sure to note the location of the seatbelt brackets.**

5. Unwrap the Velcro® strap and remove the bolt to remove the seatbelts. Perform the same procedure on the opposite side.

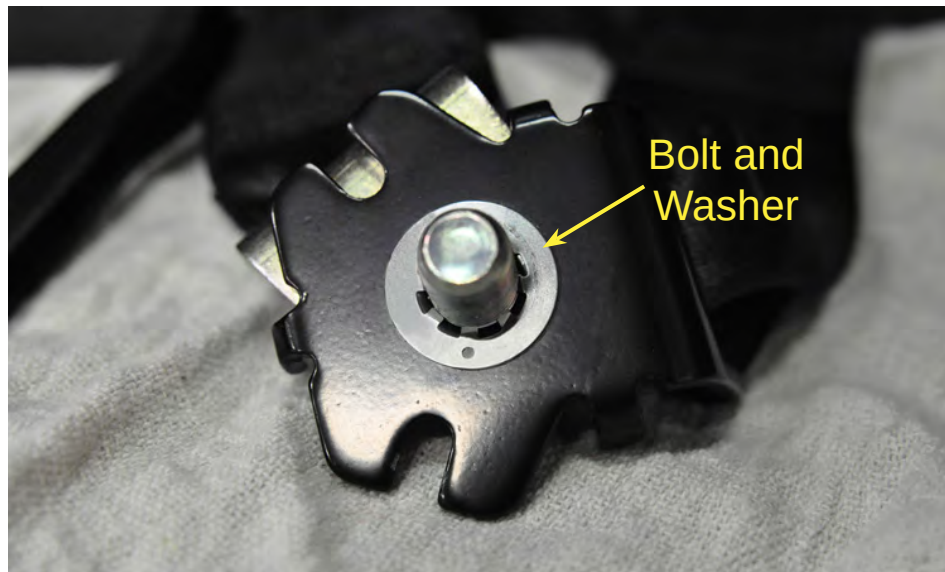
6. Separate seatbelt brackets by removing bolt and washer. Discard bolt and washer.

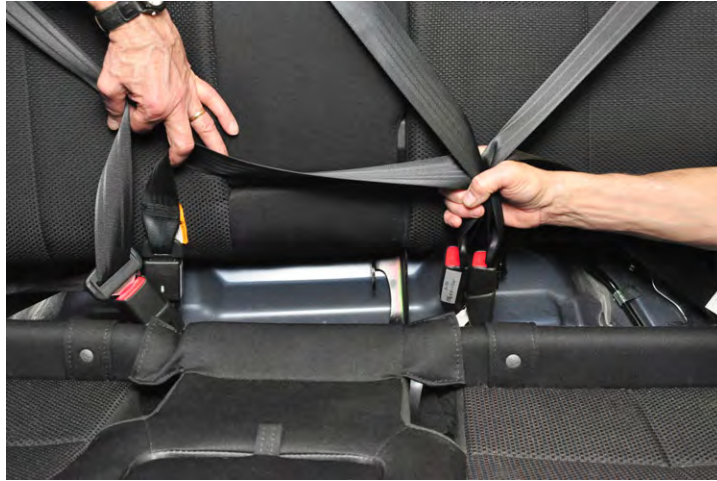
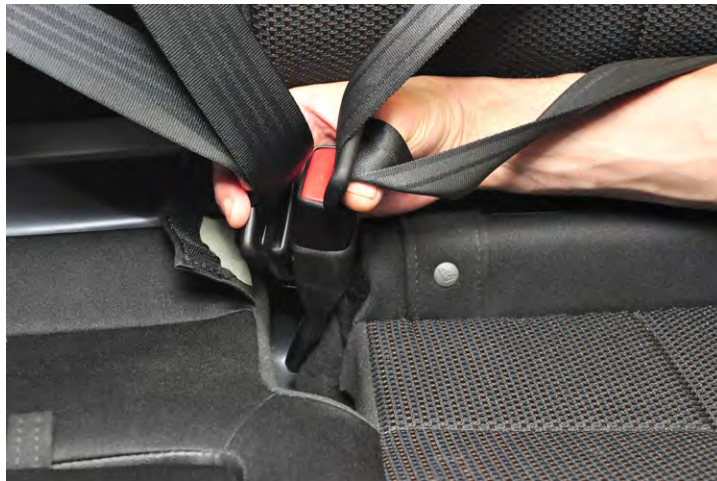
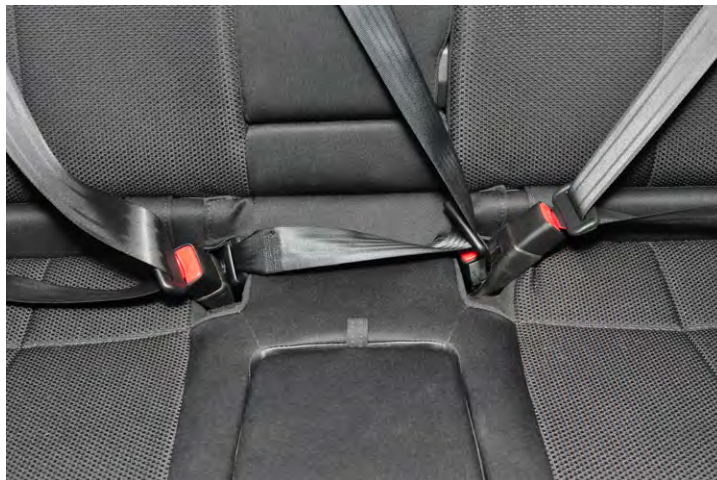
9. Reinstall the seat cushion. To facilitate positioning of the seatbelts in the cushion, connect all of the seatbelts. The next step will require an assistant. With each person holding the left and right seatbelts respectively, slide the cushion into place while pulling the belt buckles into position in the seat cushion opening.

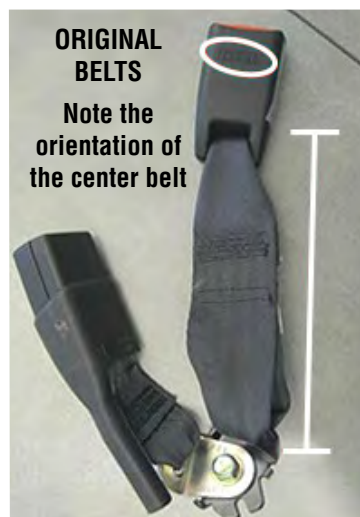
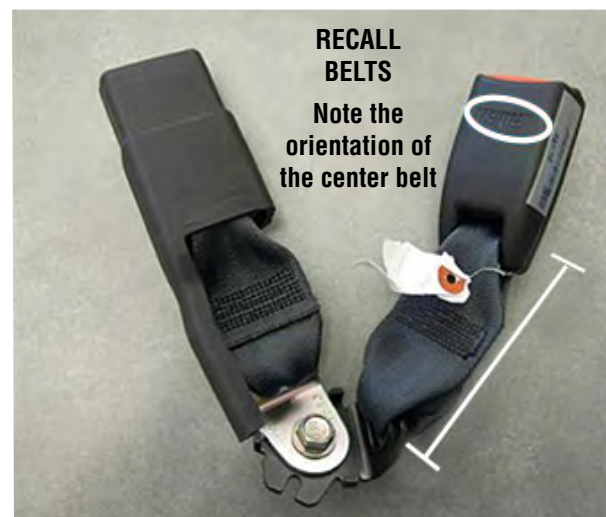
This page should clarify two areas of the Campaign and does not represent any change in procedure. The first clarification is the length of the recall belt. By design, the recall replacement belt is shorter than the original belt.

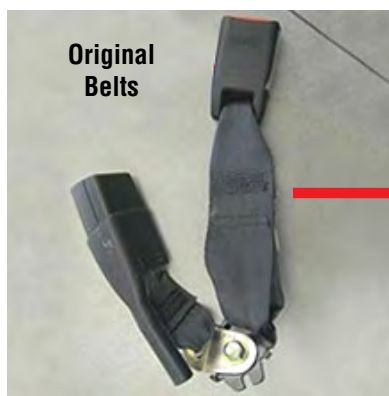
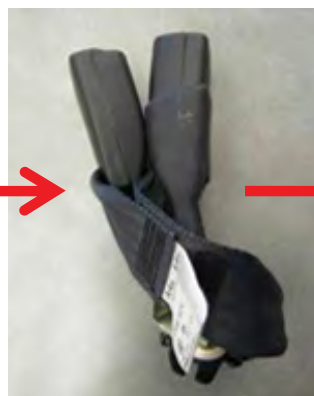
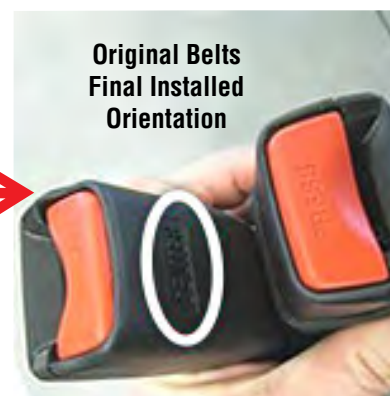
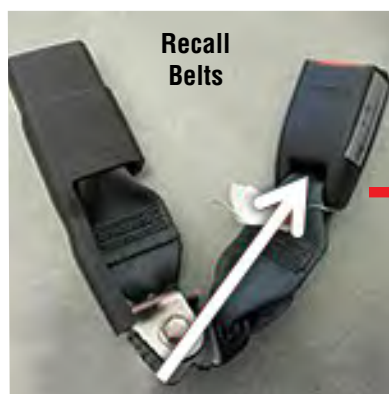
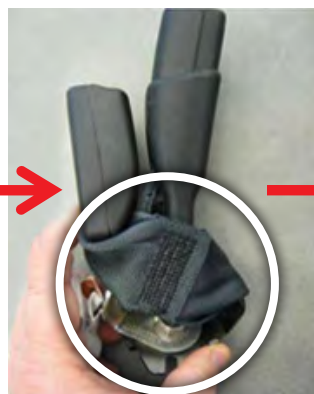
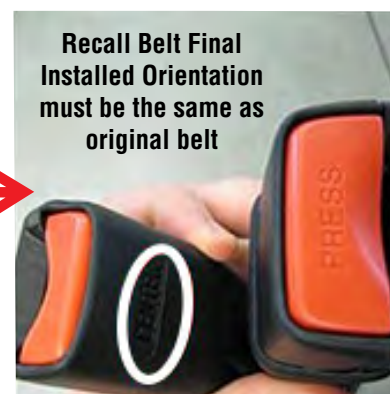
The second clarification is the final buckle/ latch orientation for the center belt. The red latch release button must face away from the seating position it services. Access to the red latch release button must not be blocked by the belt when it is latched in place for use.

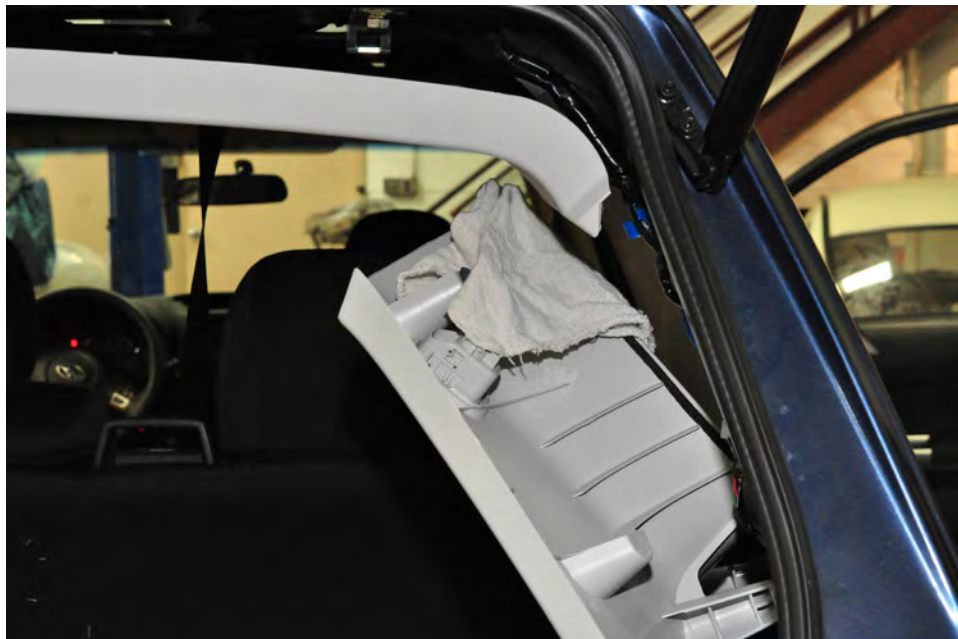
4. Carefully unclip the right rear quarter panel trim from body. It is not necessary to remove the panel. Only move it out slightly to allow the headliner to be lowered. Protect the trim edge from chafing the headliner using a shop rag or other suitable cushion. Unclip the rear upper headliner trim.

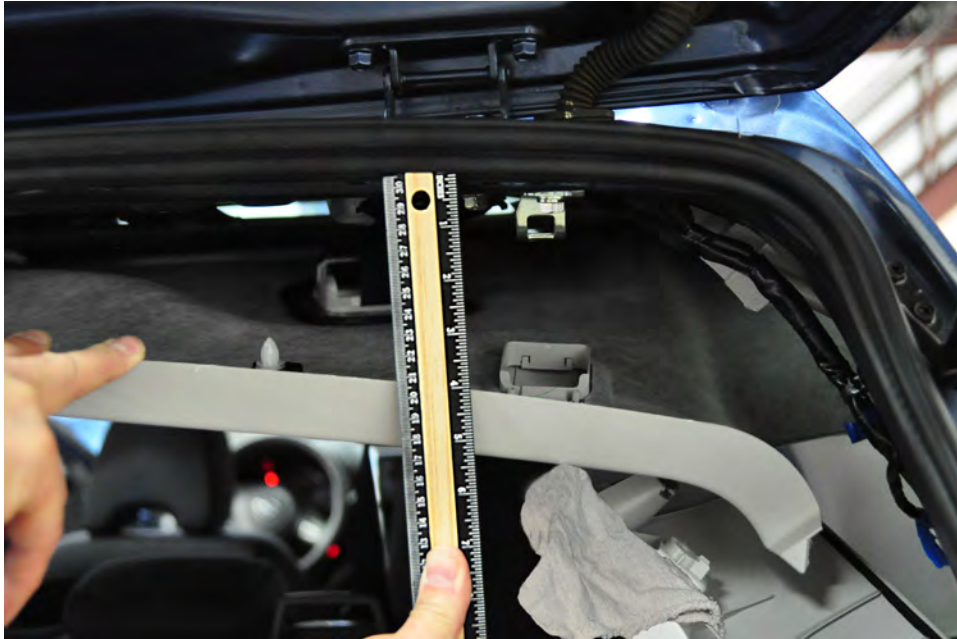
Right side

**Caution:** Headliner supports will prevent the headliner from creasing or bending, the headliner should not be allowed to drop more than 4 inches on the right side and 1.5 inches on the left side. Headliner supports must be used to prevent damage.

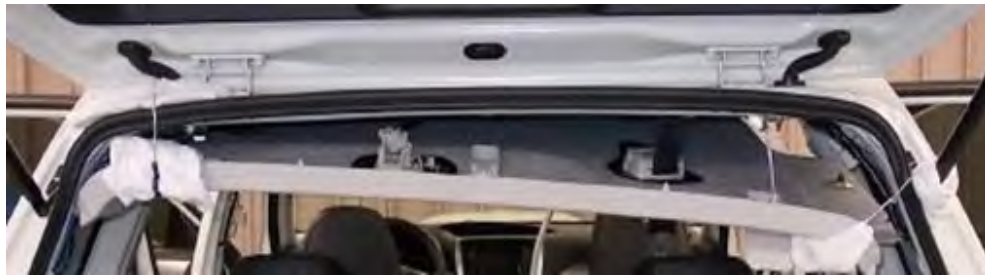
Headliner supports in place

5. Install headliner supports.

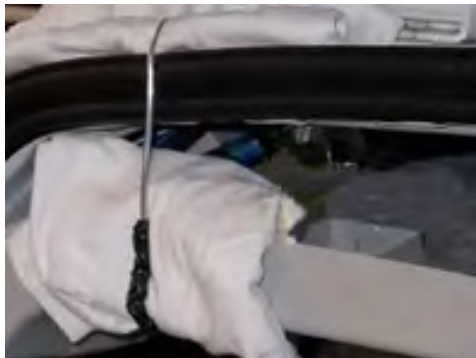
Left side headliner support  
Place over the tailgate opening  
to bottom edge of headliner

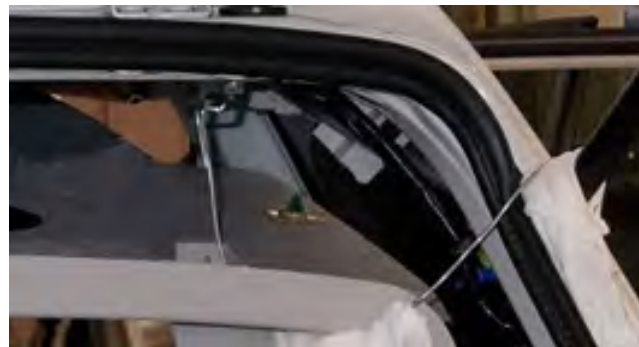
Right side headliner support  
Hook to tether anchor, then route  
through headliner opening for tether  
and attach to rear gate stay.

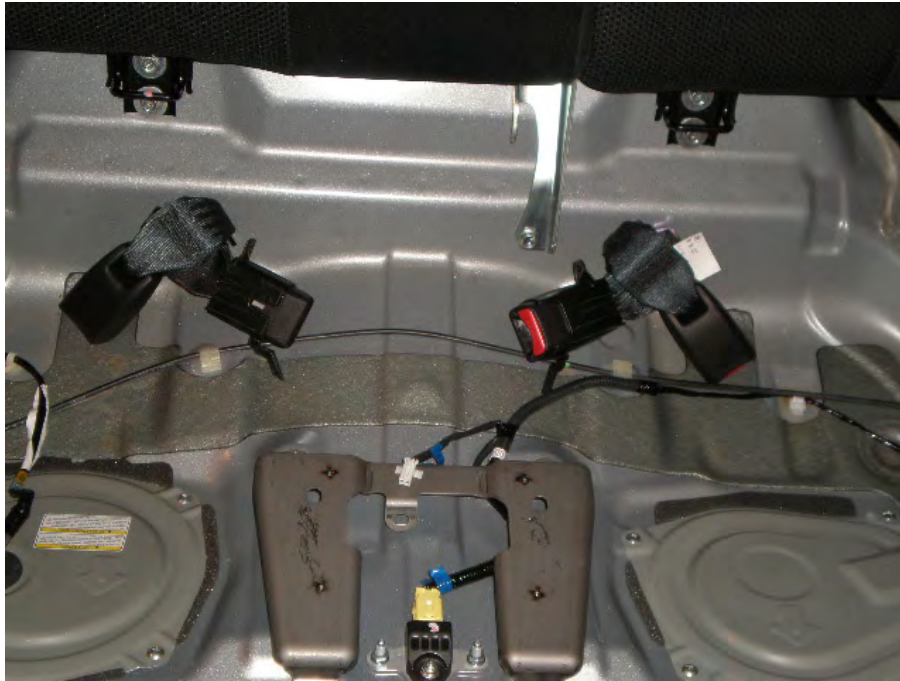
5. Position the seat belt assemblies as shown in the photo below.

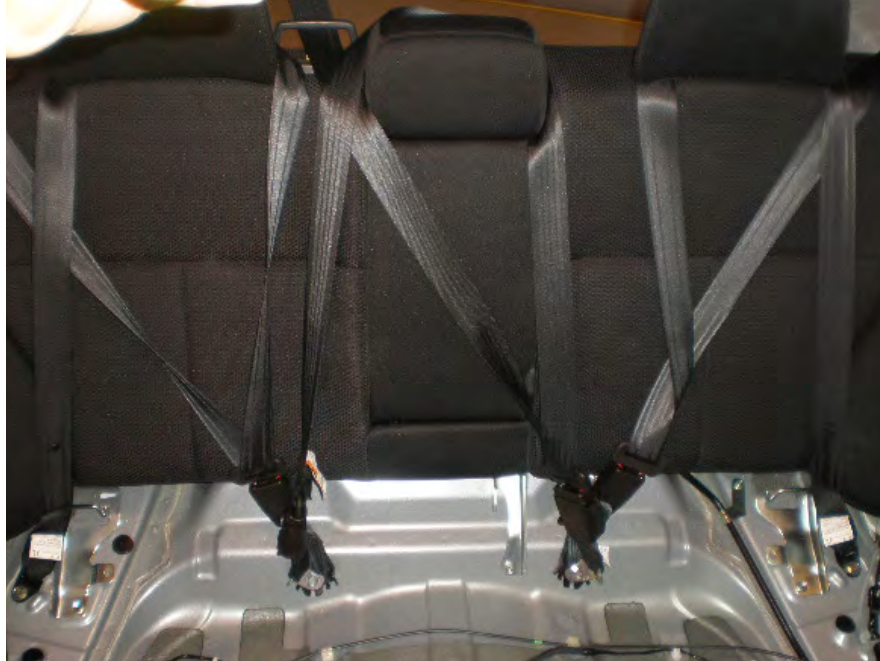
6. Connect the seat belt tongues to all buckles to assist the re-installation of the seat cushion. Extend the outer belt webbing and route them over the headrests as shown below to help hold the buckles and make it easier to re-install the seat cushion.

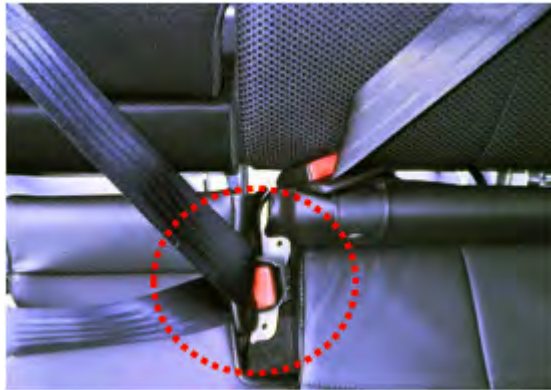
- a. Position the cushion and pull the CENTER buckles into the openings.
- b. Manipulate the brackets on the center belt over the seat openings on both sides.

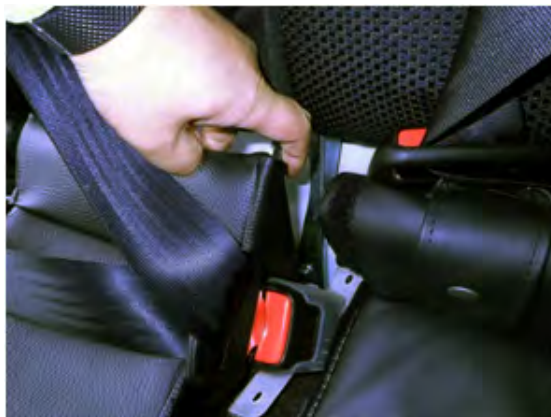
- c. Disconnect the center seat belt buckles.
- d. Push the seat rearward to almost the fully inserted position.
- e. Push the opening cover flap down into the opening out of view. It will no longer be used after installation of this Kit.

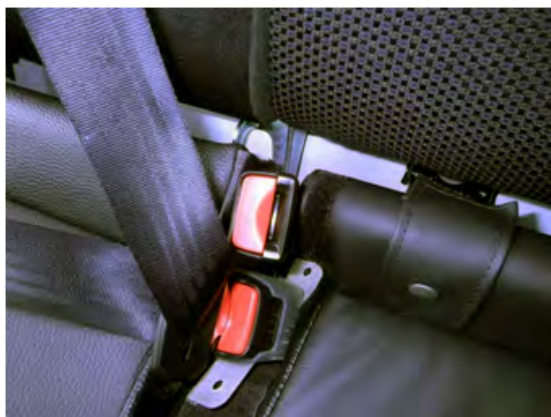
- f. Pull the outer buckles into view and disconnect the belts.
- g. Pull the outer buckles into the opening, above the center buckles on both sides. You can also refer to Figures 2 & 3 for proper positioning.
- h. Leave the outer buckles in the upper part of the opening.

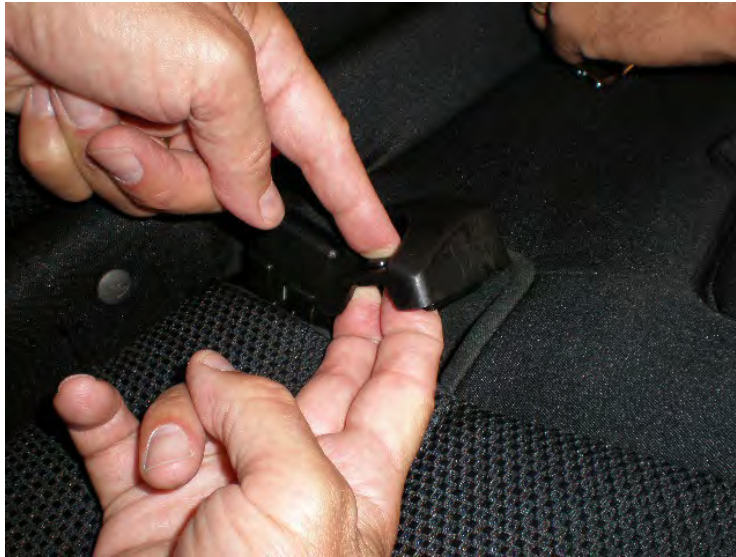
**Figure 6**

- a. Beginning on either side, insert the stabilizer into the opening in the seat, over the CENTER buckle with bracket.
- b. Make sure the stabilizer is seated properly.
- c. Push a clip into each hole, connecting the stabilizer to the bracket on the buckle.
- d. To ensure that the clip is fully seated, hold the assembly up and put fingers under the buckle bracket while inserting the retaining pins as shown in Figure 6 below.

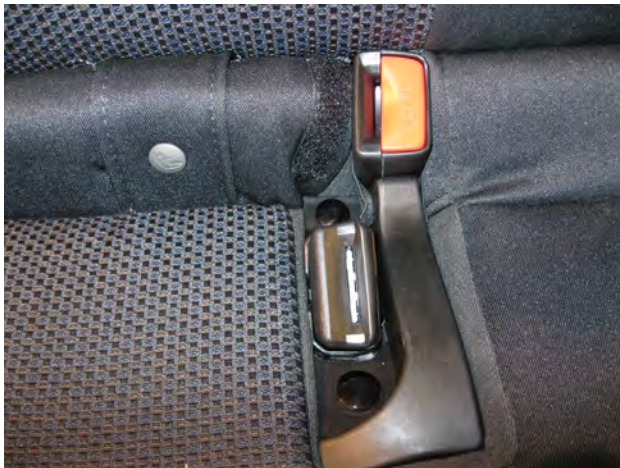
**Figure 7: Completed installation  
Passenger side**

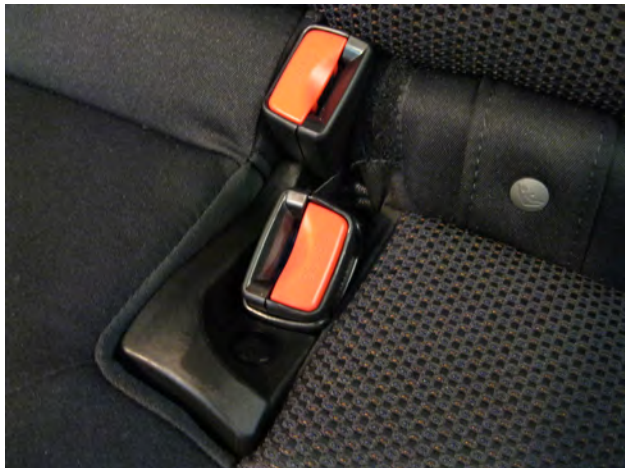
**Figure 8: Completed installation  
Driver side**

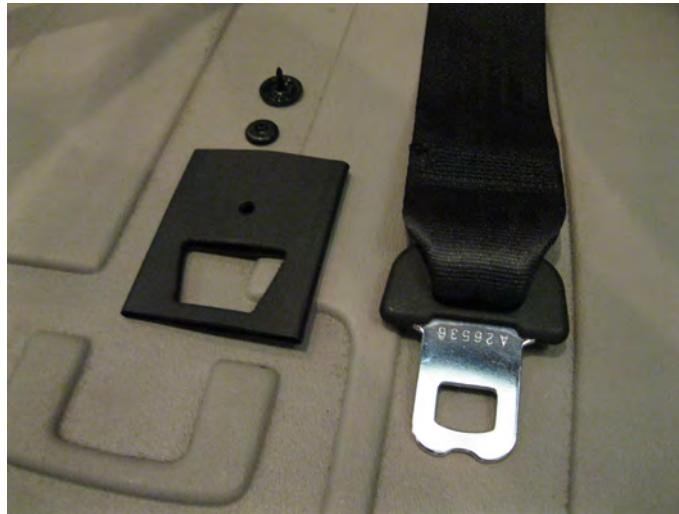
9. Center Seat Belt Tongue Stiffener Installation.

- a. Insert the Center Seat Belt Tongue into the stiffener, centering the opening in the stiffener over the bulge of belt material.

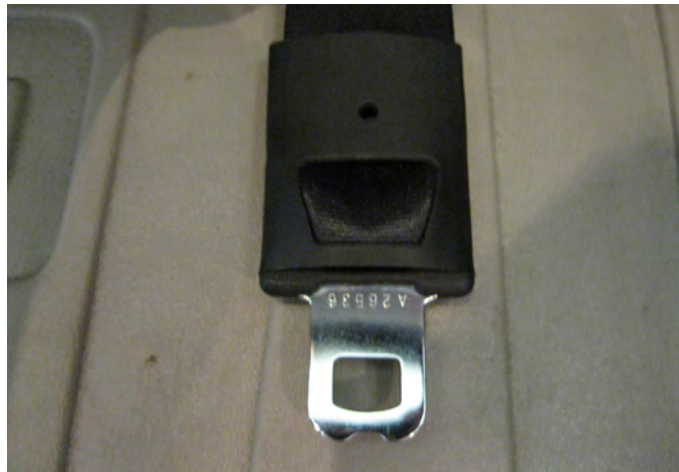
- b. Insert the tack through the hole in the stiffener from the smooth side of the belt stitching (opposite of the label).

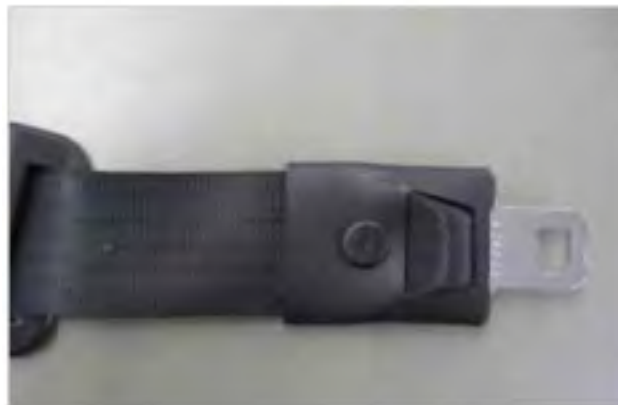
- c. Place the female collar of the tack onto the pin from the other side.
- d. Using an adjustable wrench as shown, clamp the assembly together and compress the pointed end by first tightening the jaws of the adjustable wrench by hand as far as possible.

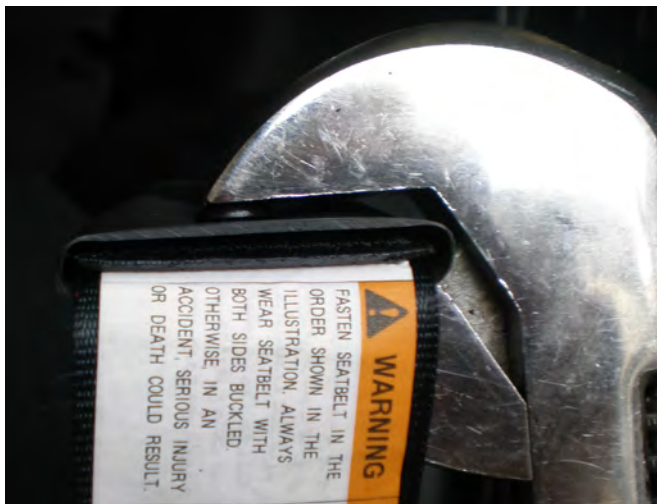
**NOTE:** Keep male and female portions of the tack assembly parallel while compressing them.

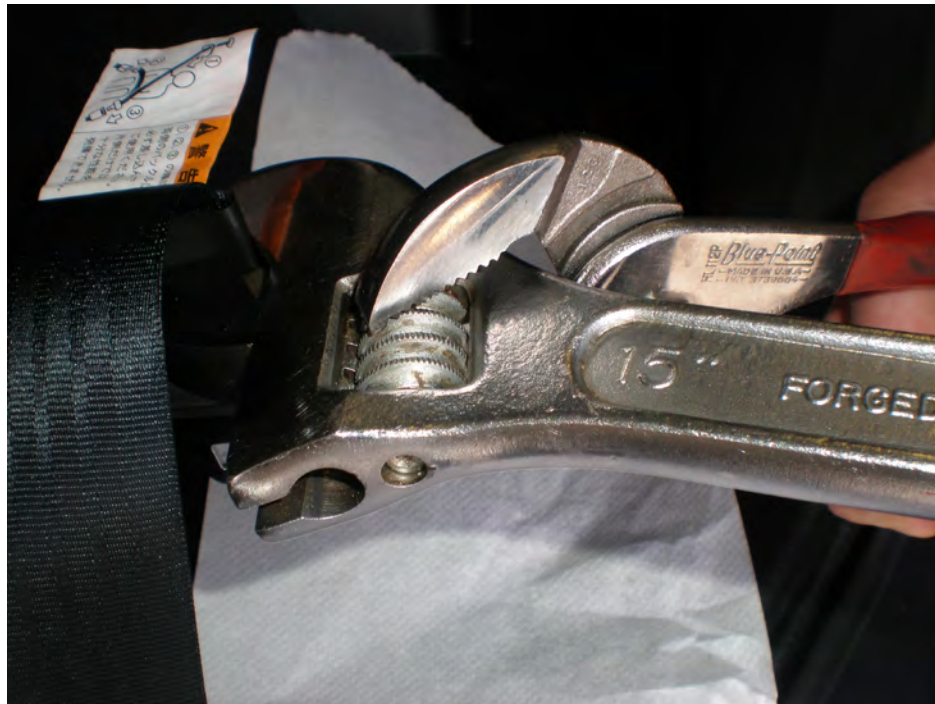
- e. Next, using channel lock pliers, tighten the adjustable wrench gear until the combined height of the tack and belt assembly is ~9.5 to 10.0 mm.

**Figure 9: Seating the Tack Collar**

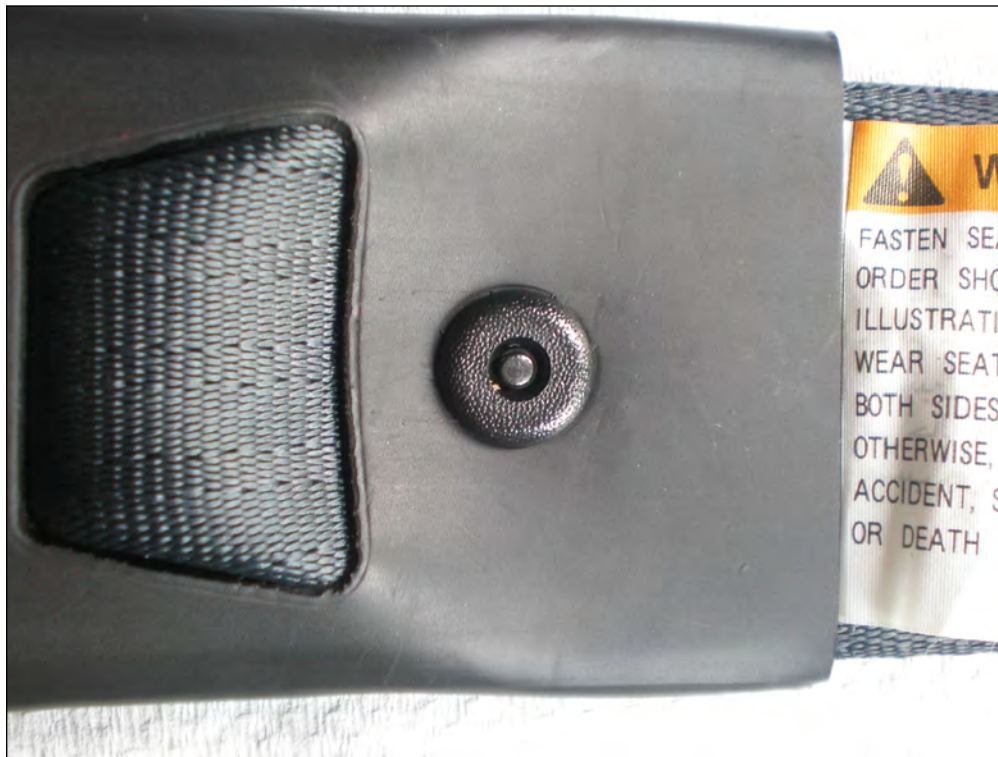
**NOTE:** Confirm that the pin of male tack is compressed as a concentric circle into the hole of collar as shown above.

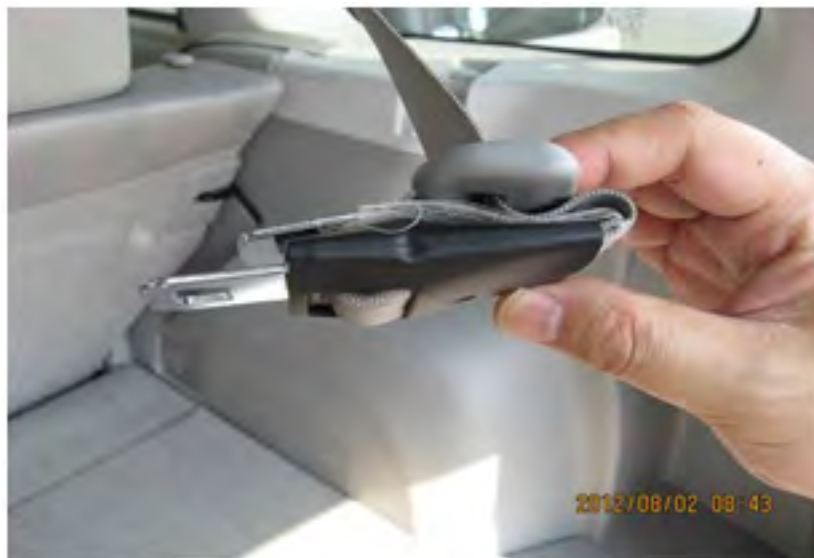
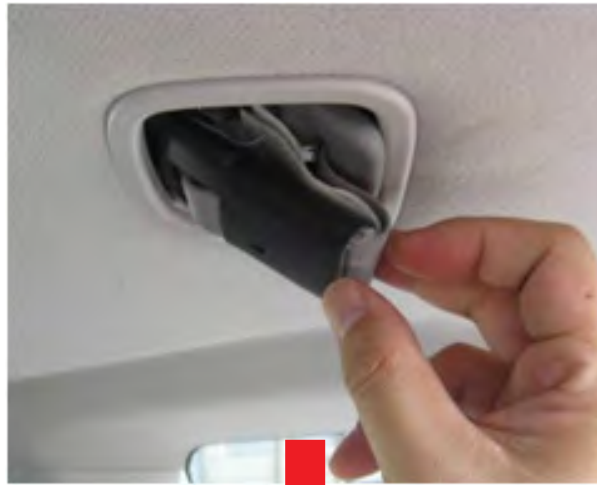
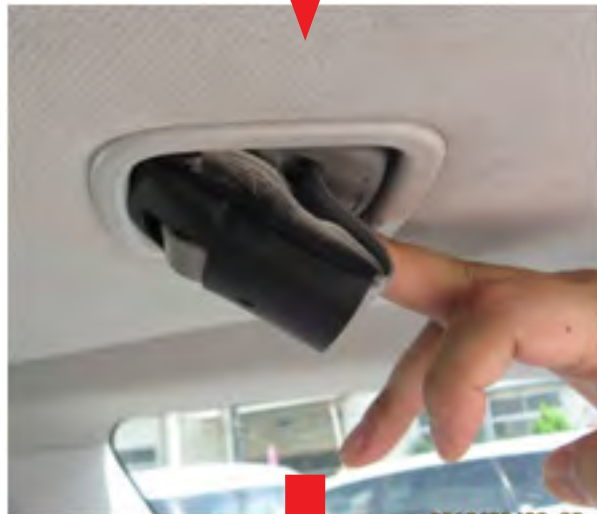
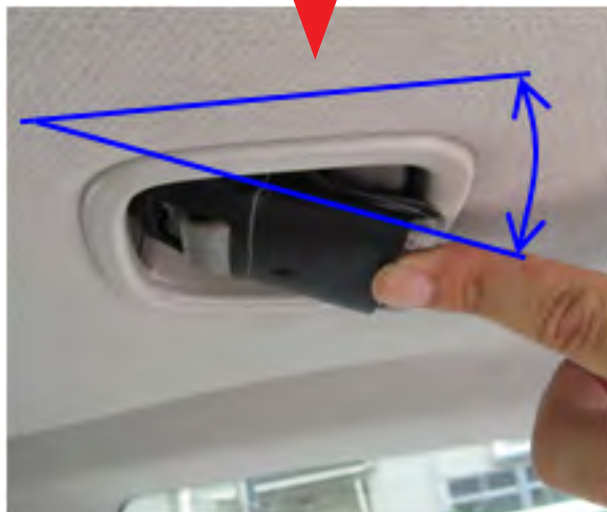
10. Since the stiffener adds some thickness to the tongue, it may be difficult to insert the tongue into the roof holder. Follow the steps in the photos below.
  - a. Fold the upper tongue over the lower tongue as shown.
  - b. While holding the pieces together, insert both into the opening and push up as shown.
