## REPAIR PROCEDURE

**SUBJECT:** Repair Procedure for Subaru Recall  
Campaign WQA-37; 2009~2012MY  
Subaru Forester Rear Seat Center Seatbelt

**DATE:** March 13, 2012

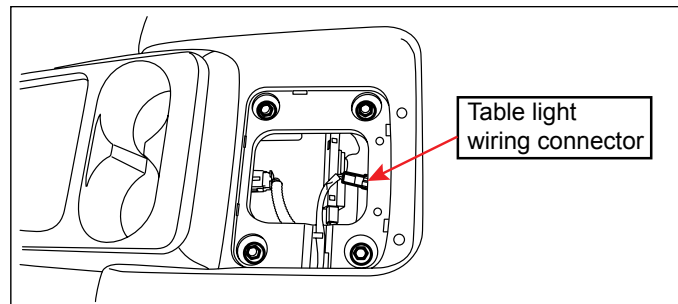
1. Record preset radio stations.
2. Turn ignition switch to OFF. Disconnect the ground cable from battery, and wait for 60 seconds or more before starting work.
3. (Models with seat table). Flip open the seat table of the rear seat cushion and remove trim cover. Disconnect the table light (white) wiring connector. **Caution:** Do not disconnect the satellite safing sensor wiring connector. Remove the 4 (10mm) bolts.

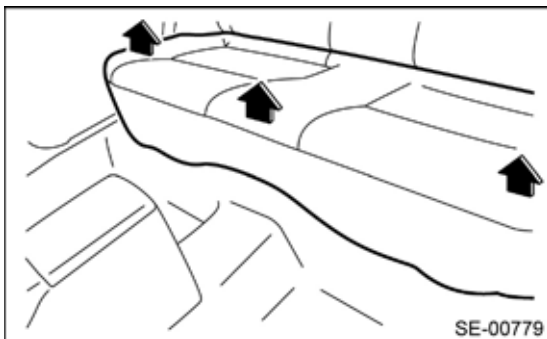
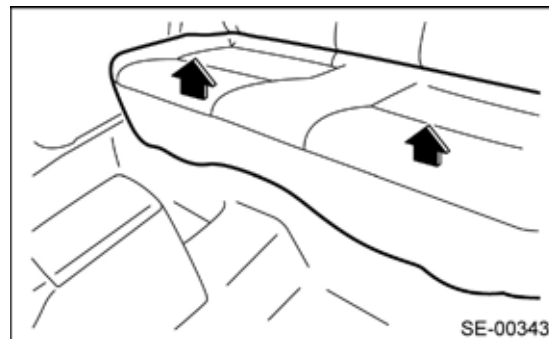
Seat Anchor locations depending upon applicability (with or without seat table).

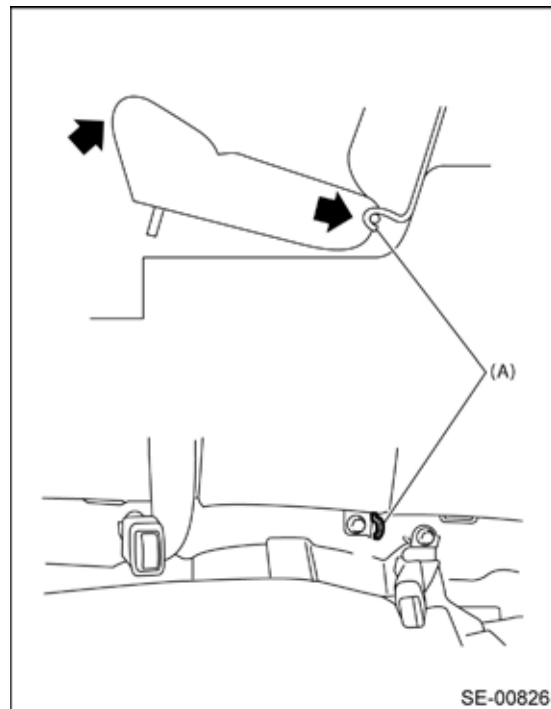
4. Disengage the hook (A) by pushing it back while lifting the front side of the seat cushion. Perform the same procedure on the opposite side. Remove seat cushion from vehicle.

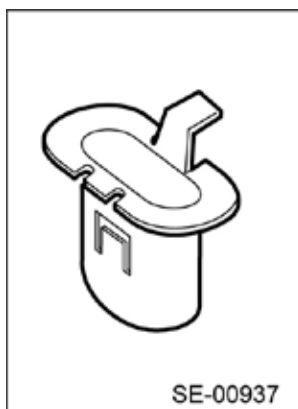
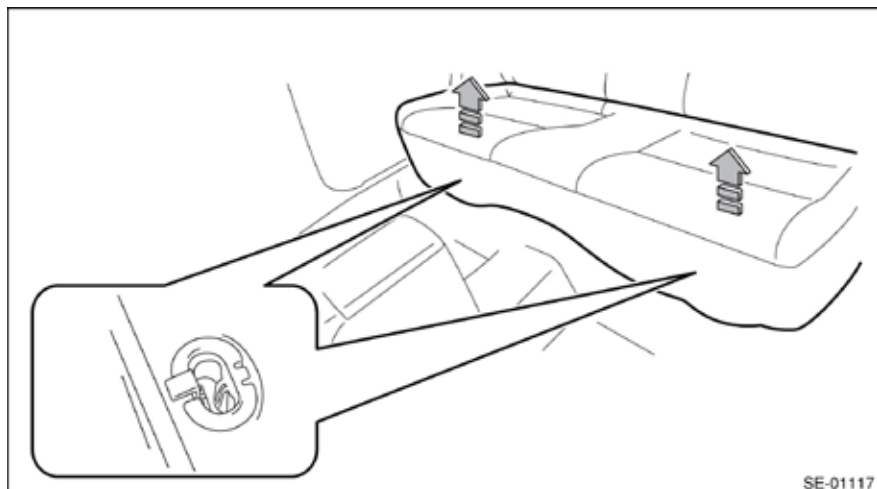
**Caution:** If the hooks (either two or three) on the vehicle body side are disengaged (remain on the seat cushion side) when removing the rear seat cushion, always replace with new hooks to prevent any reduction in the retention force of the hook.

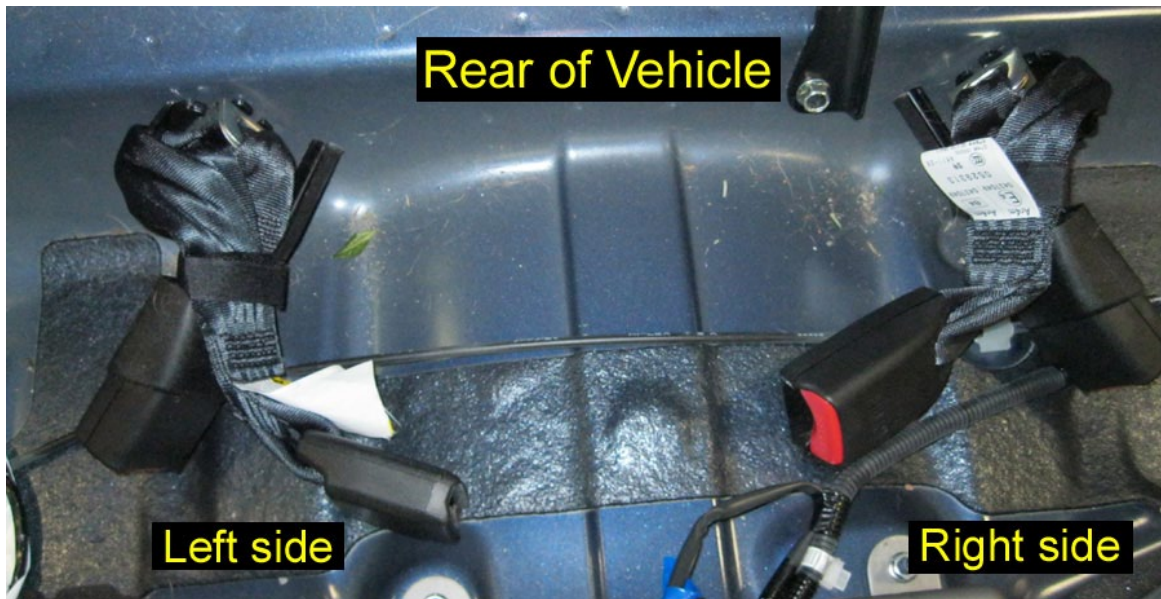
The center seatbelt with “**Key Slot Release**” requires replacement.  
The center seatbelt buckle marked “**Center**” requires replacement.

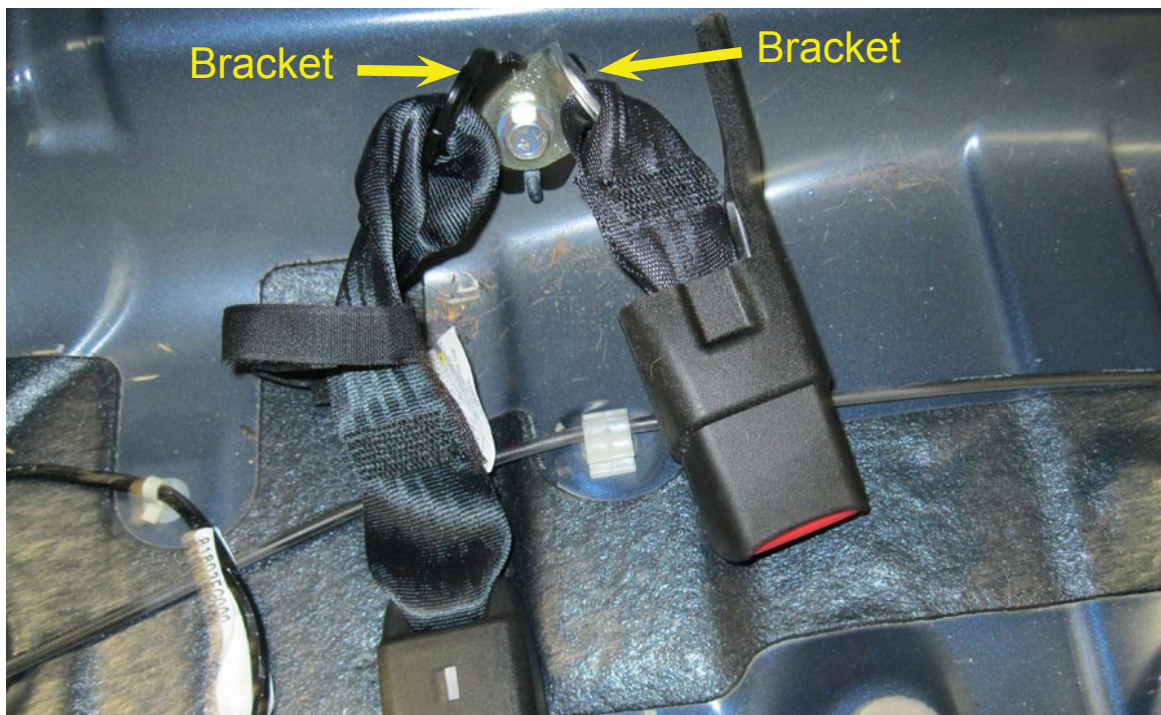
**Note: Make sure to note the location of the seatbelt brackets.**

5. Unwrap the Velcro® strap and remove the bolt to remove the seatbelts. Perform the same procedure on the opposite side.

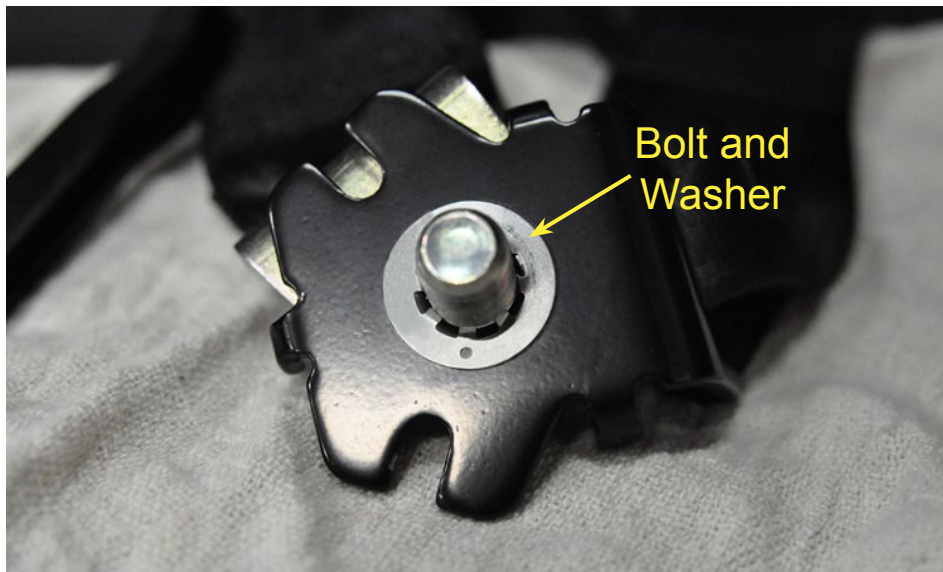
6. Separate seatbelt brackets by removing bolt and washer. Discard bolt and washer.

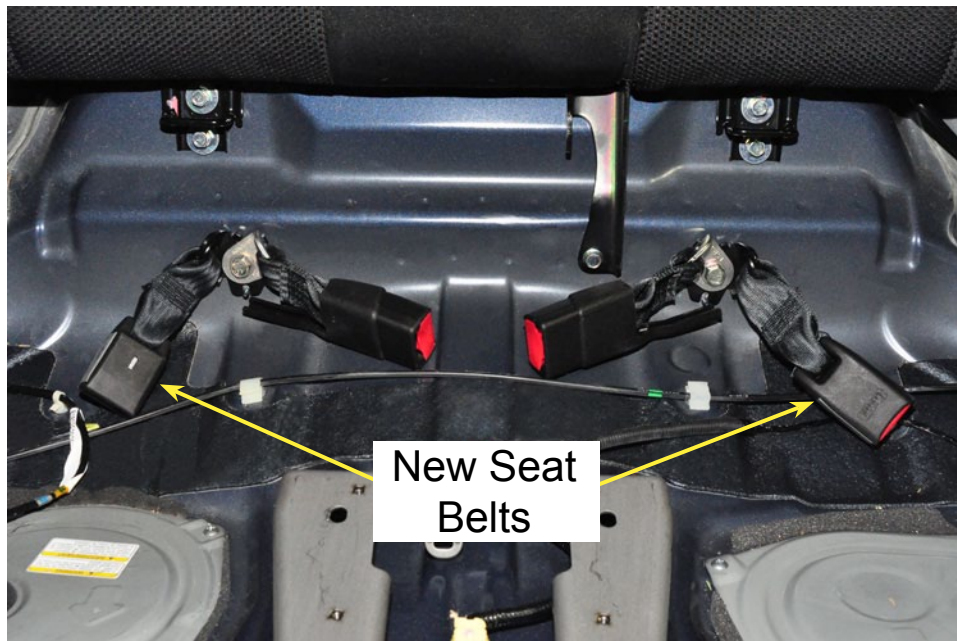
7. Reassemble both belt assemblies using new inner belt and bolt in the same orientation as original. **Note: Washer is not required.**

**Caution: Make sure new belt bracket is on the bottom.**

8. Reinstall assemblies into vehicle and torque to spec. 30 N-m (3.06 kgf-m, 22.1 ft-lb)

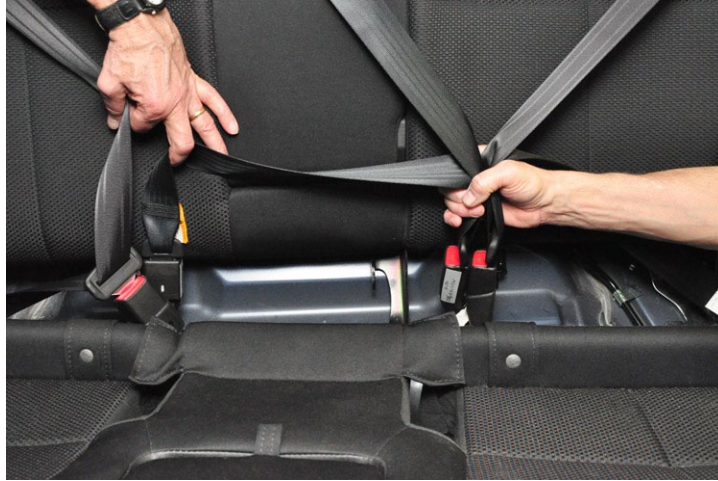
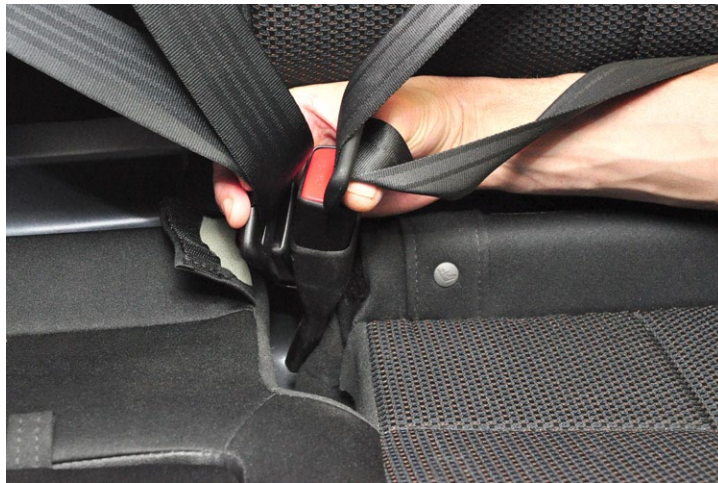
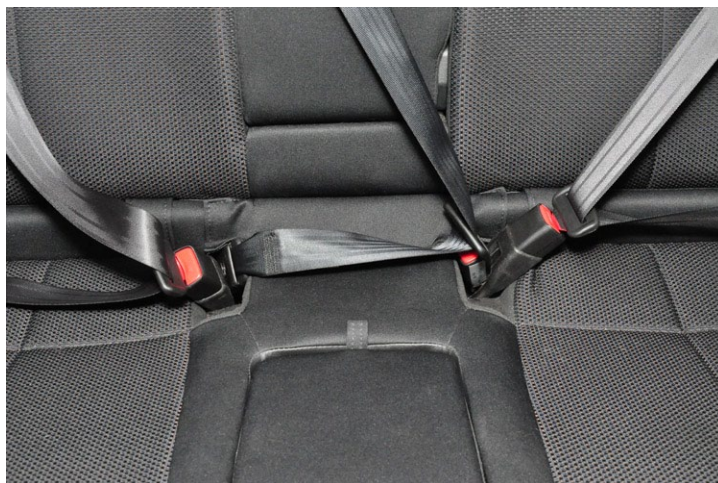
9. Reinstall the seat cushion. To facilitate positioning of the seatbelts in the cushion, connect all of the seatbelts. The next step will require an assistant. With each person holding the left and right seatbelts respectively, slide the cushion into place while pulling the belt buckles into position in the seat cushion opening.

Proper seatbelt buckle orientation

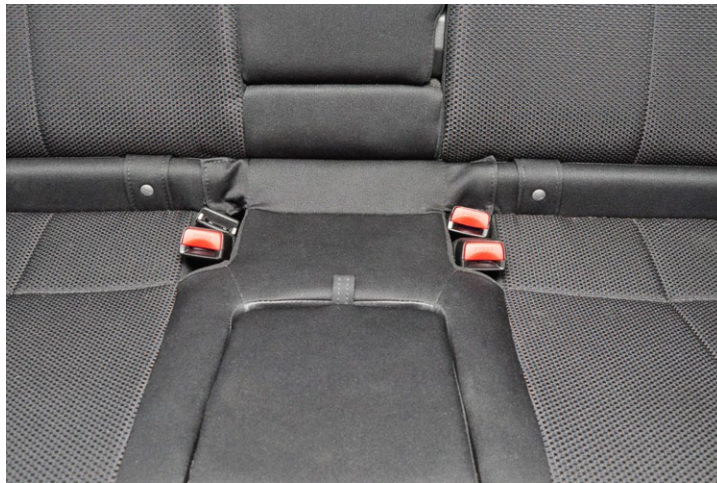
10. Disconnect the belts and position the buckles as shown.

Proper seatbelt buckle(s) positioning

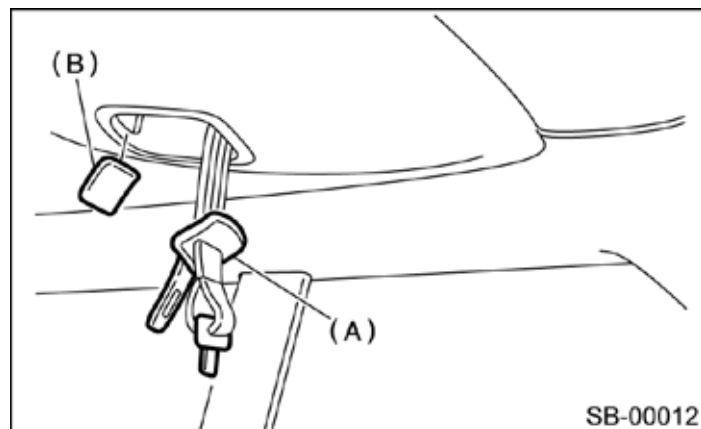
1. Carefully remove the belt trim cover (B). Pull the outer seatbelt center tongue (A) through the headliner opening.

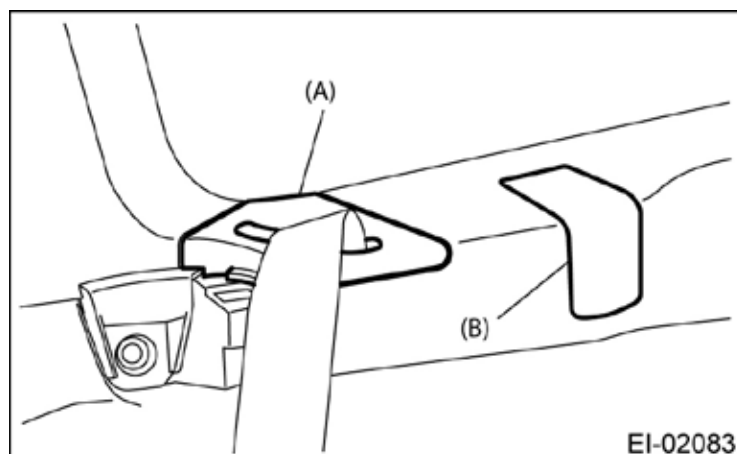
2. Remove the right rear quarter panel trim covers (A) and (B).

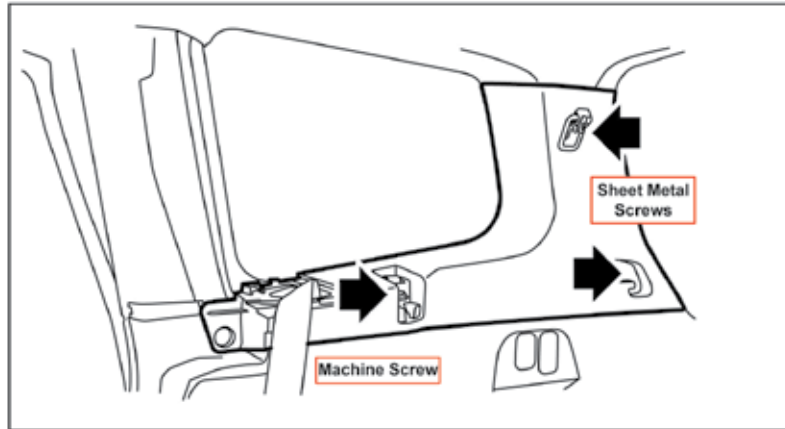
3. Remove the front machine screw and 2 rear sheet metal screws from the right rear quarter panel trim.

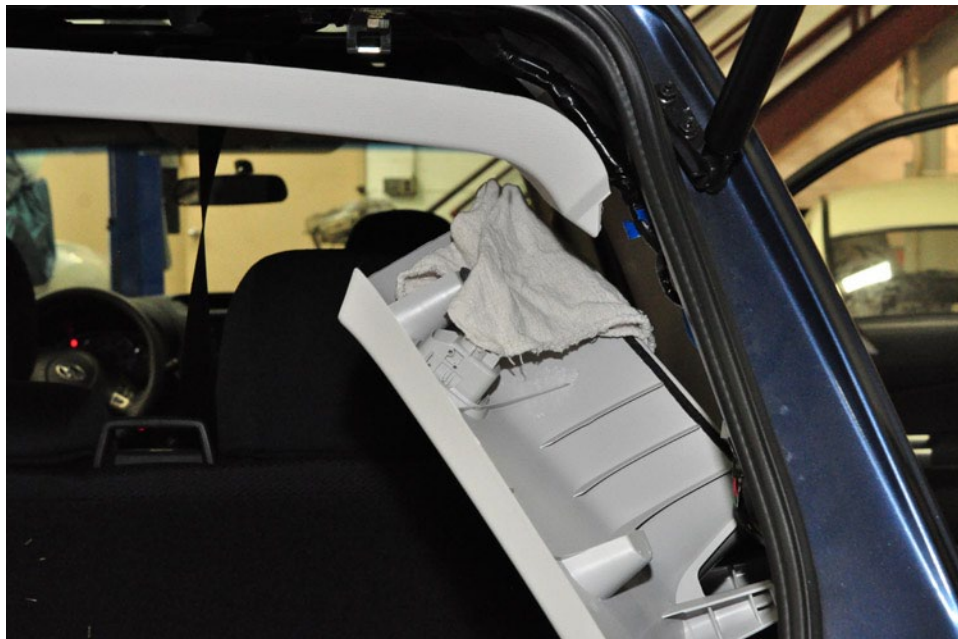
4. Carefully unclip the right rear quarter panel trim from body. It is not necessary to remove the panel. Only move it out slightly to allow the headliner to be lowered. Protect the trim edge from chafing the headliner using a shop rag or other suitable cushion. Unclip the rear upper headliner trim.

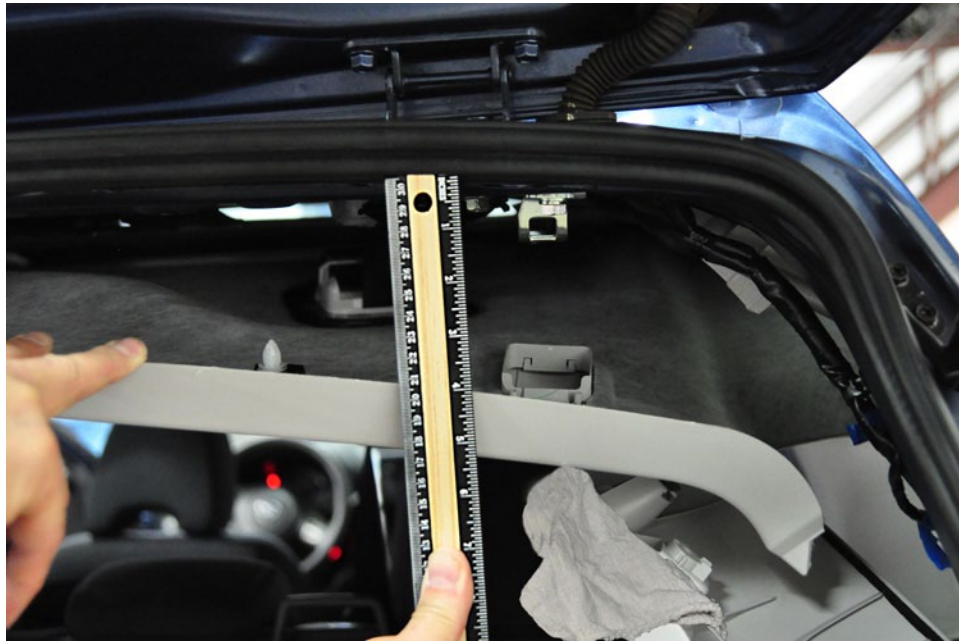
Right side

**Caution:** Headliner supports will prevent the headliner from creasing or bending, the headliner should not be allowed to drop more than 4 inches on the right side and 1.5 inches on the left side. Headliner supports must be used to prevent damage.

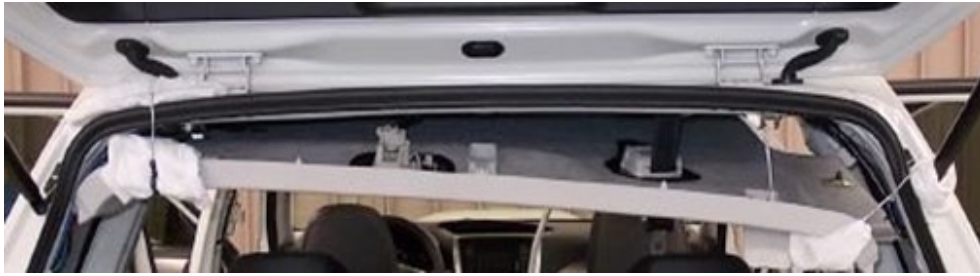
Headliner supports in place

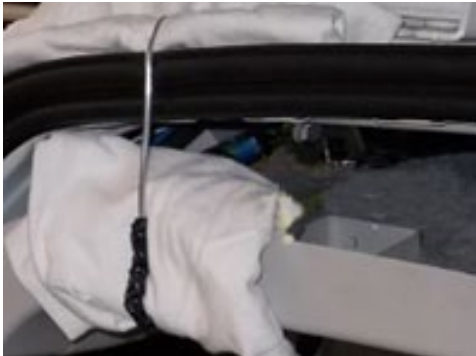
Left side headliner support  
Place over the tailgate opening  
to bottom edge of headliner

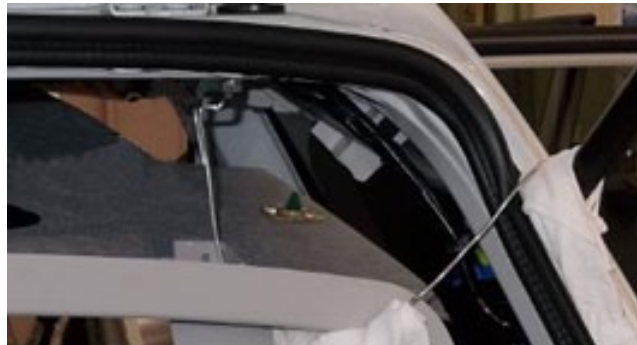
Right side headliner support  
Hook to tether anchor, then route  
through headliner opening for tether  
and attach to rear gate stay.

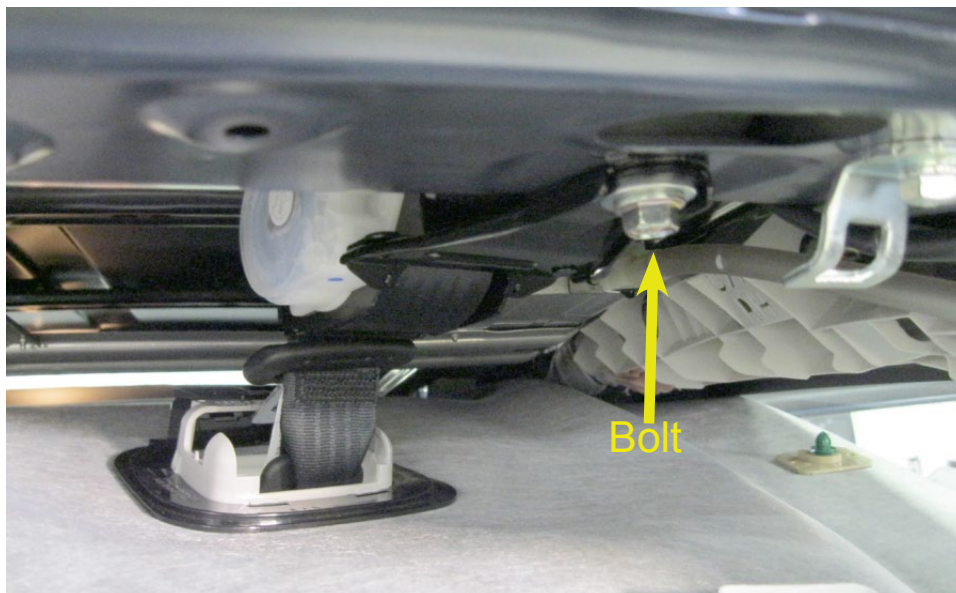
6. Remove the bolt and rear center seatbelt.

7. Install new rear center seatbelt and bolt.

**Caution: Carefully start bolt by hand to prevent cross-threading.**
