North American
Bus Industries, Inc.

Subject: 12V-118, NVS-215et

The attached Work Instruction, NABI # L3/FSV-094 is being submitted as supplemental information to Recall 12V-118. The Work Instruction is being used by NABI Field Service personnel to remedy buses involved in this Recall.

New Jersey Transit: NJT Pitman Arm / Draglink
Containment Work Plan

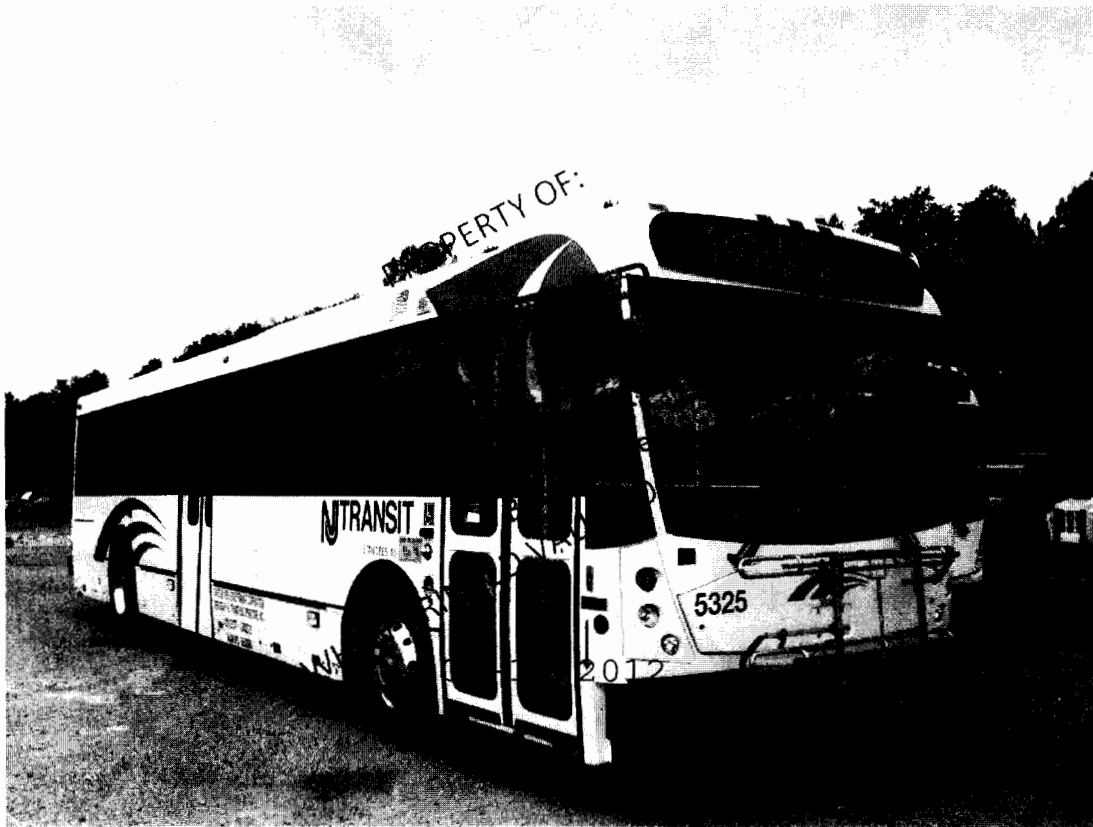
Issue: Loose drag link joint at the Pitman arm

Reason/ cause: Under investigation.

Solution: Follow procedure described in this work instruction (SOI).
