Applies To: **2002–03 Civic** – Check the iN VIN status for eligibility
2004–05 Pilot – Check the iN VIN status for eligibility

Safety Recall: Low Beam Headlights May Not Work

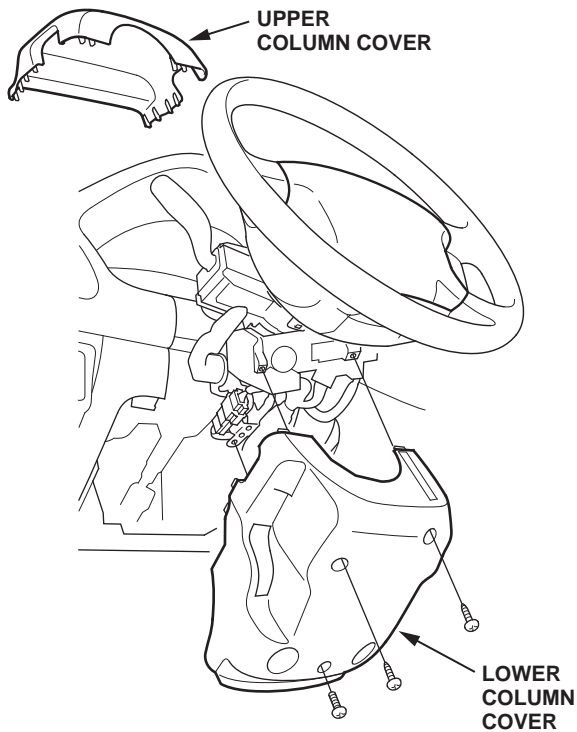
1. Remove the upper and lower column covers.

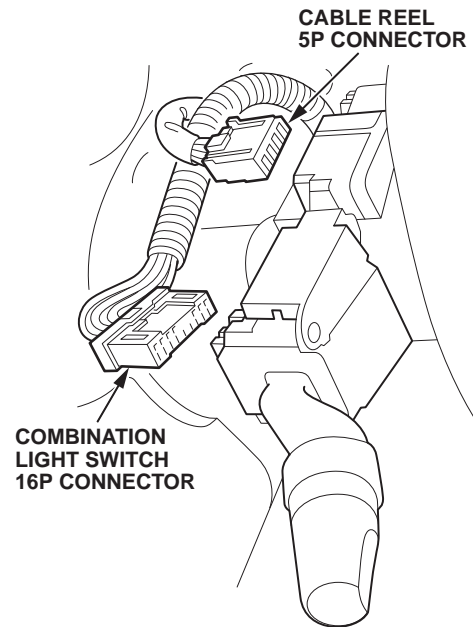
2. Disconnect the 16P connector from the combination light switch and the 5P connector from the cable reel (if equipped). On Civic Hatchbacks, also disconnect the 14P connector from the wiper switch. Then carefully pull the wire harness to the right of the steering column.

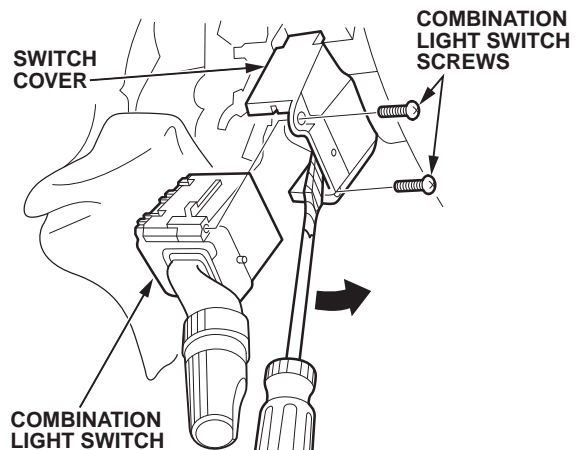
3. Turn the ignition switch to the ACC (I) position, then turn the steering wheel 90 degrees to the left to allow room for removal of the combination switch.
4. Remove the two screws from the combination light switch.

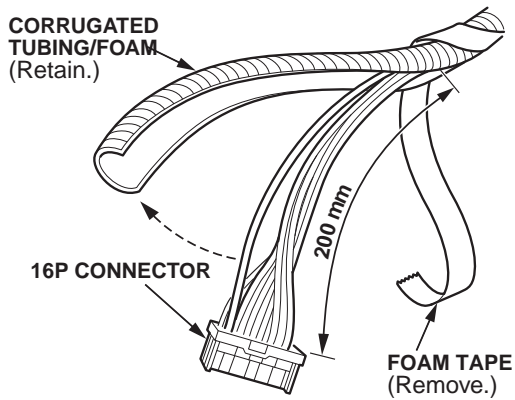
6. For Civic - Remove the tape or corrugated tubing/foam from the 16P connector wire harness to expose about 200 mm of wire. Discard the tape, but retain the tubing/foam.

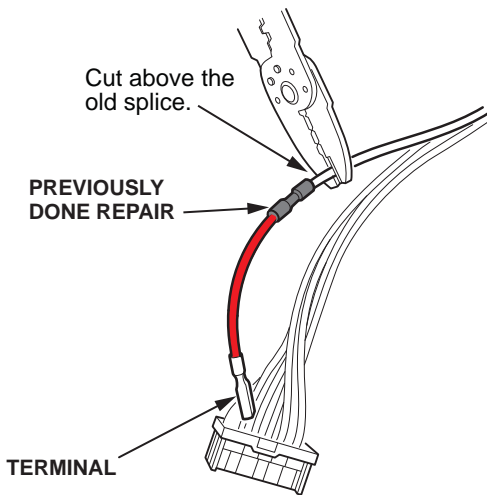
7. If you see a splice connector on the terminal No. 6 wire, cut the wire above the splice connector as shown, and continue with the repair.

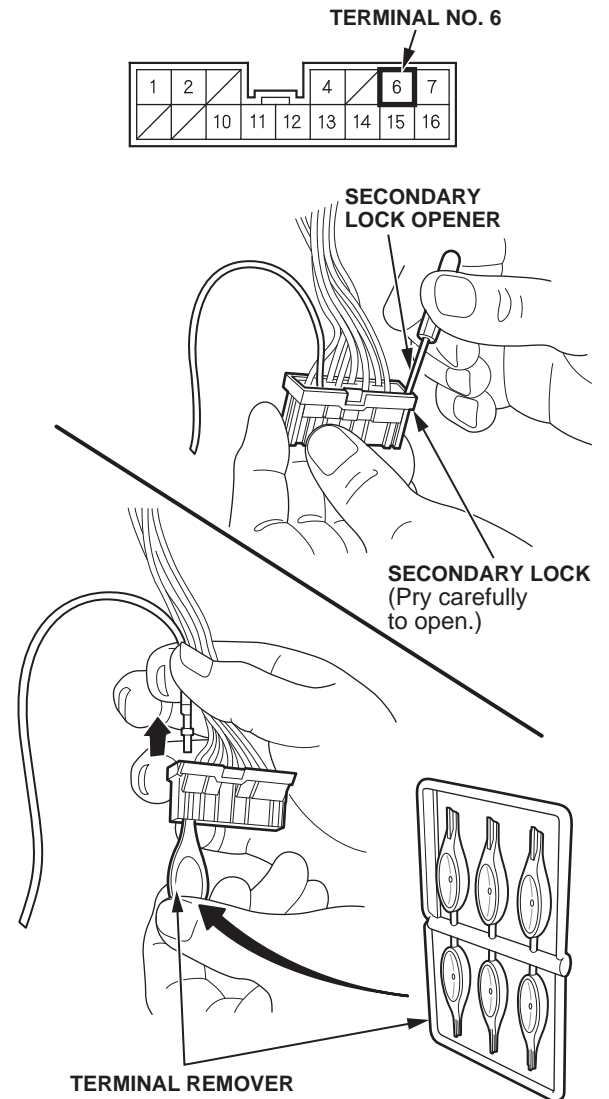
8. Using the secondary lock opener from the Terminal Maintenance Set (T/N 070AZ-S5A0100), carefully pry open the secondary lock of the combination light switch 16P connector.

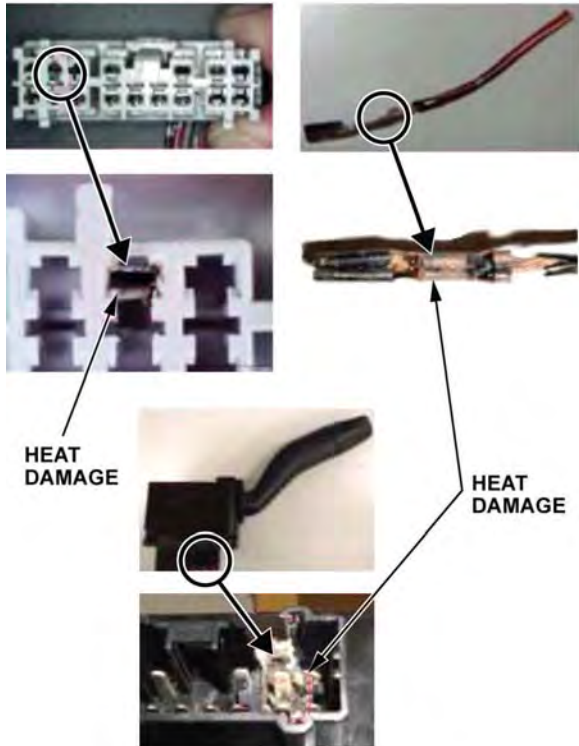
10. Using the photos below, check for signs of heat damage on the 16P connector, the terminal end of the terminal No. 6 wire, and the 16P terminals of the combination light switch.
- If you don't find any signs of heat damage, the combination light switch connector will be reused because you'll only be installing a Combination Light Switch Wire Kit. Go to step 13.
 - If you do find signs of heat damage, the combination light switch connector must **not** be reused because you'll be installing a Combination Light Switch Repair Kit, which includes a new connector and a new switch. Go to step 11.

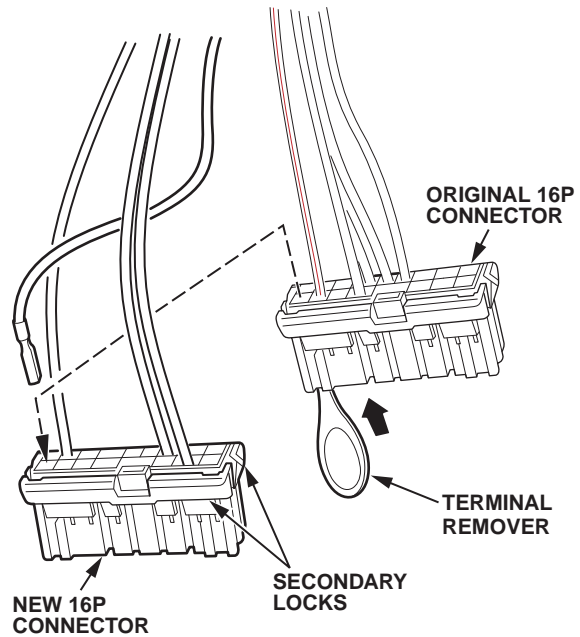
12. Twist off a terminal remover from the Terminal Maintenance Set (T/N 070AZ-S5A0100). Insert the terminal remover into a center row cavity of the original 16P connector, remove the corresponding wire from its cavity, and transfer it to the same cavity in the new 16P connector from the repair kit. Repeat this for all the wires *except* terminal No. 6; this wire will be installed later.

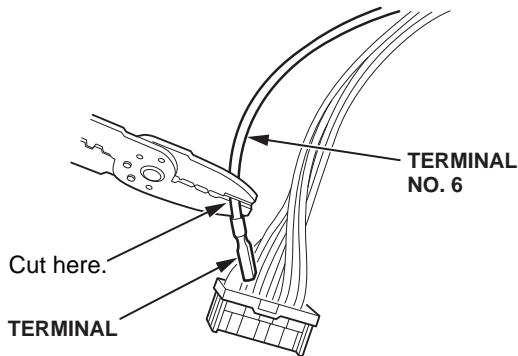
15. Cut the vehicle side terminal No. 6 wire near the terminal, then strip off 7 mm of insulation from the end of the wire.

NOTE: If there was any heat damage to the wire, make sure to cut off the damaged area before you strip off the insulation.

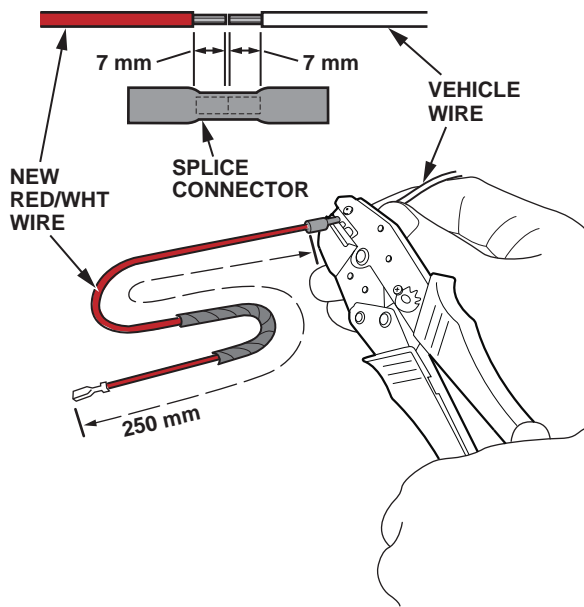
16. Insert the stripped end of the new and the original wire into each side of the splice connector from Terminal Pin Kit C, then, using the wire crimper from Terminal Pin Kit C, crimp the connector on both sides. Slightly pull on both sides of the wire to make sure it's secured in the splice connector.

NOTE: To get the correct amount of pressure on the splice connector, you need to use the wire crimper from Terminal Pin Kit C.

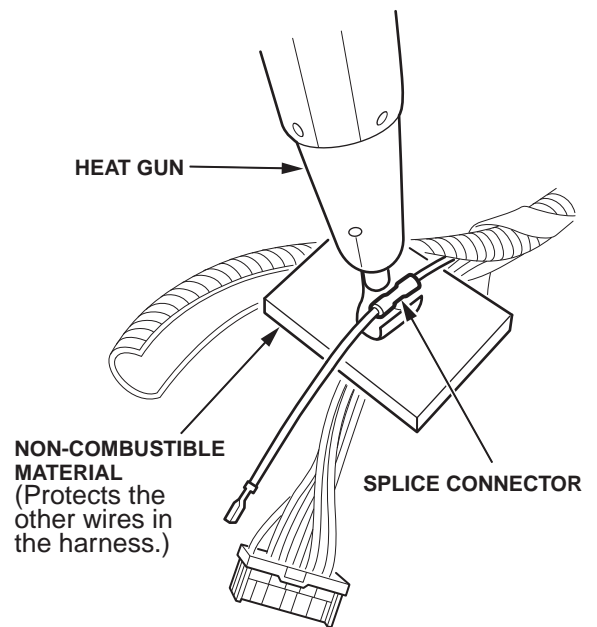
17. With a non-combustible material between the wire and the vehicle wire harness, use a heat gun to shrink the splice connector casing.

- Be careful not to get burned.
- Do not overheat the wire.

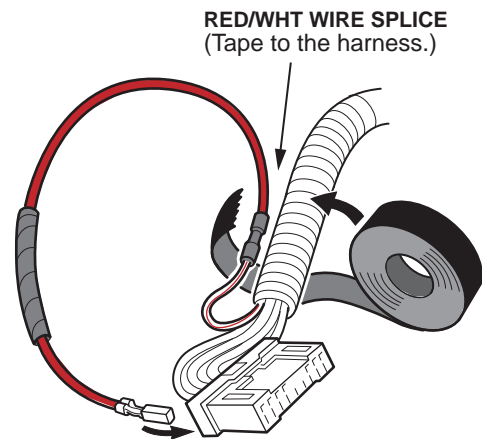
19. Place the wire splice on top of the combination switch wire harness, then attach the splice to the harness by wrapping them together with electrical tape.

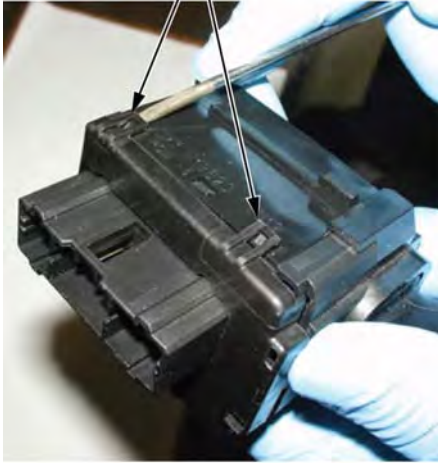
Release the switch cover locks.

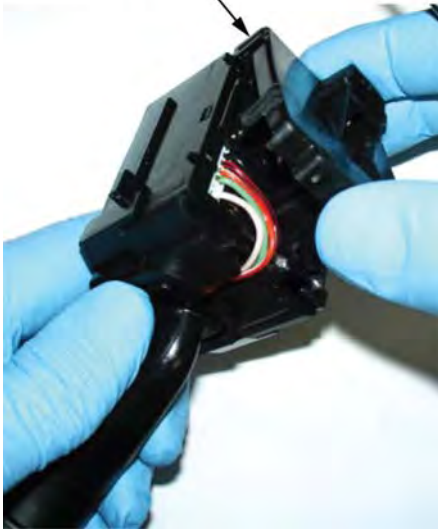
SWITCH COVER
Remove.

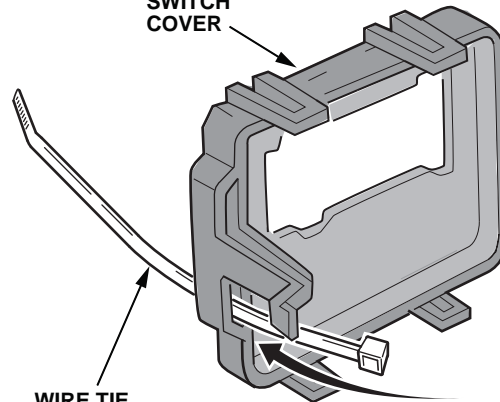
22. As shown below, route the wire tie from the kit through the hole in the lower corner of the switch cover. Then use the wire tie to secure the RED/WHT wire (in the section you taped in step 13) to the switch cover. Reinstall the cover, and cut off the excess wire tie.

SWITCH COVER

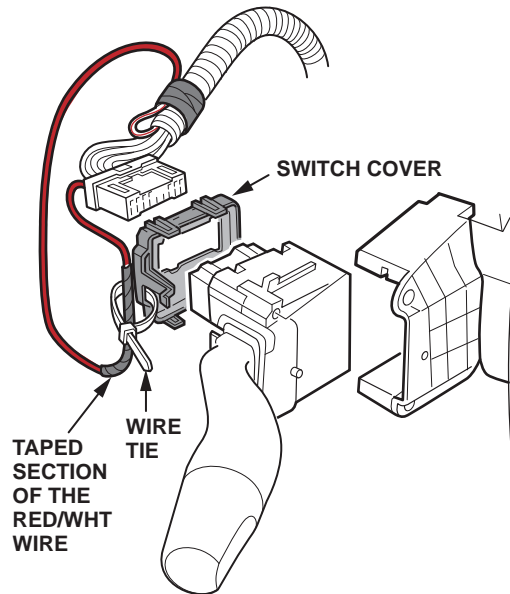
WIRE TIE
Route through the switch cover hole in the direction of the arrow.
