Reference: NHTSA Identification Number 12V-141

Safety Recall M13 / NHTSA 12V-141 Right Rear Wheel Hub and Bearing

2012 (RT) Dodge Grand Caravan and Chrysler Town & Country

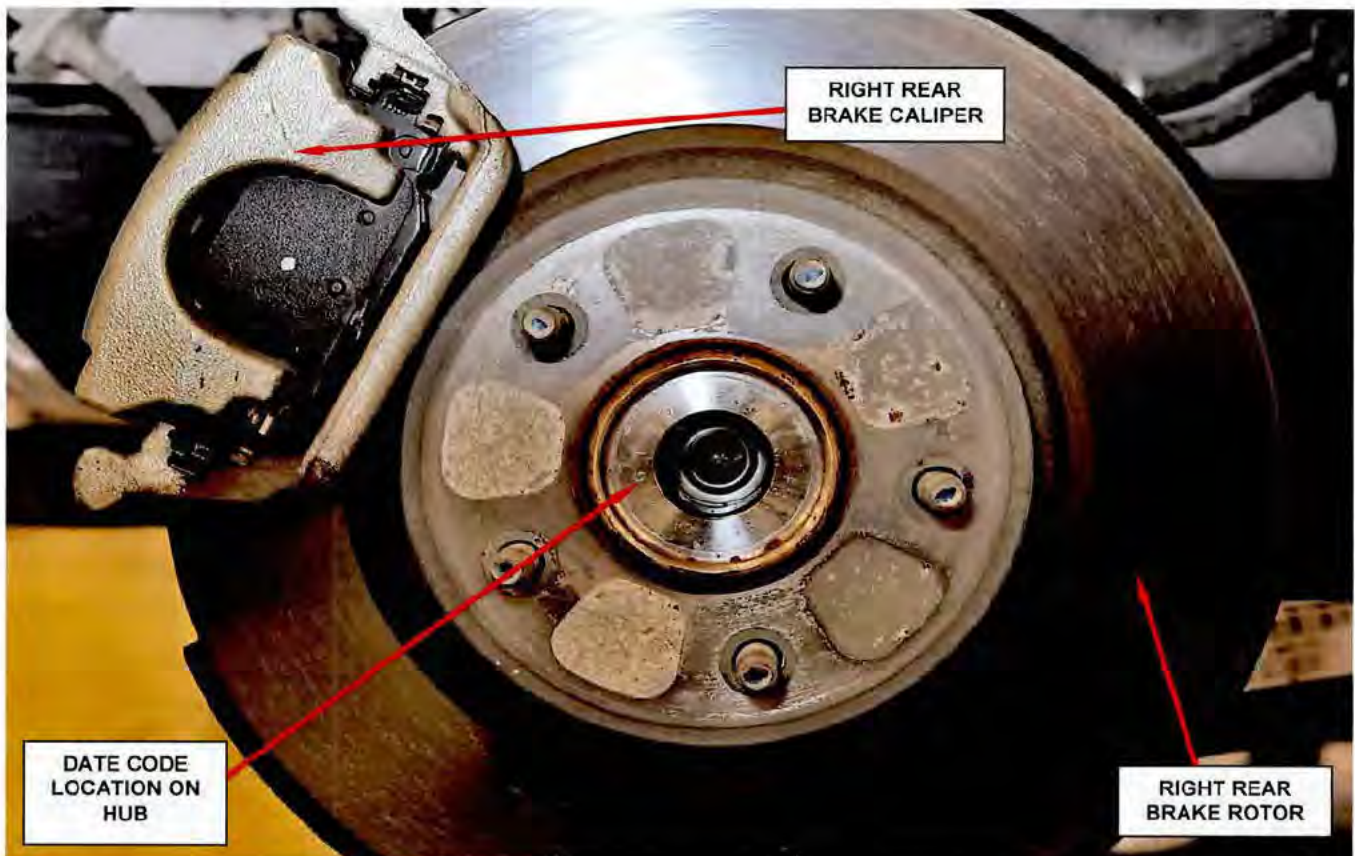
Figure 1 – Inspect the Right Rear Wheel Hub and Bearing Date Code

1. Raise the vehicle on an appropriate hoist.
2. Remove the right rear tire/wheel assembly.
3. Clean the inside of the wheel centering hub and inspect the date code (Figure 1):
 - If the date code **is not GTN11A**, the right rear wheel bearing does not need to be replaced. Install the wheel assembly, tighten the lug nuts to 100 ft. lbs. (135 N·m), lower the vehicle from the hoist and return the vehicle to the customer.
 - If the date code **is GTN11A** (or is not legible), replace the right rear wheel bearing. Continue with **Section B. Replace the Right Rear Wheel Hub and Bearing**.

The right rear wheel hub and bearing must have the date code inspected. Right rear wheel hub and bearings with a particular date code must be replaced.

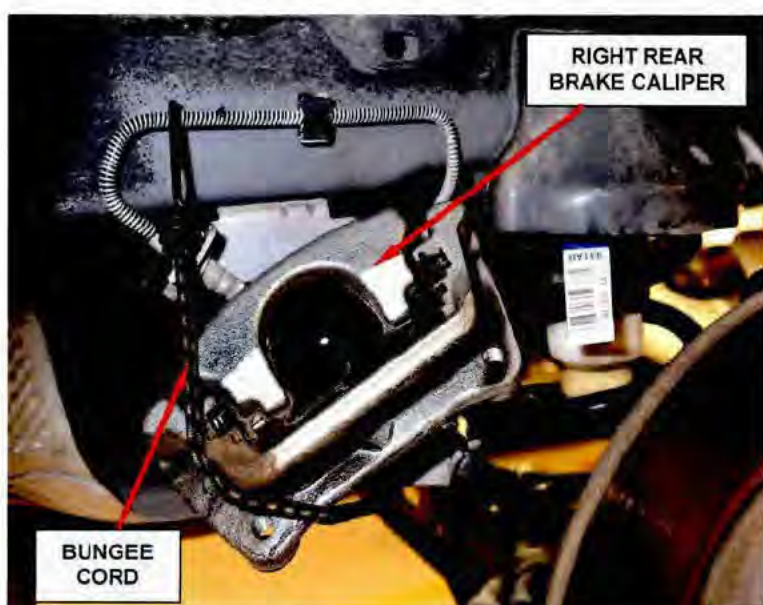
Figure 5 – Hang Caliper with Bungee Cord

8. Remove the disc brake caliper and adapter bracket from the axle as an assembly. Hang the caliper assembly out of way using wire or a bungee cord (Figure 5).

CAUTION: Use care not to overextend the rubber flex hose.
