RECALL CAMPAIGN BULLETIN

NTB12-038

VOLUNTARY RECALL CAMPAIGN 2012 TITAN AND ARMADA CERTIFICATION LABEL

CAMPAIGN I.D. # PC135
NHTSA #: 12V-143
APPLIED VEHICLE: 2012 Titan (A60)
2012 Armada (TA60)

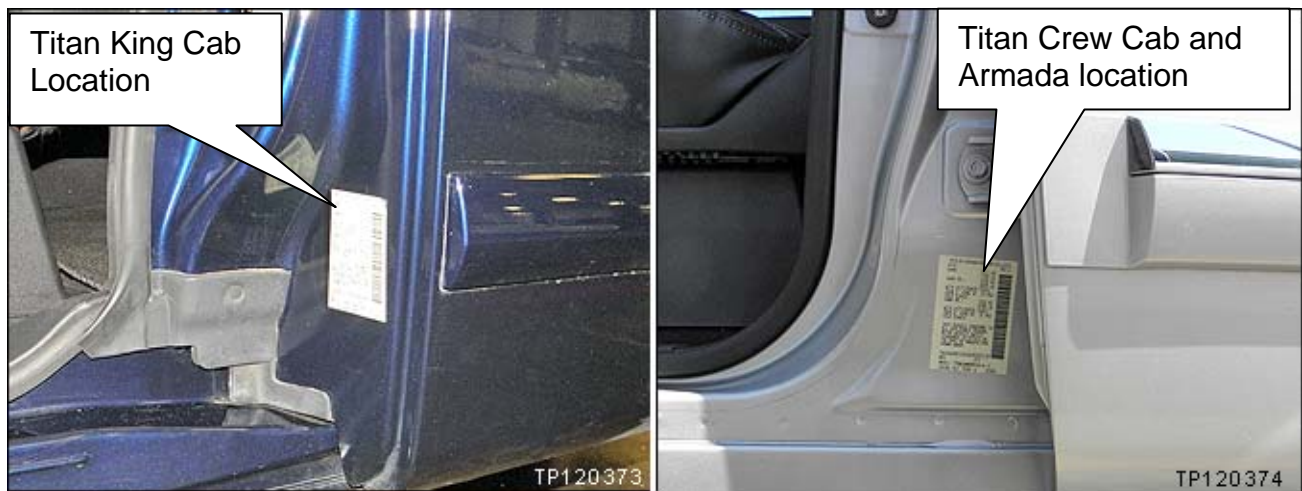
1. Park the vehicle in a safe place with the ignition OFF, the parking brake ON, and your automatic transmission in "P".
2. Open the driver's door.
3. Locate the existing certification label (see Figure 1).

NOTE: The certification label has the VIN on it.

4. Make sure the VIN on the new certification label matches the VIN on the old certification label.

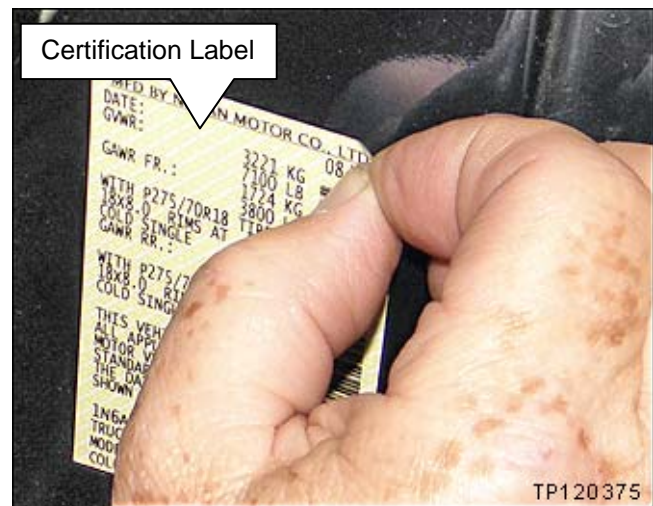
5. Clean the area around the certification label with a dry clean cloth.
6. Remove the old certification label.
 - Use a finger nail to pull / lift one corner of the label and then slowly peel off 100% of the old label.

NOTE: If needed, use a smooth thin tipped finesse stick to lift up one corner of cert. label.

7. Install the new certification label in the same location as the old label.

NOTE: If needed, clean surface before applying the new label with isopropyl alcohol and allow to dry.
