Applies To: **2012 Civic with A/T** – Check the iN VIN status for eligibility

**June 1, 2012**

**Safety Recall: Left (Driver’s Side) Driveshaft**

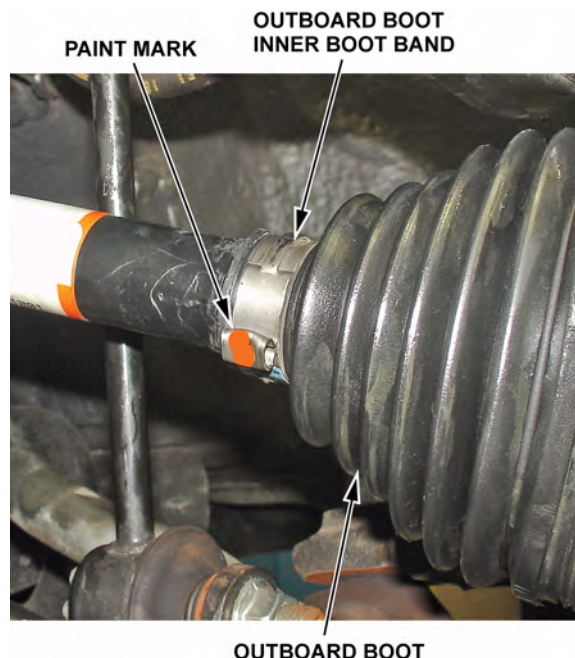
1. Raise the vehicle on a lift.
2. Using a shop light, check the small inner CV boot band for an orange paint mark.
  - If an orange paint mark is visible, the vehicle is OK.
  - If the paint mark is not orange, or if you can’t determine the color, go to step 3.

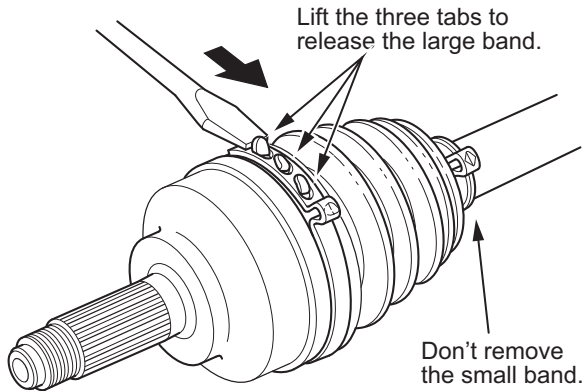
3. Remove the left front wheel.
4. Using a clean shop towel, clean the outboard CV boot and the driveshaft.
5. Lift the three tabs on the large outboard CV boot band with a flat-tip screwdriver. Release the band being careful not to damage the CV boot.

NOTE: Don't remove the small band on the CV boot.

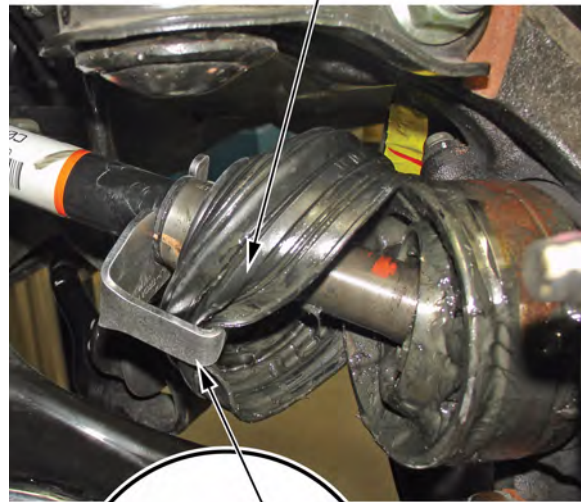
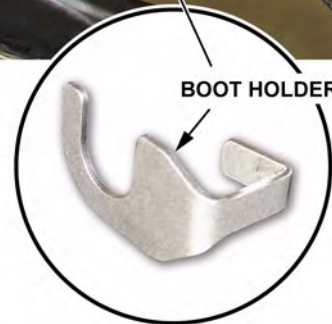
7. Carefully slide the CV boot back, and hold it in place with the boot holder.

Pull the outboard boot back and hold it with the boot holder.

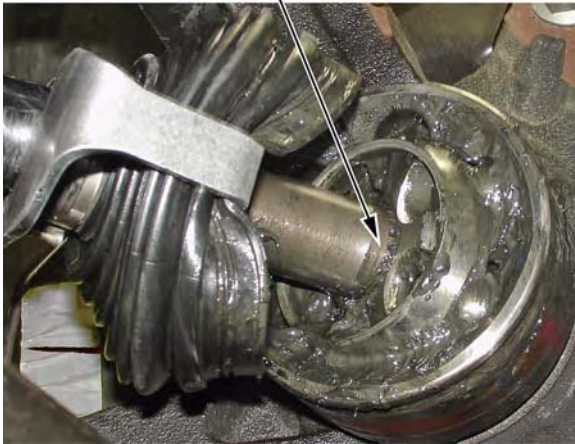
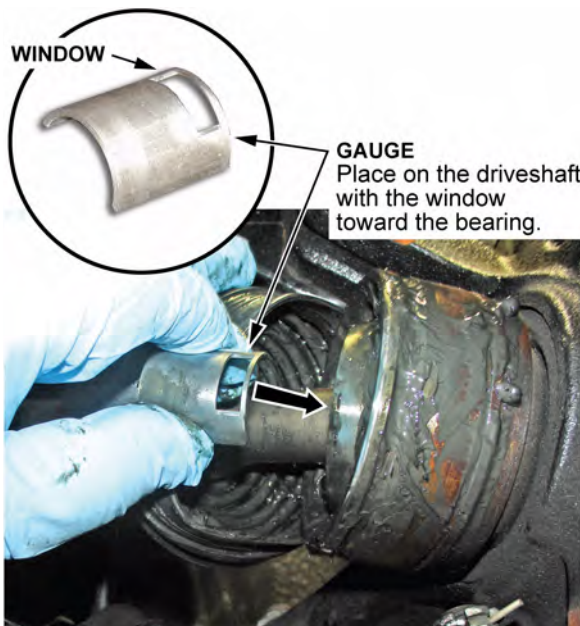
**DRIVESHAFT SPLINES**

9. There may be some play in the driveshaft. Push and hold the driveshaft all the way toward the front steering knuckle, then insert the gauge.

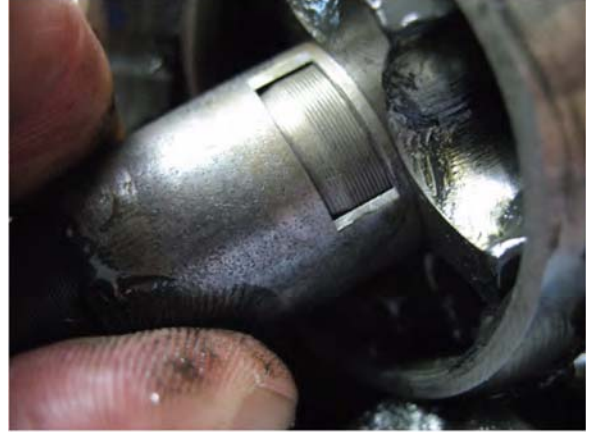
**GOOD**

10. Make sure you are pushing the driveshaft all the way toward the steering knuckle, and using a shop light, check if you can see any shaft splines through the gauge window.
  - If there are no splines visible, the driveshaft is OK. Go to step 11 to reinstall the CV boot.
  - If there are splines visible, go to REPAIR PROCEDURE.

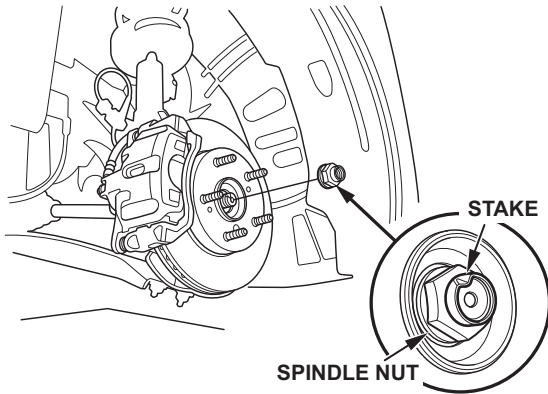
1. Pry up the stake on the spindle nut, and remove the nut.

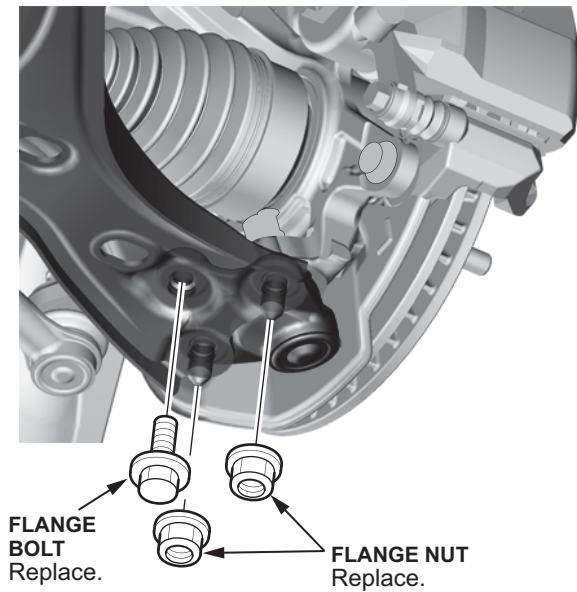
2. Remove the flange bolt and the flange nuts, then disconnect the lower ball joint from the lower suspension arm.

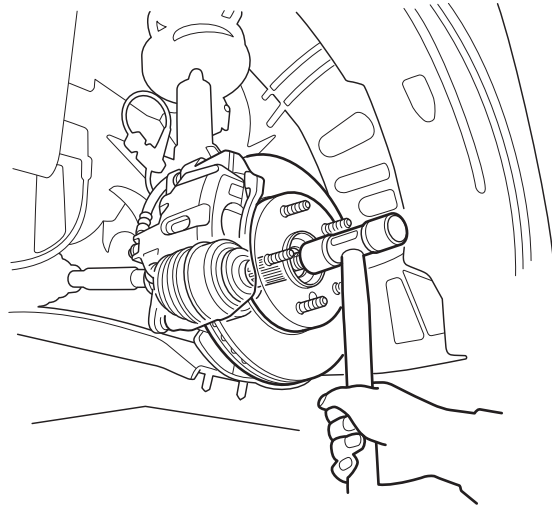
3. Using a soft-faced hammer, separate the outboard joint from the front hub.

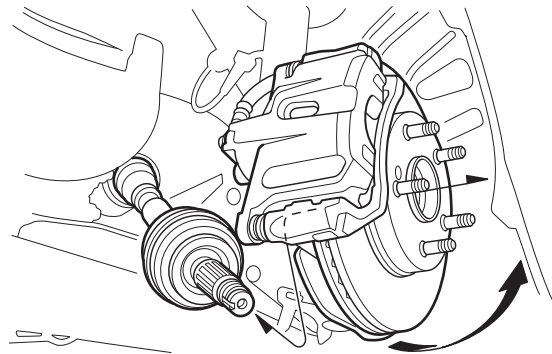
4. Pull the knuckle outward, and separate the outboard joint from the front hub.

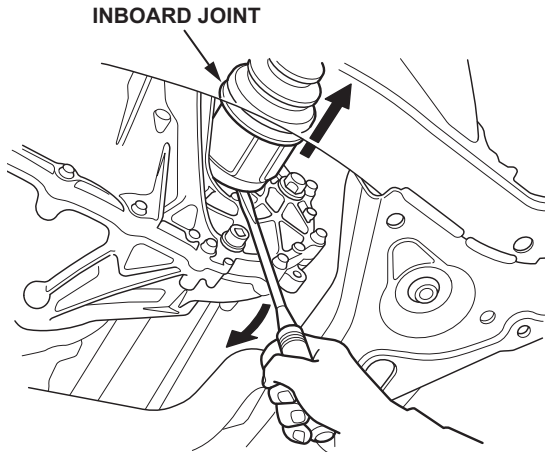
5. Pry the inboard joint from the differential using a pry bar.

- Do not pull on the driveshaft or the inboard joint may come apart. Pull the inboard joint straight out to avoid damaging the oil seal.
- Be careful not to damage the oil seal when using the prybar.

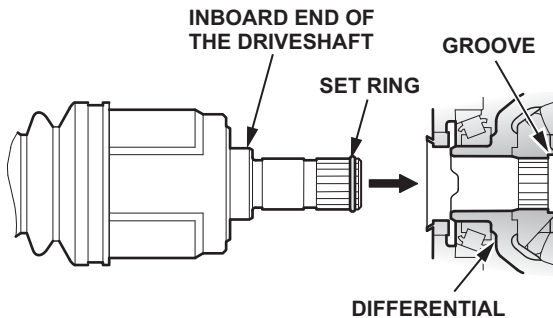
6. Remove the original driveshaft.
7. Remove the protective cap from the new driveshaft.
8. Insert the inboard end of the new driveshaft into the differential until the set ring locks in the groove.

**NOTE:** Insert the driveshaft horizontally to avoid damaging the oil seal.

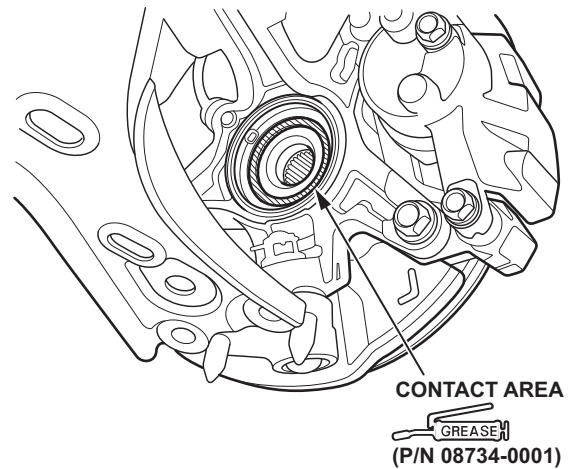
9. Apply about 5 g (0.18 oz) of Moly 60 paste (or equivalent) to the contact area of the outboard joint and the front wheel bearing to help reduce noise and vibration.

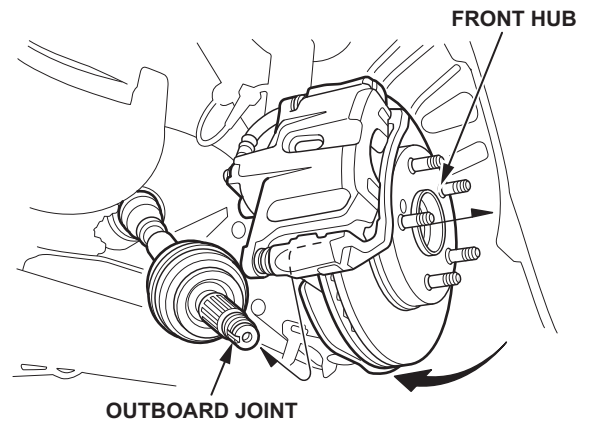
10. Install the outboard joint into the front hub on the knuckle.

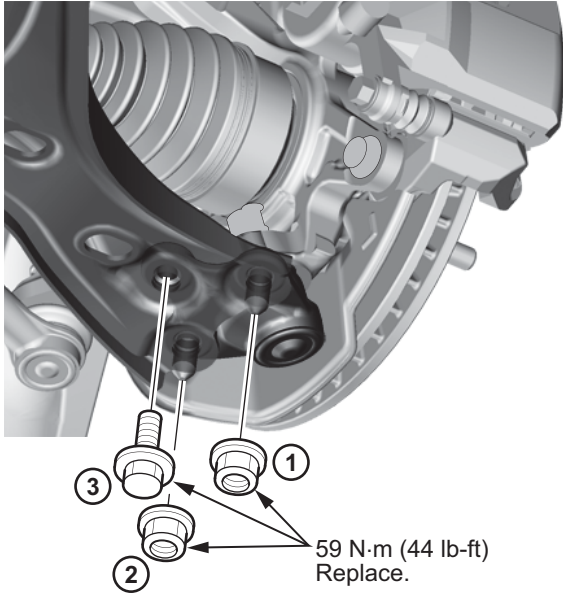
11. Connect the lower ball joint to the lower arm, and install the new nuts and the new flange bolt in the order shown, and torque them to **59 N·m (44 lb-ft)**.

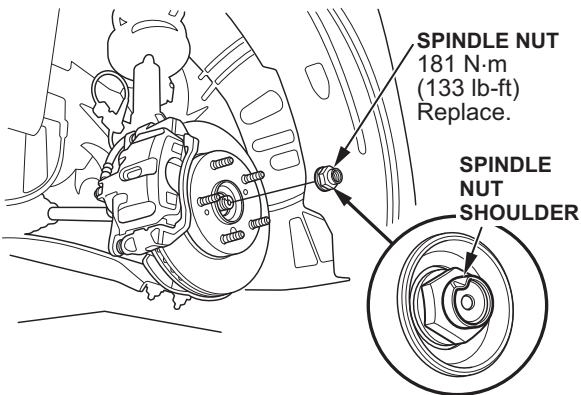
12. Apply a small amount of engine oil to the seating surface of the new spindle nut, torque the nut to **181 N·m (133 lb-ft)**, and stake it.

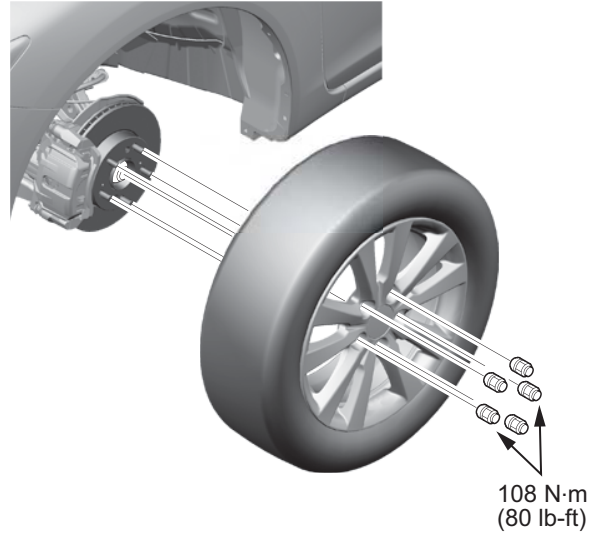
13. Clean the mating surfaces between the brake disc and the inside of the wheel, then install the wheel. Torque the lug nuts to **108 N·m (80 lb-ft)**.

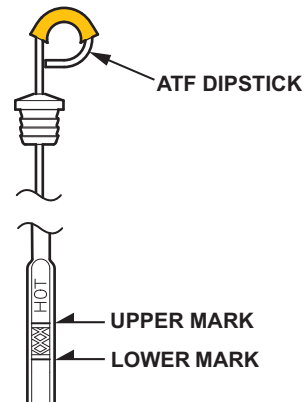
15. Lower the vehicle, and check the ATF dipstick to make sure the fluid level is between the upper and lower mark on the dipstick. If it isn't, add ATF.
