Safety Recall: Left (Driver's Side) Driveshaft

(Supersedes 12-033, dated June 8, 2012, to revise the information marked by the black bars)

During manufacturing, a circlip that locks the shaft to the outboard CV joint may not be properly set. If the shaft backs out of the CV joint, the vehicle can't move in any gear, and it may also roll away when the shift lever is in Park without the parking brake set.

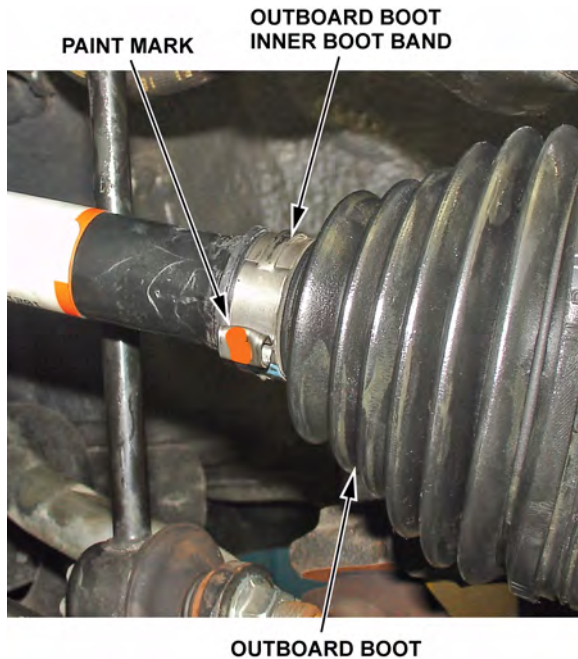
1. Raise the vehicle on a lift.
2. Using a shop light, check the small inner CV boot band for an orange paint mark.
 - If an orange paint mark is visible, the vehicle is OK.
 - If the paint mark is not orange, or if you can't determine the color, go to step 3.

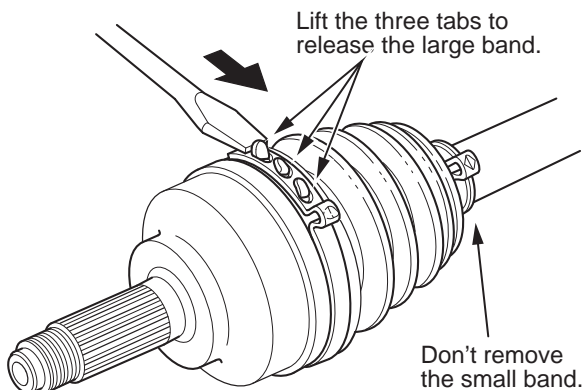
3. Remove the left front wheel.
4. Using a clean shop towel, clean the outboard CV boot and the driveshaft.
5. Lift the three tabs on the large outboard CV boot band with a flat-tip screwdriver. Release the band being careful not to damage the CV boot.

NOTE: Don't remove the small band on the CV boot.

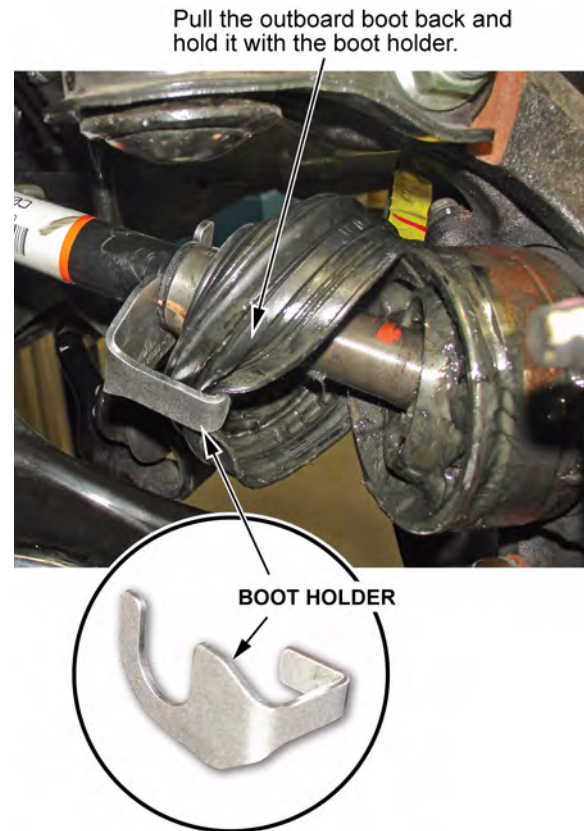
6. Turn the steering wheel all the way to the left full lock position.
7. Carefully slide the CV boot back, and hold it in place with the boot holder.

NOTE: The grease may be in a semi-liquefied state, so make sure you have a container to catch the grease when you pull back the CV boot.

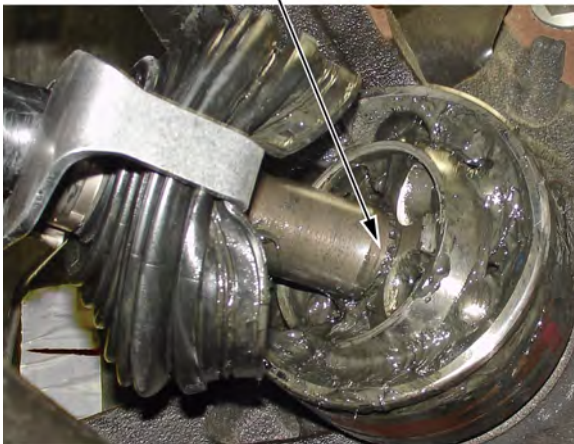
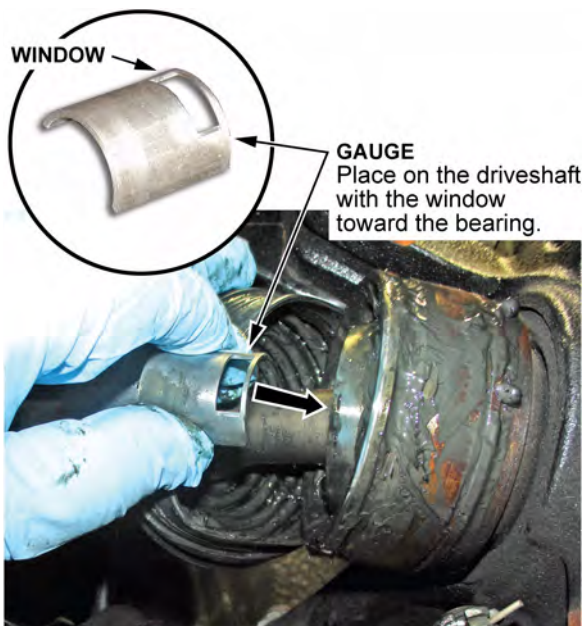
DRIVESHAFT SPLINES

9. There may be some play in the driveshaft. Push and hold the driveshaft all the way toward the front steering knuckle, then insert the gauge.

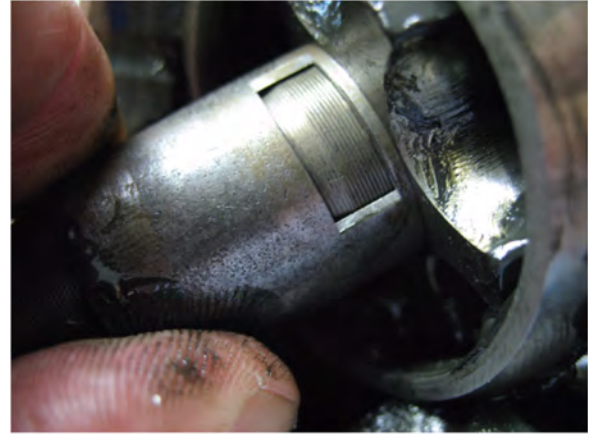
GOOD

10. Make sure you are pushing the driveshaft all the way toward the steering knuckle, and using a shop light, check if you can see any shaft splines through the gauge window.

- If there are no splines visible, the driveshaft is OK. Go to step 11 to reinstall the CV boot.
- If splines are visible, go to REPAIR PROCEDURE.

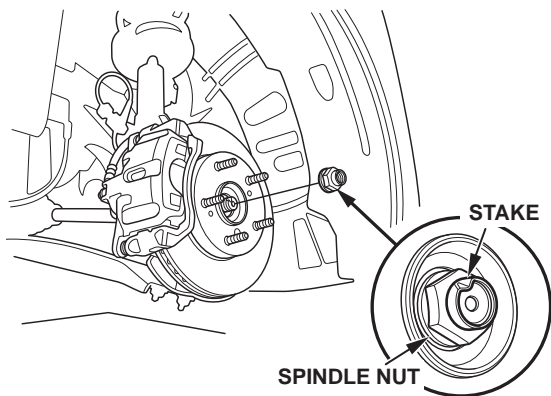
1. Pry up the stake on the spindle nut, and remove the nut.

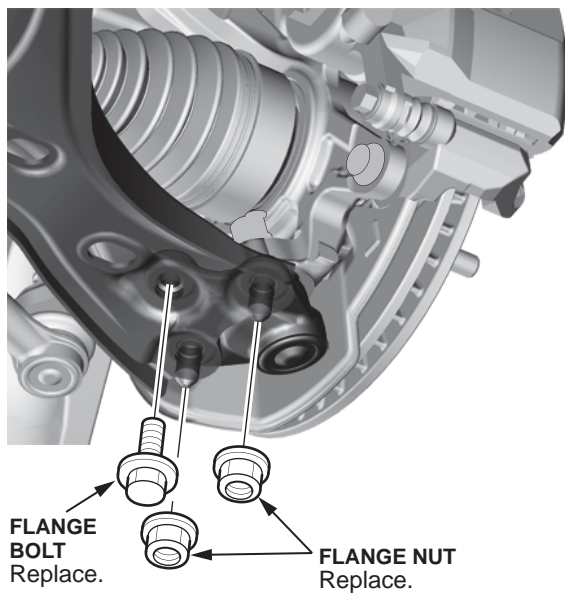
2. Remove the flange bolt and the flange nuts, then disconnect the lower ball joint from the lower suspension arm.

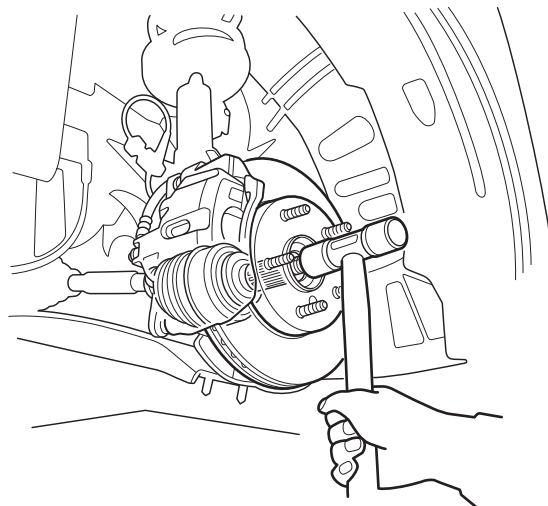
3. Using a soft-faced hammer, separate the outboard joint from the front hub.

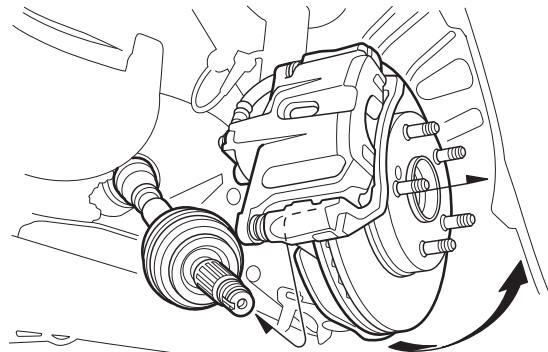
4. Pull the knuckle outward, and separate the outboard joint from the front hub.

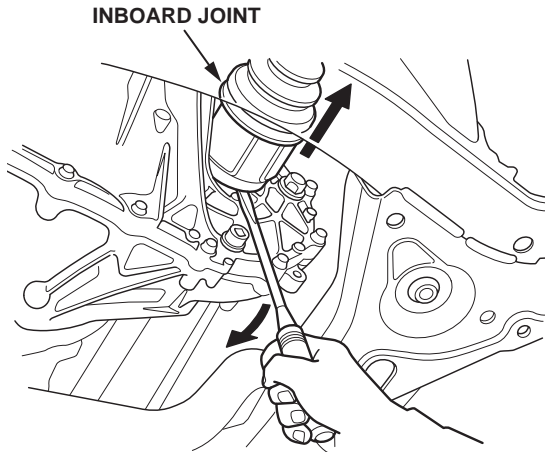
5. Pry the inboard joint from the differential using a pry bar.

- Do not pull on the driveshaft or the inboard joint may come apart. Pull the inboard joint straight out to avoid damaging the oil seal.
- Be careful not to damage the oil seal when using the pry bar.

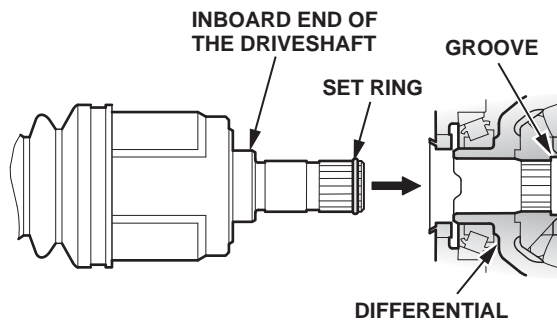
6. Remove the original driveshaft.
7. Remove the protective cap from the new driveshaft.
8. Insert the inboard end of the new driveshaft into the differential until the set ring locks in the groove.

NOTE: Insert the driveshaft horizontally to avoid damaging the oil seal.

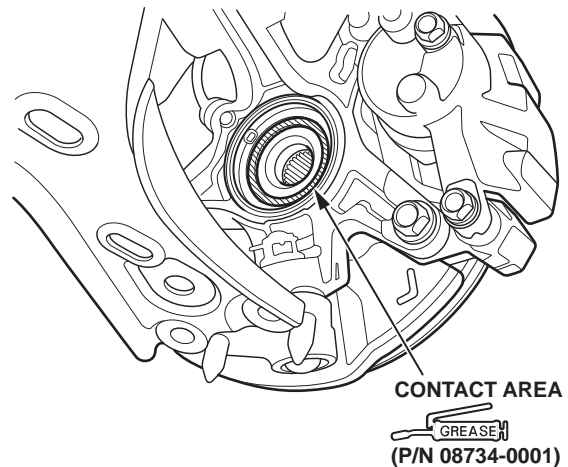
9. Apply about 5 g (0.18 oz) of Moly 60 paste (or equivalent) to the contact area of the outboard joint and the front wheel bearing to help reduce noise and vibration.

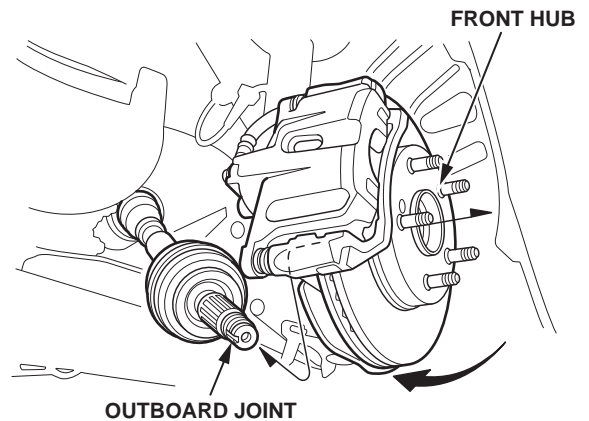
10. Install the outboard joint into the front hub on the knuckle.

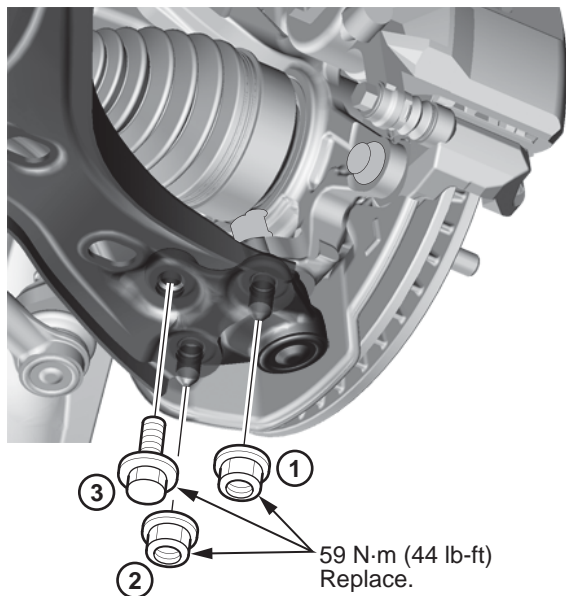
11. Connect the lower ball joint to the lower arm, install the new nuts and the new flange bolt, and torque them to **59 N·m (44 lb-ft)** in the sequence shown.

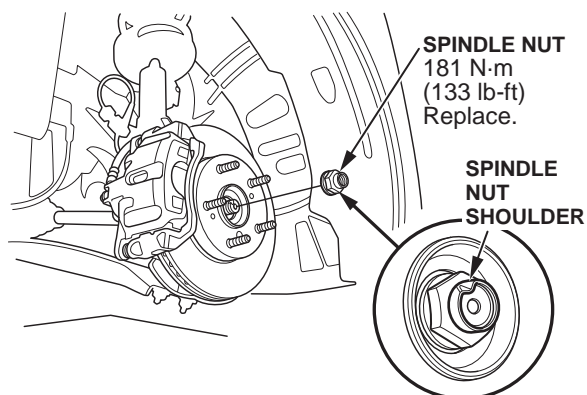
12. Apply a small amount of engine oil to the seating surface of the new spindle nut, torque the nut to **181 N·m (133 lb-ft)**, and stake it.

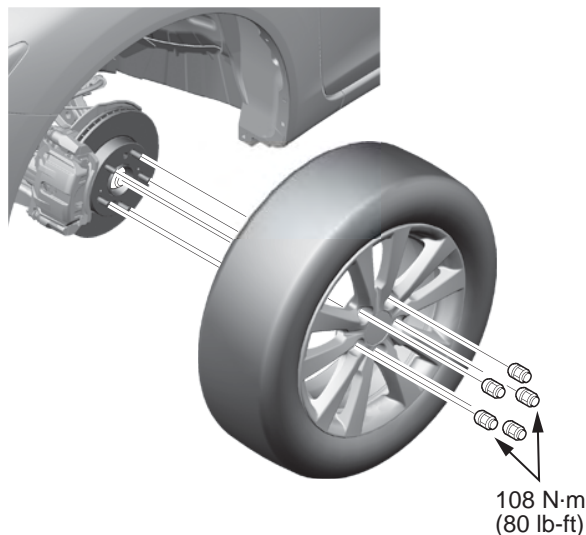
13. Clean the mating surfaces between the brake disc and the inside of the wheel, then install the wheel. Torque the wheel nuts to **108 N·m (80 lb-ft)**.

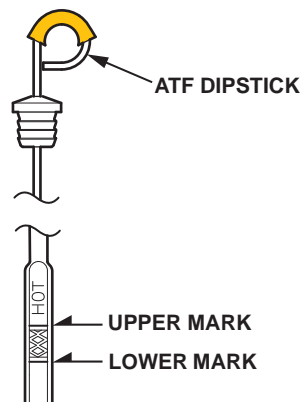
14. Turn the wheel by hand, and make sure there is no interference between the driveshaft and the surrounding parts.
15. Lower the vehicle, and check the ATF dipstick to make sure the fluid level is between the upper and lower mark on the dipstick. If it isn't, add ATF.
