SERVICE PROCEDURE

**G-12518
JULY 2012**

**SUBJECT: NON-COMPLIANCE RECALL
Inner-lower-lining to lower-lining joint seam screw
torque on certain CE models built 07 September 2010
through 09 September 2010**

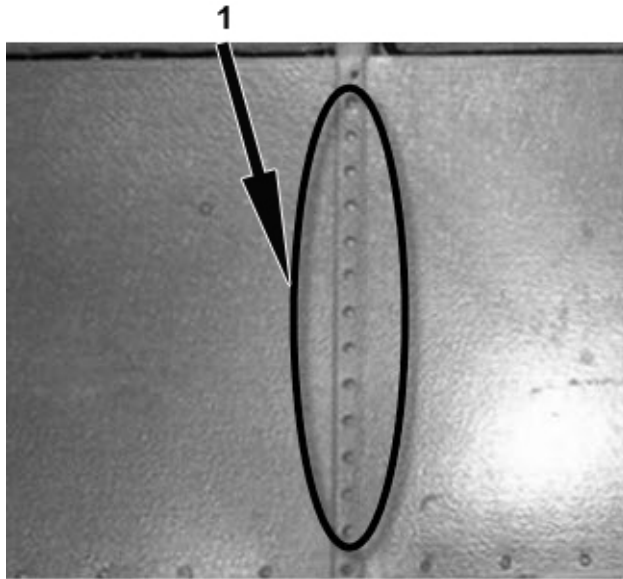
Figure 1

The inner-lower-lining to lower-lining joint seam screws may not be tightened to the correct specification, which could result in a Non-Compliance to Federal Motor Vehicle Safety Standard 221. The purpose of this standard is to reduce deaths and injuries resulting from the structural collapse of school bus bodies during crashes. In the event of an accident involving the body structure, a portion of the interior panel could separate from the adjoining inner-lower-lining panel, which could increase the risk of injury.

1. Lower-inner-lining joint

1. Park vehicle on a flat surface, shift transmission to park or neutral, set parking brake, and block wheels to prevent vehicle from moving in both directions.
2. Inspect lower-inner-lining to lower-lining joints. Make sure screws are torqued to no less than 25 lb-in (2.8 N·m) (Figure 1).

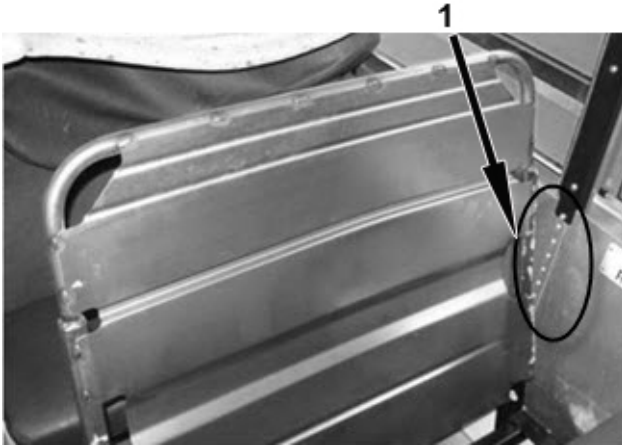
Figure 2

1. Inner-lower-lining joint seam screws

3. Should seat back cover and foam require removal from any seat to gain access to inner-lower-lining joint seam screws, unlatch and lift seat cushion. Release J-clips from bottom of seat back upholstery and remove seat back cover and foam (Figure 2).

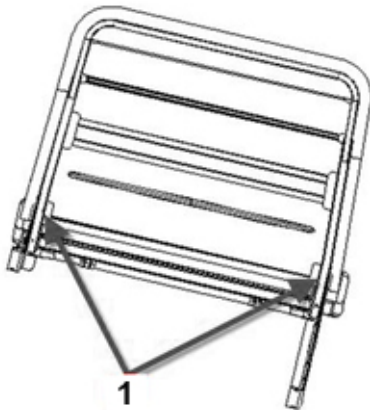
Figure 3

1. Pinch bolts

4. Should seat back require removal from any seat riser to gain access to inner-lower-lining joint seam screws, remove pinch bolts between seat back and seat back riser and remove seat back (Figure 3).

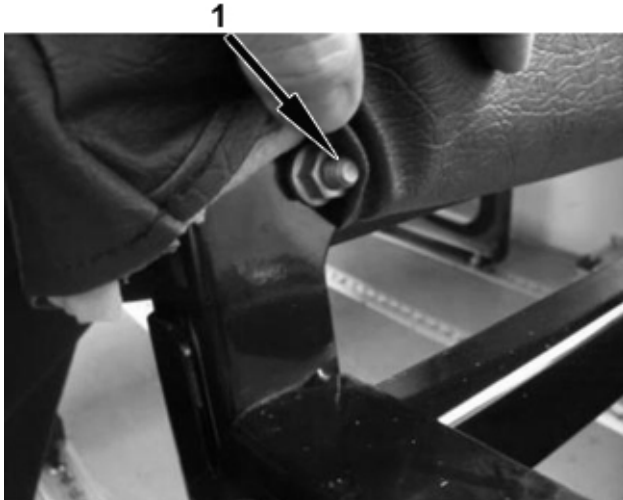
1. Correct installation where bolt threads extend three threads past the nut.

NOTE: Figure 4 is for illustration only as the seat foam and cover should not be installed at this time.

5. Reinstall any seat back removed. Tighten pinch bolts until there are three threads past nut (Figure 4).
