RECALL CAMPAIGN BULLETIN

NTB12-058

VOLUNTARY SAFETY RECALL CAMPAIGN 2012 JUKE REAR SEATBACK STRIKER

CAMPAIGN ID #: R1216
NHTSA #: 12V-328
APPLIED VEHICLE: 2012 Juke (F15)

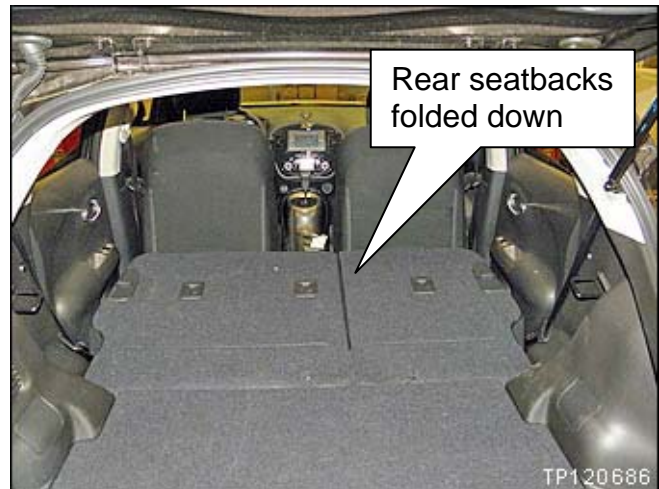
Figure 1

2. Fold down the rear seatbacks.

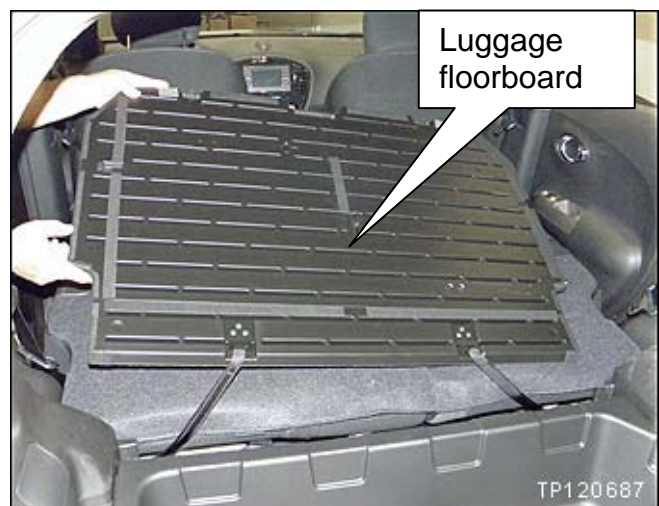
Figure 2

3. For 2WD models: Fold the luggage floorboard forward and rest it on the rear seatbacks.

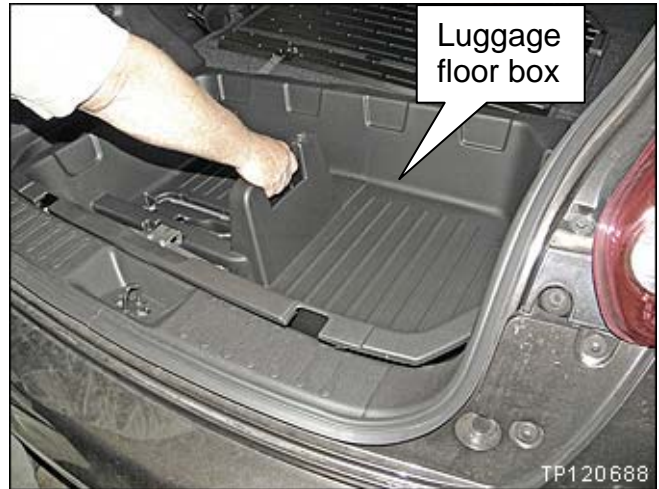
Figure 3

4. For 2WD models: Remove the luggage floor box.

NOTE: For 2WD models the spare tire does not need to be removed.

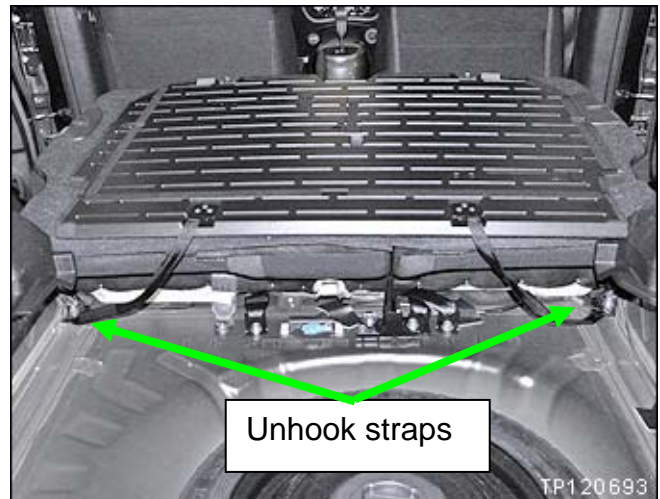
Figure 4

5. For 2WD models: Unhook the straps from the luggage floorboard and remove it from the vehicle.

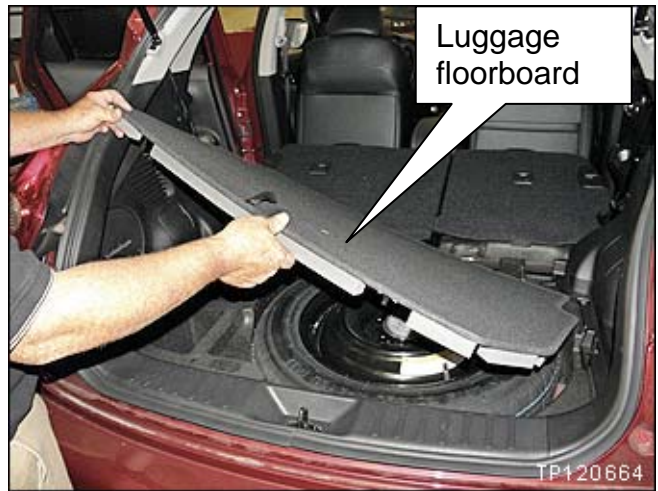
Figure 5

6. For 4WD models: Remove the luggage floorboard.

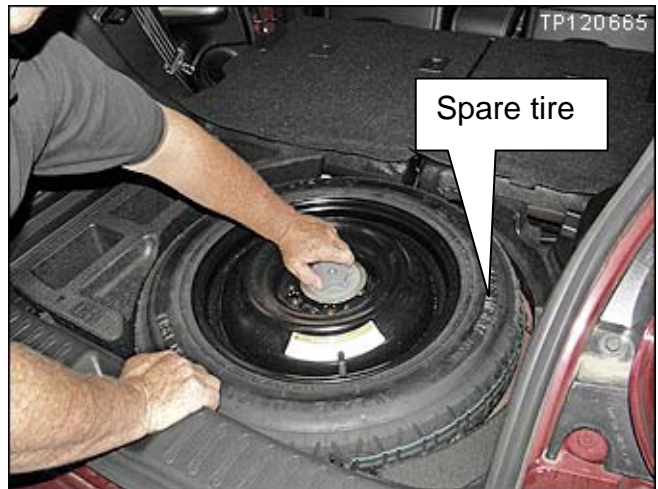
Figure 6

7. For 4WD models: Remove the spare tire.

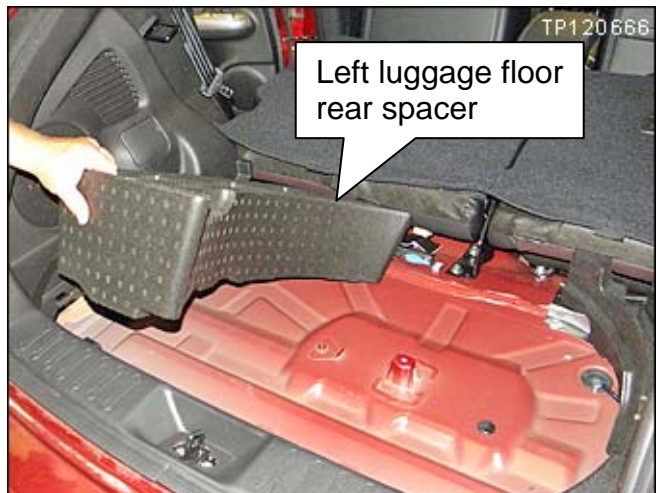
Figure 7

8. For 4WD models: Remove the left side luggage floor rear spacer.

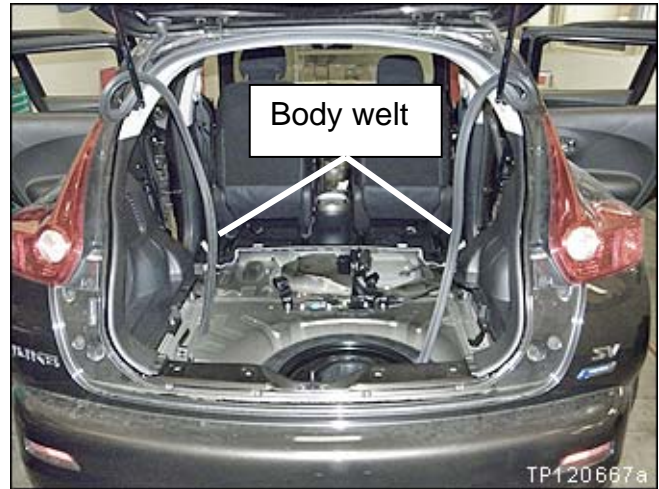
Figure 8

9. Remove the body welt (weather strip) along the bottom and both sides of the rear door (hatch) opening.

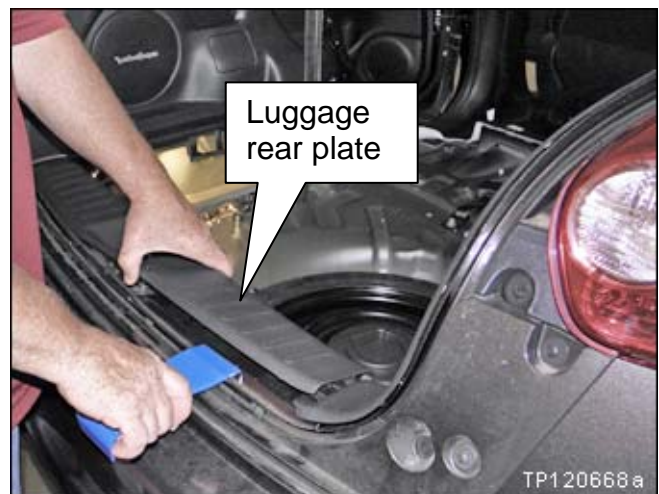
Figure 9

10. Use a plastic trim tool to snap loose and remove the luggage rear plate.

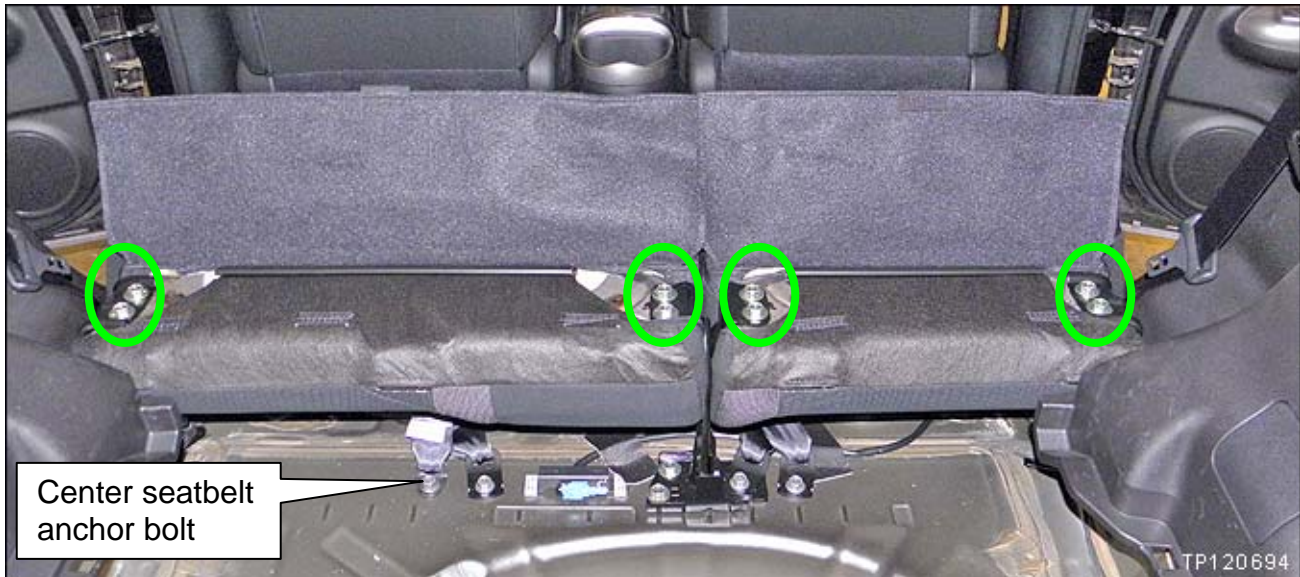
Figure 10

11. Remove the rear seatbacks as follows:

- a. Remove the 8 rear seatback bolts shown (circled) in Figure 10.
- b. Remove the rear center seat bolt anchor bolt shown in Figure 10.
- c. Remove both seatbacks from the vehicle.

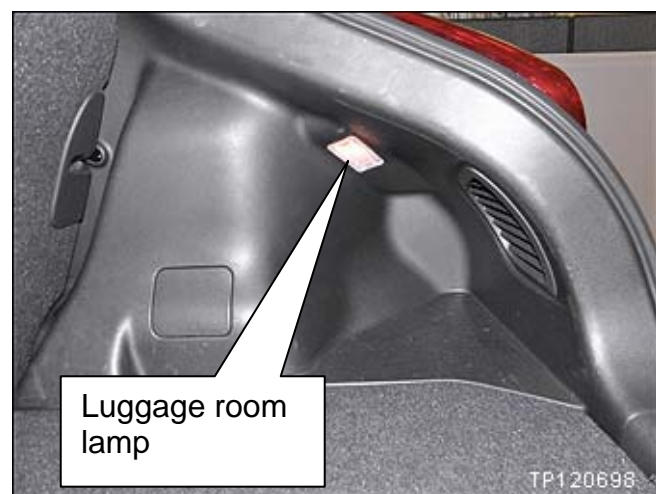
Figure 11

12. Remove the luggage room lamp:

- Luggage room lamp is located on the right side lower luggage finisher.
- Use a plastic trim tool to snap out the lamp.
- Disconnect the electrical connector.

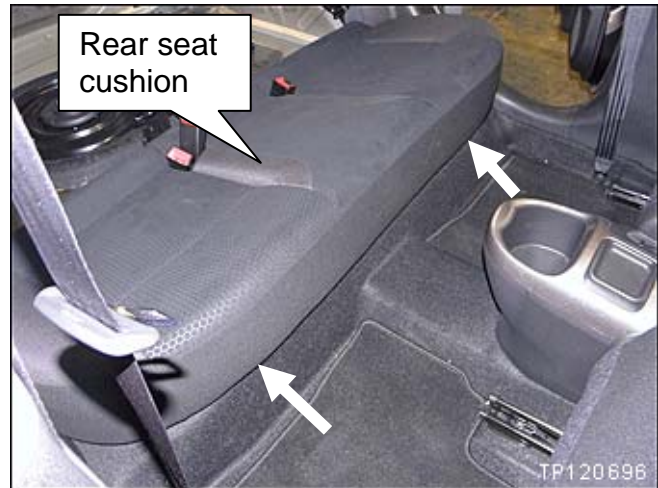
Figure 12

- Note the location of the seat cushion hooks (See Figures 12 and 13).
- When removing the seat cushion, pull up as close as possible to each seat cushion hook.
- If excessive force is used to pull up on the seat cushion, the seat cushion hook and wire will be deformed.

13. Remove the rear seat cushion.

- Approximate location of cushion hooks is shown with arrows in Figures 12.

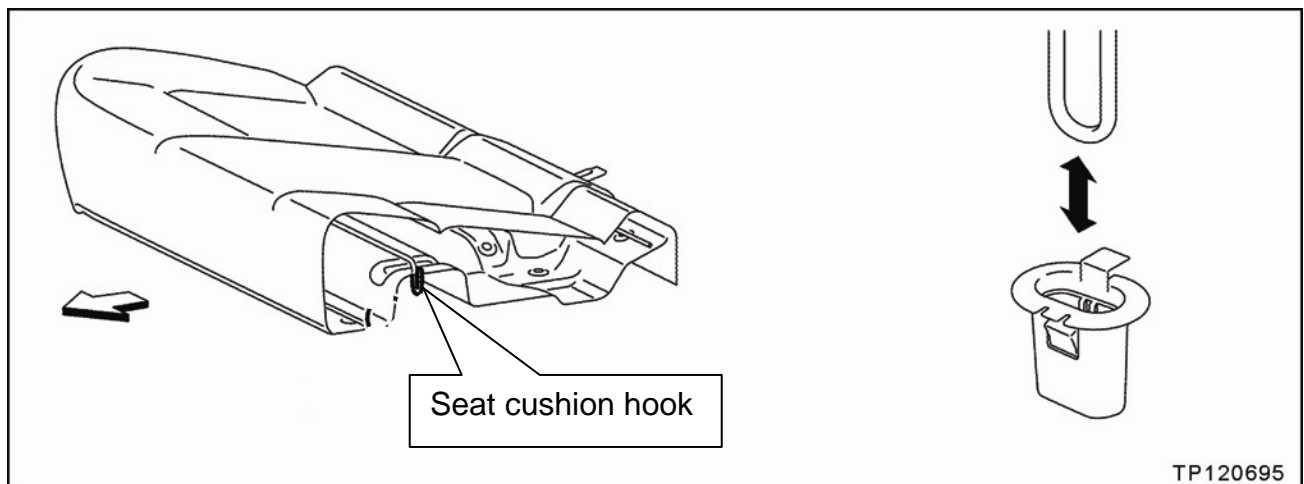
Figure 13

- Pull up on the cushion hooks to disengage them.

CAUTION: Pull up as close as possible to the hooks to avoid damaging the cushion hooks and wire.

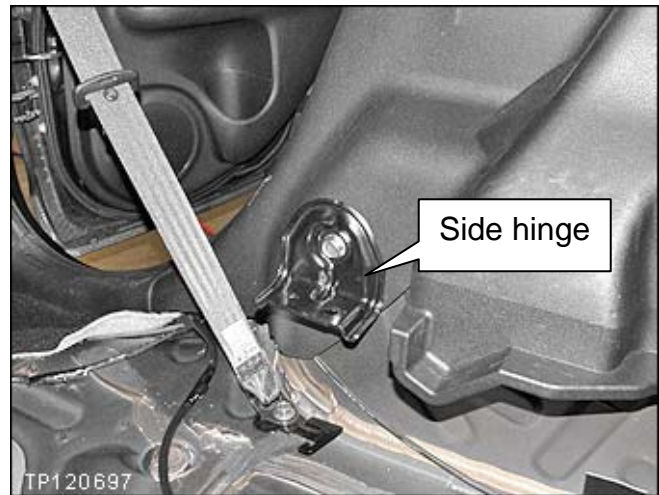
Figure 14

14. Remove the seatback side hinge.

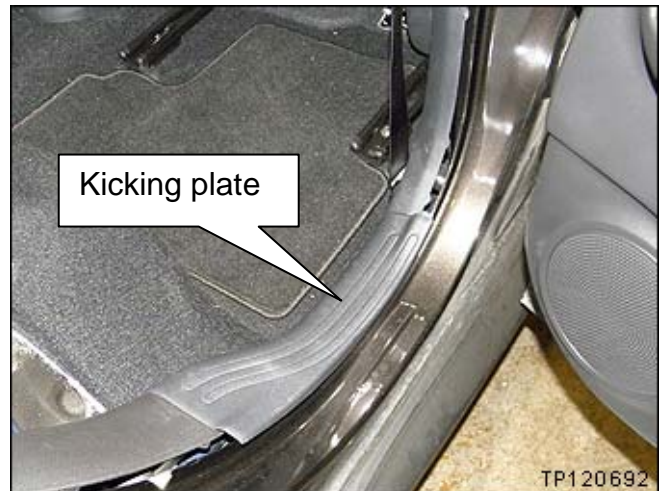
Figure 15

15 Remove the rear side door kicking plate.

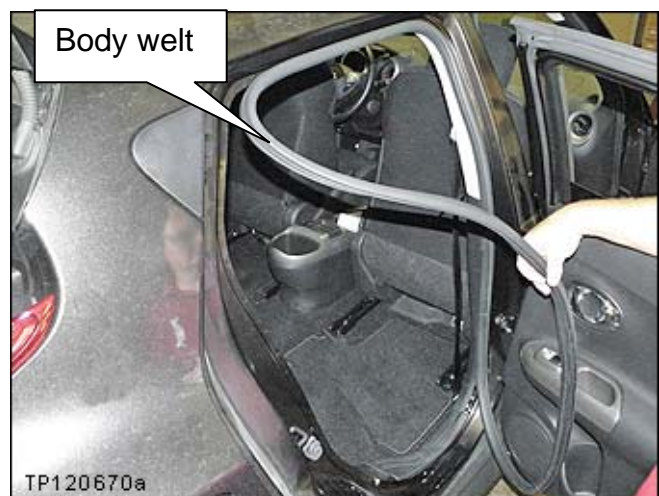
Figure 16

16. Remove the rear side door body welt (weather-strip).

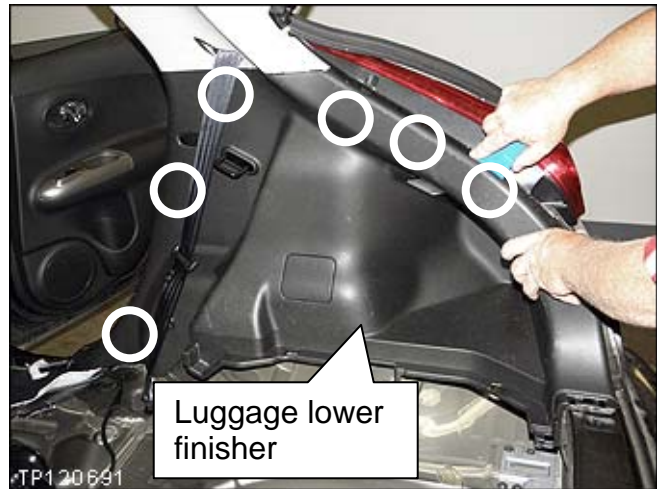
Figure 17

17. Remove the luggage lower finisher.

- Approximate location of 6 clips is shown with circles.
- Use a plastic trim tool as needed.

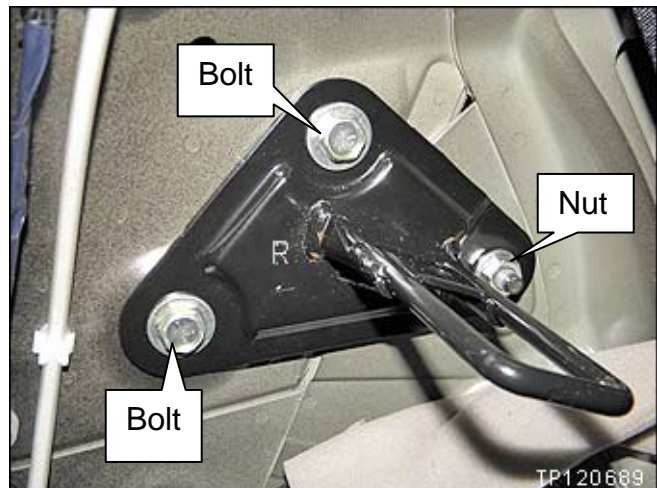
Figure 18

18. Remove the old rear seatback striker.

- Mark the old striker so it will not be confused with the new striker.
- Do not reuse the old strikers.

- Passenger side shown – 2 bolts and 1 nut.
- The driver side has 3 bolts.

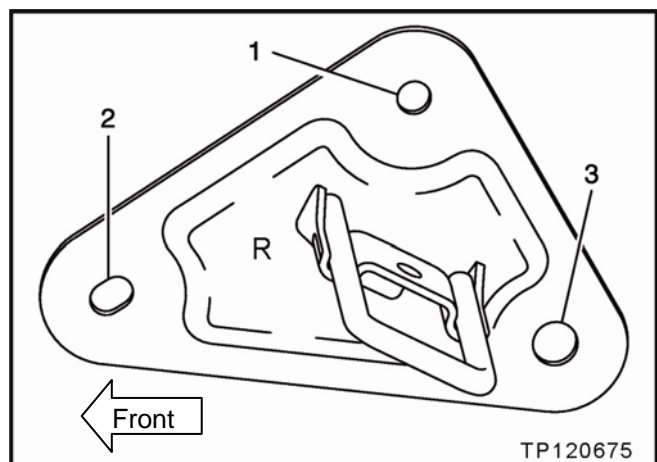
Figure 19

19. Install the new rear seatback striker.

- Make sure the correct striker is installed.
Right side is marked with an **R**.
Left side is marked with an **L**.
- Tighten bolts/nut in the order shown.
- Torque bolts/nut to:
45 Nm (4.6 kg-m, **33 ft-lb**)

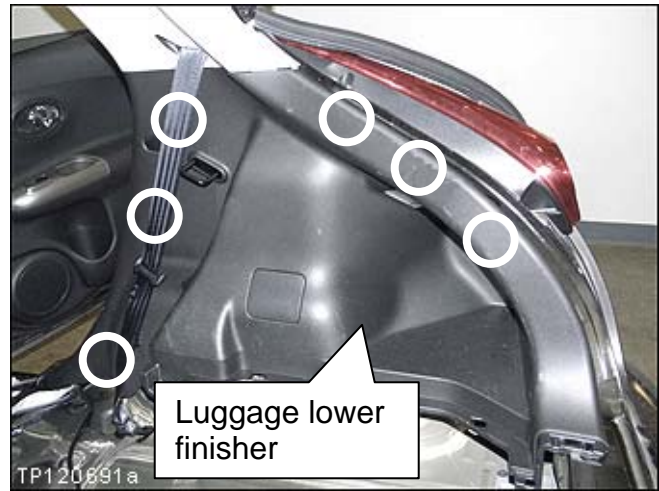
Figure 20

20 Reinstall the luggage lower finisher.

- For the passenger side, make sure the room lamp electrical connector is pulled through the room lamp opening.
- Approximate location of 6 clips is shown with circles.
- Make sure all clips are securely snapped in place.

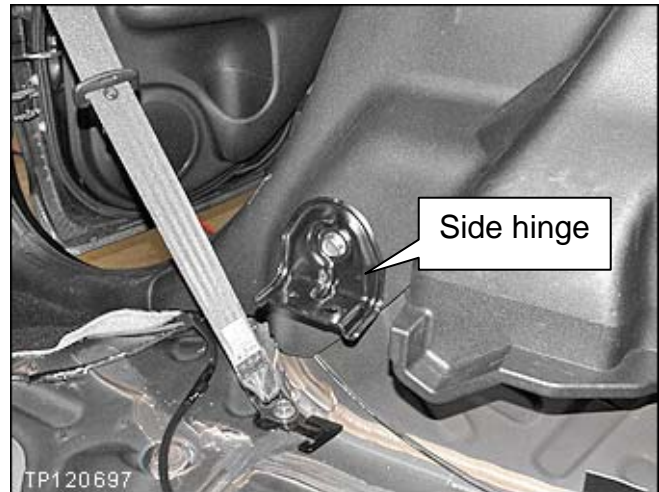
Figure 21

21. Reinstall the seatback side hinge.

- Torque bolt to:
45 Nm (4.6 kg-m, **33 ft-lb**)

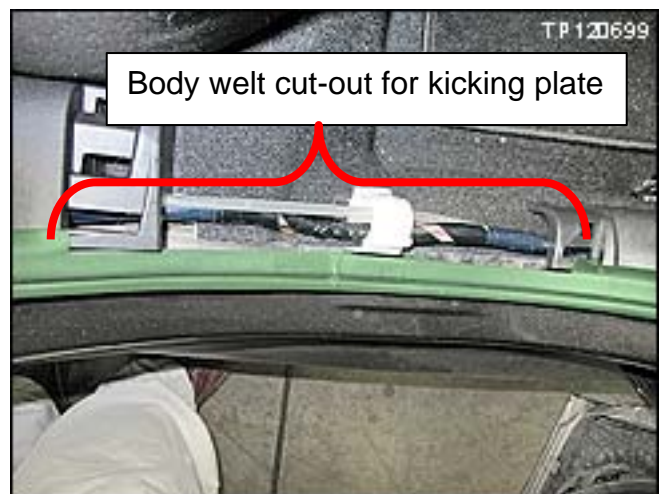
Figure 22

22. Reinstall the rear side door body welt (weather-strip).

- Make sure the body welt is installed with the kicking plate “cut-out” positioned correctly as shown.

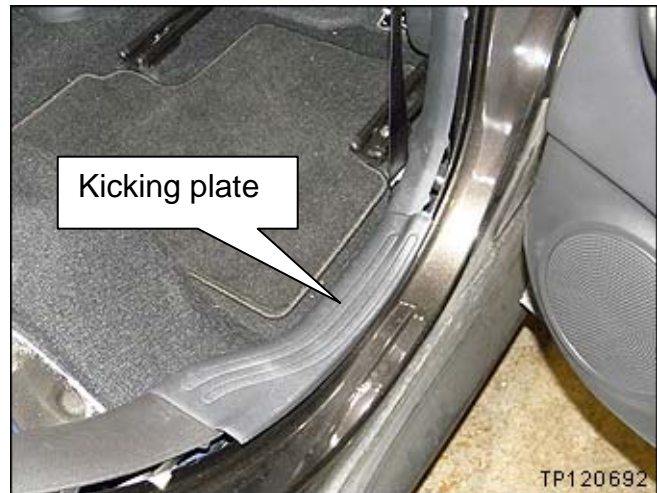
Figure 23

23. Reinstall the rear side door kicking plate.

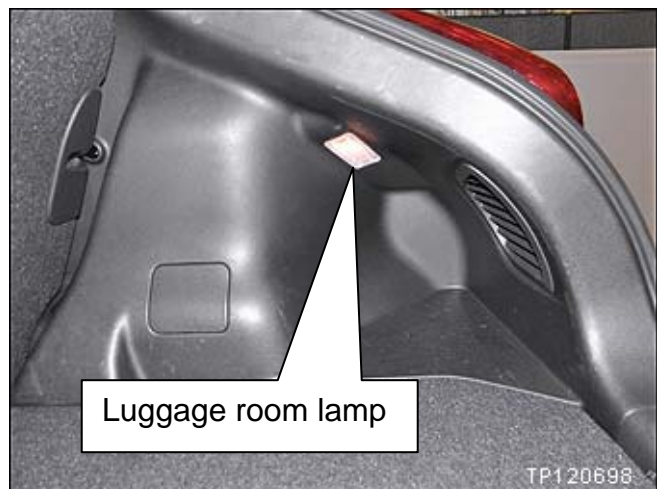
Figure 24

25. Reinstall the luggage room lamp:

- Luggage room lamp is located on the right side lower luggage finisher.
- Reconnect the electrical connector and snap the lamp back in place.

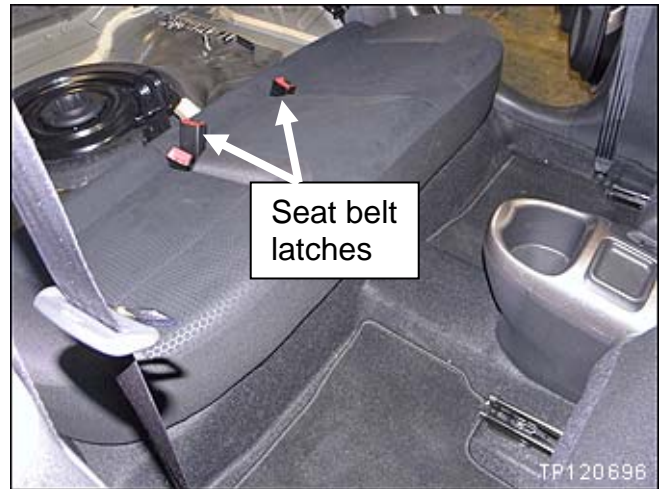
Figure 25

26. Reinstall the rear seat cushion.

- Make sure seat belt latches are pulled through the seat.
- Make sure the center latch (it is marked center) is in the center position.

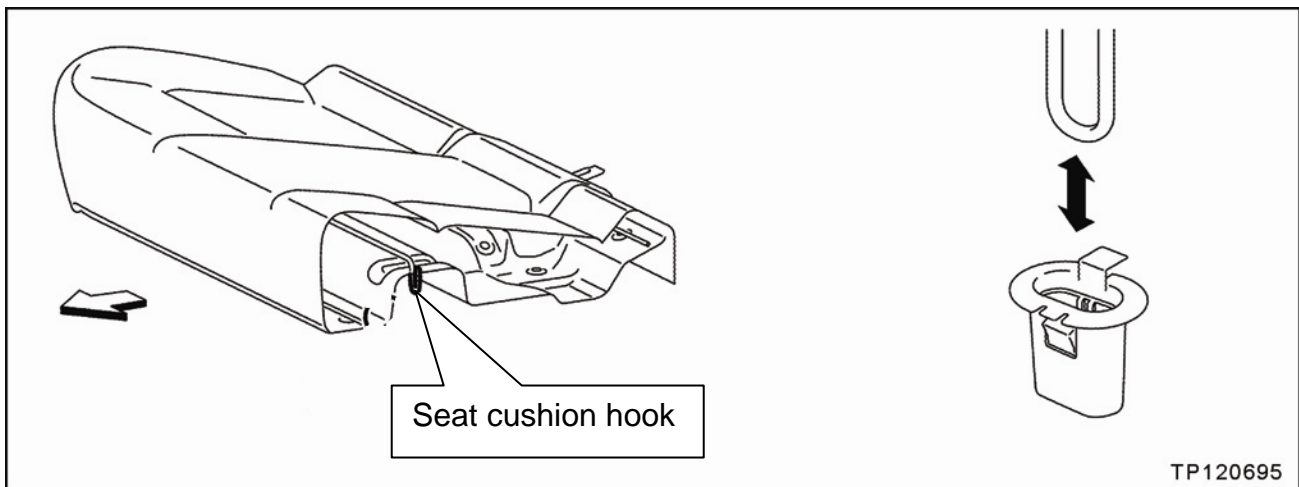
Figure 26

- Push down on the seat cushion to engage the cushion hooks.

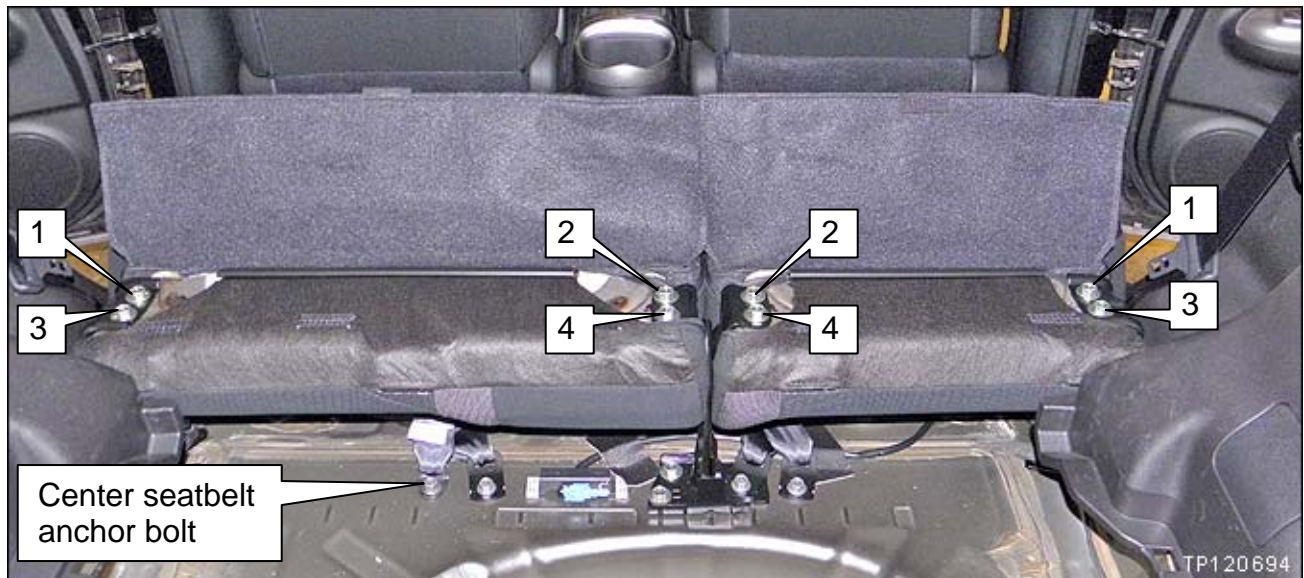
Figure 27

27. Reinstall the rear seatbacks (see Figure 27).

- Reinstall the 4 left side rear seatback bolts, tighten in the order shown:
Torque to 45 Nm (4.6 kg-m, **33 ft-lb**)
- Reinstall the 4 right side rear seatback bolts, tighten in the order shown:
Torque to 45 Nm (4.6 kg-m, **33 ft-lb**)
- Reinstall the rear center seat belt anchor bolt; torque to 49 Nm (5.0 kg-m, **36 ft-lb**).

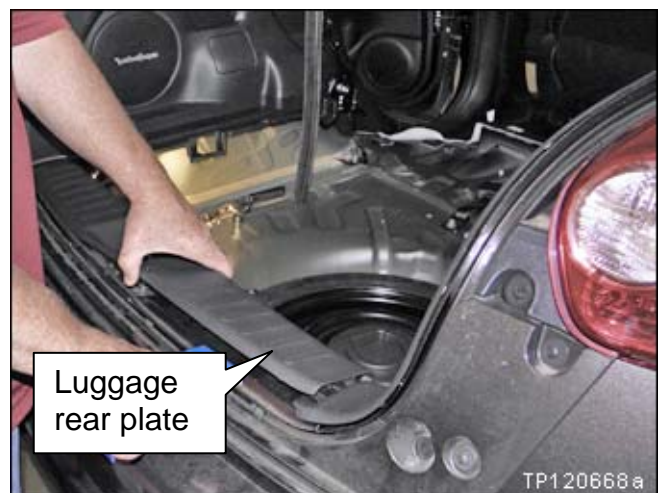
Figure 28

28. Reinstall the luggage rear plate.

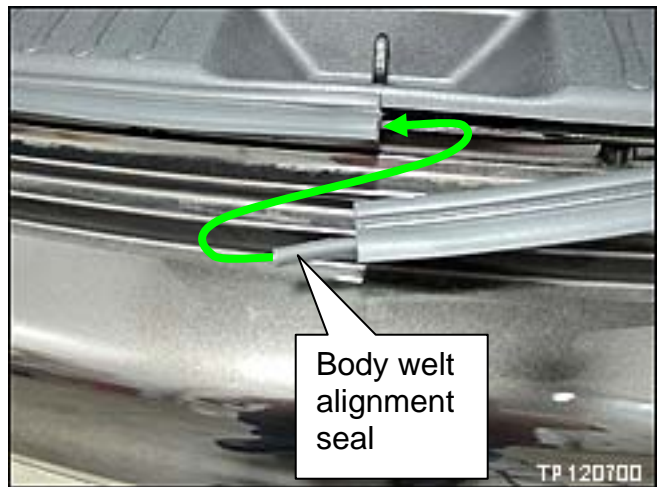
Figure 29

29. Reinstall the rear door (hatch) body welt (weather-strip).

- Make sure the rubber alignment seal is installed in the ends of the body welt.

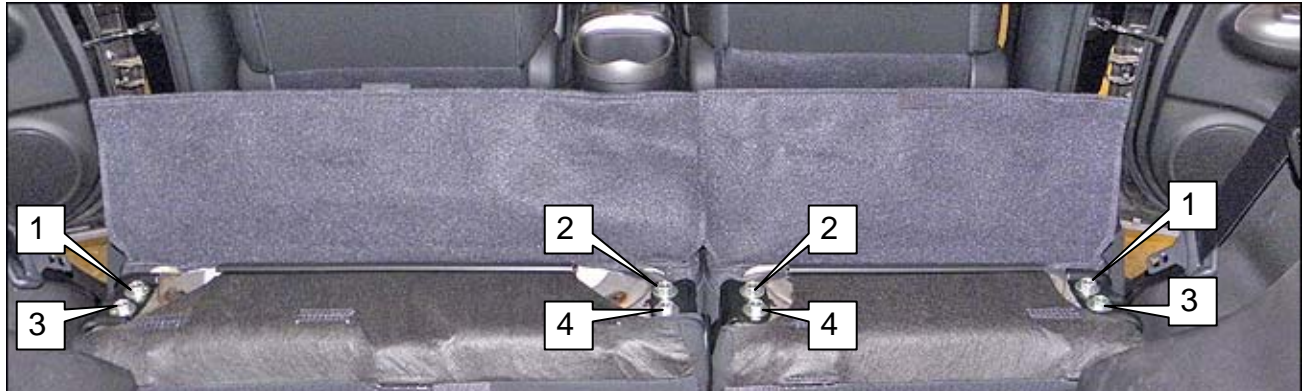
Figure 30

NOTE: Latching of the rear seatbacks can be adjusted by:

- a. Loosening the bolts shown in Figure 30.
- b. Moving / shifting the position of the seatback as needed.
- c. Retightening the bolts enough to prevent shifting of the seatback.
- d. Recheck latch for smooth operation.
- e. Repeat above steps as needed.

f. Once the seatback is adjusted, torque the bolts as follows:

- 4 left side rear seatback bolts, tighten in the order shown:
Torque to 45 Nm (4.6 kg-m, **33 ft-lb**)
- 4 right side rear seatback bolts, tighten in the order shown:
Torque to 45 Nm (4.6 kg-m, **33 ft-lb**)
