Compliance Recall

Code: 44K8

Subject: 2012 Beetle
Tire Replacement

September 11, 2012

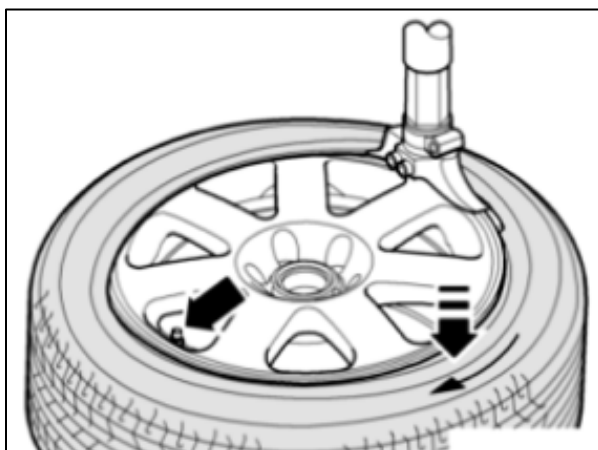
- Retrieve the wheel lock key from the vehicle.
 - With vehicle sitting on the ground, loosen but do not remove the five wheel bolts on all four wheels.
 - Raise vehicle on a hoist.
- ← Remove all five wheel bolts <arrows> from each wheel and remove the wheels.
- Remove core of each valve stem.
 - Remove all four tires from wheels.

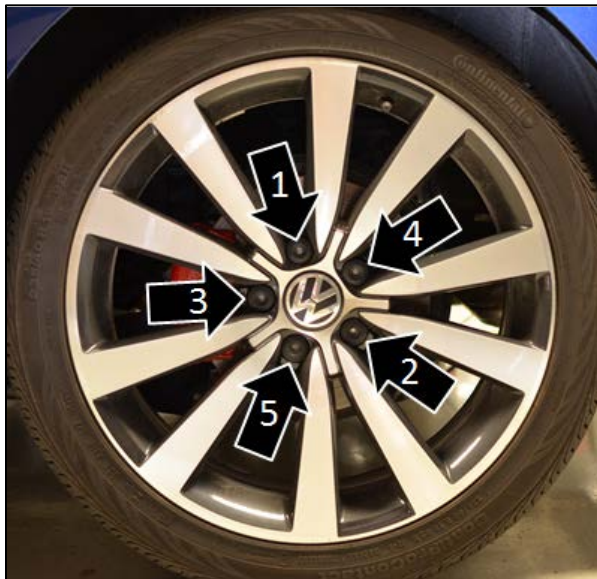
- ⇐ Make sure contact surfaces of hubs are clean of debris or corrosion <arrows>.
- Reinstall wheels on wheel hubs and hand tighten wheel bolts uniformly.
- Tighten wheel bolts diagonally to 30 Nm.
