ITB12-048a

## VOLUNTARY SAFETY RECALL CAMPAIGN 2013 JX35 FUEL SENDER

CAMPAIGN ID#: PC179  
NHTSA # 12V-398  
APPLIED VEHICLES: 2013 JX35 (L50)

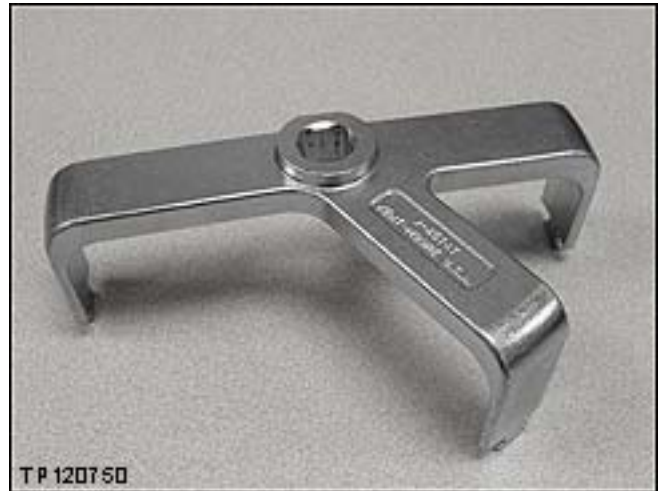
Figure A

**Required Special Tool – J-45747**  
(Lock Ring Wrench)

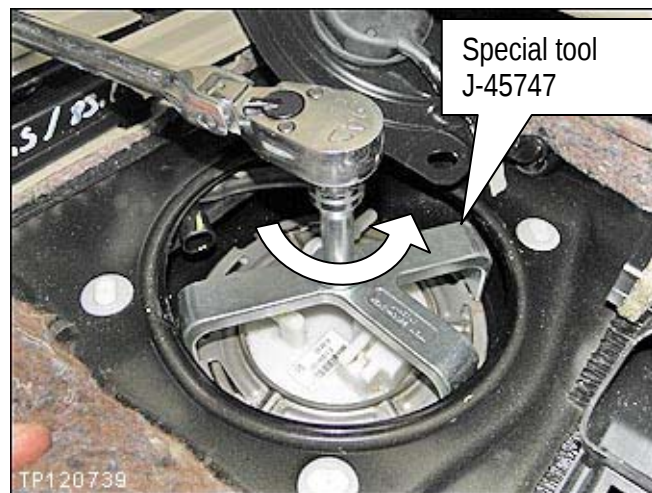
Figure 12

- In the next steps you will be removing and then reinstalling the fuel pump assembly to make sure the transfer hose inside the fuel tank is routed correctly.
- Figure 13 is provided to help understand the correct routing of the transfer hose.

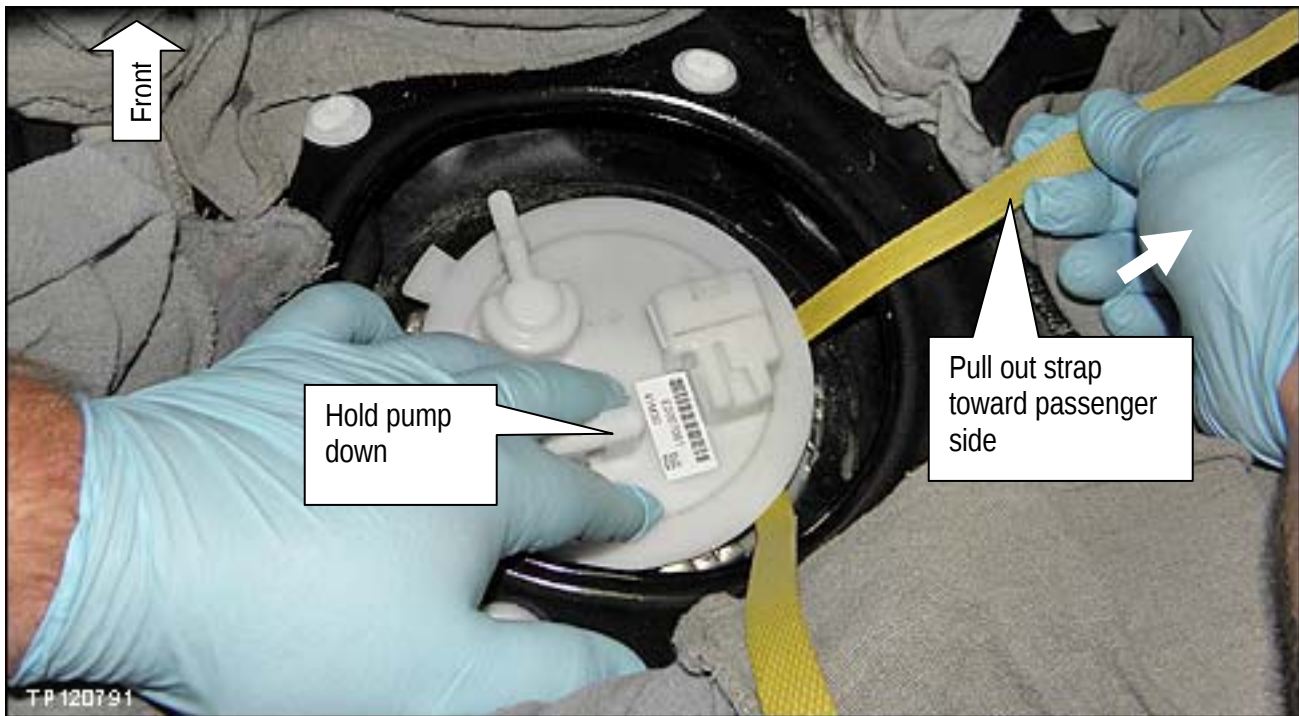
Figure 23

- h. Hold the fuel pump down so the bottom of the pump stays against the bottom of the tank.
- i. While holding the pump down, pull out the packing strap. Pull toward the passenger side.
  - Make sure the O-ring seal is still in place.

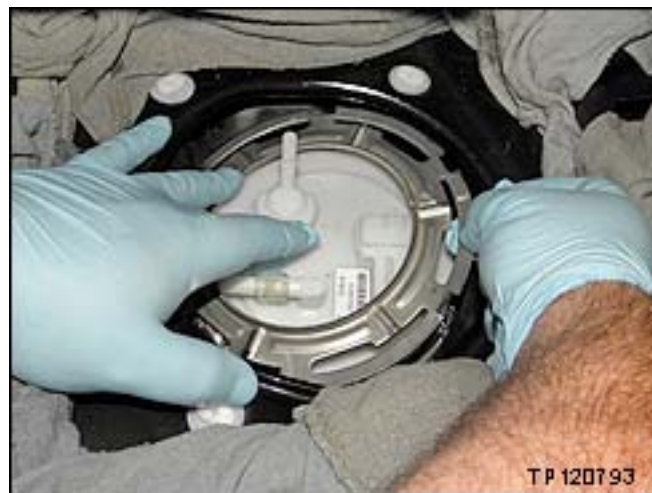
Figure 24

- j. Continue to hold down the fuel pump while installing the fuel pump lock ring.
  - Use special tool J-45747 to secure the lock ring.
  - Turn clockwise.

- If the fuel pump is allowed to lift off of the bottom of the fuel tank the transfer hose may slide under it.
- If the fuel pump lifts off the bottom of the tank before the lock ring is installed, remove the fuel pump and restart from the beginning of step 19.
