Models: MY 2012 and MY 2013 Panigale (All Versions)

Recall Bulletin RCL-12-006

Description of the technical problem:

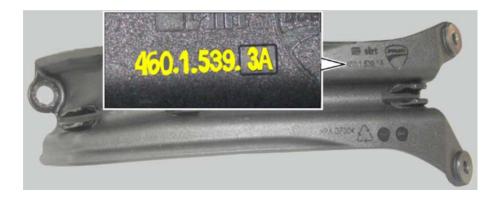
A) **EXHAUST BUTTERFLY VALVE BOWDEN CABLE SUPPORT** (all versions): In some rare conditions of engine faulty operation (for instance when the bike is operated while running on one cylinder due to a fouled spark plug) it is possible that the excess heat built up in the catalytic converter can overheat the lower engine area. This could cause the exhaust butterfly valve Bowden cable support, installed to the oil sump, to melt or burn. This part must be replaced with the new one having a higher heat rating. During this procedure it is also required that the technician re-tighten the screws retaining the silencer central brackets. (Even if this has previously been performed during the OIL SERVICE 1000 pursuant to Tips&Tricks no. 54).

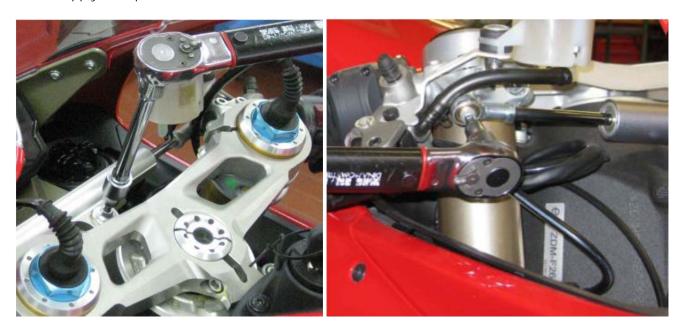
C) <u>STEERING DAMPER RETAINING SCREWS</u> (all versions): The two steering damper retaining screws might loosen from their original tightening torque. It is necessary to re-tighten the screws and properly apply the specified threadlocker.

- 1) Remove the *central screw (17)* retaining the steering damper to the frame, remove any trace of threadlocker and thoroughly degrease the surface.
- 2) Tighten the *screw (17)* with *LOCTITE 222* to *10 Nm ± 10%*.

- 3) Remove the *screw (18)* retaining the *steering damper (19)* to the right-hand handlebar, remove any trace of threadlocker and thoroughly degrease the surface.
- 4) Start the *screw (18)* with *washer (20)* in-between.

5) Tighten the *screw (18)* with *LOCTITE 222* to *10 Nm ± 10%*.

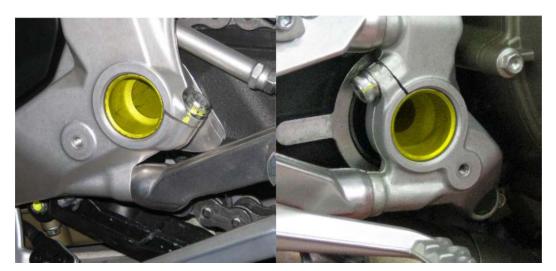
D) <u>SWING-ARM SHAFTS</u> (all versions): It is necessary to re-tighten again the right-hand and left-hand shafts fastening the swinging arm to the engine since they might not be tightened correctly.

- 1) Loosen the *screw (21)* from clamp on RIGHT-hand swinging arm shaft.
- 2) Loosen the *RIGHT-hand swinging arm shaft (22)* by 180° without removing it.
- 3) Tighten *RIGHT-hand swinging arm shaft (22)* to <u>100 Nm ± 10%</u>.
- 4) Tighten clamp *screw (21)* to <u>8 Nm ± 5%</u>.

- 5) Slacken the *screw (23)* from clamp on LEFT-hand swinging arm shaft.
- 6) Loosen the *LEFT-hand swinging arm shaft (24)* by 180° without removing it.
- 7) Tighten *LEFT-hand swinging arm shaft (24)* to <u>100 Nm ± 10%</u>.
- 8) Tighten clamp *screw (23)* to <u>8 Nm ± 5%</u>.

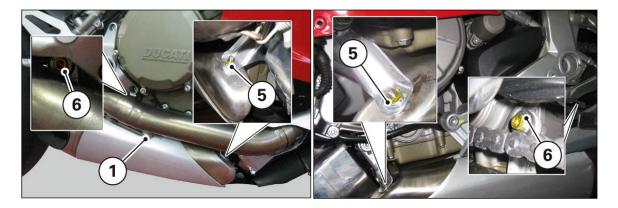
- 1) Remove the right-hand lower fairing (Section 05 of the Workshop Manual).
- 2) Remove the left-hand lower fairing (Section 05 of the Workshop Manual).
- 3) Remove the rear wheel (Section 07 of the Workshop Manual).
- 4) Remove the left-hand front footpeg (Section 07 of the Workshop Manual).
- 5) Remove the *silencer (1)* after loosening:
 - the *two screws (6)* retaining silencer brackets to crankcase.
 - the two front nuts (5).
 - the three screws (2) retaining silencer to central exhaust pipe (3).

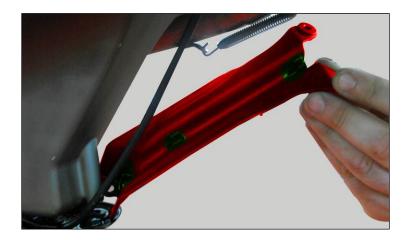
8) Release the exhaust butterfly valve cable from the clips of the *exhaust butterfly valve Bowden cable support (A)* and remove the latter.

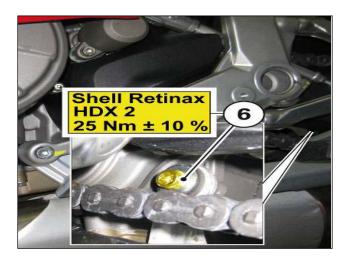
• Start the *two screws (6)* retaining silencer central brackets to crankcase.

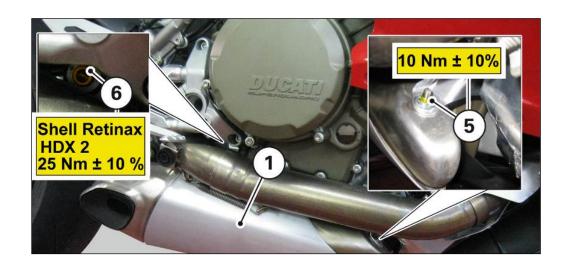
• Tighten all nuts and bolts to the specified torque settings shown in the figures below.

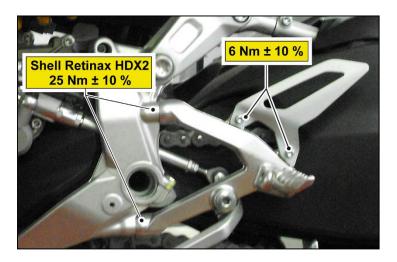
9) Refit the left-hand front footpeg and tighten the screws to the torques specified below.
