FOREST RIVER INC.

2013 LP GAS RECALL
US 12V-458/CANADA 2012-305
OCTOBER 2012

RECALL SUMMARY

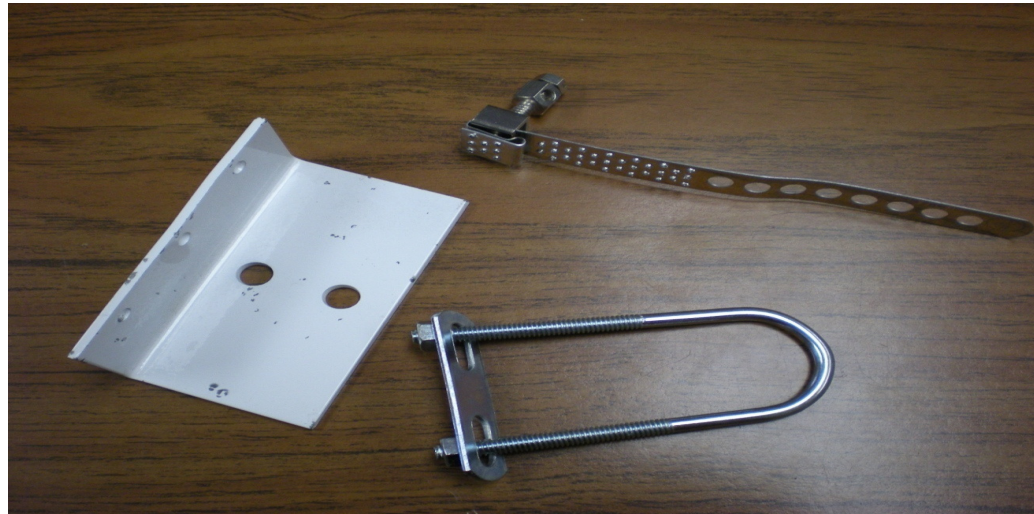
PARTS NEEDED

New bracket, U-bolt, and ground strap can be ordered as a kit from Forest River using part number 50G 01856A

In the event you need to order the parts from Forest River, all of these parts are available as a kit using Forest River part number 50G 01856A

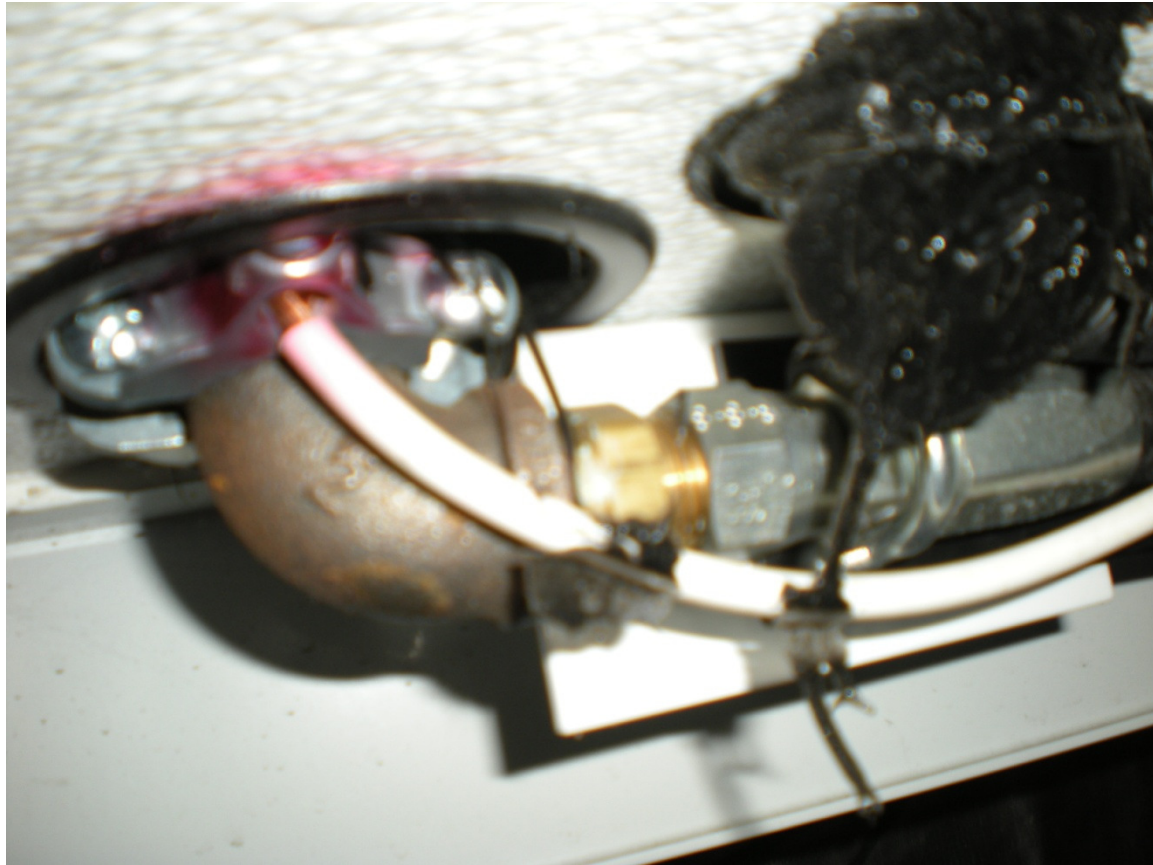
Example A

EXTERIOR UNDER SLIDE OUT

- **Start by removing the bracket and U-bolt on the LP line, the grounding bracket, ground wire, and black plastic flex guard. All found under the slide room (Example A). Disconnection of the LP line is not required or necessary.**

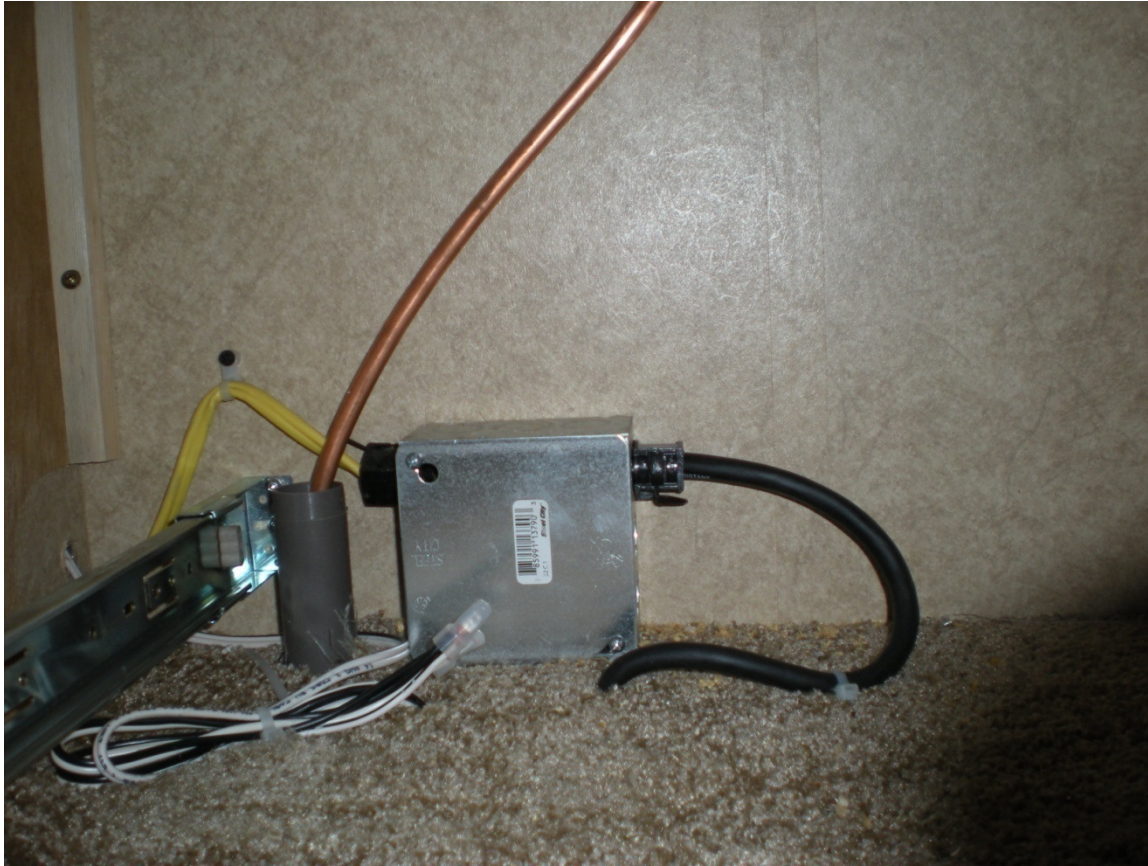
Example B

INTERIOR JUNCTION BOX

- **Fit the new bracket into place with the U-bolt holes against the slide room floor. Mark where the new U-bolt holes will need to be drilled.**
- **Locate the interior 12 volt junction box under the range or refrigerator appliance (Example B). Remove the drawer under the appliance to access the junction box for inspection. The junction box and/or wiring may need to be moved before drilling into the slide out floor. You can simply raise the junction box to prevent any disconnections (Example C)**

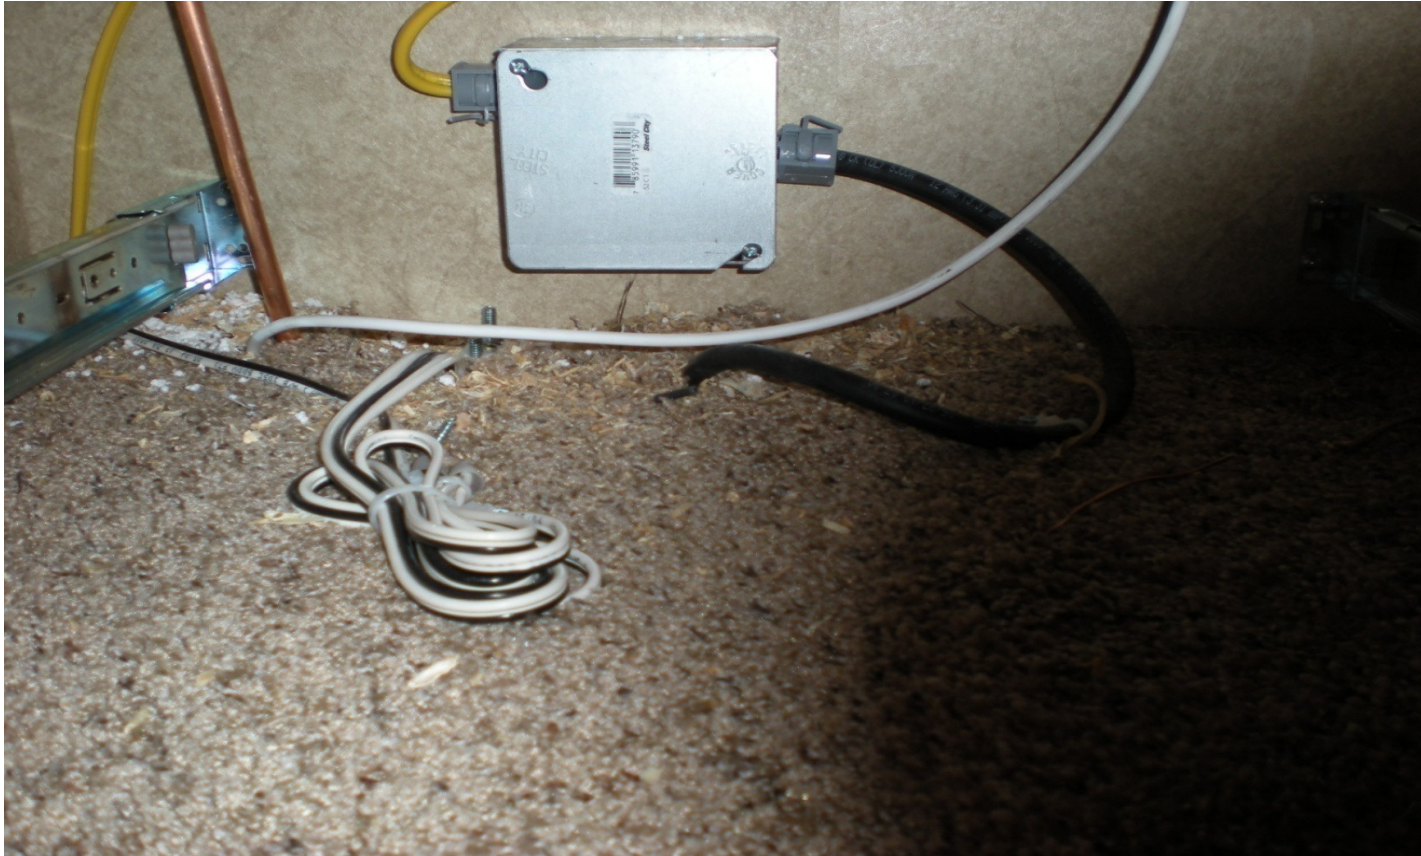
Example C

RAISED JUNCTION BOX

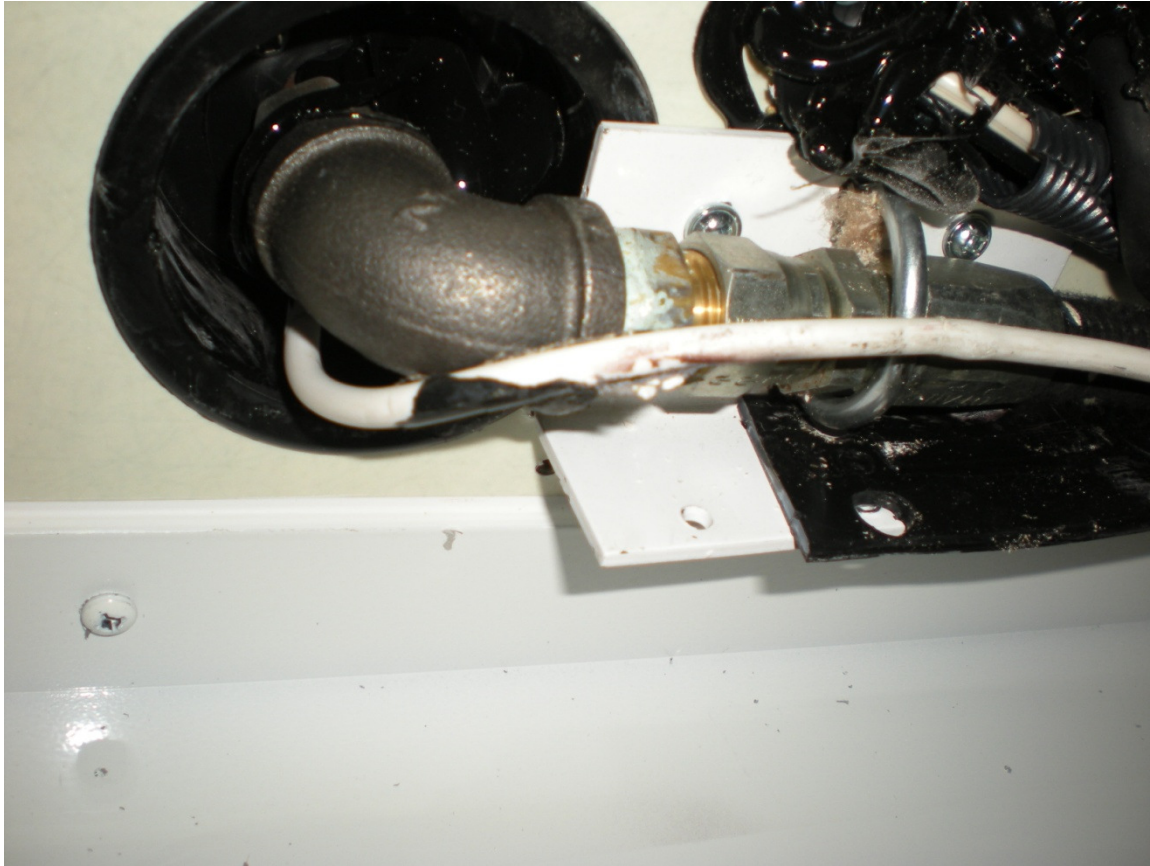
Example D

EXAMPLE OF A COMPLETED REPAIR

- **Drill the marked holes in the floor from under the slide out.**
- **Install ground wire to the steel LP line using the new smaller ground strap.**
- **Insert the U-bolt and attach the LP line to the bracket. The U-bolt must secure the LP line at the collar, not at the fitting (Example D).**
