Applies To: **2001–02 Civic** - Check the iN VIN status for eligibility
2000–01 Insight - Check the iN VIN status for eligibility

Safety Recall: Combination Light Switch

(Supersedes 04-015, dated April 1, 2004 to revise the information marked by the black bars)

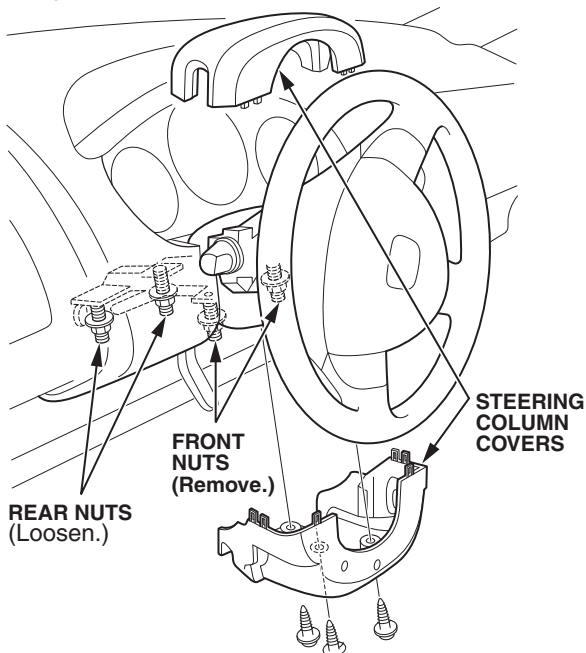
- For Civic 2/4 Door see page 17-27, step 4 in the 2001-04 Civic Service Manual, or
- Online enter keyword **GH99F-B**; and select **Steering Column Removal and Installation** from the list.
- For Civic Hatchback see page 17-9, step 4 in the 2002-04 Civic Hatchback Service Manual, or
- Online enter keyword **GH99F-B**; and select **Steering Column Removal and Installation** from the list.
- For Insight see page 17-9, step 5 in the 2000-04 Insight Service Manual, or
- Online enter keyword **GH99F-B**; and select **Steering Column Removal and Installation** from the list.

Insight is shown

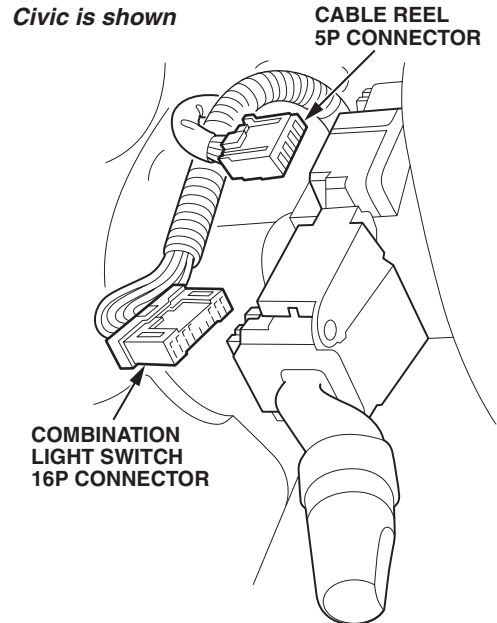
3. On *Civics*, disconnect the 16P connector from the combination light switch and the 5P connector from the cable reel.

On *Civic Hatchbacks*, also disconnect the 14P connector from the wiper switch. Then carefully pull the wire harness to the right of the steering column.

On *Insights*, disconnect the 16P connector from the combination light switch.

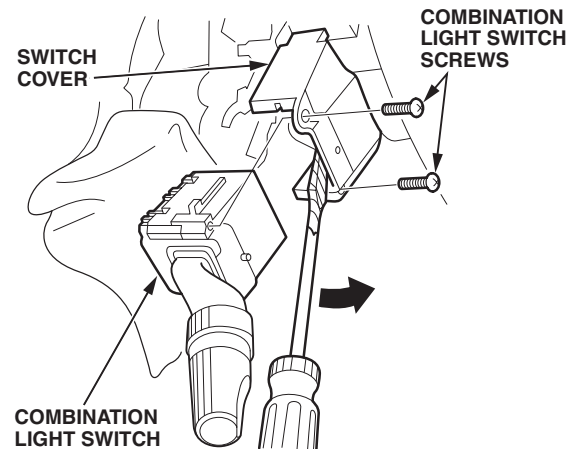
4. Turn the ignition switch to the ACCESSORY (I) position, then turn the steering wheel to the right.

5. Remove the two screws from the combination light switch.

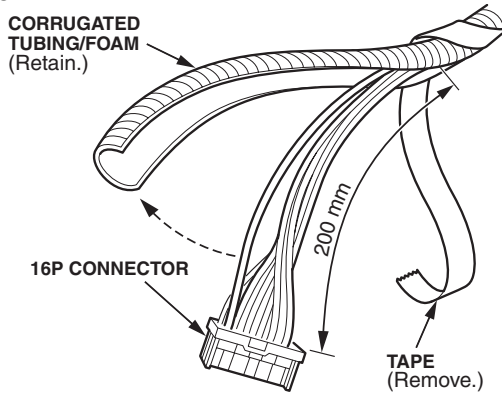
6. Using a flat-tip screwdriver wrapped with electrical tape, slightly lift the switch cover, then remove the switch, and discard it.

- Remove the tape or corrugated tubing/foam from the 16P connector wire harness to expose about 200 mm of wire. Discard the tape, but retain the tubing/foam.

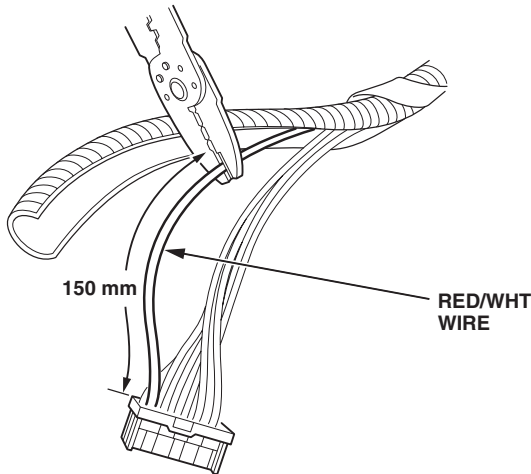
- Locate the RED/WHT wire in the 16P connector. Then measure 150 mm from the end of the connector, and cut the RED/WHT wire there.

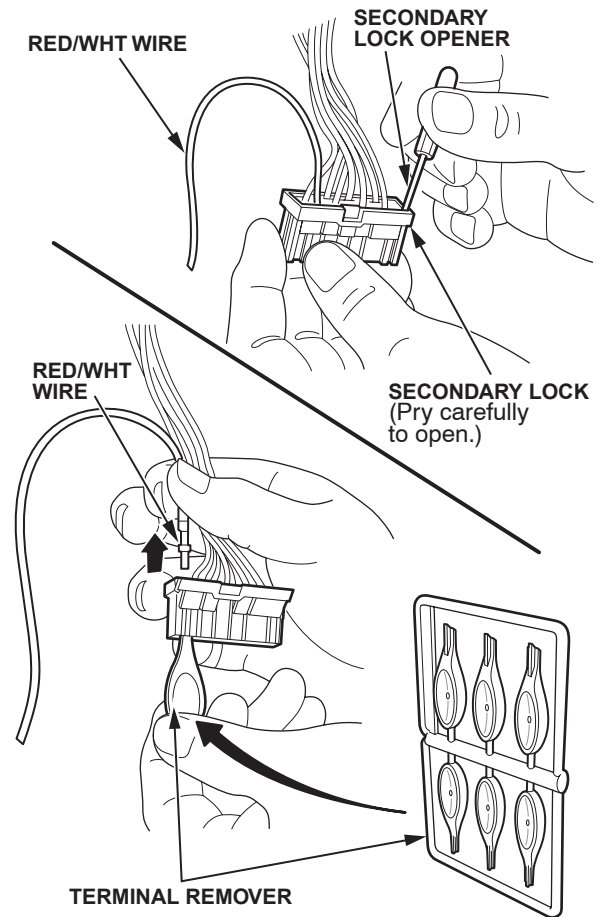
- Inspect the 16P connector for heat damage or discoloration.
 - If the connector is OK, go to step 10.
 - If the connector is damaged or discolored, go to step 12.

- Using the Secondary Lock Opener from the Terminal Maintenance Set (T/N 070AZ-S5A0100), carefully pry open the secondary lock on the RED/WHT wire side of the 16P connector.

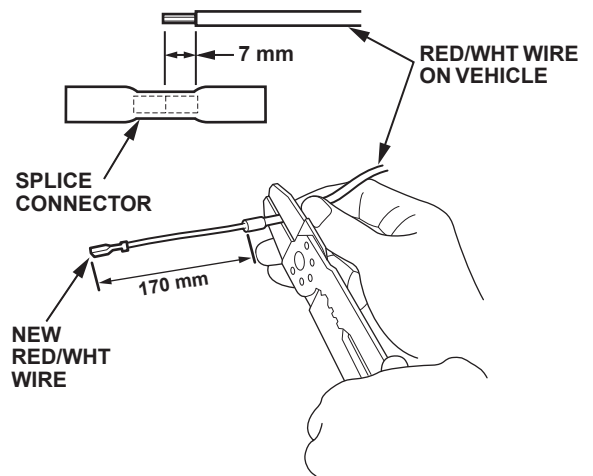
- Twist off a terminal remover from the Terminal Remover Set (T/N 070AZ-S5A-011). Insert the terminal remover into the center row cavity of the 16P connector, above the RED/WHT wire cavity, then remove and discard the RED/WHT wire.
- Strip off 7 mm of insulation from the vehicle wire harness side of the RED/WHT wire. Insert the stripped end into one side of the splice connector, and crimp the connector.

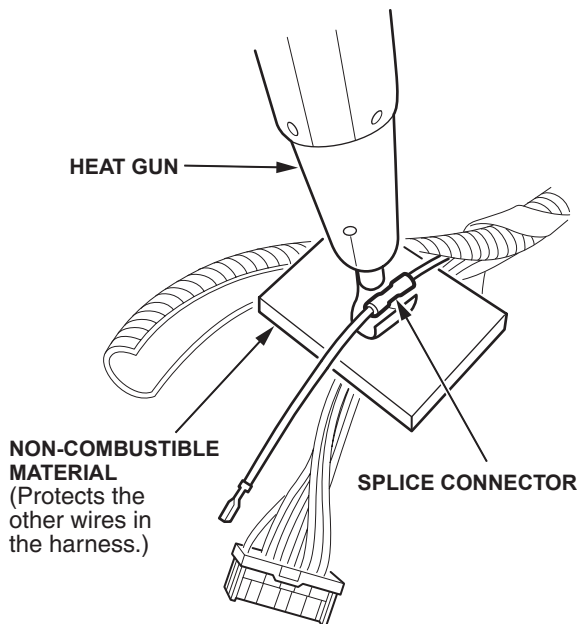
13. Cut the new RED/WHT wire 170 mm from the end of its terminal. Then strip off 7 mm of insulation from the cut end.
14. Insert the stripped end of the new RED/WHT wire into the other side of the splice connector, then crimp the connector.
15. With a non-combustible material between the RED/WHT wire and the vehicle wire harness, use a heat gun to shrink the splice connector casing.

- Be careful not to get burned.
- Do not overheat the wire.

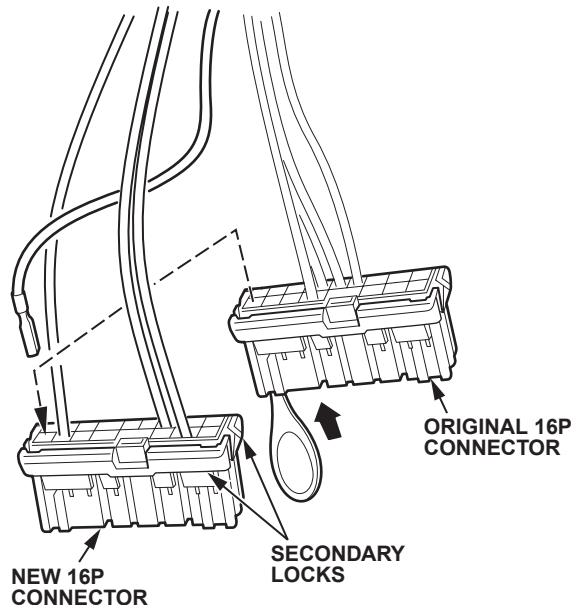
16. If the original 16P connector is not heat damaged or discolored, insert the new RED/WHT wire into its proper terminal cavity on the connector, then go to step 20. If the 16P connector is damaged, go to step 17.
17. Using the secondary lock opener from the Terminal Maintenance Set (T/N 070AZ-S5A-010), carefully pry open the other secondary lock on the 16P connector.

18. Twist off a terminal remover from the Terminal Remover Set (T/N 070AZ-S5A-011). Insert the terminal remover into a center row cavity of the original 16P connector, remove the corresponding wire from its cavity, and transfer it to the same cavity in the new 16P connector. Repeat this for all the wires except the original RED/WHT wire.
