**Safety Recall Notice**  
**NHTSA Campaign No. 12V-496**  
**Service Bulletin 38045**

Instructions for Aftermarket Front Seat  
Cover Evaluation and Removal  
Applicable for 2012 Chrysler/Dodge  
Commercial ADA Entervan

# Front Seat Cover Safety Recall Service Bulletin 38045

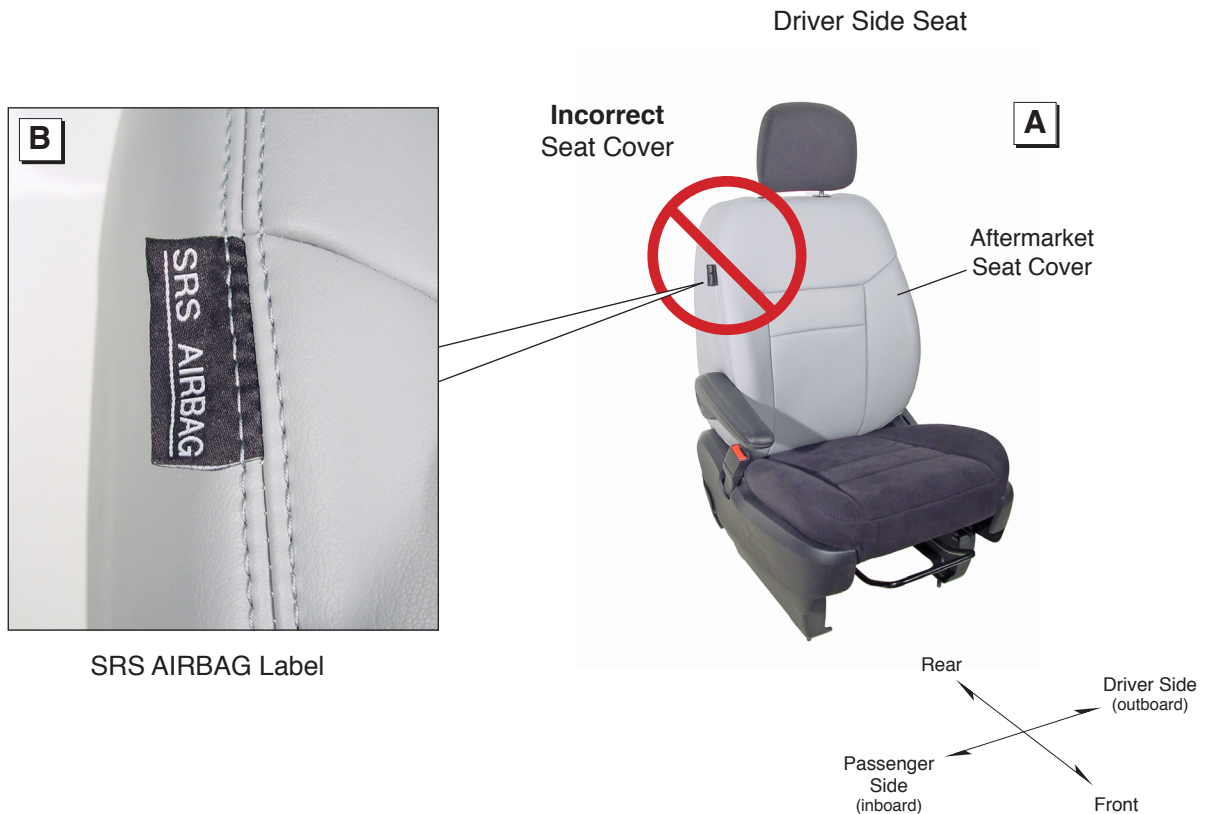
Examine the front seat covers. Refer to Photos A and B.

The seat mounted side airbag is marked with an airbag label sewn into outboard side of the seat. The SRS Airbag labels must be located on outboard seat bolster (toward the door).

If SRS Airbag labels are on outboard bolster - no further action is required. **Disregard** the remainder of this bulletin.

If the labels are on inboard bolster, the aftermarket seat covers **must be removed** as detailed in this bulletin (seat back covers only). Review all procedures before beginning.

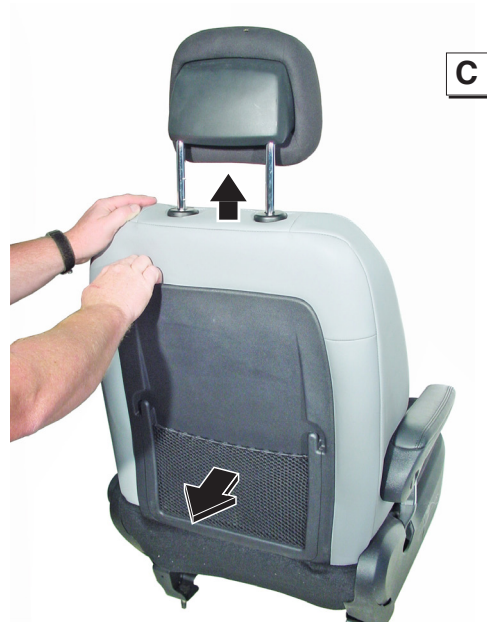
Carefully pry outward, unsnap, remove and retain the plastic seat back cover. See Photo C.

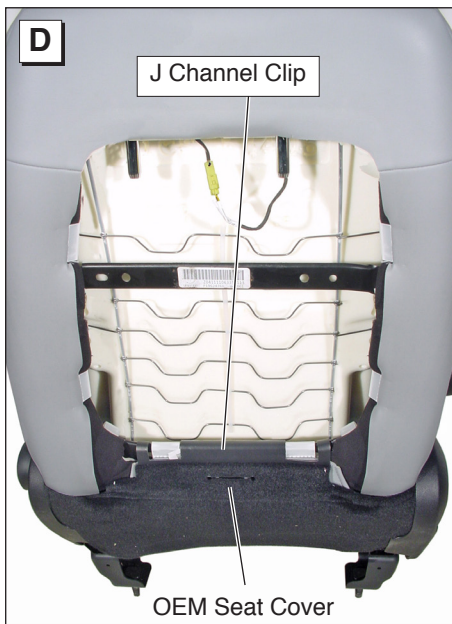
Disengage the plastic “J” channel securing the bottom of the OEM seat cover to the lower cross bar (Photo D). Allow to hang freely. See Photo E.

- 7** Reattach the plastic “J” channel to secure the bottom of the OEM seat cover to the lower cross bar. See Photos D and E on page 2.

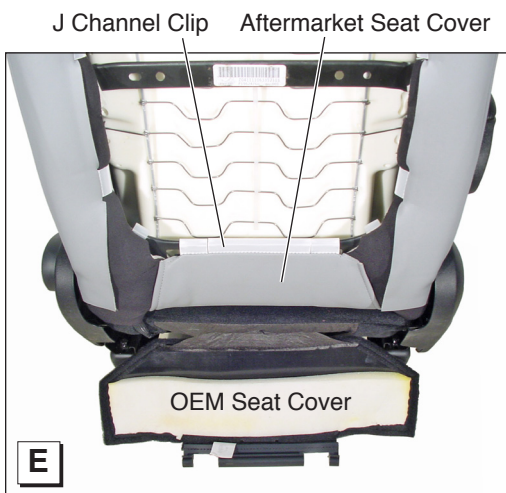
Disengage the plastic “J” channel securing the bottom of the aftermarket seat cover to the lower cross bar. See Photo E.

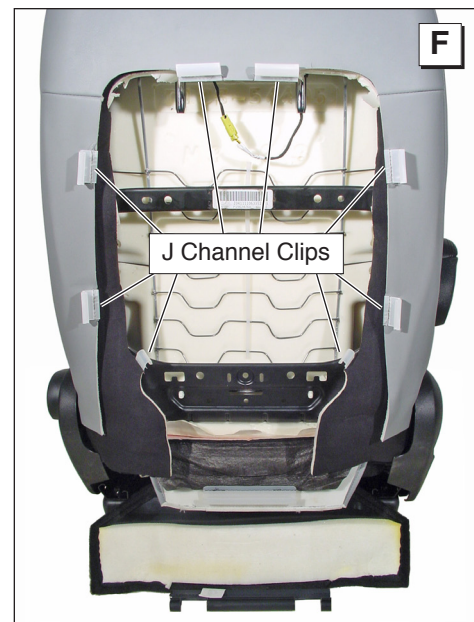
Disengage all remaining plastic “J” channel clips securing aftermarket seat cover to seat (both sides and top). See Photo F.

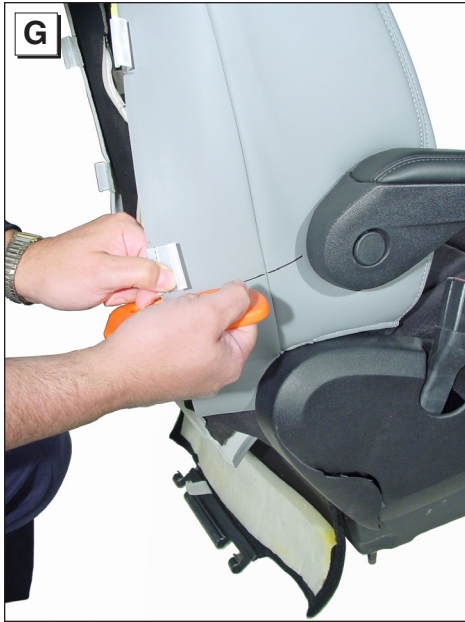
- 4** Using the supplied web cutter, **carefully** cut a horizontal line from the back of the cover to center of the armrest pivot mount. See Photo G.

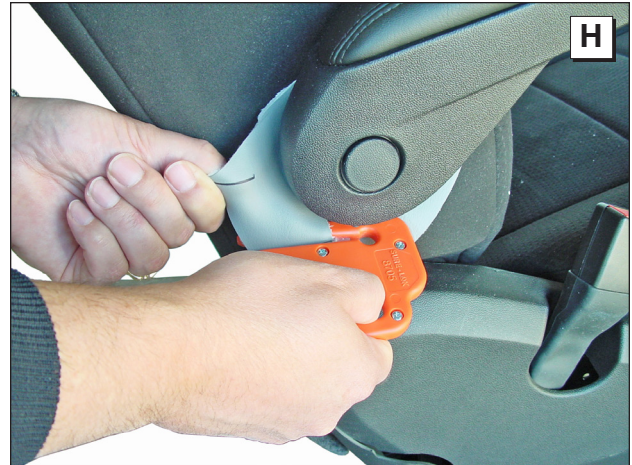
Carefully insert web cutter in seat cover armrest access hole and cut a path away from the hole. See Photo H.

Manually split the vinyl from cut to armrest mount to free the cover from the armrest position.

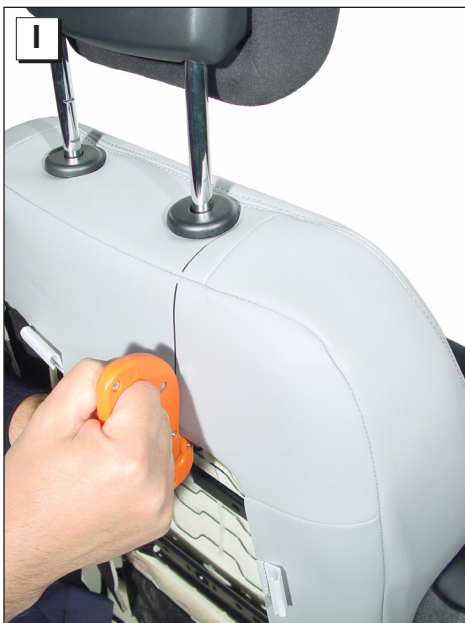
- 5** Using the web cutter, **carefully** cut a path from the back of the cover to the side of the headrest telescoping tube trim ring. See Photo I.

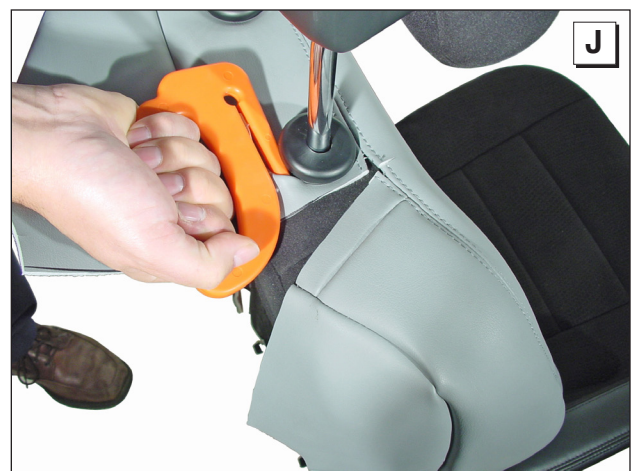
Carefully insert web cutter in seat cover tube access hole and cut a path away from the hole. See Photo J.

Manually split the vinyl from cut to telescoping tube. Free the cover from the headrest position.

Typical procedures for both headrest tubes.
