# ***SERVICE PROCEDURE***

**G-12530  
JANUARY 2013**

**SUBJECT: SAFETY RECALL – INTERIM NOTICE**  
**Brake S-Cam tube bracket assembly on certain ProStar® and TranStar® models built 1 August 2011 through 12 June 2012 with feature code 0504501, 0504504, or 04EWM.**

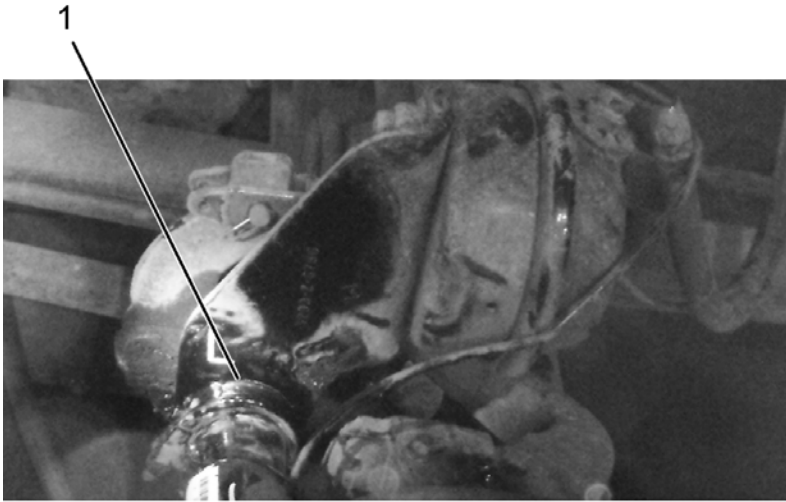
**Figure 1. S-Cam Tube and Wing Bracket.**

1. Area between S-Cam tube and wing bracket

A final remedy is under development and repair parts will not be available until mid-April 2013. During this interim period, the S-Cam tube-to-bracket area should be inspected for signs of any cracking at each regularly scheduled Preventive Maintenance (PM) Service. Refer to Figures 1 and 2 in this Safety Recall. If any cracks are noted during inspection, a case file must be created before replacing the tube assembly. Fleets should contact Tech Service at 800-336-4500 and press option 3 for Diagnostic and Repair Support.

Inspect entire area between S-Cam tube and wing bracket for cracks (Figure 1, Item 1 and Figure 2, Item 1).

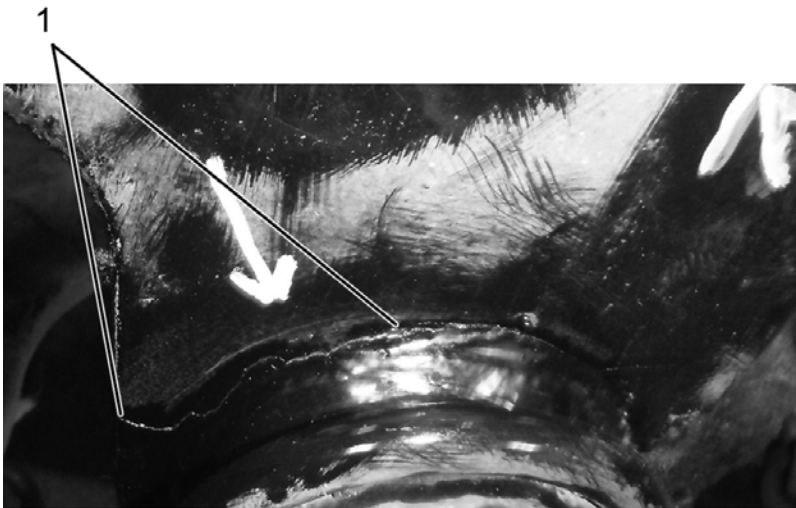
**Figure 2. S-Cam Tube and Wing Bracket.**

The brake S-Cam tube bracket assemblies on steer axles may exhibit fractures between the wing bracket and the tube steel when mounted to stamped spiders. Fractures between the wing bracket and the tube steel may result in an inoperative brake on the affected wheel end. This may result in an unexpected pull condition during braking application or an unexpected increase in stopping distance and may contribute to a vehicle crash, which may result in property damage, personal injury, or death.

1. Crack between S-Cam tube and wing bracket
