Safety Recall: Steering Column

BACKGROUND

During vehicle assembly, the wrong tilt bracket was installed on the steering column on a small number of vehicles. If an affected vehicle is involved in a crash, the steering column may not absorb the force of the impact as designed.

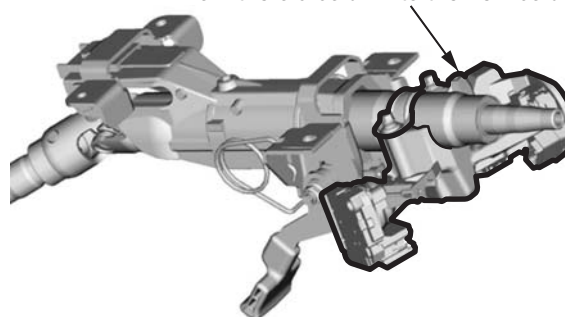
Transfer the ignition switch assembly from the old column to the new column.

2. Remove the two break-away bolts and remove the ignition switch assembly from the original steering column.

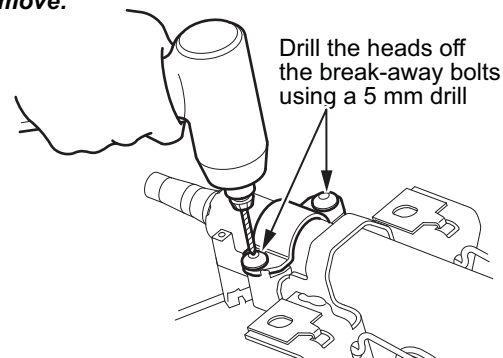
Remove:

Drill the heads off the break-away bolts using a 5 mm drill

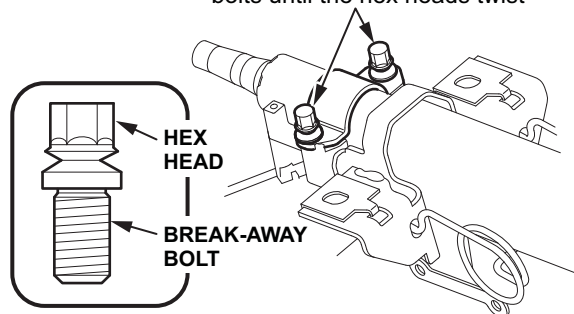
Reinstall:

Tighten the new break-away bolts until the hex heads twist

3. Transfer the ignition switch assembly to the new steering column using new break-away bolts.
4. Install the steering column. Refer to the online service manual.
