## INSTRUCTIONS TO PERFORM CAMPAIGN 127 (Era® Models 144U, 170A, 170R, and 170X) (View® Profile/Navion® iQ Models 524G and 524V)

Certain 2009 through 2013 model year Winnebago Industries Era (Models 144U, 170A, 170R, and 170X) and Winnebago View Profile/Itasca Navion iQ (Models 524G and 524V) motorhomes.

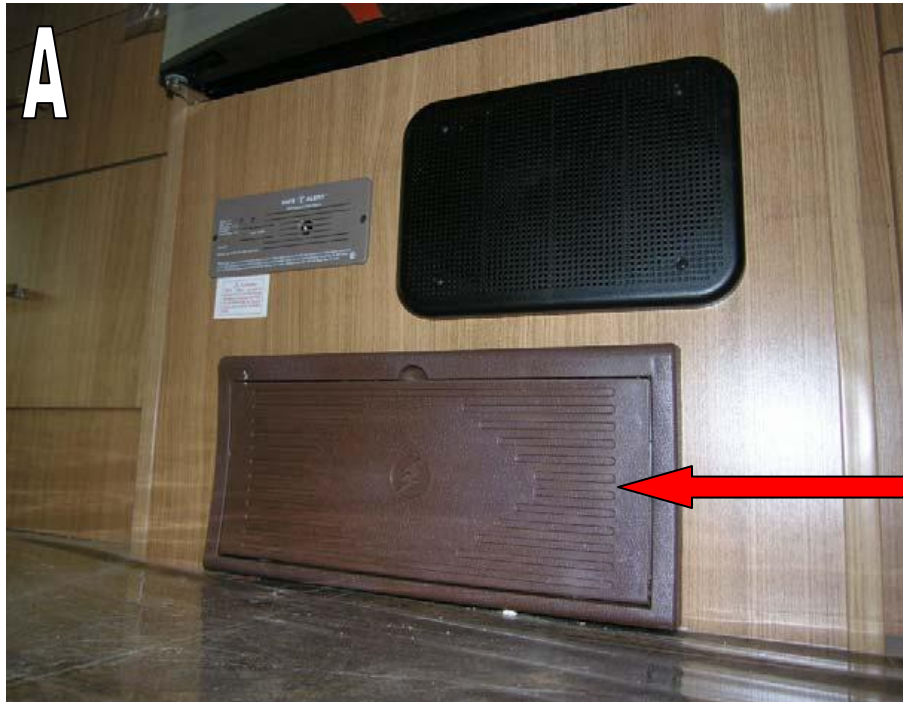
1. Locate the Power Center. See Photo A.

*(Typical View)*

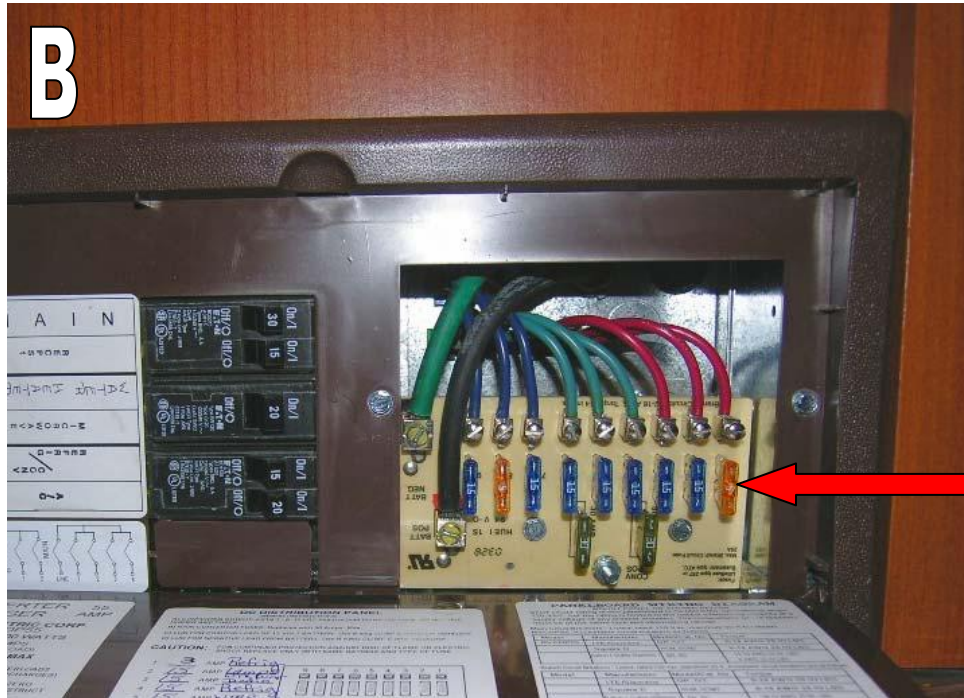
3. View "DC Distribution Panel," label to locate the 5-amp. (tan) refrigerator fuse (generally the far right fuse in the power center). Remove the current 5-amp. (tan) fuse and discard. **NOTE: There is also a 15-amp. refrigerator fuse. Do not change the 15-amp. refrigerator fuse.** See Photo B.

(Typical View)  
(Fuse configuration may vary by model according to available equipment)

Remove current 5-amp. (tan) refrigerator fuse and replace with 3-amp. (violet) refrigerator fuse, as required.

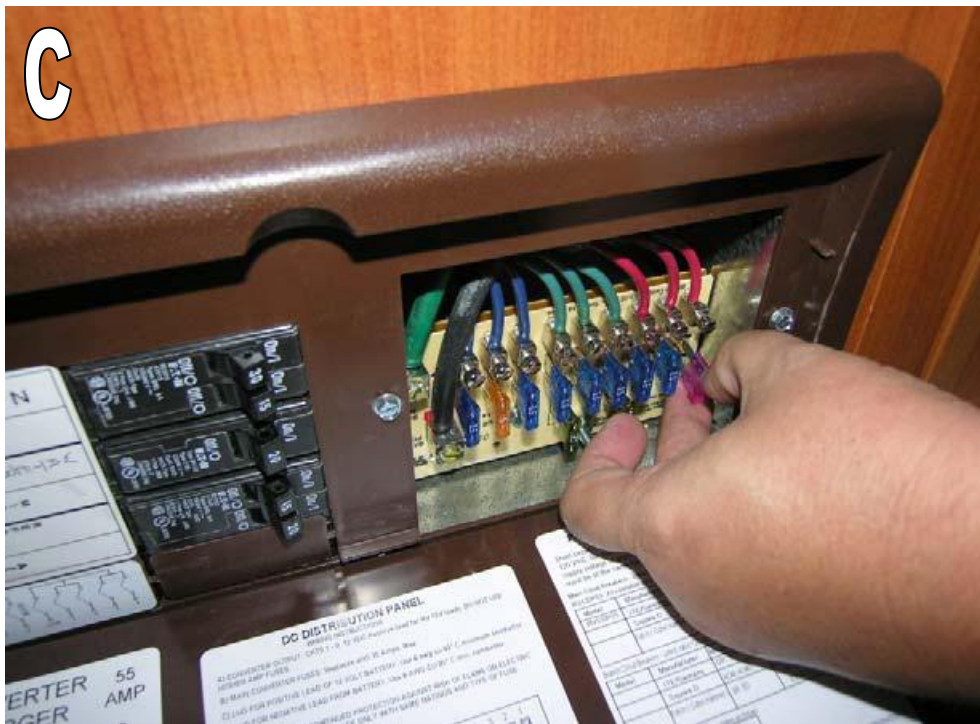
4. Install new 3-amp. (violet) fuse (from kit) into socket. See Photo C.

(Typical View)

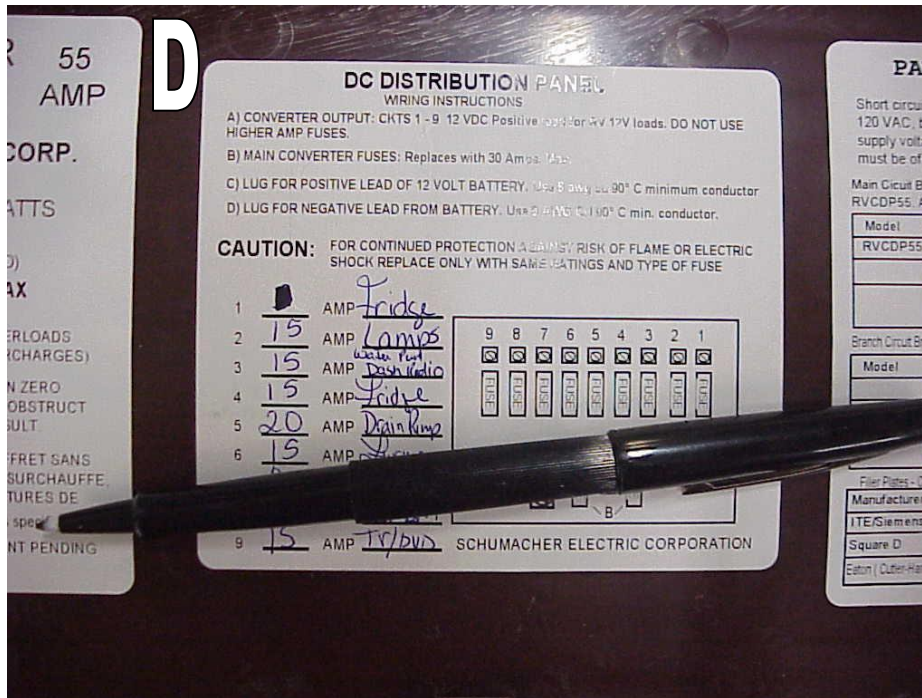
- On the "DC Distribution Panel," label with a permanent marker, black out the "5" and write in a "3" for the refrigerator. See Photos D and E.

(With a Permanent Marker, Black Out the "5" on Line 1)

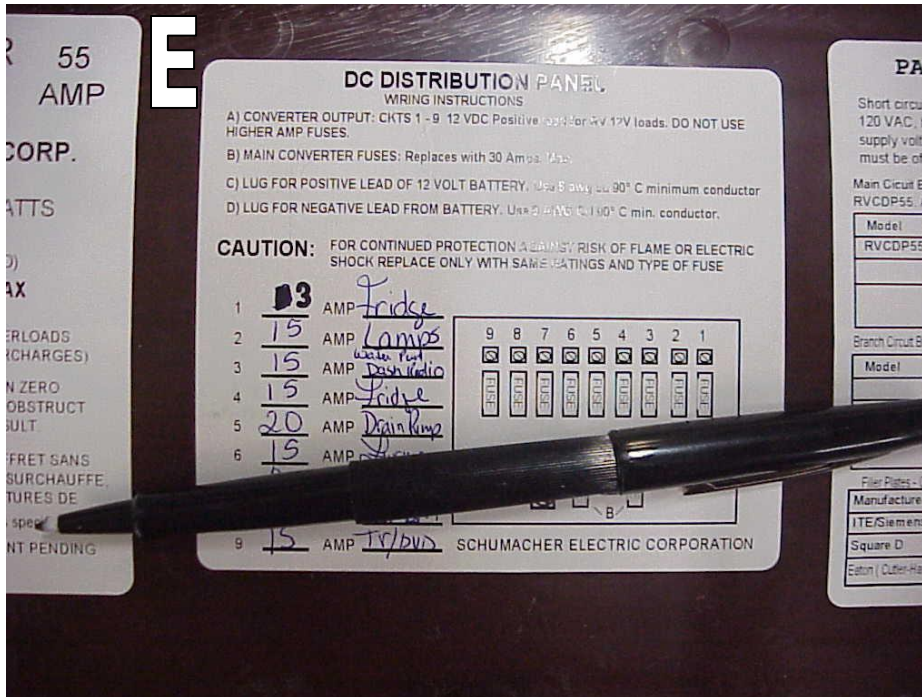
(With a Permanent Marker, Black Out the Number "5" and Write In "3")
